### HOME INSPECTION REPORT

On Monday, March 31, 2025 The HomeTeam Inspection Service made a visual inspection of 123 Anywhere St., City, ST 12345. Enclosed please find a written, narrative report of our findings in accordance with the terms of our Inspection Agreement.

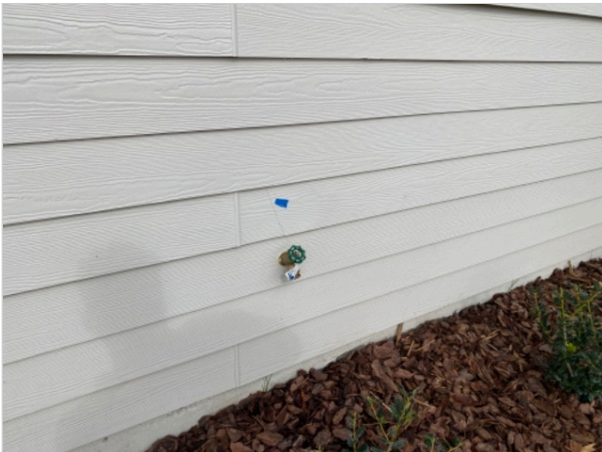
Photo 7

**Damaged siding was observed on the right side of the structure. Consult with a qualified contractor for replacement.**

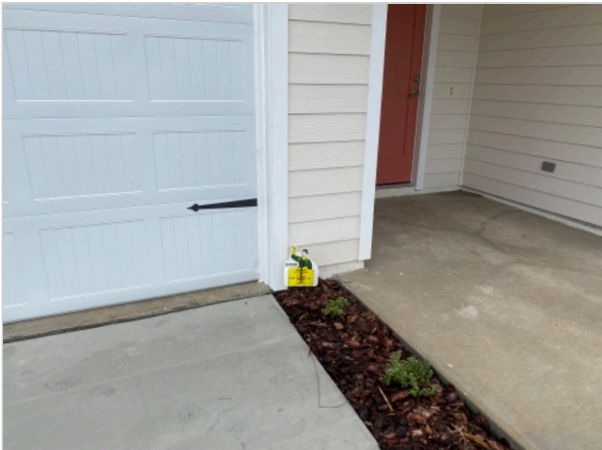
Photo 24

**The garage door is dented from what appears to be impact.** The door was operating correctly at the time of the inspection. Care should be exercised to ensure that the door is not subjected to further impact, as the door may crack or fail.

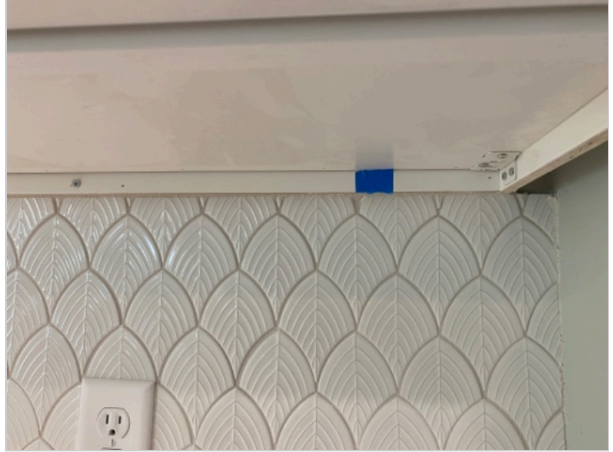
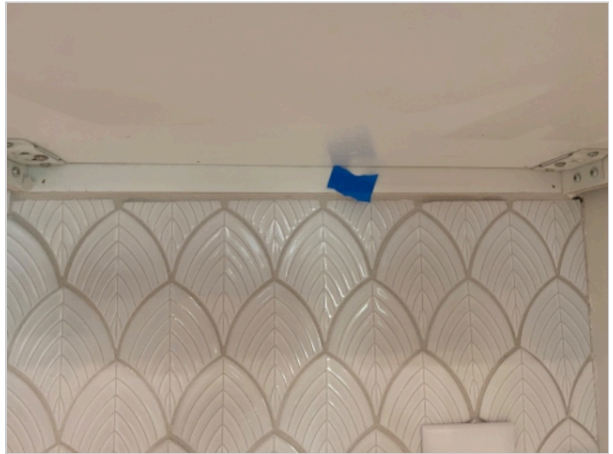
**Portions of the kitchens cabinets were not completely secure to the wall.** The cabinets should be secured to prevent them from falling.

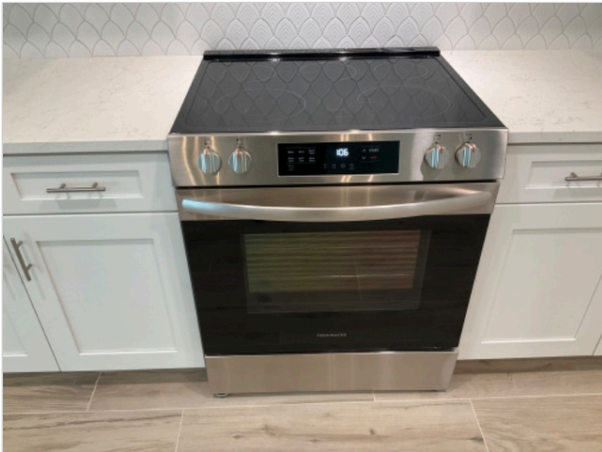
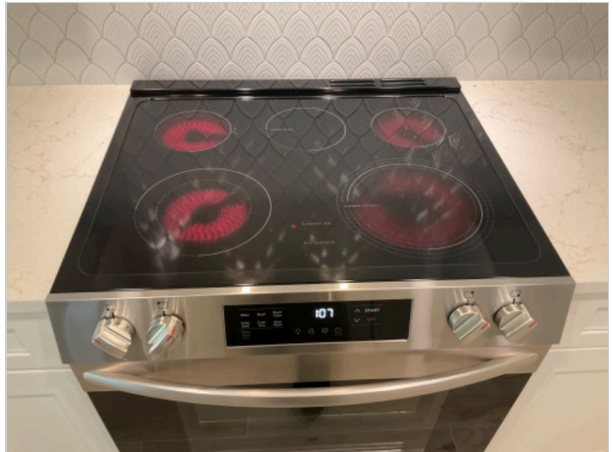
The electric oven and range combo was inspected and did appear to be functional. The accuracy of the clock, timers and settings on ovens are not within the scope of this inspection.

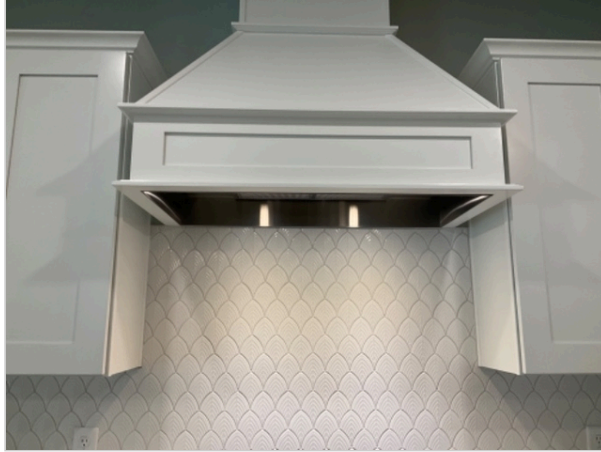
**Photo 77**

The range hood was inspected and did appear to be functional. The exhaust capacity is not within the scope of this inspection. Cleaning the fan and filter may increase the exhaust capability.

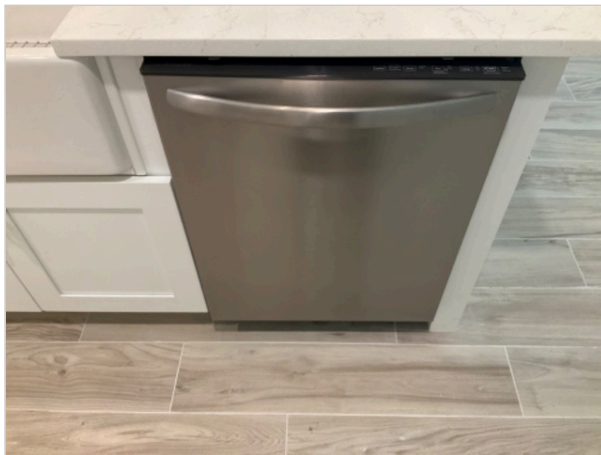
**Photo 78**

The dishwasher was tested and did appear to be functional.

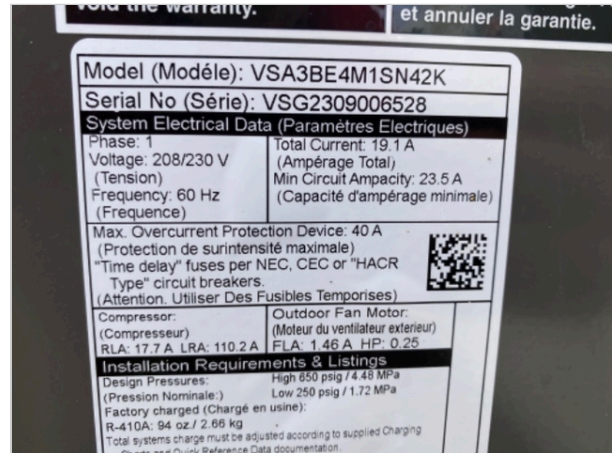
Number VSG2309006528. The unit is located on the left side of the structure. This unit is approximately less than one years old. Periodic preventive maintenance is recommended to keep this unit in good working condition. The cooling system was functional.
