HOME INSPECTION REPORT

**123 Sample Drive
Anytown, TX 55555**

PROPERTY INSPECTION REPORT

Prepared For:	Bill Sample	
	(Name of Client)	
Concerning:	123 Sample Drive, Anytown, TX, 55555	
	(Address or Other Identification of Inspected Property)	
By:	Inspector 1 Inspector 2	9-29-2017
	(Name and License Number of Inspector)	(Date)
	(Name, License Number of Sponsoring Inspector)

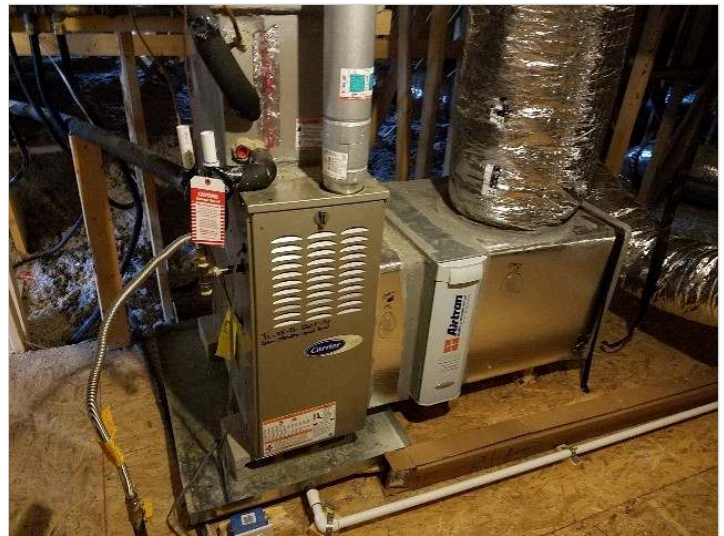
view of upper HVAC unit.
