HOME INSPECTION REPORT

The HomeTeam Inspection Service made a visual inspection of 123 Anywhere St., City, ST 12345. Enclosed please find a written, narrative report of our findings in accordance with the terms of our Inspection Agreement.

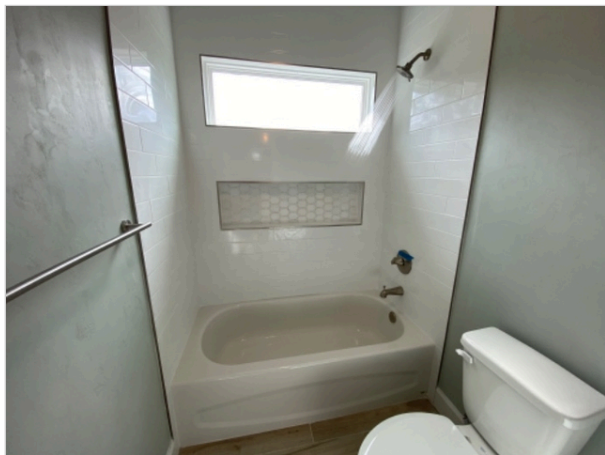
Photo 49

The Jack and Jill toilet shut off is leaking.

Leaks were observed at the toilet shut off in the Jack and Jill bathroom when in use. The tub and sink in the hall bathroom drain slowly. A licensed plumbing company should be called to evaluate the system and make any repairs.

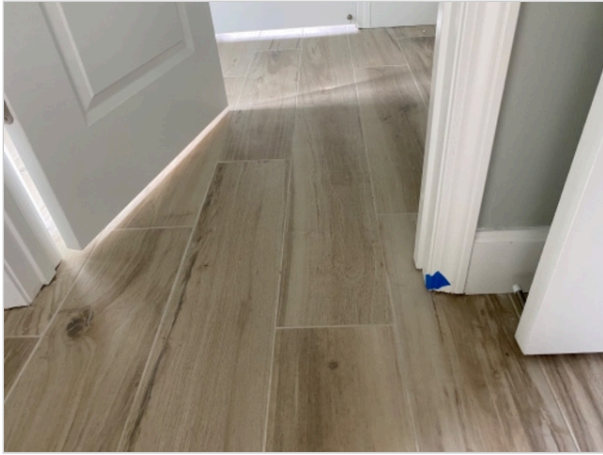
Photo 59

An exposed nail was observed at the guest bedroom/ jack & jill bathroom door frame that should be removed

and has been marked with blue tape to help the builder and contractors identify said issues.

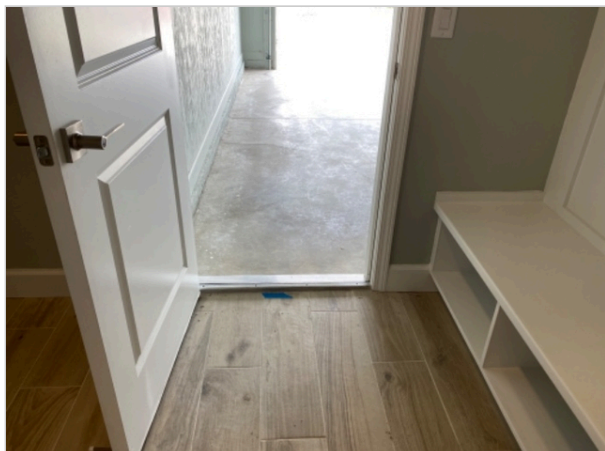
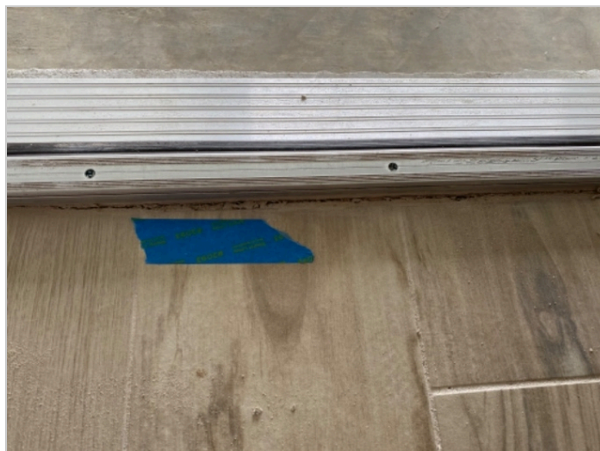
The home was in the final stages of construction. There were blemishes and nicks observed in areas of the home, which is normal. Many areas were marked with blue tape, to help the builder and contractors identify said issues.
