HOME INSPECTION REPORT

Address of Inspection: **123 Sample Drive, Louisville, KY**

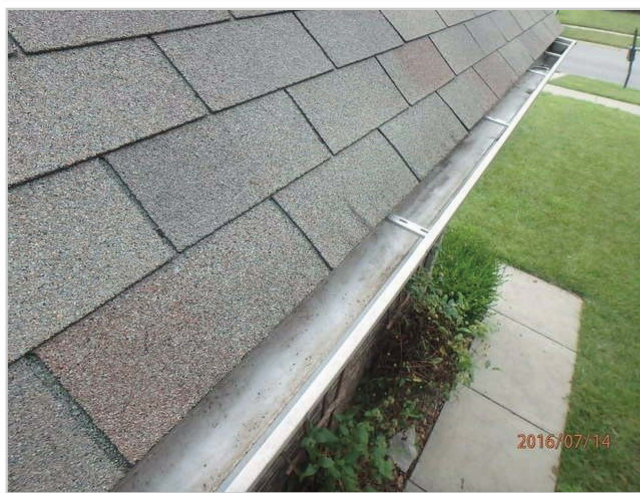
Photo 7

gutters

Several downspouts were draining at or too close to the base of the foundation. To reduce the likelihood of water problems at the base of the home, all roof drainage should be directed at least six feet from the base of the foundation.

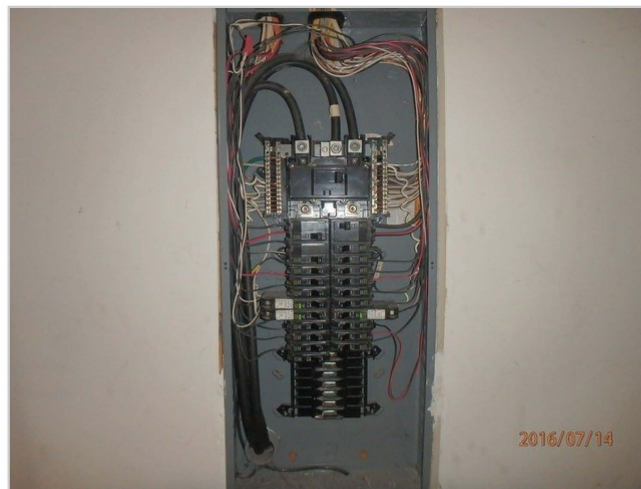
Photo 17

The electrical service appeared to be adequate. As a reminder, alarms, electronic keypads, remote control devices, landscape lighting, telephone and television wiring are beyond the scope of this inspection.

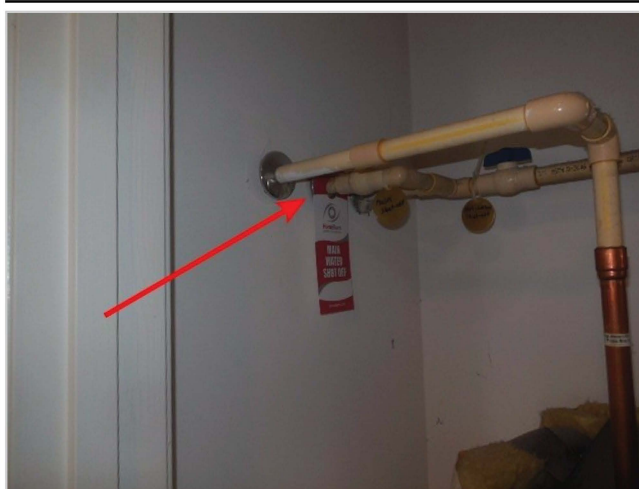
Photo 21

The main water shutoff valve for the home was located adjacent to the water service entry point above the water heater in the closet. Water shutoff valves are visually inspected only. No attempt is made to operate the main or any other water supply shutoff valves during the inspection. These valves are infrequently used and could leak after being operated.

Main water shut off.

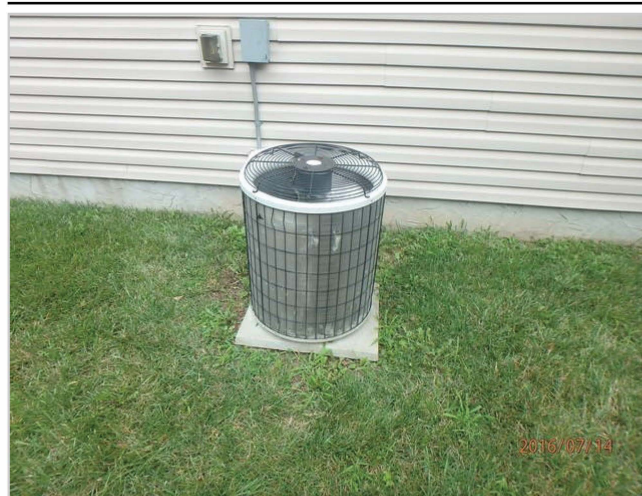
Photo 27

The electric outdoor air conditioner condensing unit was a Payne, Model Number PA10JA036C and Serial Number 4104E13255. The unit is located on the left side of the home. This unit is approximately 12 years old. Periodic preventive maintenance is recommended to keep this unit in good working condition, and HomeTeam strongly recommends partnering with a reputable HVAC company for routine maintenance for the heating and cooling systems in the fall and spring. The air conditioning system was tested and found to be functional. As a reminder, this is functionality test and visual inspection only; we do not check suction pressures, contactor amps, or refrigerant levels. If a more detailed inspection is required, please consult with an HVAC company.

The temperature split for the air conditioner was measured at several locations and was approximately 10 degrees F, which is normal.
