HOME INSPECTION REPORT

On Wednesday, July 24, 2019 The HomeTeam Inspection Service made a visual inspection of 123 Sample Dr, Anytown, TN . Enclosed please find a written, narrative report of our findings in accordance with the terms of our Inspection Agreement. Although maintenance items may have been addressed verbally at the time of inspection, they may not be included in the enclosed report.

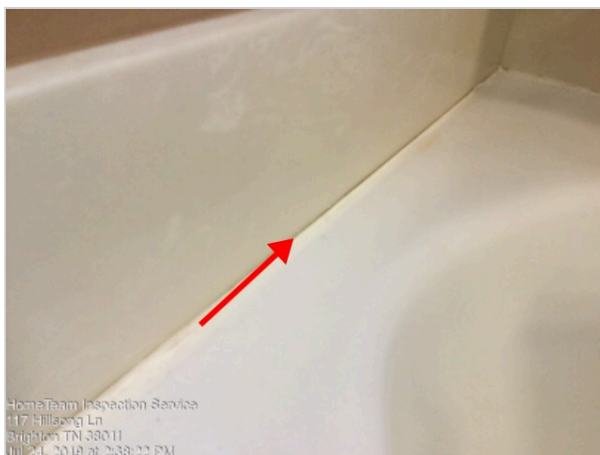
Photo 34

There was a gap in some of the caulk around the tub in the master bathroom. These areas should be sealed to prevent moisture penetration. Failure to keep walls sealed can cause deterioration and extensive moisture damage including mold growth to the interior walls, which is not always visible at the time of the inspection.

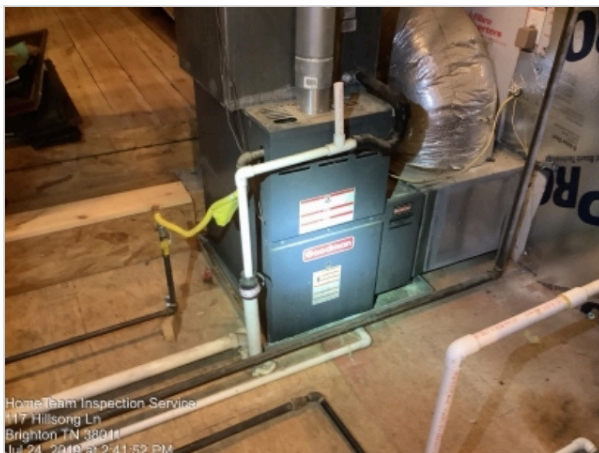
Photo 41

1. There is water in the catch pan beneath the downstairs furnace. This indicates there is a problem with the condensate drainage system. A licensed heating and air specialist should further evaluate and repair as necessary.

There is water in the catch pan beneath the furnace. This indicates there is a problem with the condensate drainage system. A licensed heating and air specialist should further evaluate and repair as necessary.

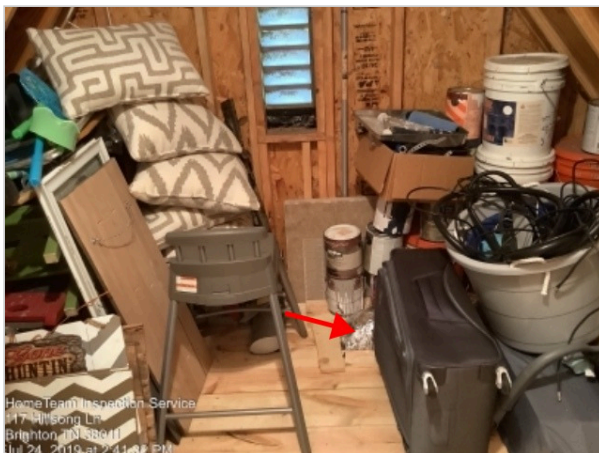
Photo 48

3. Condensation was forming at one or more of the supply air ducts in the home due to poor insulation in some areas. The area above the downstairs left bedroom was wet at the time of inspection and the insulation was observed to be loosely installed around the duct in this area. A qualified contractor should further evaluate and ensure that all ducts are appropriately insulated as necessary.

Condensation was forming at one or more of the supply air ducts in the home due to poor insulation in some areas. The area above the downstairs left bedroom was wet at the time of inspection and the insulation was observed to be loosely installed around the duct in this area. A qualified contractor should further evaluate and ensure that all ducts are appropriately insulated as necessary.

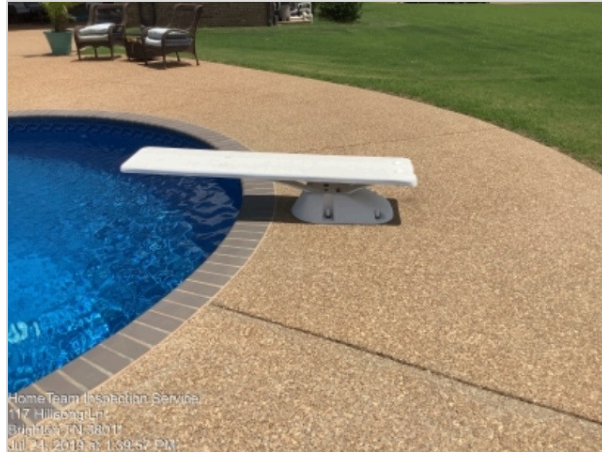
Photo 51

NOTE: The pool had a diving board. The diving board was not inspected. HomeTeam considers diving boards and slides to be safety hazards and recommends removal of these features. If further evaluation of the diving board is desired, a qualified pool contractor should be consulted.
