HomeTeam[®]

HOME INSPECTION REPORT

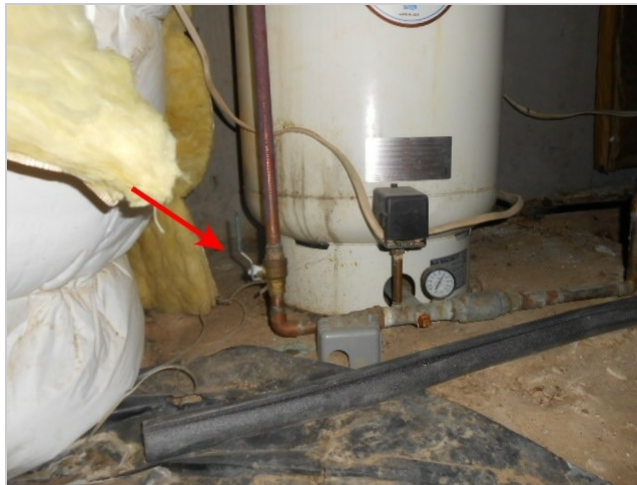
The main water shutoff valve for the home was also located in the crawlspace.

This is the main water shut off valve for the home.
