**RE: 555 Sample Dr.
Sample, OH 45069
Inspection #: 001-000000-0000**

File Number: **001-000000-0000**
Address of Inspection: **555 Sample Dr.**

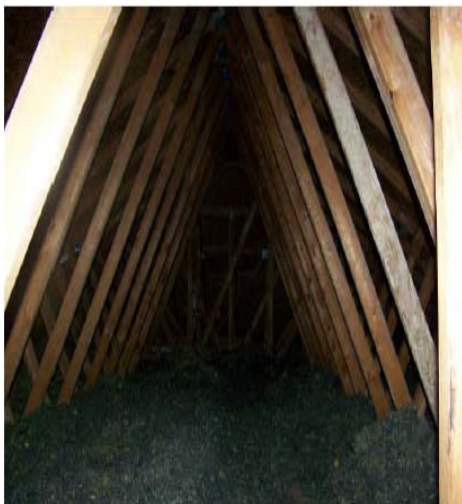
The attic was accessed through a scuttle in the 2nd floor bedroom closet. The attic above the living space was insulated with blown insulation, approximately 6-inches in depth.

Ventilation throughout the attic was provided by soffit and roof vents. The roof structure consisted of two-inch by six-inch wood trusses and rafters spaced 16 inches on center and OSB (wafer board) sheathing.

There was no moisture visible in the attic space. The absence of visible indications of moisture is not necessarily conclusive evidence that the roof is free from leaks. The only way to be sure a roof does not leak is to inspect the underside of the roof during a heavy rain. There were no major visual defects observed in the attic or roof structure.
