HOME INSPECTION REPORT

The HomeTeam Inspection Service made a visual inspection of 123 Main Street, Anytown, USA 55555. Enclosed please find a written, narrative report of our findings in accordance with the terms of our Inspection Agreement.

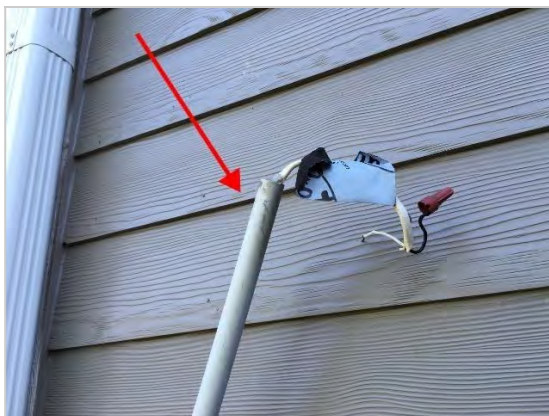
Photo 2

Exposed or un-terminated live wires were observed on the exterior. The wires should either be disconnected at the source or properly terminated in an approved, covered electrical box. Consult with a qualified electrician for repair and further assessment.

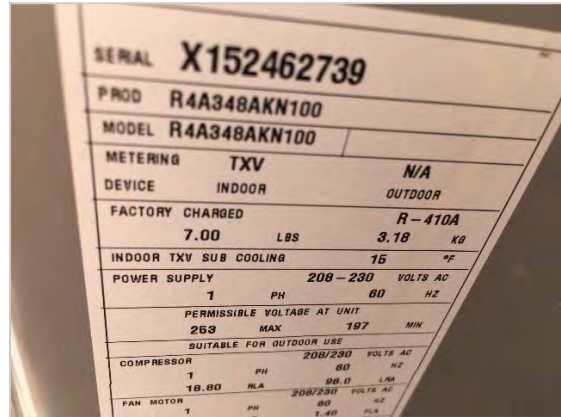
Photo 22

The insulation on the exterior air conditioning line set is missing. This could affect the efficiency of the system and should be replaced.
