HOME INSPECTION REPORT

Saturday,
December
8, 2018

**Bill
Sample
123
Sample Rd
Anytown
WA,
55555**

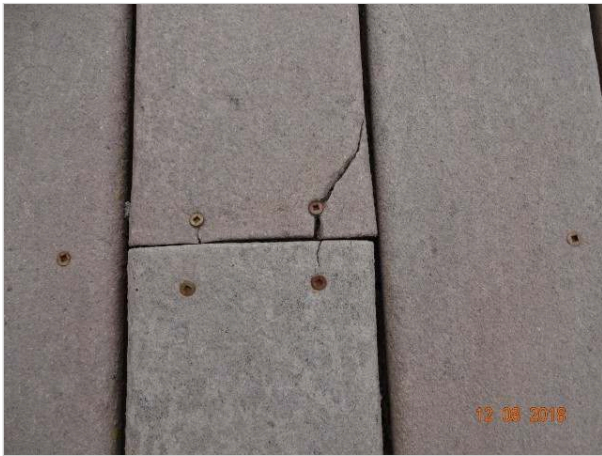
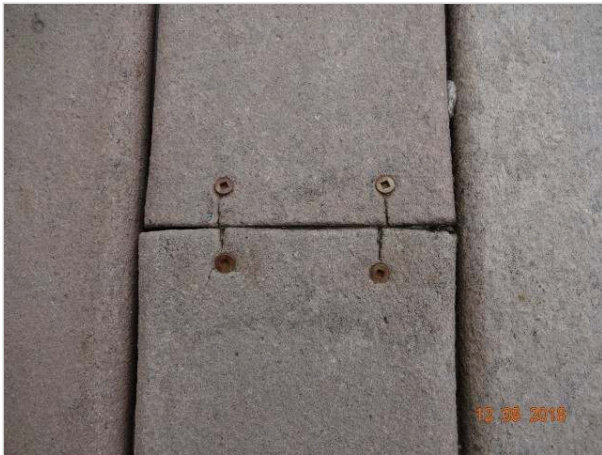
- There were minor damaged and cracked boards noted around the right and rear sides deck. Repairs should be made as desired.

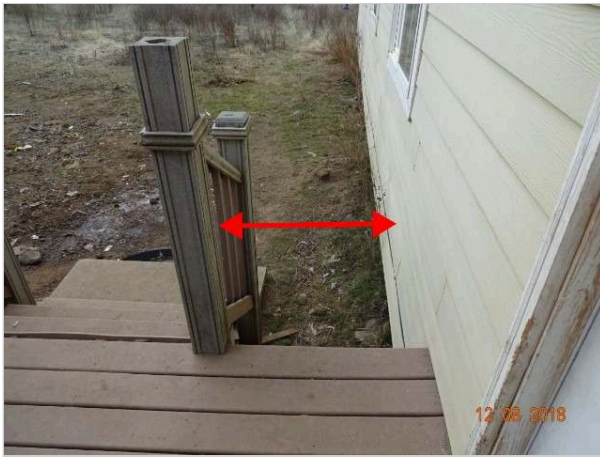
- There was no handrail/ guard rail installed on the left side of the deck stairs. Local codes may require the installation of handrails in locations where three or more steps are present, and or anywhere there is a height of 30 inches or more off grade. Although it may not be required, it is recommended that railing be installed.

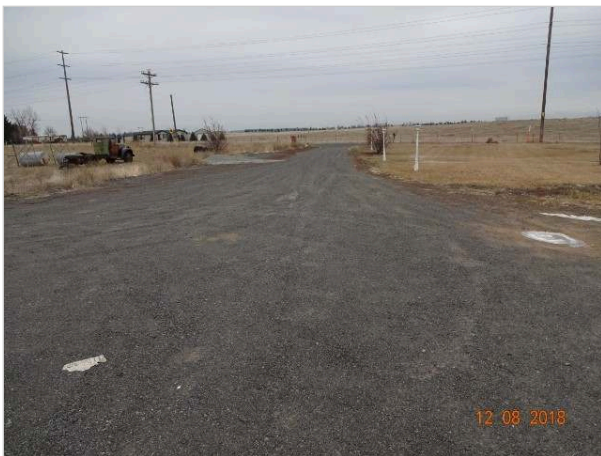
- There were uneven areas and potholes noted on the front and rear sides of the gravel driveway. These conditions can be a trip hazard and could potentially cause damage to a vehicle. It is recommended that these areas be repaired using a suitable or similar surfacing material to "feather" the out-of-level conditions to make a smooth transition. Contact a qualified contractor for further recommendations and repairs.

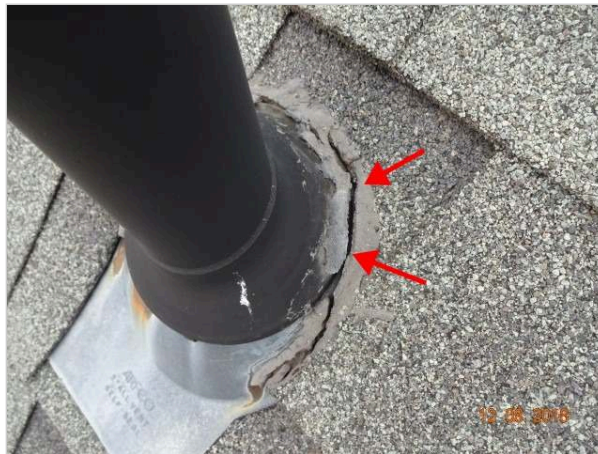
- The rubber boot sealant around the drain vent flashing on the left rear roof was cracked and split. Consult with a qualified roofer for repair.

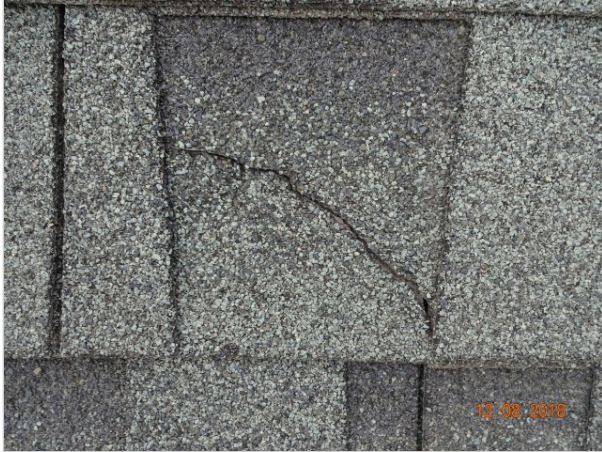
- There were torn, missing and damaged shingles observed on the roof that should be repaired to help prevent water intrusion into the attic space. Contact a qualified contractor for repairs.

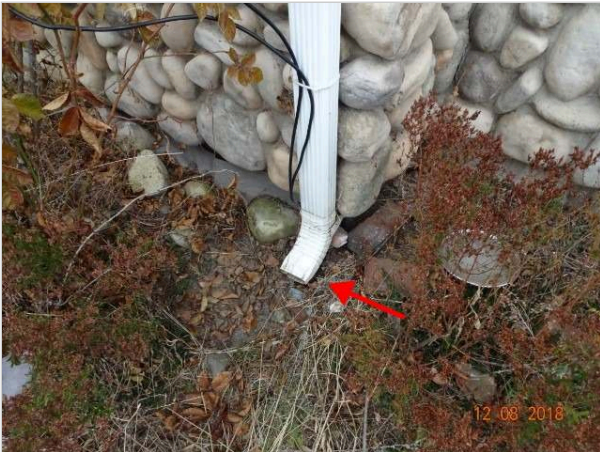
- All of the downspout (s) were draining at or too close to the base of the foundation. All roof drainage should be directed at least six feet from the base of the foundation.

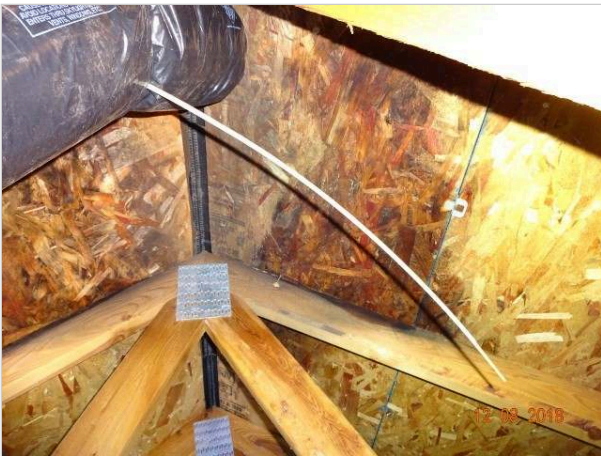
- Water marked or damaged roof decking was noted in the attic. The marks appear to be the result of previous leaks. Repairs to the affected areas are not required. No immediate action is necessary. It is recommended that the attic be monitored for further leaks and be repaired as needed.

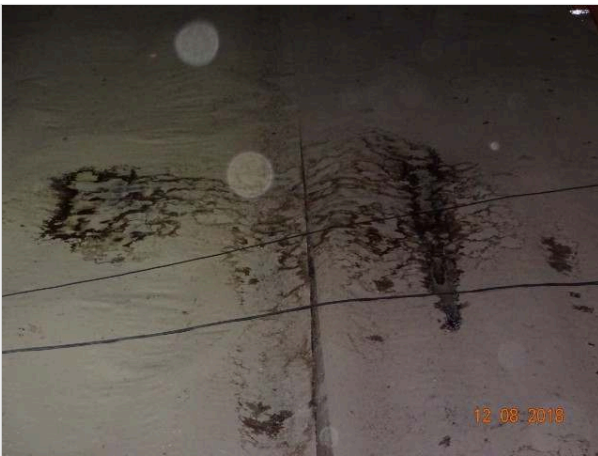
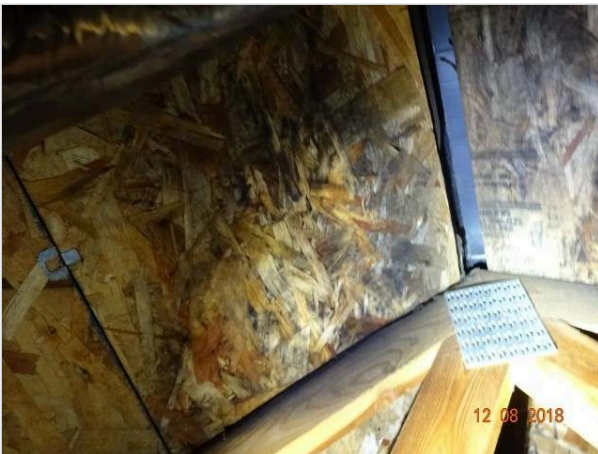
- A substance with the characteristics of mold is visible in the attic. Since the attic is not a part of the living space, the condition may not have any affect on those that are sensitive to mold. The presence of certain mold and mold spores in housing can result in mild to severe health effects in humans and can deteriorate the structure of the dwelling resulting in structural damage. Health effects include, but are not limited to: asthma, allergy symptoms, watery eyes, sneezing, wheezing, difficulty breathing, sinus congestion, blurry vision, sore throat, dry cough, aches and pains, skin irritation, bleeding of the lungs, headaches, memory loss and fever. As humans vary greatly in their chemical make-up, so does the individual's reaction to mold exposure. For some people, a small number of mold spores can cause ill effects. In others it may take many more. The EPA (<http://www.epa.gov/mold/moldresources.html>) advises consumers that areas less than ten square feet of coverage can usually be controlled using readily available household products. In the event the substance cannot be controlled, a certified mold testing and remediation firm should be contacted for a recommended course of action.

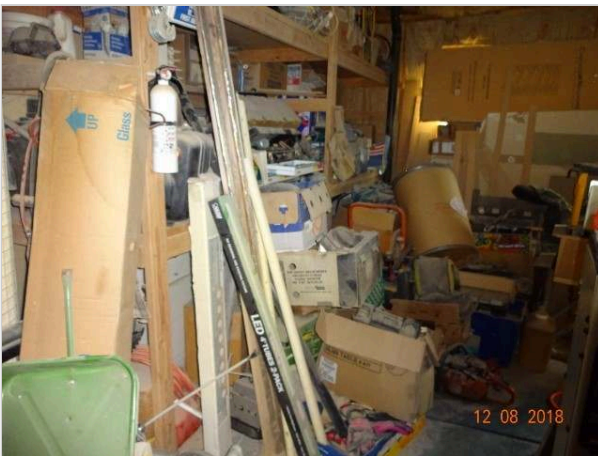
- NOTE: There was limited visibility and or limited access in one or more areas in the garage. The limited visibility was due to the garage being cluttered with some stored items and/or shelves at the time of inspection, therefore several areas were unable to be inspected.

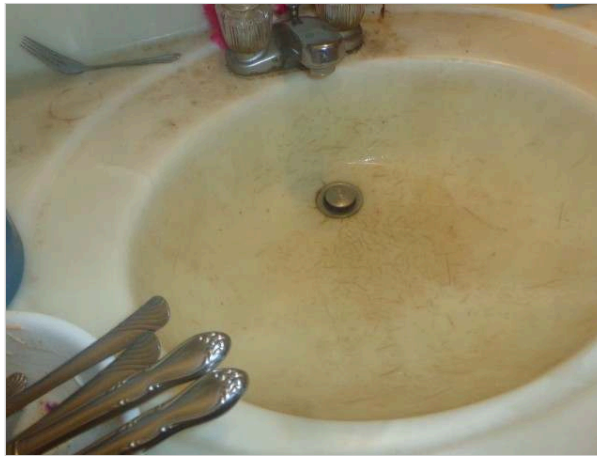
- There was not a drain present in the basement laundry room. The basement should have a drain and trap present, it is recommended that a qualified plumbing contractor be contacted for installation.
- The basement bathroom sink drains slowly. The trap could need to be cleaned out or there could be a minor blockage in the pipe. If cleaning the trap out or using a drain cleaner does not remedy the problem then it is recommended you contact a licensed plumber for service,

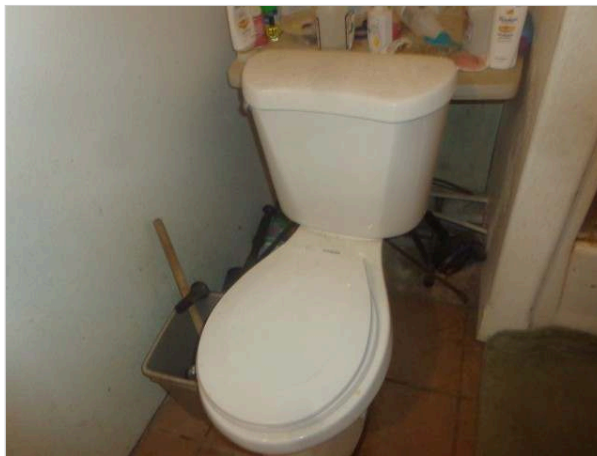
- The basement toilet was loose in the floor. It is recommended the toilet be properly secured and sealed to help prevent leaking.

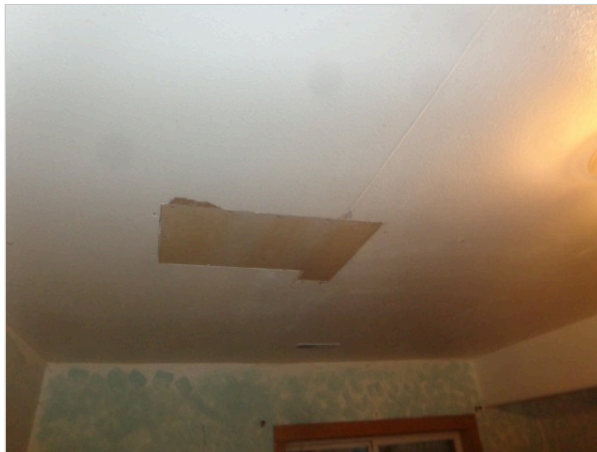
- An incomplete patch repair was noted in the basement bedroom ceiling. Although cosmetic, it is recommended that the patch repair be completed.

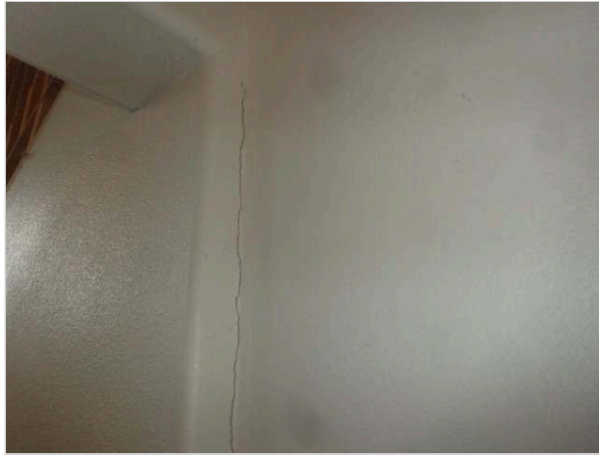
- Minor settlement cracks were noted in the family room wall. This typical of homes as settling normally occurs. It is recommended that repairs be made.

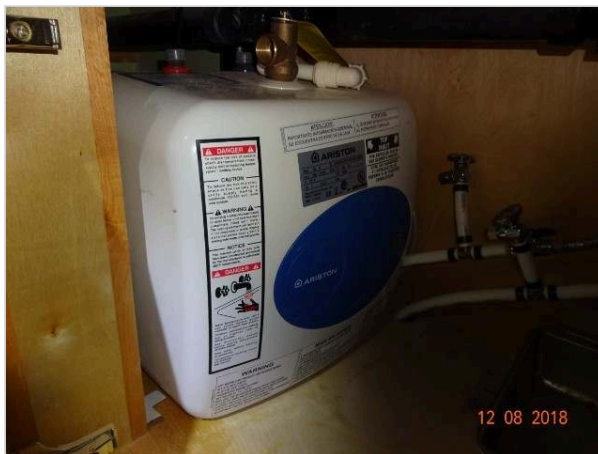
- NOTE: Although completely functional at the time of inspection, due to the age of the water heater (being more than 10 years old), it could be a candidate for replacement sometime in the near future.
- No seismic restraints (earthquake straps) were present. It is recommended that water heaters be double strapped with a heavy gauge metal for added stability. The straps should be installed on the upper third and lower third of the tank.

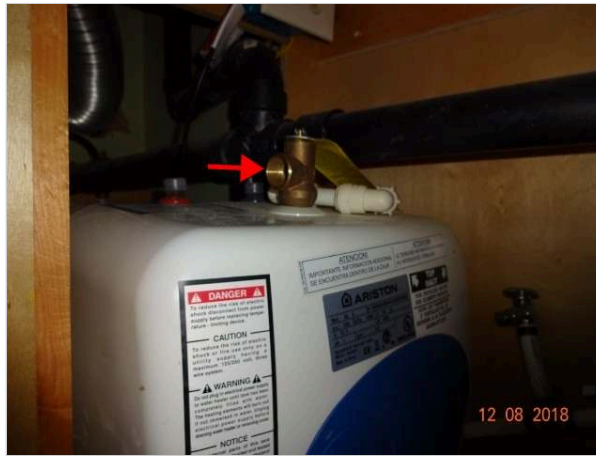
- There was no drip leg installed on the T&P valve of water heater #2 . The drip leg directs water from the T&P valve toward the floor. A drip leg terminating within six-inches of the floor should be installed.

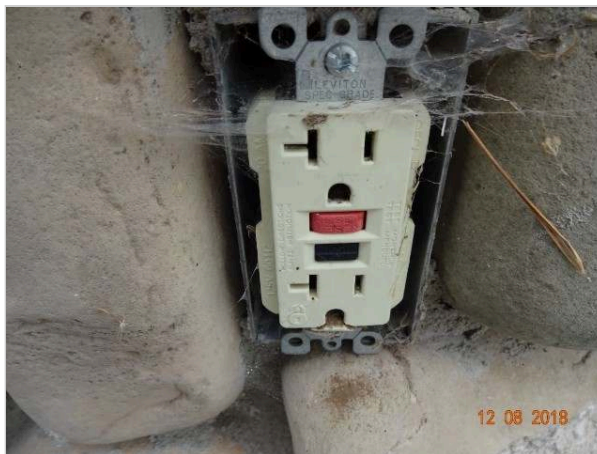
- One or more of the exterior outlets were not GFCI protected at the time of inspection. It is recommended that GFCI outlets are present in all kitchen outlets, bathroom outlets, exterior outlets, basement outlets(if applicable),at least one garage outlet, and any outlet within six feet of a water source.

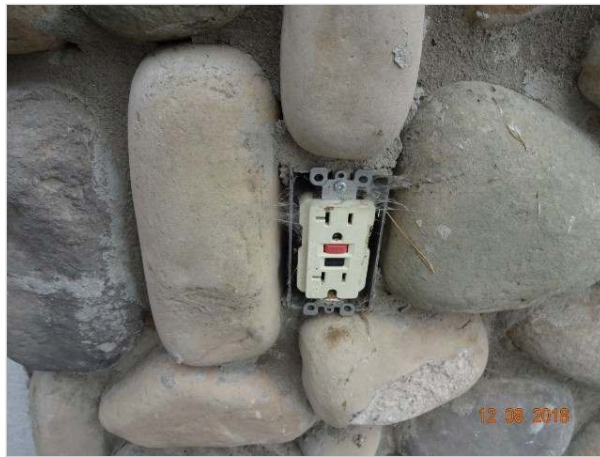
- One or more missing switch or outlet covers were noted in the basement. All switch and outlet boxes should be properly covered to avoid a shock hazard. Electrical related repairs should be performed by a qualified electrician.

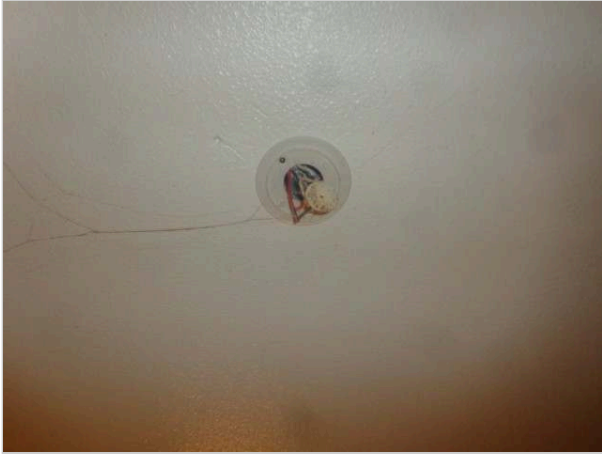
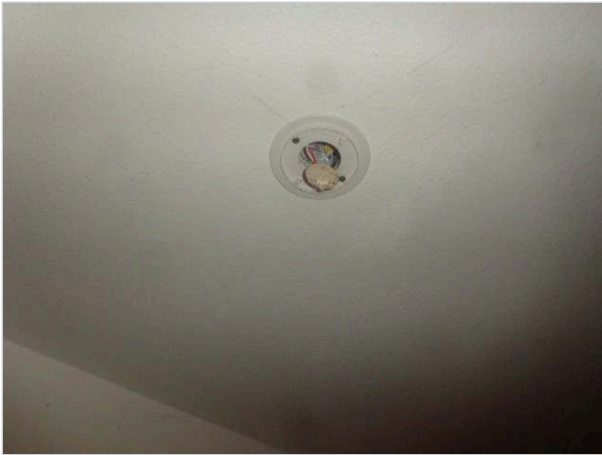
- There were missing smoke detectors found in many areas of the home. Smoke detectors are required in WA State. It is recommended that smoke detectors be in each bedroom for safety reasons.

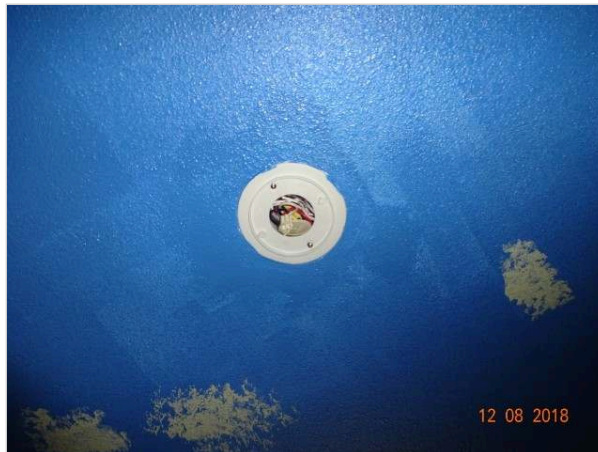
- There were no carbon monoxide detectors found in the home at the time of inspection. It is recommended that there be at least 2 in the home for safety reasons.

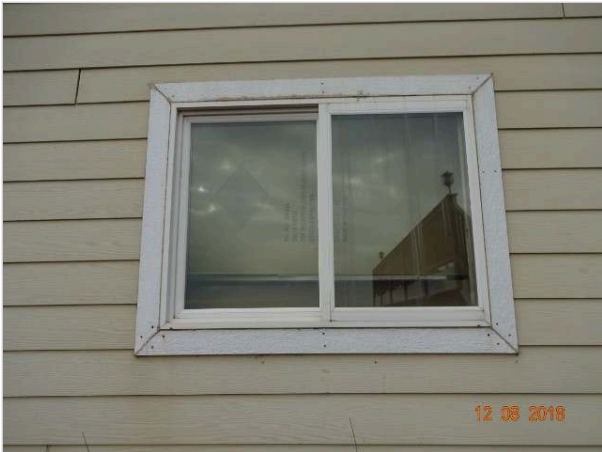
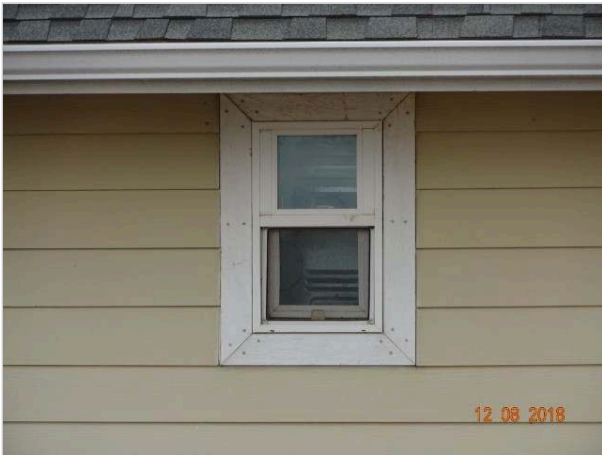
- Cracked glass was noted on the basement window(s). For safety and security all cracked and broken glass should be replaced.

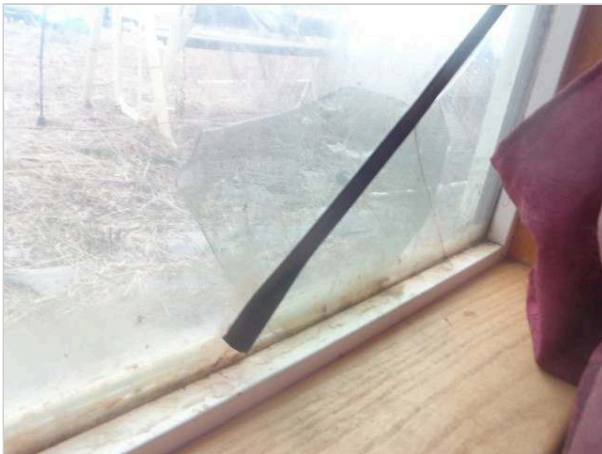
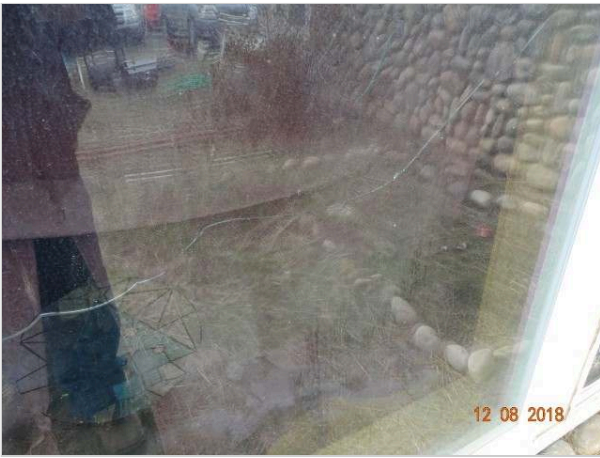
- One or more of the insulated window panes throughout the home had a defective thermal seal. A defective thermal seal can be identified when fogging is observed between the panes of glass. A defective thermal seal does not affect the performance of the window. Repair of the thermal seal can be accomplished by replacing the affected glass panel.

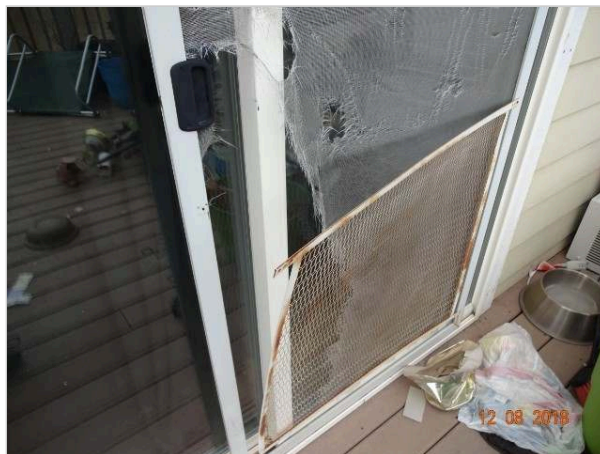
- There were missing, loose or damaged doors, and or door hardware noted around the home. Repairs should be made as desired. All repairs should be completed by qualified contractors.

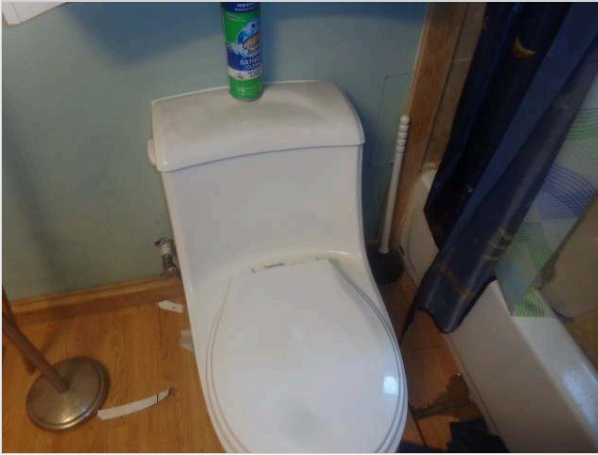
- All of the toilets on the main level are not fully secured to the floor. It is recommended they be properly

secured to help prevent water damage from potential leaks.

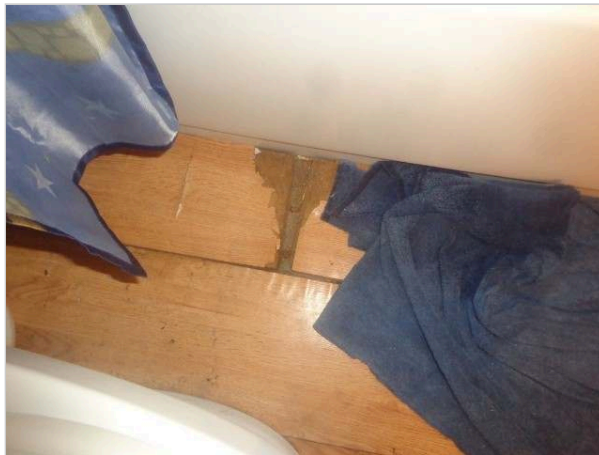
- Water marks with minor surface damage was noted on the main level bathroom floor. The water marks appeared to be the result of previous leaks. Consult with a qualified contractor for evaluation and repairs as required.

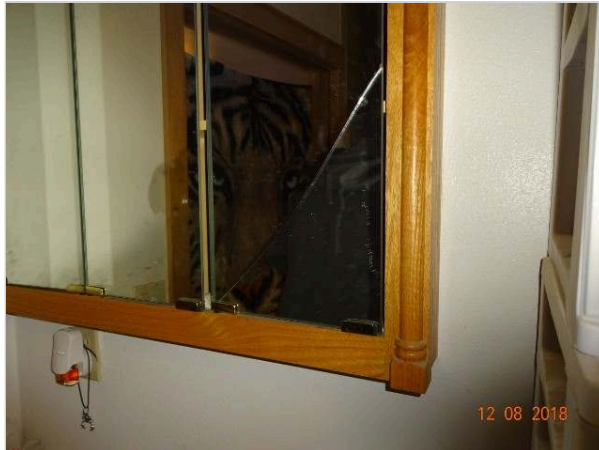
- One or more minor cracks were noted in the bathroom mirror. It is recommended that repairs be made.

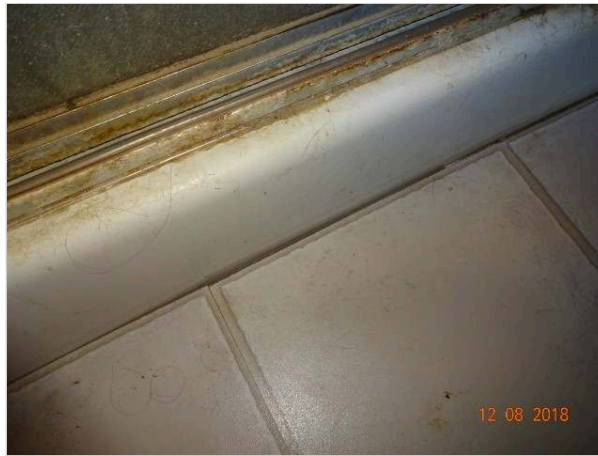
- Missing or cracked grout or caulk was noted in one or more of the main level bathrooms. It is recommended that these areas be re-grouted or re-caulked to help prevent moisture intrusion.

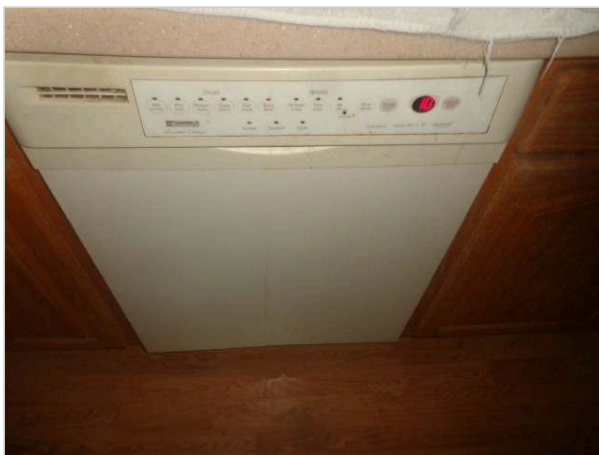
- The dishwasher was noisy while operating. It is recommended the dishwasher be serviced by a licensed appliance repair company.

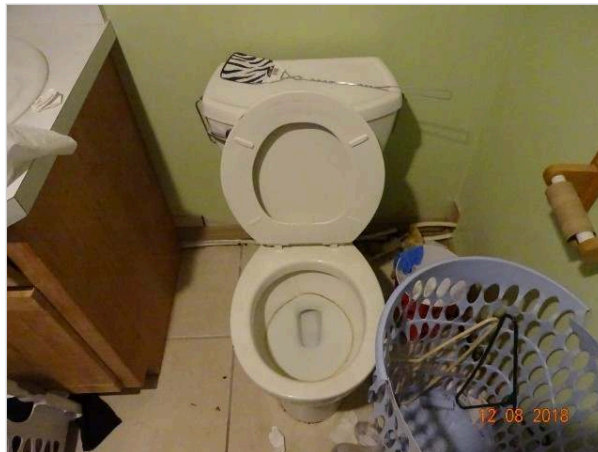
- The second floor bathroom toilet is not fully secured to the floor. It is recommended it be properly secured to help prevent water damage from potential leaks.

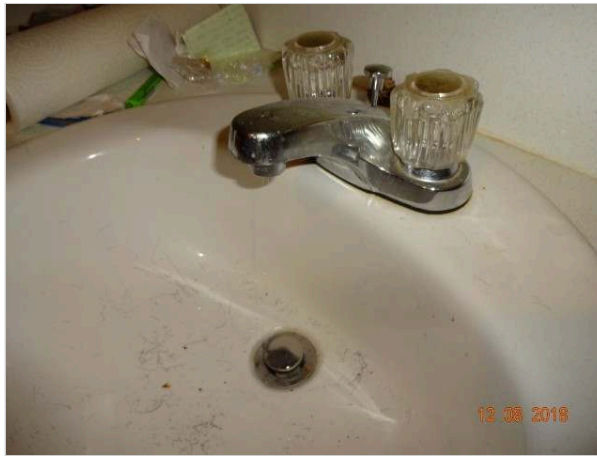
- The second floor bathroom sink has extremely low volume and water pressure. Consult with a licensed plumber for repair.

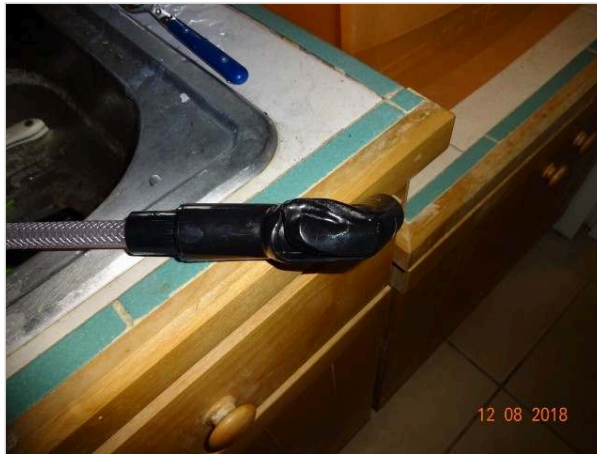
- The sprayer on the second floor sink was melted and was not functional when tested. Repairs should be made.

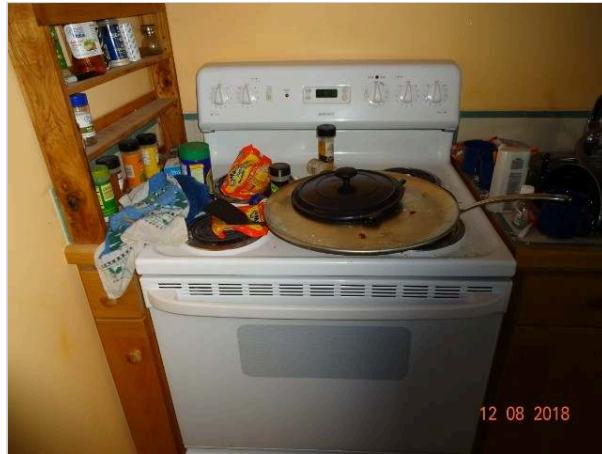
The Hot Point electric range was inspected and did appear to be functional. The accuracy of the clock, timers and settings on ovens are not within the scope of this inspection.

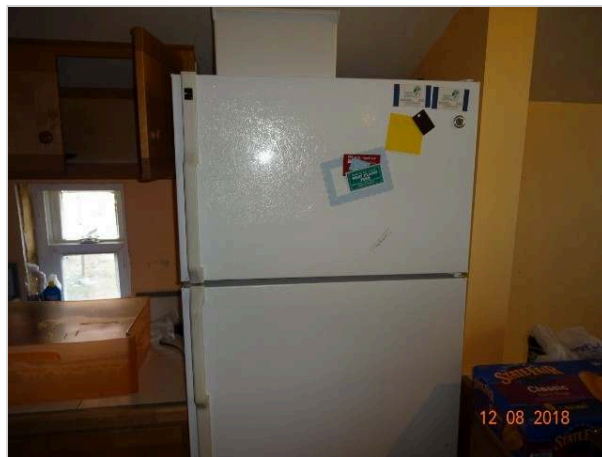
The Hotpoint refrigerator was inspected and did appear to be functional. The temperature setting and ice maker, if present, are not within the scope of the inspection.

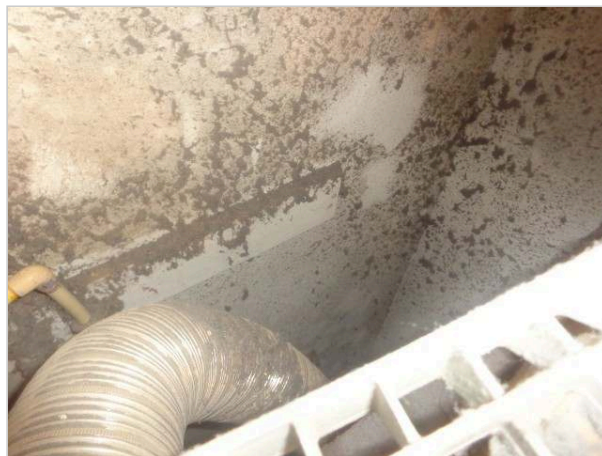
A dryer vent was not installed. The visible portion of the dryer vent was inspected and appeared to be inoperable and insufficient for venting to the exterior of the home.

- There was no visible dryer vent installed. Clothes dryers should be vented to the exterior of the home. Consult

with a qualified contractor for installation.

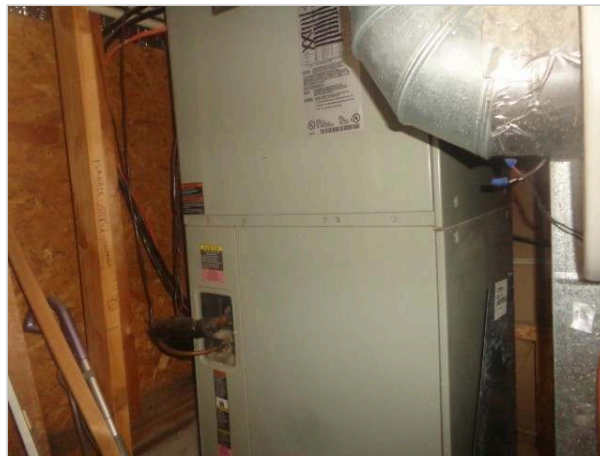
The home was heated by a Trane electric forced air furnace, serial number 2015 NYA2V, model number 4TEE3F65A1000AA which is 16 years old. The unit was located in the basement of the home. It has an approximate net heating capacity of 100,000 BTUH.

- There was no recent service record for the HVAC system at the time of inspection. It is recommended that the furnace be serviced by a licensed HVAC contractor before continued use and on an annual basis thereafter.

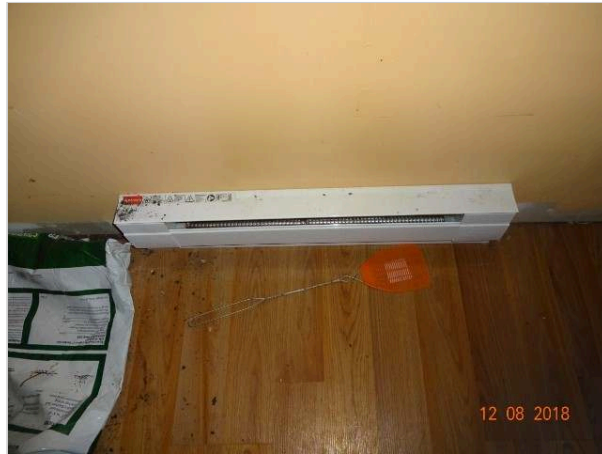
The heating system on the second level, consisted of electric baseboard units controlled by either wall-or unit mounted thermostats in one or more locations. The thermostats were turned up during the inspection and appeared to be functional. Electrical heating units require minor servicing and upkeep. The metal fins within the units should be kept clean and the surrounding area should be left open to allow for sufficient airflow.

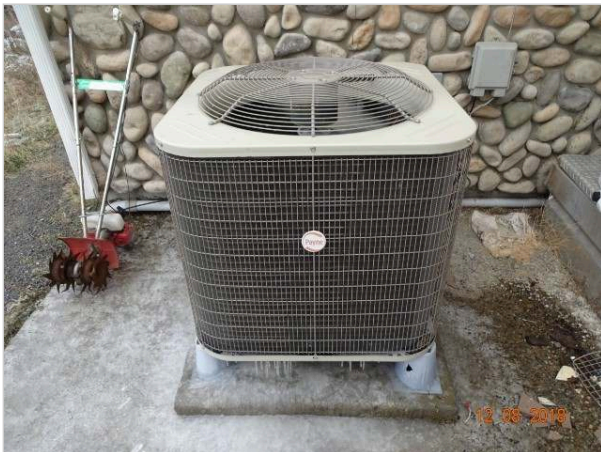
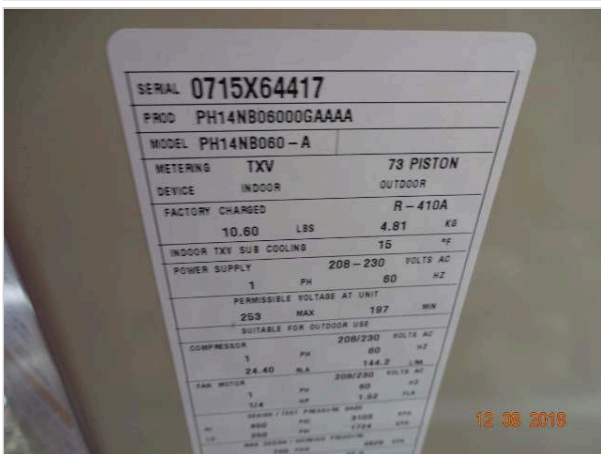
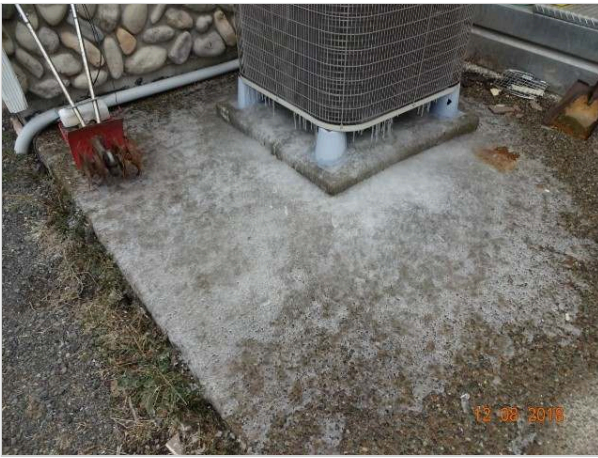
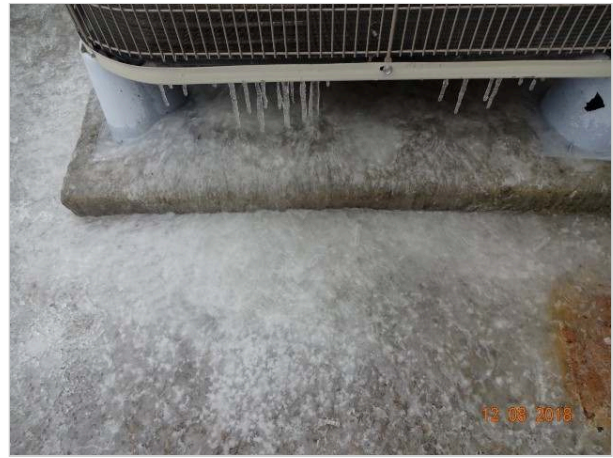
- The heat pump unit appeared to be have leaked prior to the time of inspection. Due to the cold temperature, the water has frozen over and the unit was surrounded by ice. If the unit continues to function in this state, severe damage to the unit could occur. It is highly recommend that a licensed HVAC contractor be contacted for further evaluation and repair recommendations before further use.

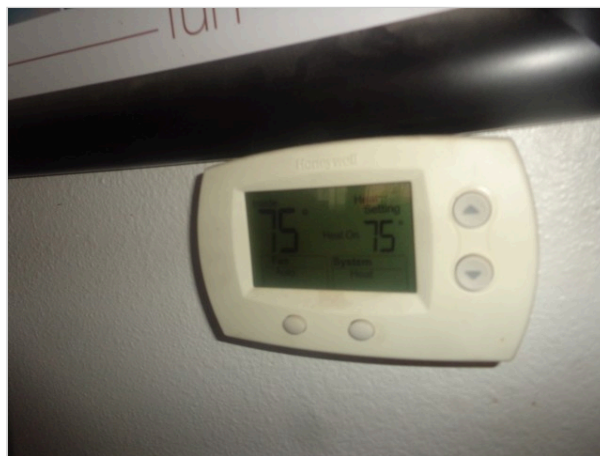
The control for the heating and air conditioning system was a 24 volt thermostat located on the living room wall of the home. The thermostat was manufactured by Honeywell and was found to be in working order.
