HOME INSPECTION REPORT

The HomeTeam Inspection Service made a visual inspection of 123 Anywhere St., City, ST 12345. Enclosed please find a written, narrative report of our findings in accordance with the terms of our Inspection Agreement.

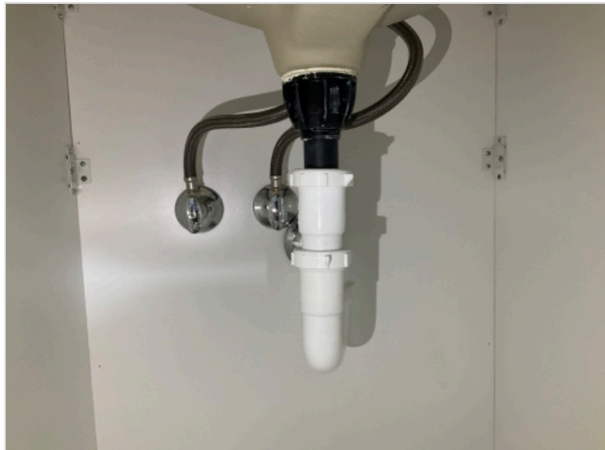
Photo 42

Jack and Jill bathroom

Leaks were observed at the toilet shut off in the Jack and Jill bathroom when in use. The tub and sink in the hall bathroom drain slowly. A licensed plumbing company should be called to evaluate the system and make any repairs.

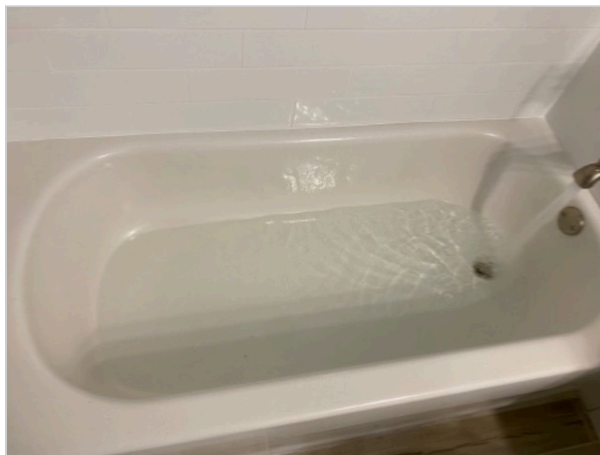
Photo 46

Hall bathroom drains slowly.

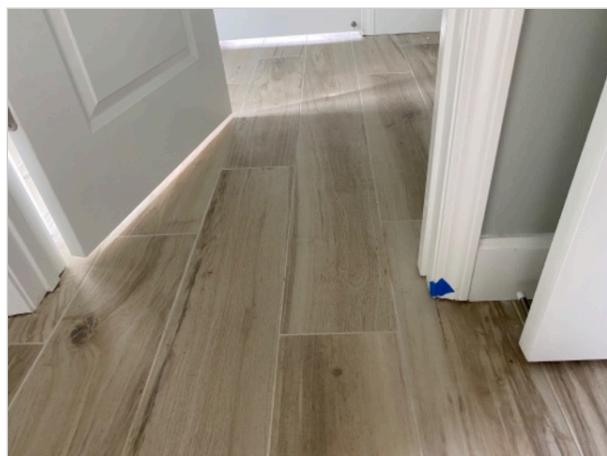
Photo 59

An exposed nail was observed at the guest bedroom/ jack & jill bathroom door frame that should be removed

and has been marked with blue tape to help the builder and contractors identify said issues.

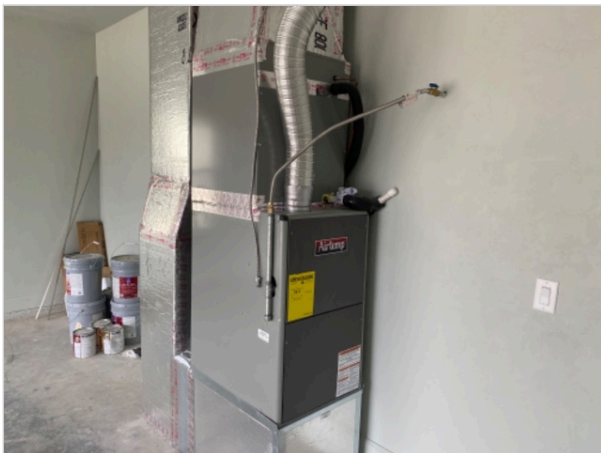
Photo 80

The HVAC condensate line was raised above the floor drain or drain inlet. The condensate line was trapped. The HVAC condensate line must be trapped and not in contact with wet drain inlets to prevent the possible migration of bacteria and mold into the air-handling system. The heating system was found to be functional.

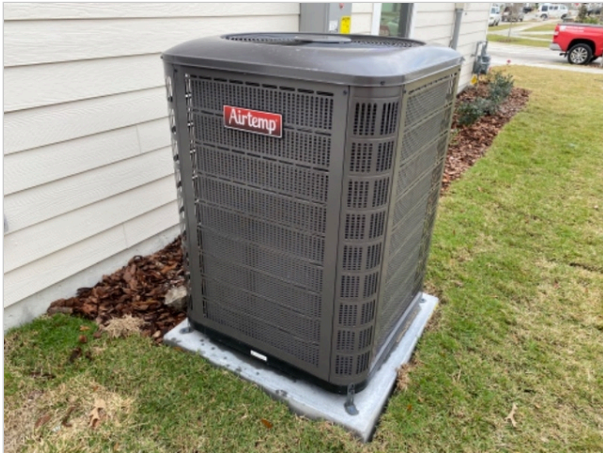
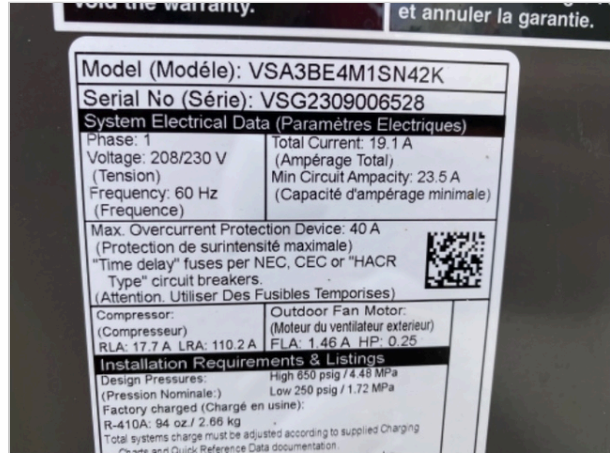
Number VSG2309006528. The unit is located on the left side of the structure. This unit is approximately less than one years old. Periodic preventive maintenance is recommended to keep this unit in good working condition. The cooling system was functional.

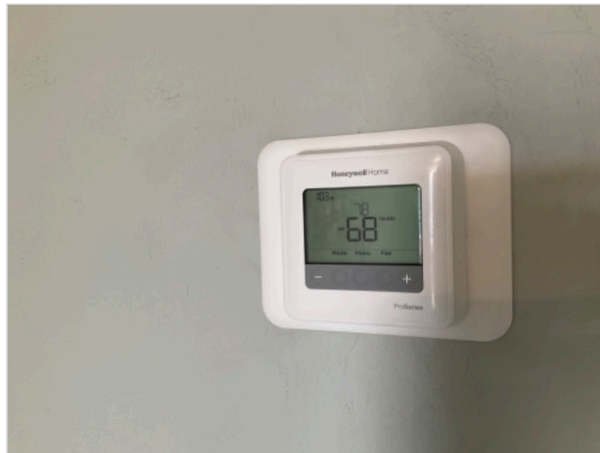
Hallway

The control for the heating and air conditioning system was a 24 volt digital programmable thermostat located on the hallway wall of the home. The thermostat was manufactured by Honeywell and was found to be in working order.
