HOME INSPECTION REPORT

The HomeTeam Inspection Service made a visual inspection of 123 Anywhere St., City, ST 12345. Enclosed please find a written, narrative report of our findings in accordance with the terms of our Inspection Agreement.

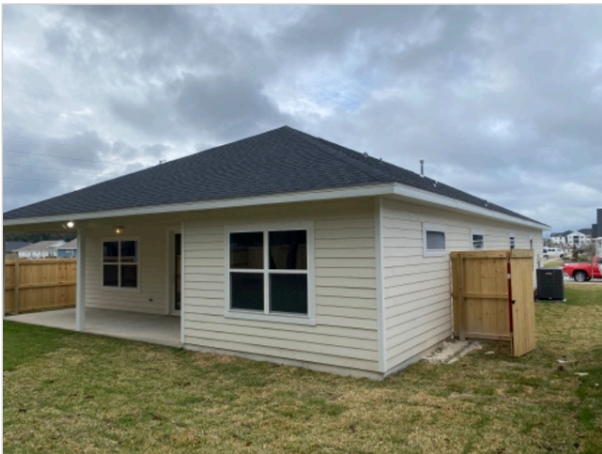
Photo 5

Damaged siding was observed on the right side of the structure. Consult with a qualified contractor for replacement.

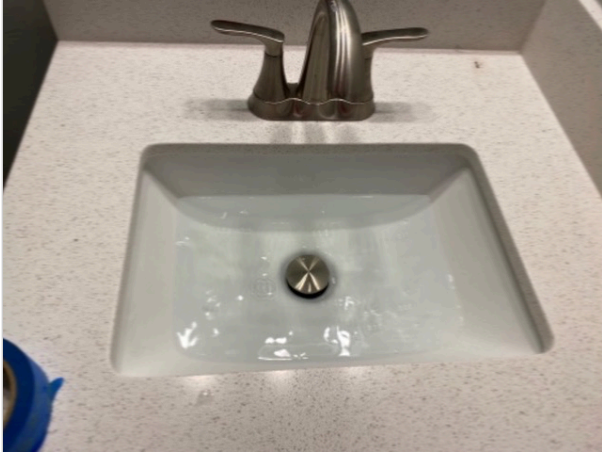
Photo 45

Hall bath sink drains slowly.

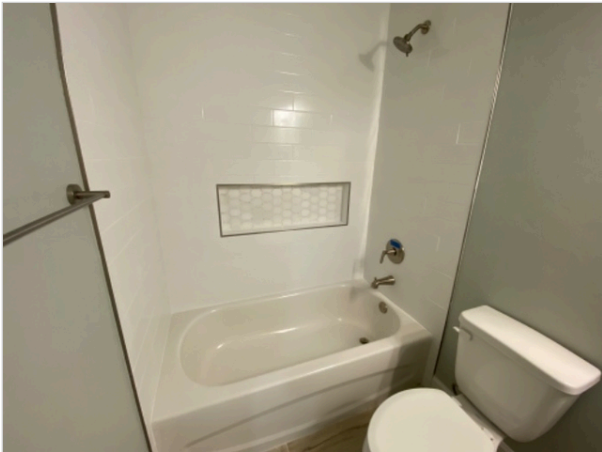
Photo 47

The shower controls in both guest bathrooms had the hot/cold reversed, which is a possible scald issue and should be corrected.

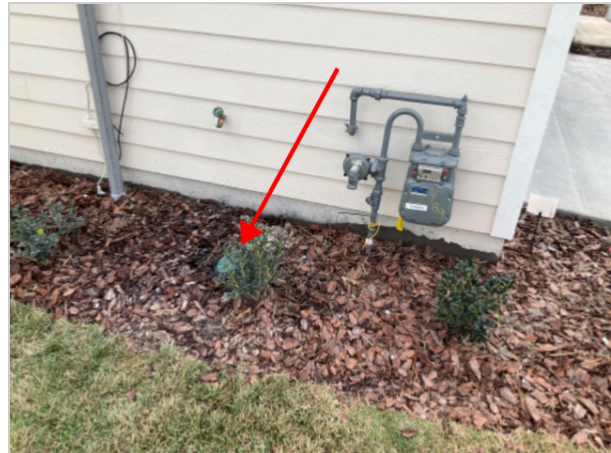
Water shut off

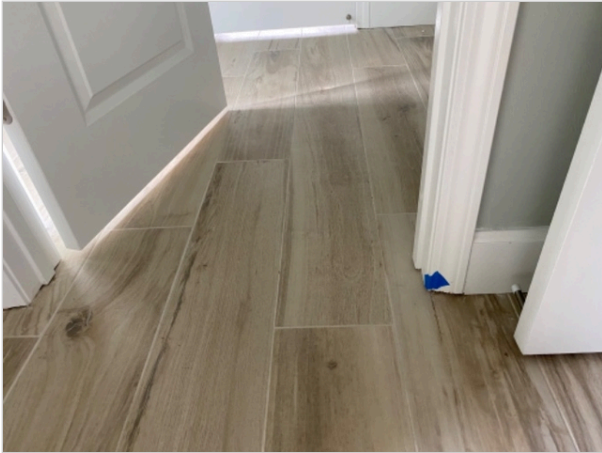
Photo 59

An exposed nail was observed at the guest bedroom/ jack & jill bathroom door frame that should be removed

and has been marked with blue tape to help the builder and contractors identify said issues.

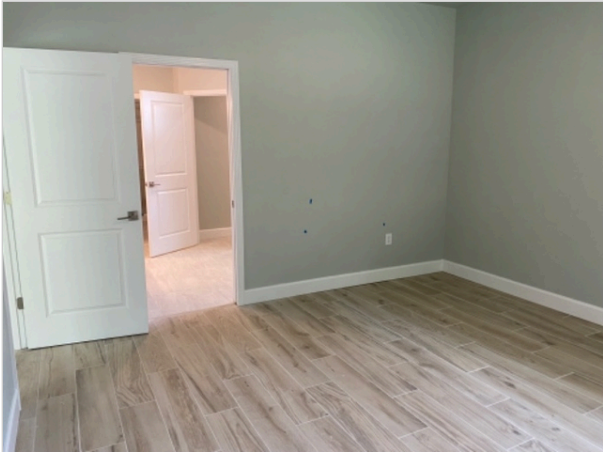
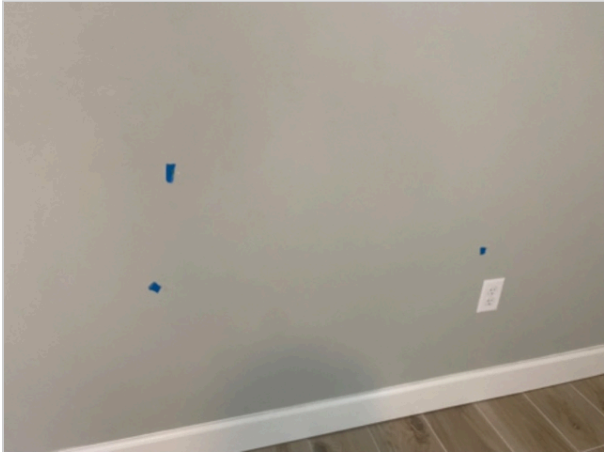
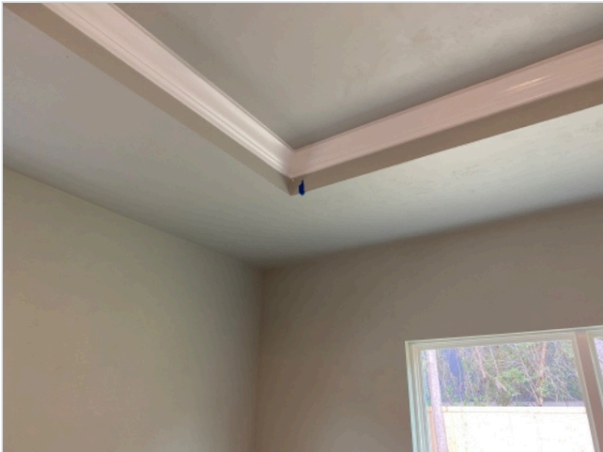
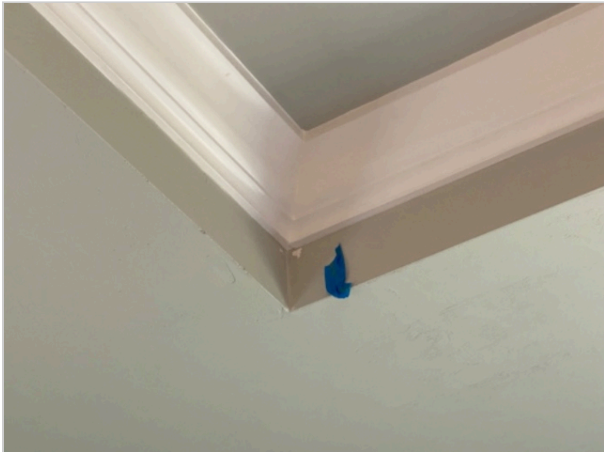
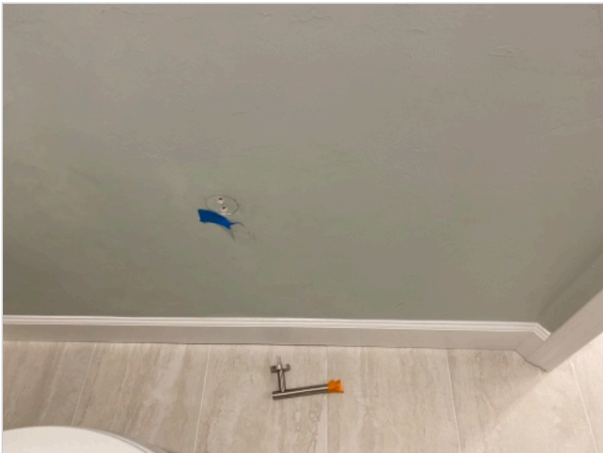
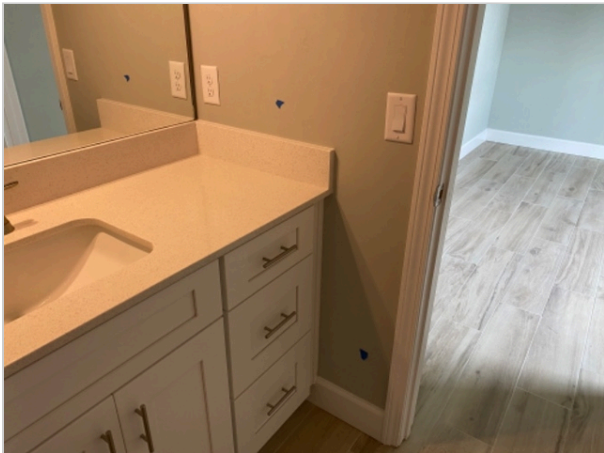
The home was in the final stages of construction. There were blemishes and nicks observed in areas of the home, which is normal. Many areas were marked with blue tape, to help the builder and contractors identify said issues.

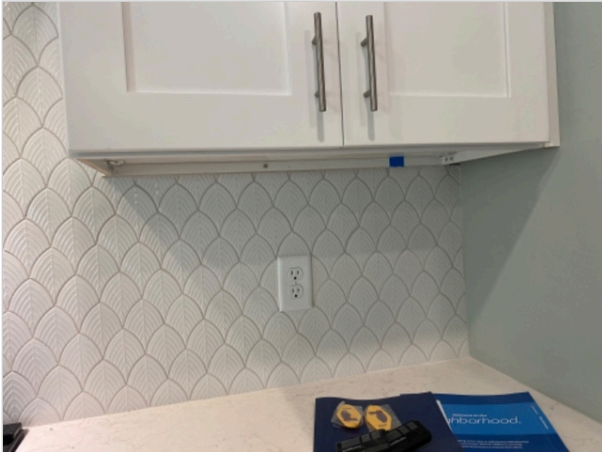
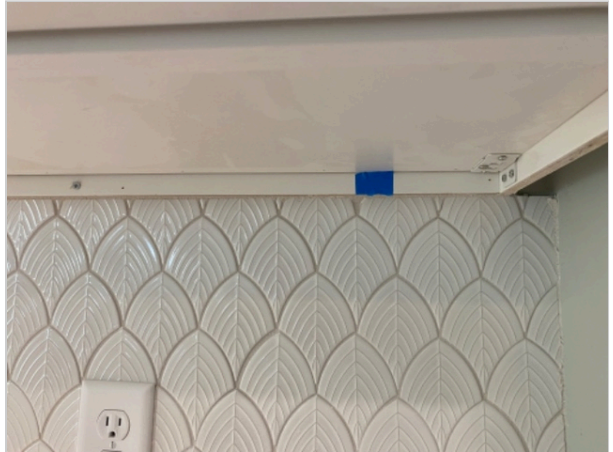
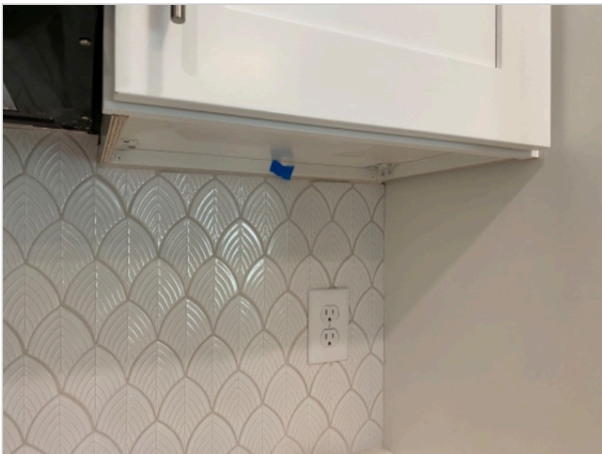
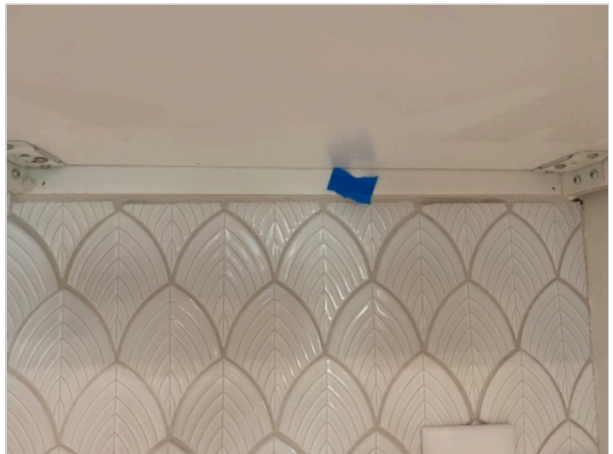
Portions of the kitchens cabinets were not completely secure to the wall. The cabinets should be secured to prevent them from falling.
