Monday, July 22, 2019

RE: 123 Sample Drive Anytown, FL 12345

HOME INSPECTION REPORT

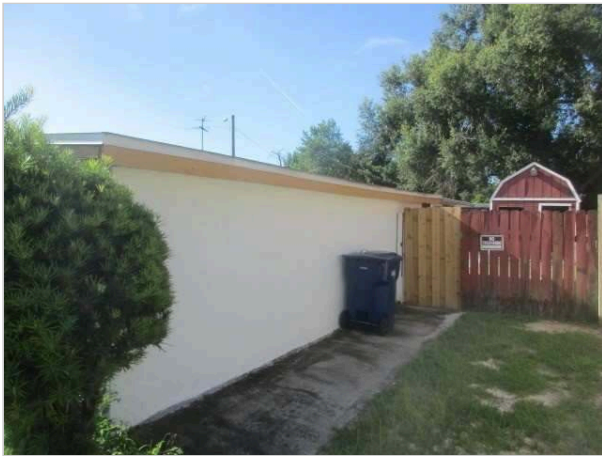
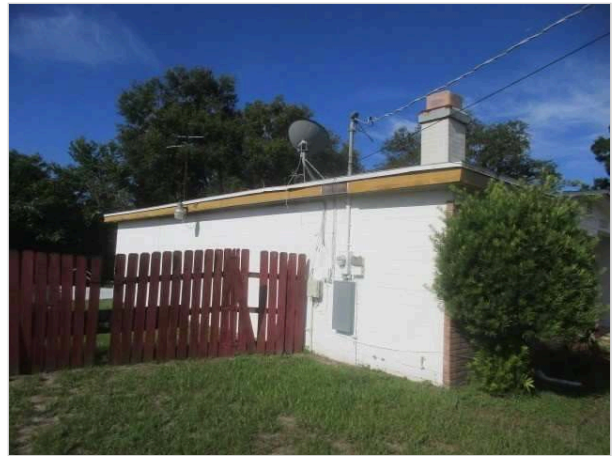
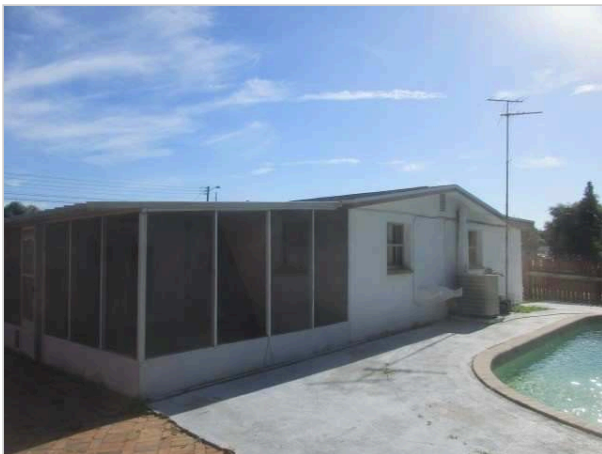
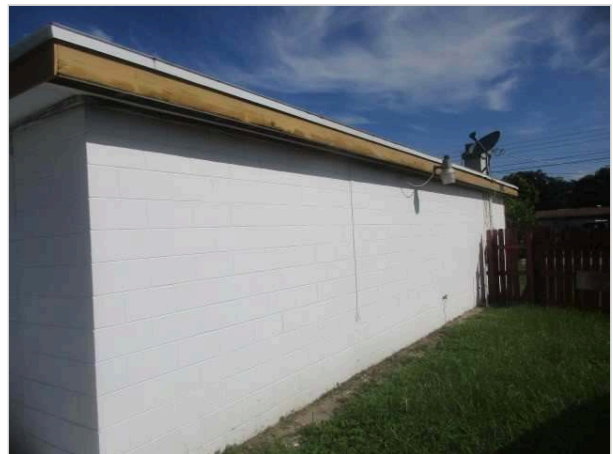
A SETTLEMENT CRACK WAS OBSERVED ON THE LEFT SIDE OF THE HOME.

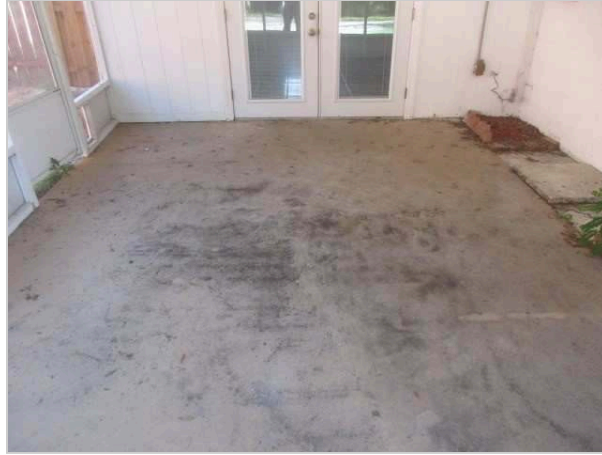
There was a screened enclosure around the patio. There were no material defects observed in the visible portions of the patio cover or its supports BUT, RIPS WERE OBSERVED.

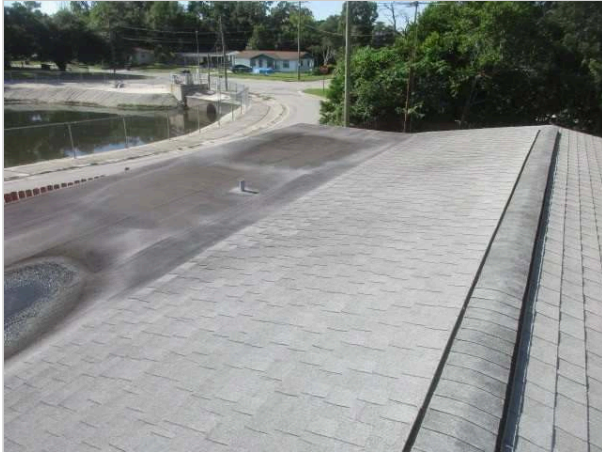
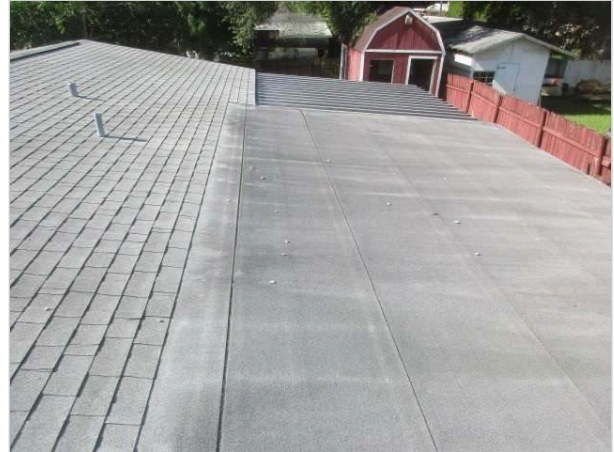
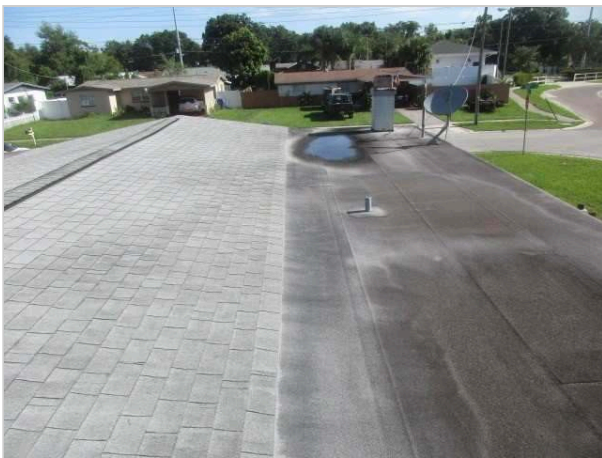
WATER PONDING ALONG WITH ALLIGATOR CRACKING WAS OBSERVED ON THE FLAT ROOF ON THE LEFT SIDE OF THE HOME. THE REAR SECTION WAS NOT SEALED.

THE ROOFING SYSTEM SHOULD BE FURTHER EVALUATED BY A QUALIFIED ROOFING CONTRACTOR TO DETERMINE THE EXTENT AND COST OF REPAIR/REPLACEMENT. A RECEIPT SHOULD BE LEFT FOR YOUR RECORDS AND PROTECTION.

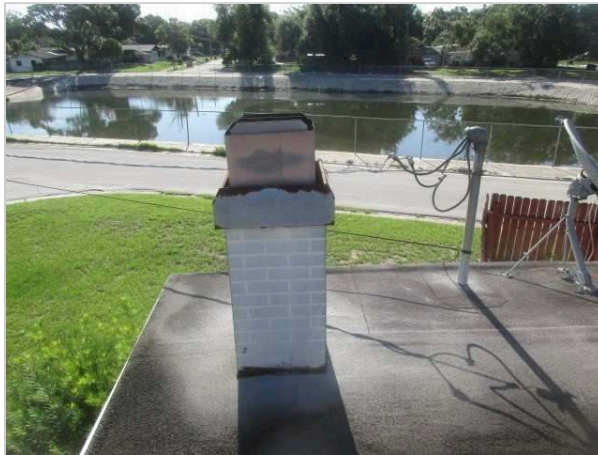
CHIMNEY: There was no rain cap on the chimney. This device will help to prevent rainwater from entering the flue and causing water damage.

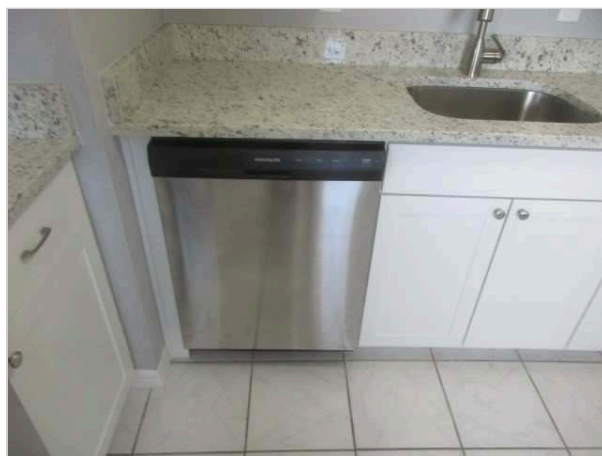
THE DISHWASHER WAS NOT SECURED TO THE COUNTER.
