HOME INSPECTION REPORT

**123 Sample Drive
Anytown, TX 55555**

PROPERTY INSPECTION REPORT

Prepared For:	Bill Sample	
	(Name of Client)	
Concerning:	123 Sample Drive, Anytown, TX, 55555	
	(Address or Other Identification of Inspected Property)	
By:	Inspector 1 Inspector 2	9-29-2017
	(Name and License Number of Inspector)	(Date)
	(Name, License Number of Sponsoring Inspector)

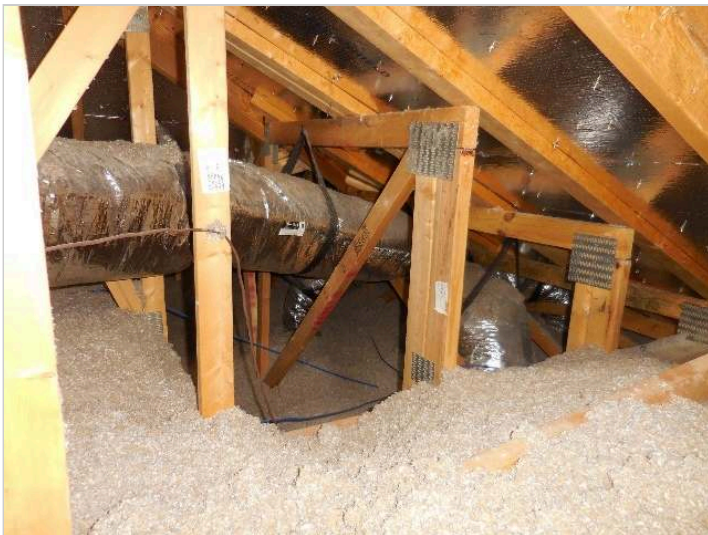
(none) No major visual deficiencies were observed on the roof structures and attics at the time of the inspection.

View of upper attic space (over common room).

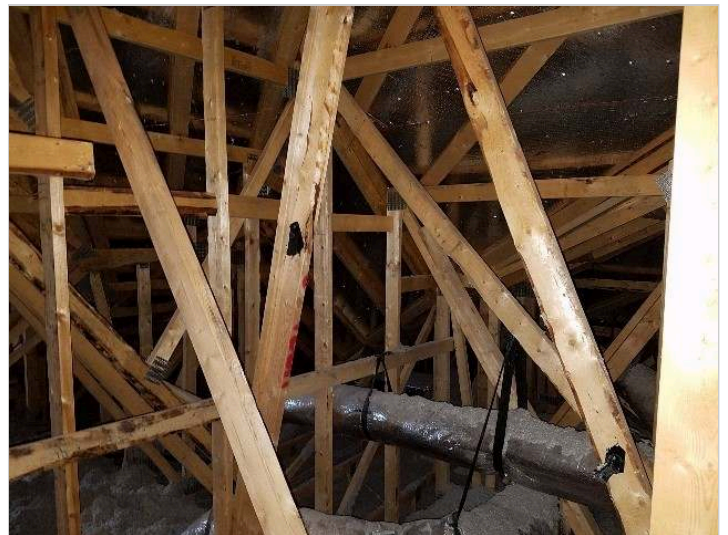
view of Texas attic space (left side).
