# HomeTeam<sup>®</sup>

### HOME INSPECTION REPORT

**Tom and Sue Brown**  
**123 Main Street**  
**Anywhere, NC 12345**

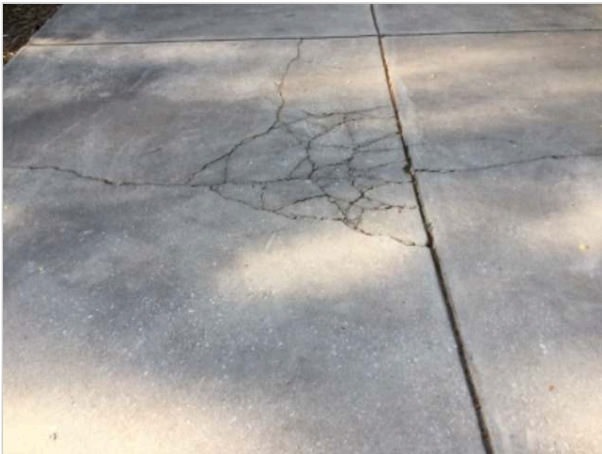
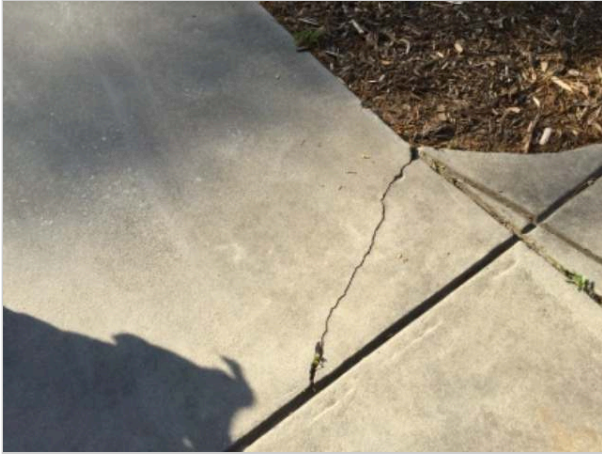
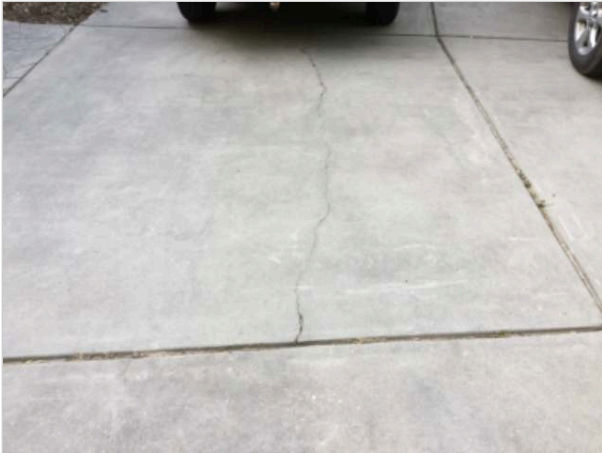
1. The driveway has cracked and settled unevenly. This condition may deteriorate further and can be a tripping hazard. Have a qualified contractor evaluate and repair as required.

***The driveway has cracked and settled unevenly. This condition may deteriorate further and can be a tripping hazard. Have a qualified contractor evaluate and repair as required.***

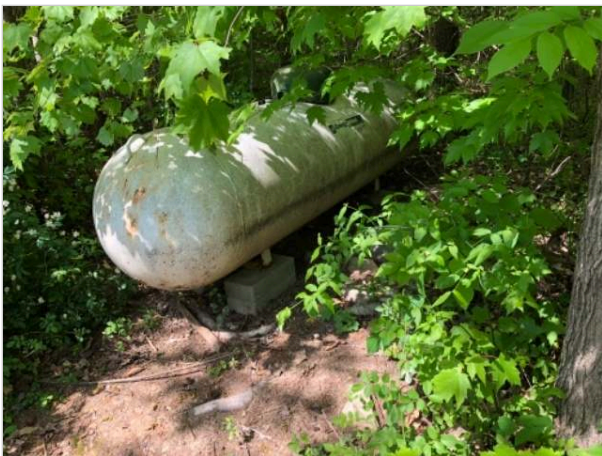
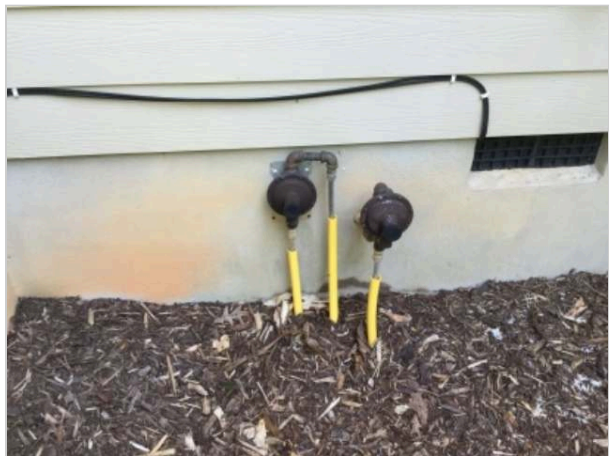
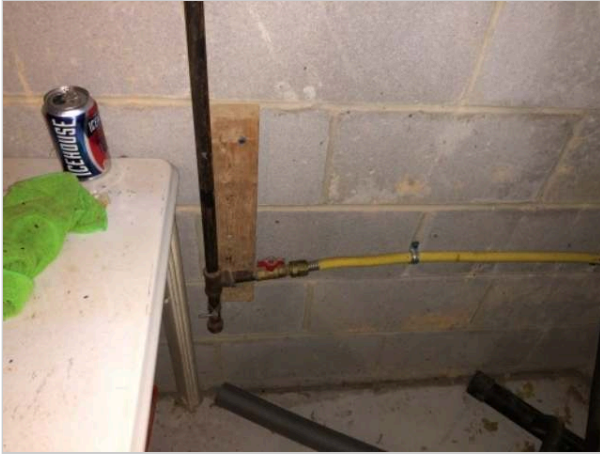
4. The gas piping in this home includes corrugated stainless steel tubing (CSST). The gas piping was not bonded to the electrical grounding system of the home. Though not required when this home was constructed, it is a valid safety enhancement with CSST installed. Bonding the gas piping to the electrical system grounding adds protection to the gas line and equipment during an electrical storm. Have a qualified electrical contractor install bonding to the gas line of this home.

***The gas piping in this home includes corrugated stainless steel tubing (CSST). The gas piping was not bonded to the electrical grounding system of the home. Though not required when this home was constructed, it is a valid safety enhancement with CSST installed. Bonding the gas piping to the electrical system grounding adds protection to the gas line and equipment during an electrical storm. Have a qualified electrical contractor install bonding to the gas line of this home.***

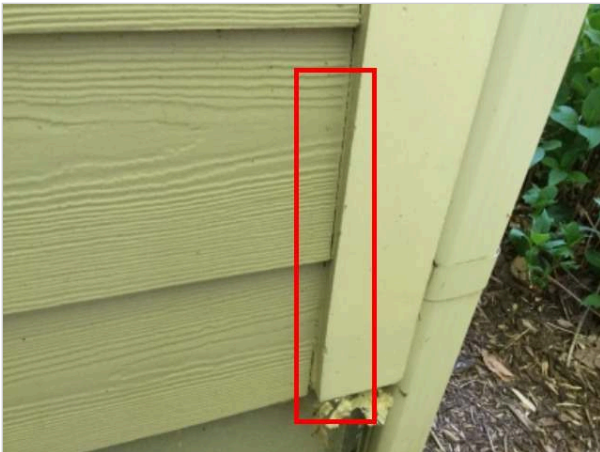
1. The exterior caulking around the siding and trim is cracked or missing in numerous areas. Failed or missing caulk can allow moisture to infiltrate siding and structural components and lead to mold or rotted wood. Have a qualified contractor rework the caulking everywhere required.
2. Loose siding was noted on the right side of the home. If left, this condition can allow water infiltration behind the siding. Have a qualified contractor repair the siding.

***The exterior caulking around the siding and trim is cracked or missing in numerous areas. Failed or missing caulk can allow moisture to infiltrate siding and structural components and lead to mold or rotted wood. Have a qualified contractor rework the caulking everywhere required.***

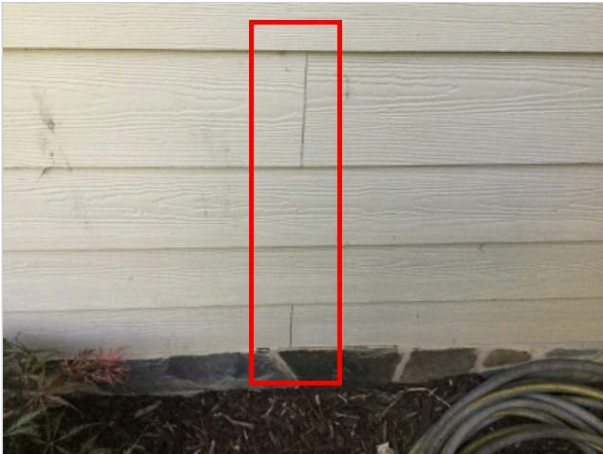
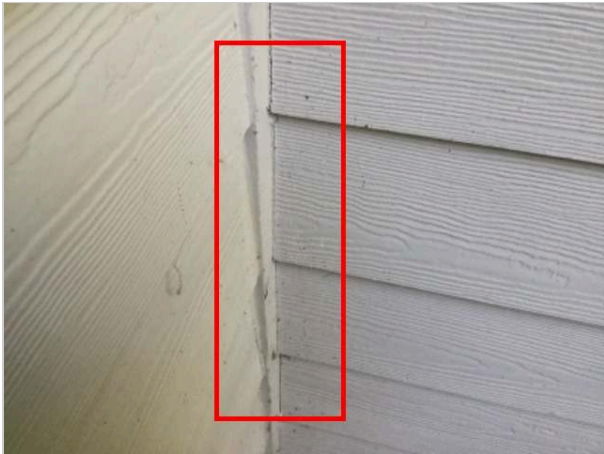
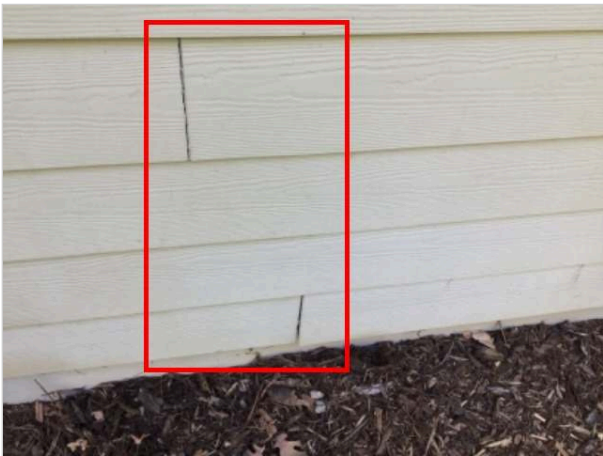
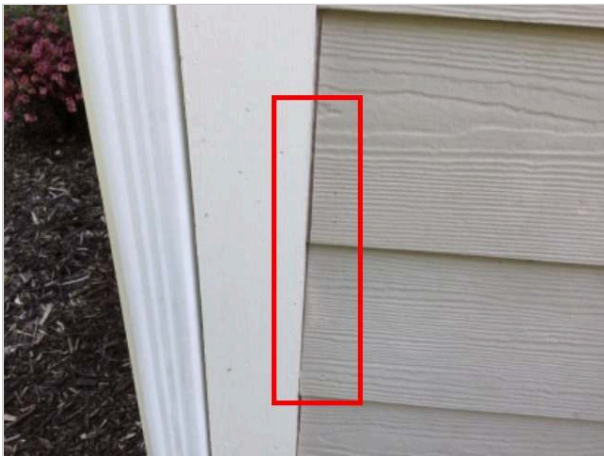
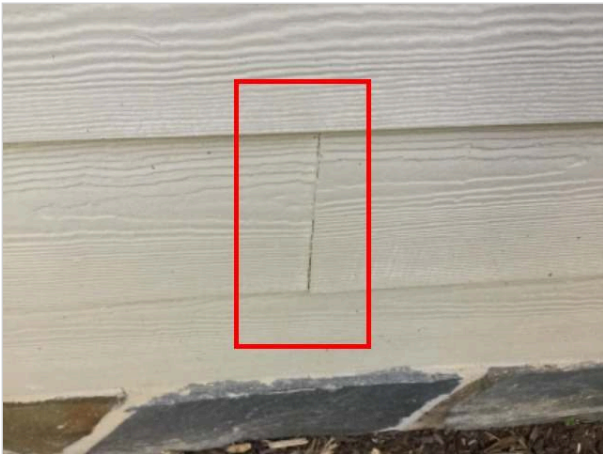
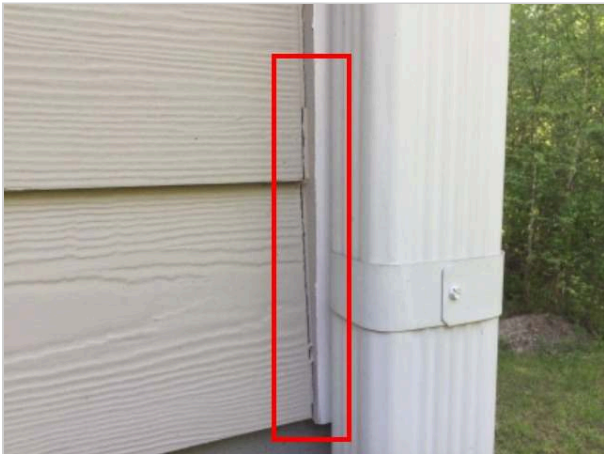
**Loose siding was noted on the right side of the home. If left, this condition can allow water infiltration behind the siding. Have a qualified contractor repair the siding.**

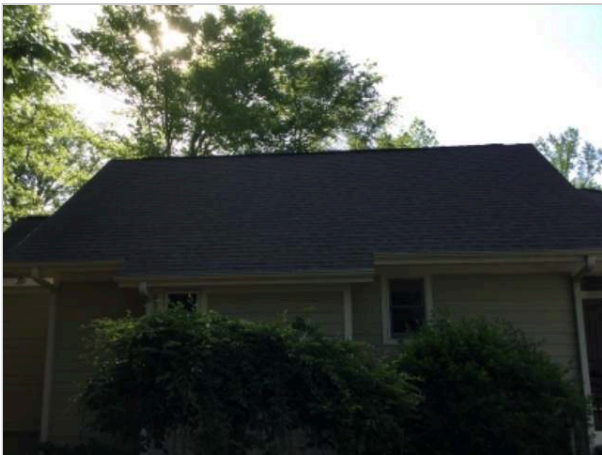
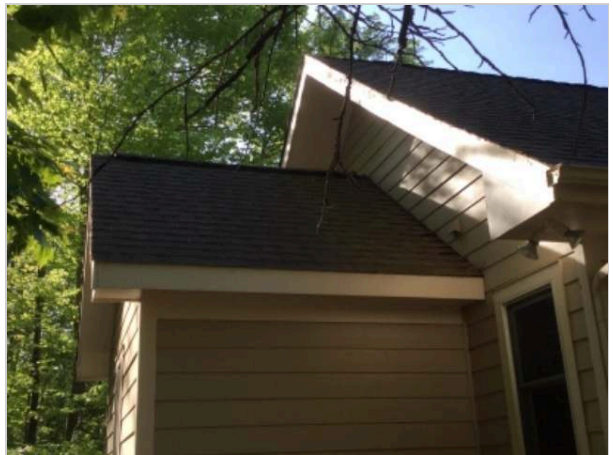
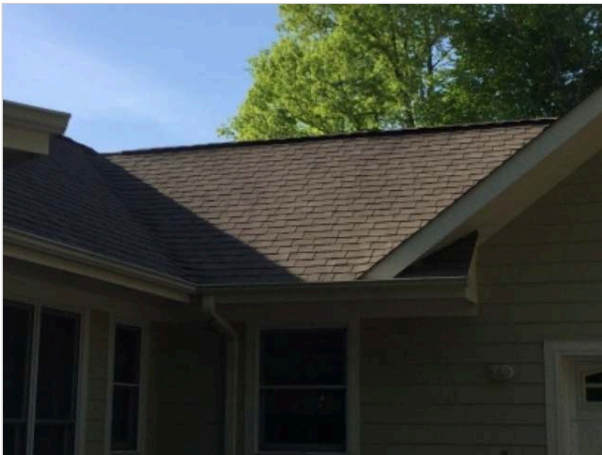
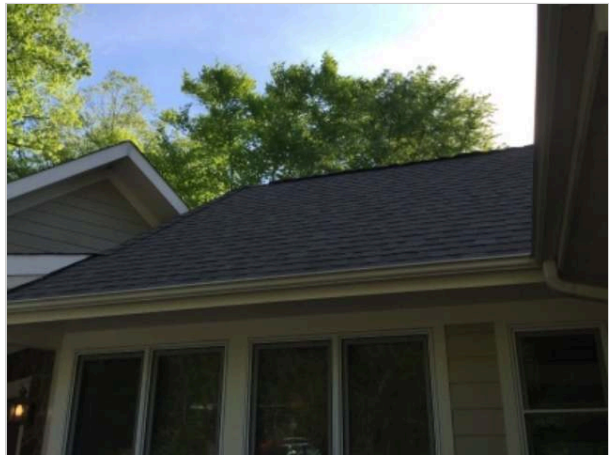
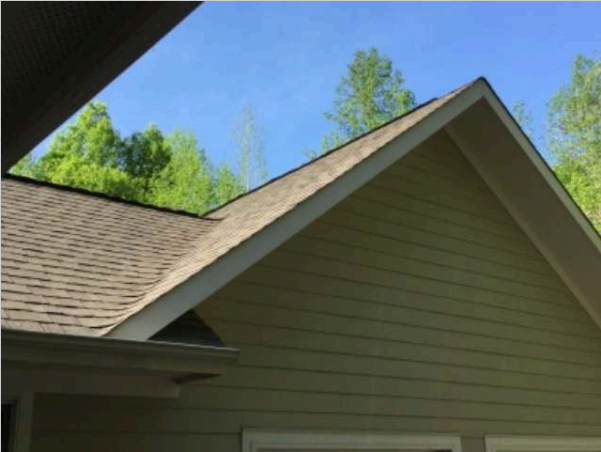
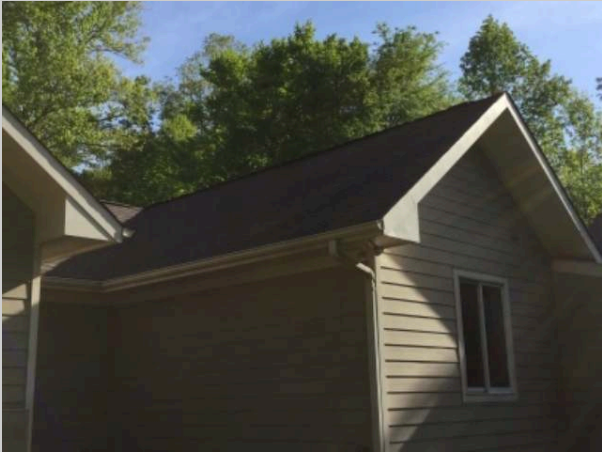
1. On this roof, one shingle appeared to be in poor condition. Further, there was one curled shingle and one that appeared to be pushed up by a nail. Broken, loose curled and/or cracked shingles can allow the infiltration of water and lead to damaged structural components. Have a qualified contractor to evaluate and repair as required.

***On this roof, one shingle appeared to be in poor condition. Further, there was one curled shingle and one that appeared to be pushed up by a nail. Broken, loose curled and/or cracked shingles can allow the infiltration of water and lead to damaged structural components. Have a qualified contractor to evaluate and repair as required.***

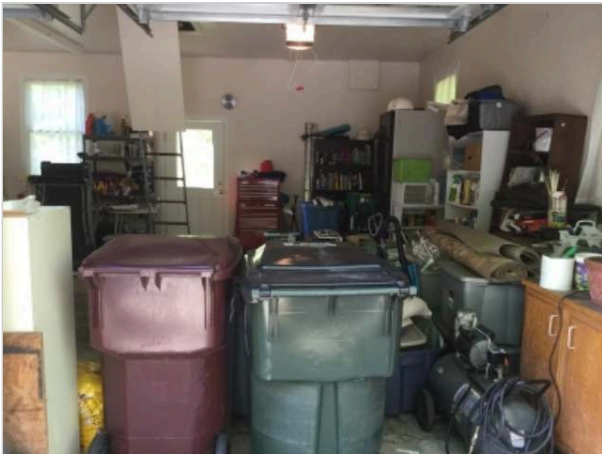
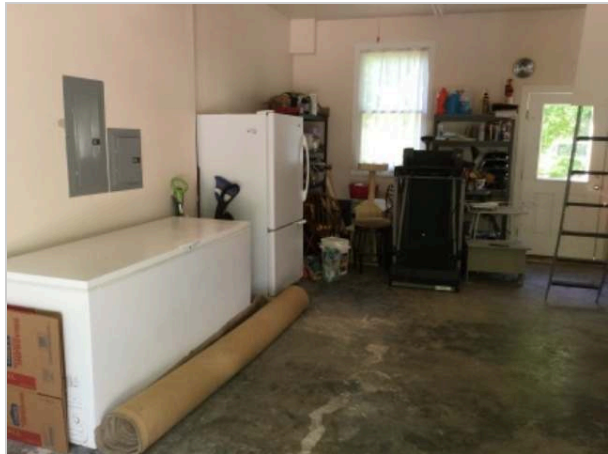
***The garage floor and wall inspection was limited by the presence of stored equipment and material. If concerned, once the area is clear, have a qualified contractor evaluate and advise***

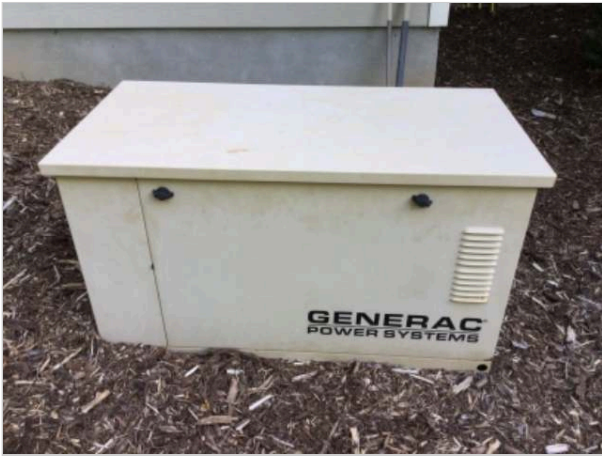
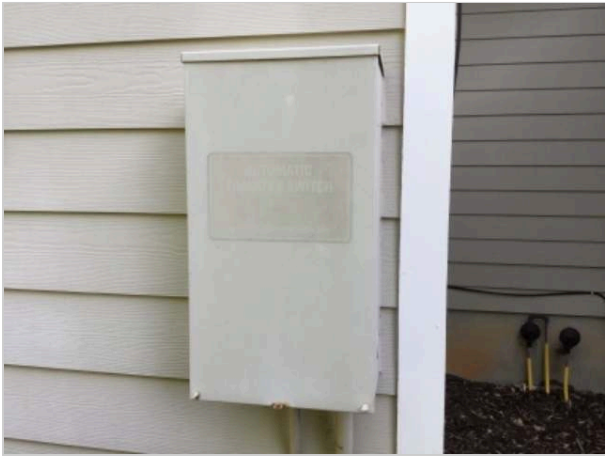
***This home has a gas-fired emergency electric generator. These are not part of the home inspection scope. This unit does have an automatic transfer switch. The unit did not cycle on during this inspection. Often, permanently installed generators with automatic functions will be on a test-run cycle (weekly/monthly/etc.). Ask the seller for full disclosure on the set-up and operation of this unit and for all operating and parts manuals or have a qualified electrical contractor evaluate and advise.***

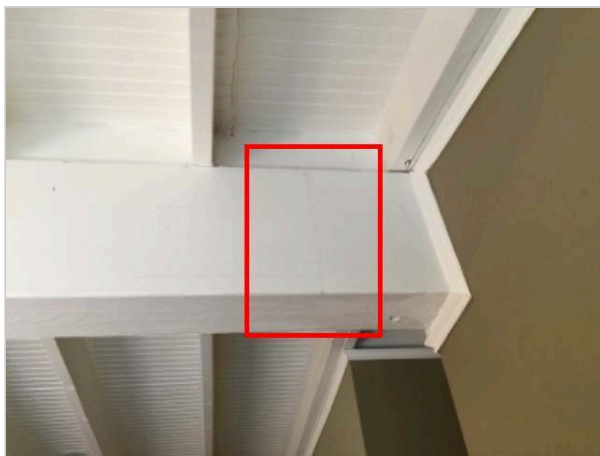
***At the living room, there is evidence of moisture staining on one beam at the left end. Ask for seller disclosure on the history of leakage and repair in this area or have a qualified contractor evaluate and repair as required.***

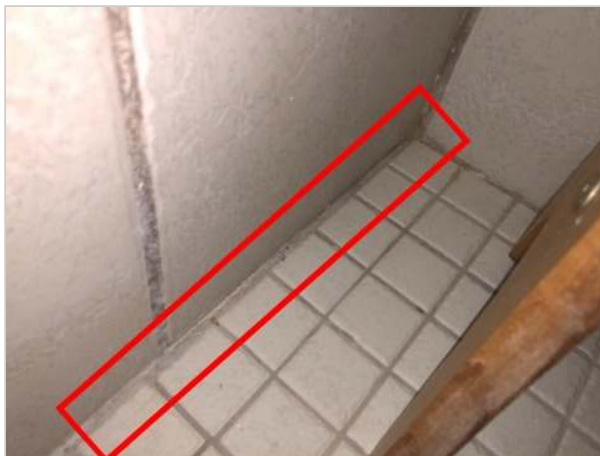
***In the master bathroom, around the base of the shower, some of the grout exhibited shrinkage. Failure to keep walls sealed can cause deterioration and extensive moisture damage including mold growth to the interior walls. Have a qualified contractor re-grout this area to prevent moisture penetration.***

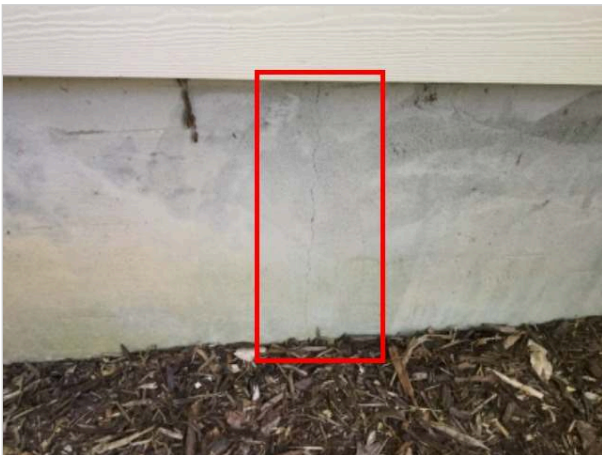
***On the foundation wall around the home, there are several places where the mortar parge coat exhibits shrinkage cracking. The foundation wall in the crawl space did exhibit damage but not at each of these. This parge coat is cosmetic but moisture entering the cracks and freezing may contribute to further damage. Have a qualified contractor seal or repair this parge coat as required.***

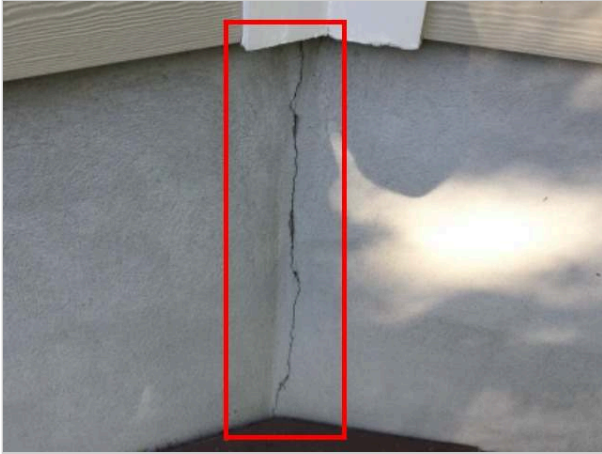
Foundation cracked here

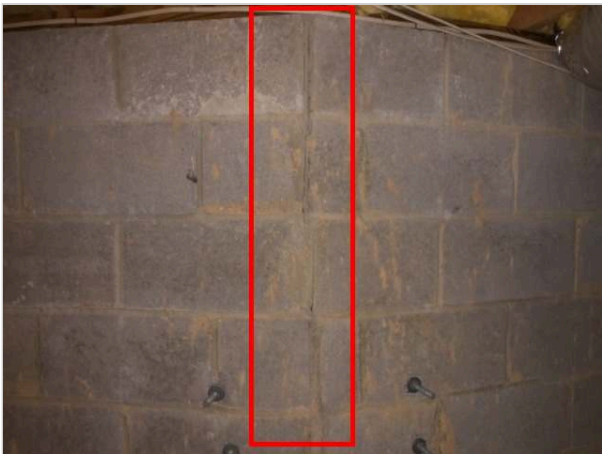
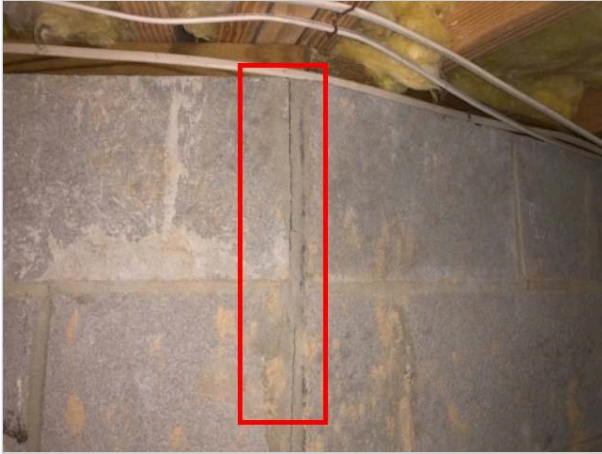
***On the rear of the home, the foundation is cracked. This crack is not open and there is no differential movement.. There was no apparent structural movement in the living space above. Have a qualified structural engineer evaluate and advise.***

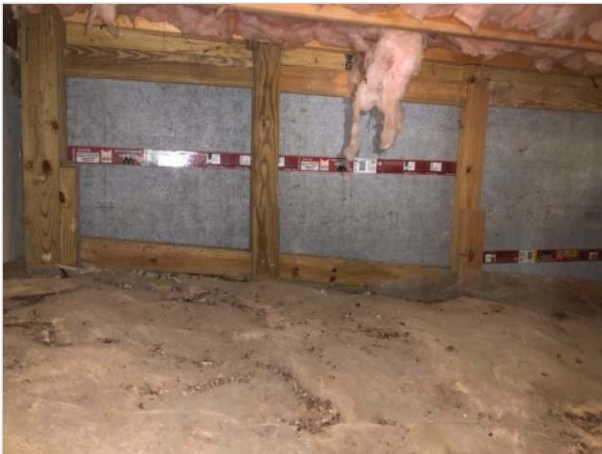
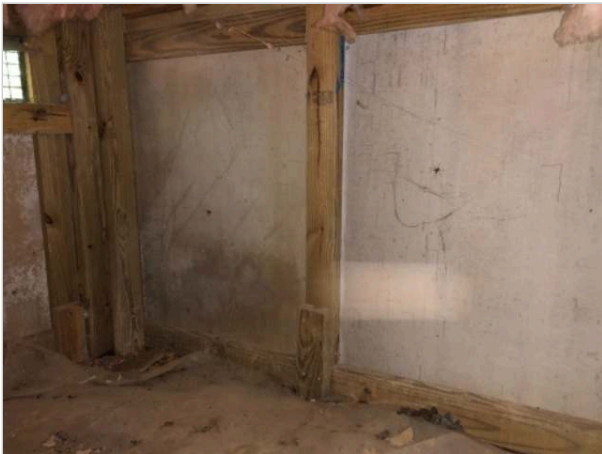
***At the left end of the home, it appears the walk-in closet was added on to the home. The foundation for this area is deck-like and the space closed with attached panels. This may not be structurally sufficient. Have a qualified structural engineer evaluate the foundation here and advise..***

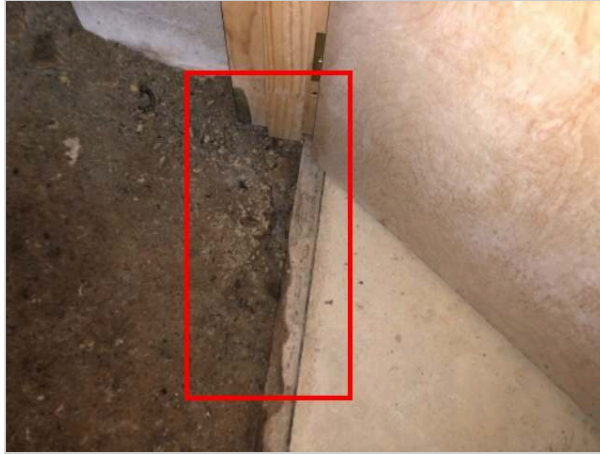
***At the door from the concrete slab space to the dirt crawl, the wood frame is in contact with the ground. Wood to ground contact provides a path for wood destroying insects to enter the home. Have a qualified contractor reconfigure this area as required.***

Wood to ground

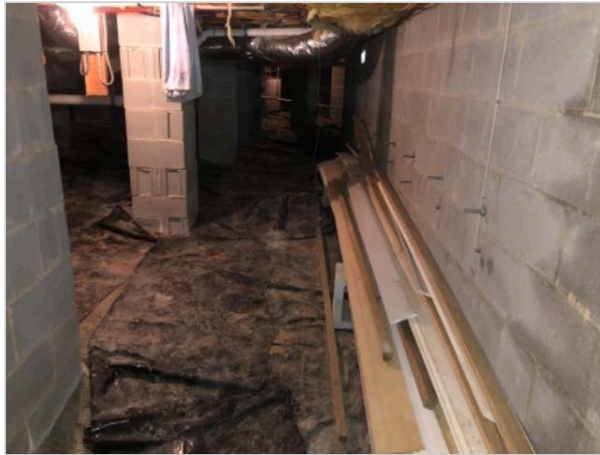
***In the crawlspace, there is scrap wood. This material can attract wood destroying insects and organisms. Have this material removed from the crawlspace.***

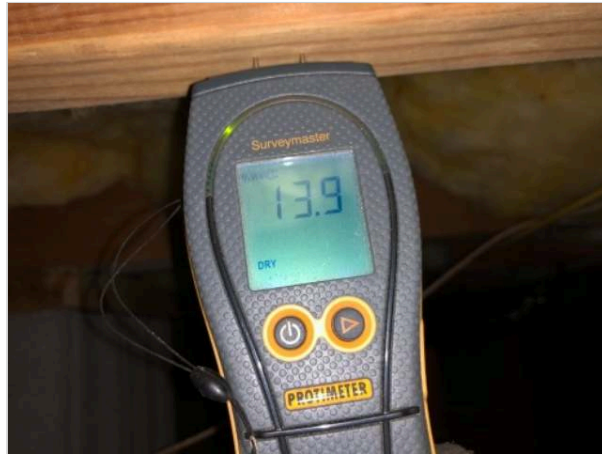
*In the crawl space, there is evidence of possible microbial growth on the floor structure. This is evidence of higher than normal moisture levels at some point. Higher moisture levels can lead to harmful mold and fungus and makes the wood more susceptible to wood destroying insects. Have a qualified contractor mitigate the conditions and perform any necessary repairs.*

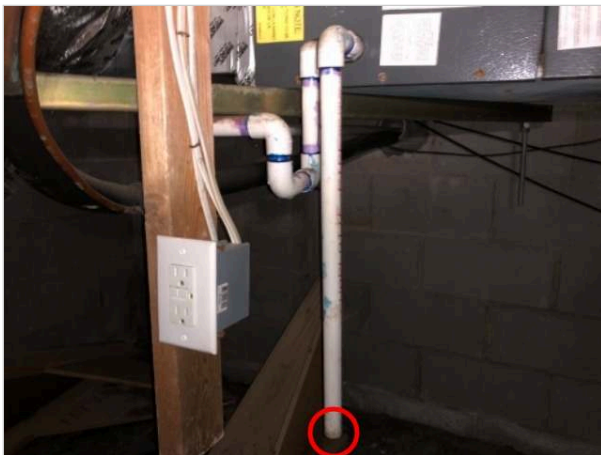
**In the crawl space, the right side HVAC indoor unit secondary drain line exits to the vapor barrier. If the primary drain becomes inoperable, this will drain condensate into the crawl space. A functional secondary drain, with a means to drain to the exterior, is essential for proper functioning of this unit. Have a qualified HVAC contractor evaluate and repair as required.**

Open to ground

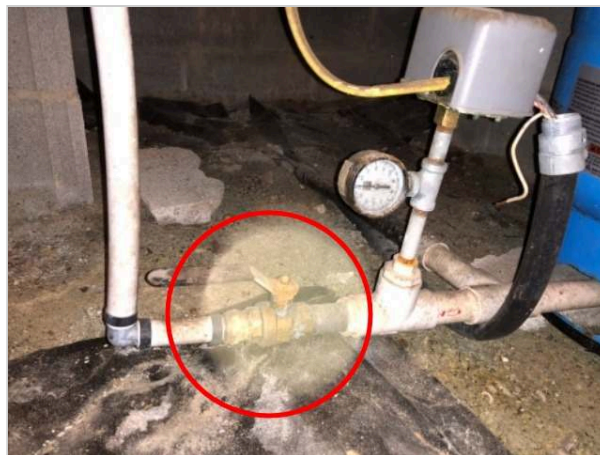
### main water shutoff

The main water shutoff valve for the home was located at the well expansion tank in the crawl space . Water shutoff valves are visually inspected only. No attempt is made to operate the main or any other water supply shutoff valves during the inspection. These valves are infrequently used and could leak after being operated. This is for your information.

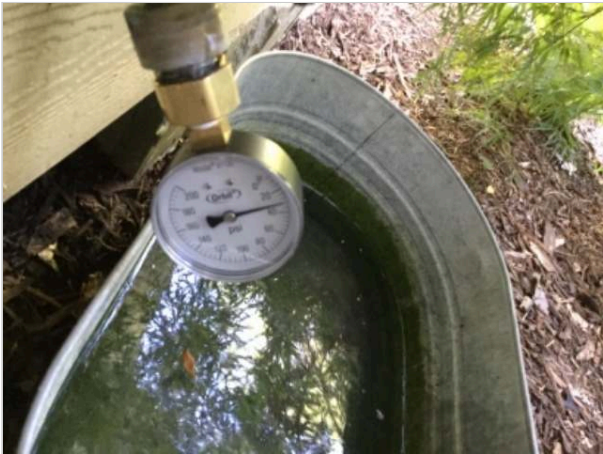
All plumbing fixtures not permanently attached to a household appliance were operated and inspected for visible leaks. Water flow throughout the home was below average. Water pressure was tested at an outdoor faucet and found to be 30 pounds per square inch. This report is not intended to be an exhaustive list of minor plumbing issues. Concealed, latent or intermittent plumbing issues may not be apparent during the testing period. There were defects observed in the visible portions of the plumbing system.

*The water pressure and flow seemed deficient in the home. When running multiple fixtures at the same time, the flow drops off considerably. Have a qualified plumbing contractor evaluate the water flow in the home and adjust or repair as required*

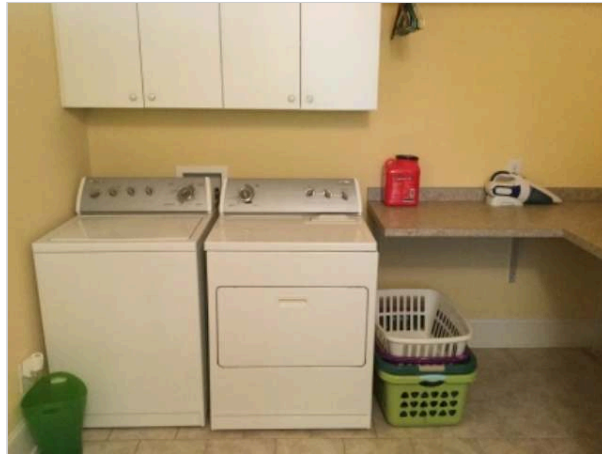
**washer/dryer**

***The dryer vent outlet cover appears to be partially clogged. A clogged dryer vent can overheat and lead to fire. Have a qualified contractor replace the vent outlet cover and clean the vent hose.***

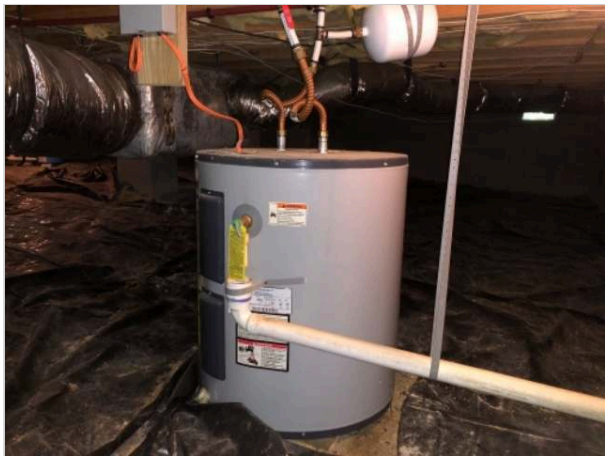
There was a 30 gallon capacity, electric water heater located in the crawl space beneath the living room. The water heater was manufactured by American Water Heater , and appeared to be 13 years old. Client should note that water temperature greater than 120 degrees presents a scalding/burn concern.

There were no concerns observed with the hot water heater.

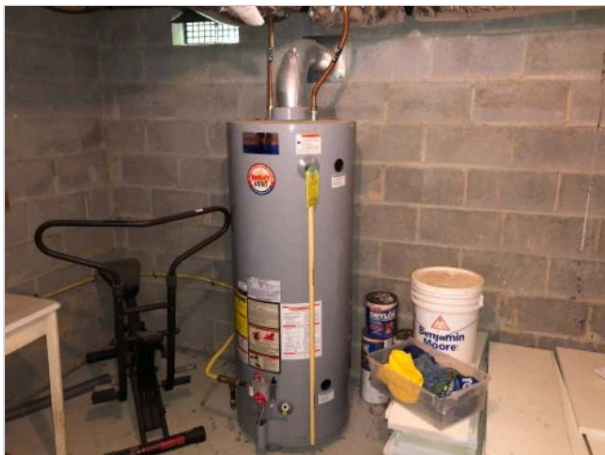
## RIGHT WATER HEATER

There was a 50 gallon capacity, LP gas water heater located in the storage room under the guest room. The water heater was manufactured by American Water Heater, and appeared to be 13 years old. Client should note that water temperature greater than 120 degrees presents a scalding/burn concern.

There were no concerns observed with the hot water heater.
