HOME INSPECTION REPORT

Wednesday, July 3, 2024

John Doe
123 Anywhere St.
City, ST 12345

The inspected property consisted of a two story wood-framed structure with brick, stucco, and wood siding that was occupied at the time of the inspection. There were no material defects on the visible portions of the siding.

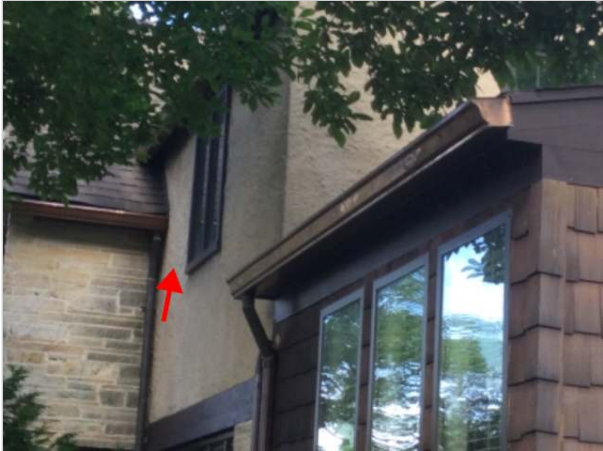
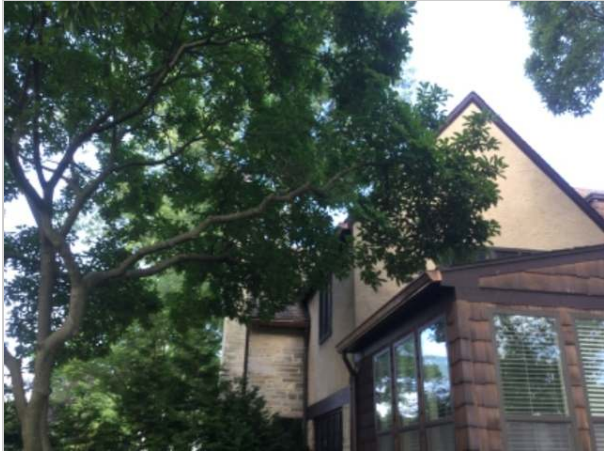
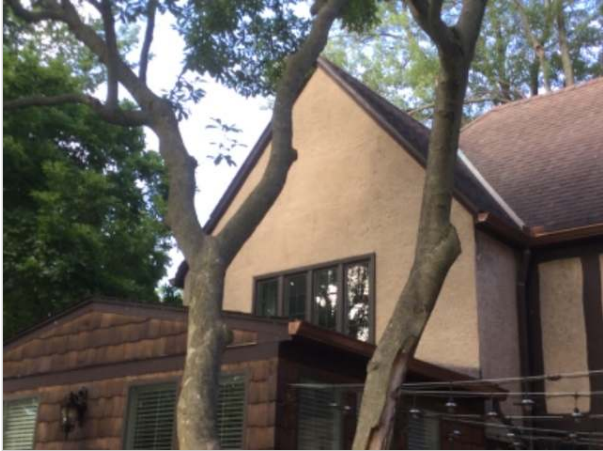
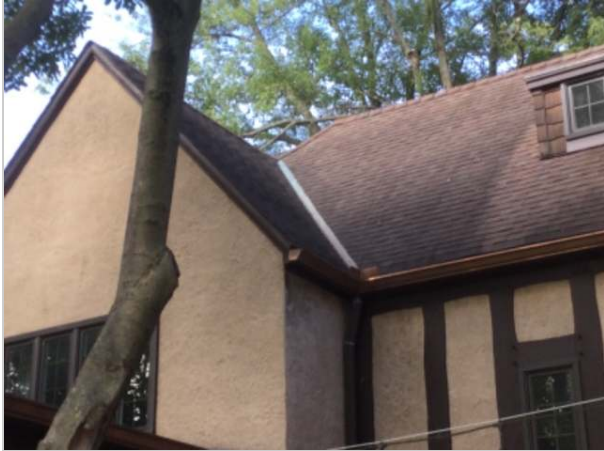
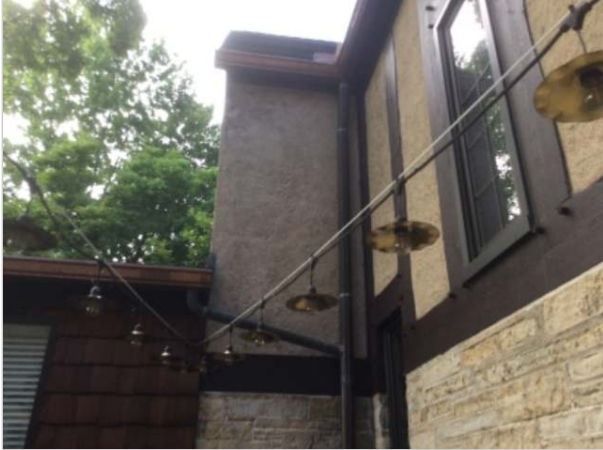
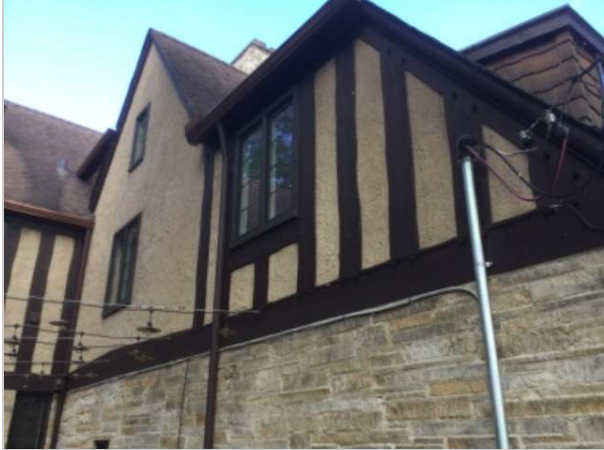
Section seven item (I) of the home inspection agreement specifically excludes the inspection of the exterior insulated finish system (EIFS). These systems are dependent on proper installation by certified contractors in strict accordance with the manufacturer's specifications. We cannot confirm that this installation conforms to all technical specifications. If there is any question on the condition of this finish system, you should consult with a contractor certified in EIFS

installation. All open voids should sealed. Previous repairs were noted.

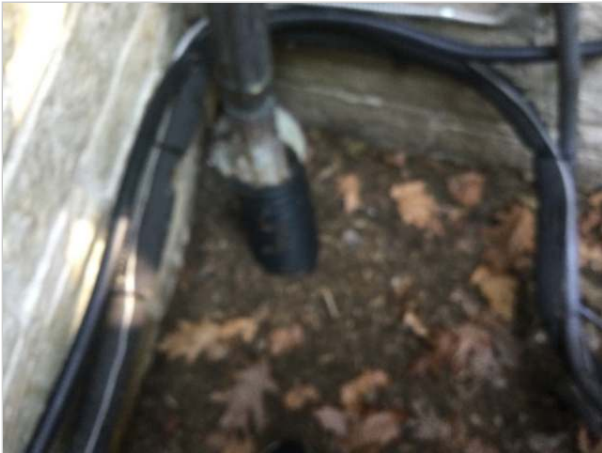
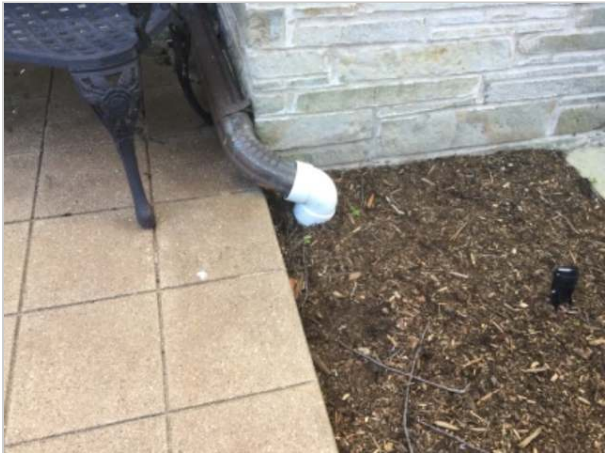
The roof drainage system consisted of copper gutters and downspouts which appeared to be functional at the time of the inspection. Gutters and downspouts should receive routine maintenance to prevent premature failure. There were no material defects observed on the visible portions of the gutters or downspouts.

We could not determine where the gutters drained after entering the ground.

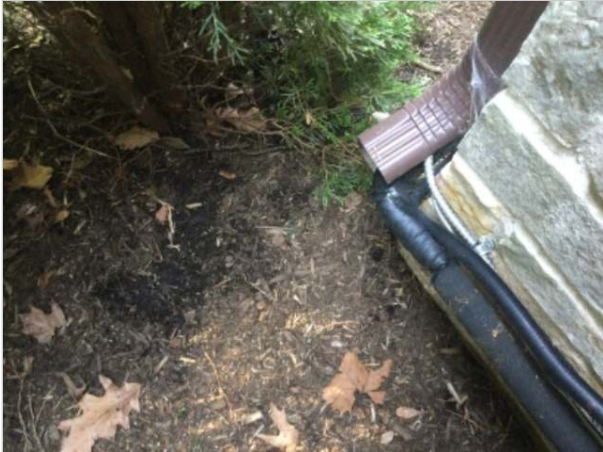
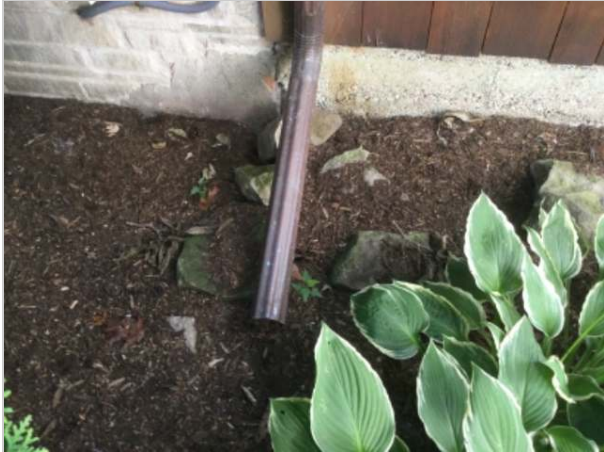
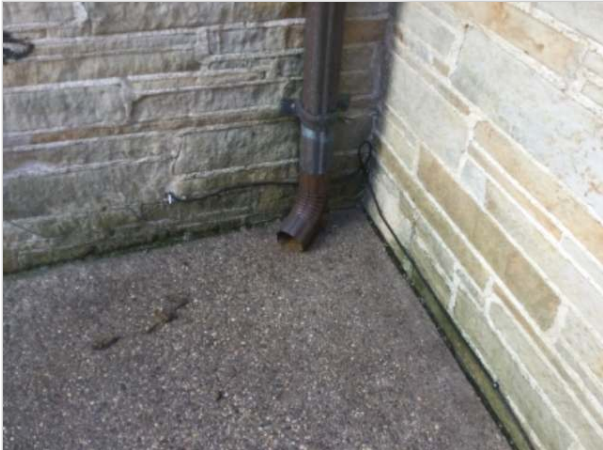
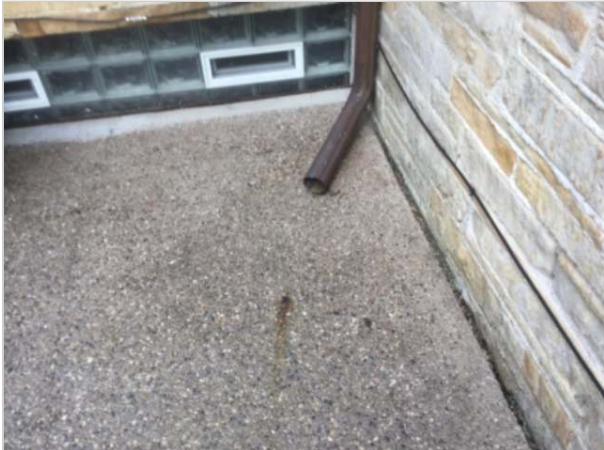
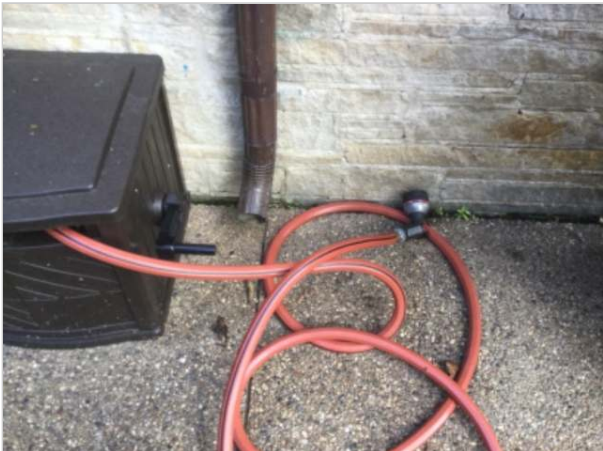
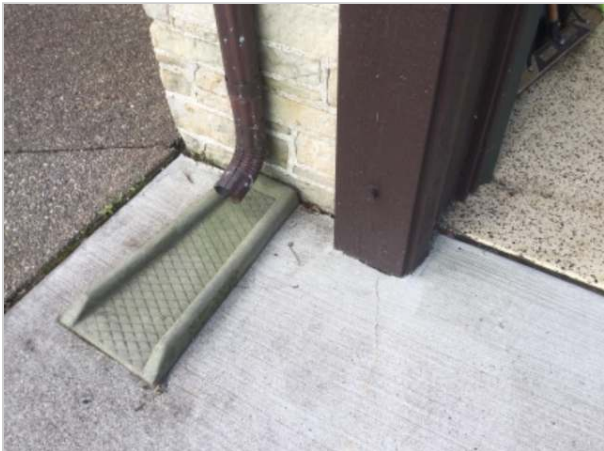
Some of the downspout (s) were draining at or too close to the base of the foundation. All roof drainage should be directed at least six feet from the base of the foundation.

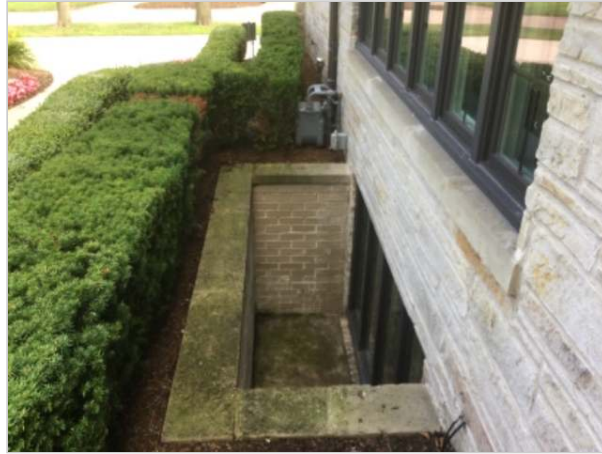
The home was situated on a level lot. The general grade around the home appeared to be inadequate to direct rain water away from the foundation.

By improving the exterior grade so water flows away from the foundation will take pressure off the walls. Added pressure can cause leaks, cracks and foundation movement.

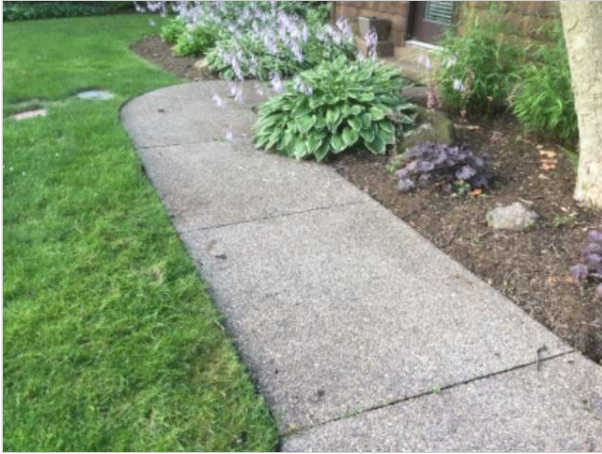
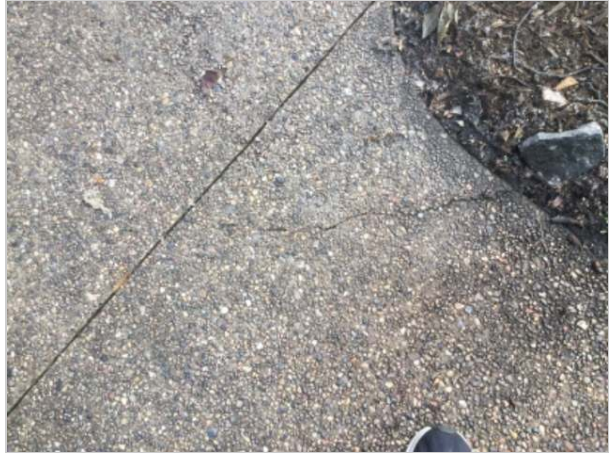
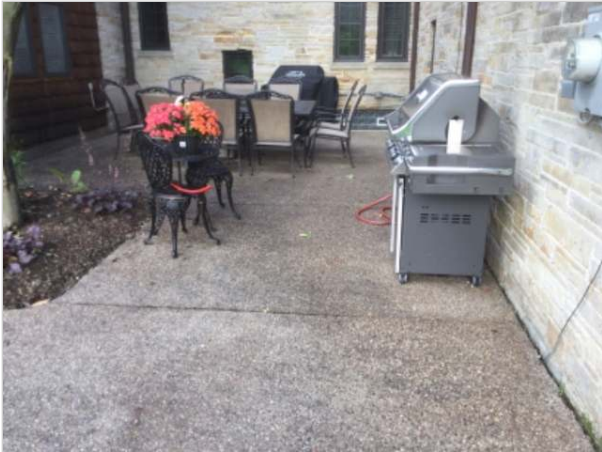
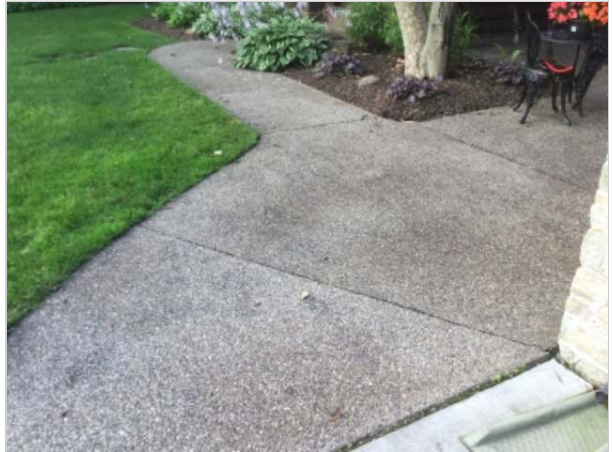
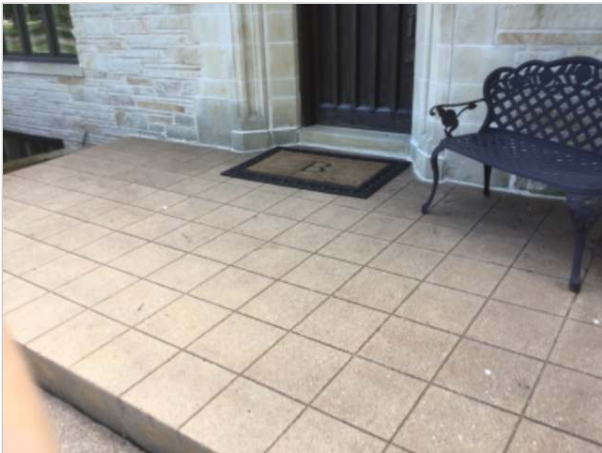
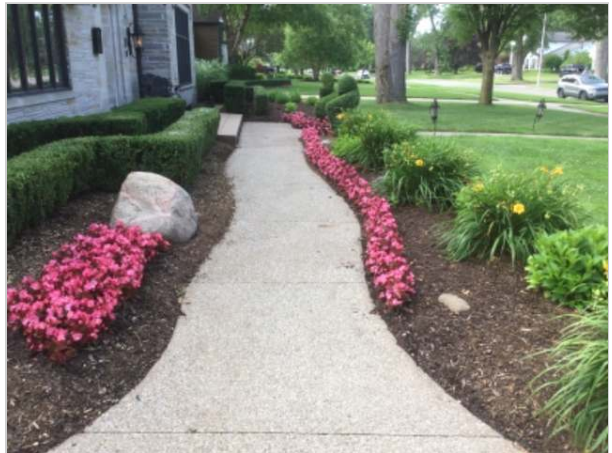
There was a crushed aggregate walkway leading to stamped concrete porch in the front of the home. Surface defects in walkways develop and progress with age and are considered normal as long as they do not create a safety hazard. There were no material defects observed in the walkway or the porch.

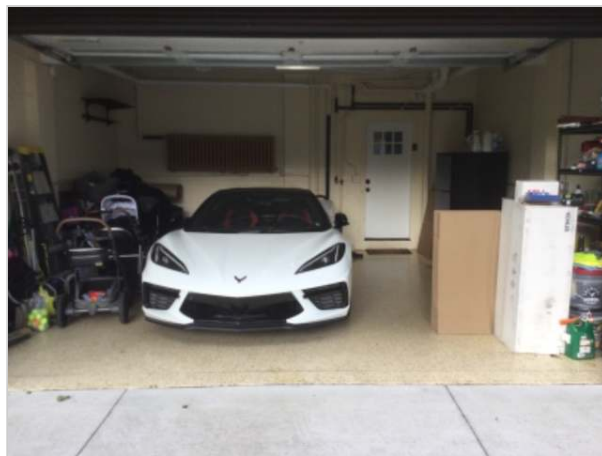
The garage was cluttered with many stored items and/or shelves at the time of inspection, therefore several areas were unable to be inspected.

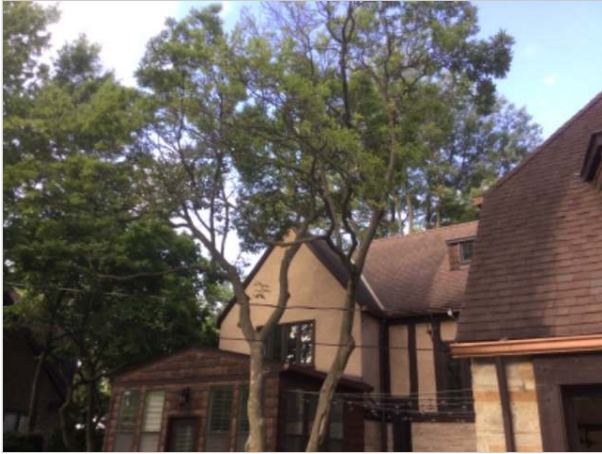
Tree branches were hanging over, or making contact with the roof. The trees should be cut back away from the roof to avoid damage to the roofing material.

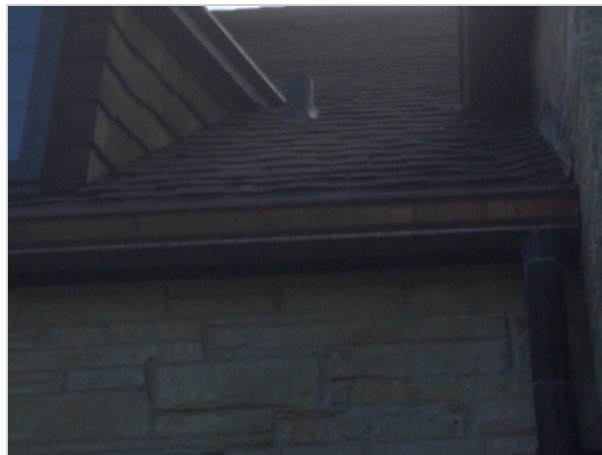
There were signs of moderate shingle wear at the time of the inspection. Fiberglass and the beginning signs of map cracking were noted. If this is a concern we recommend further evaluation by a licensed roofer.

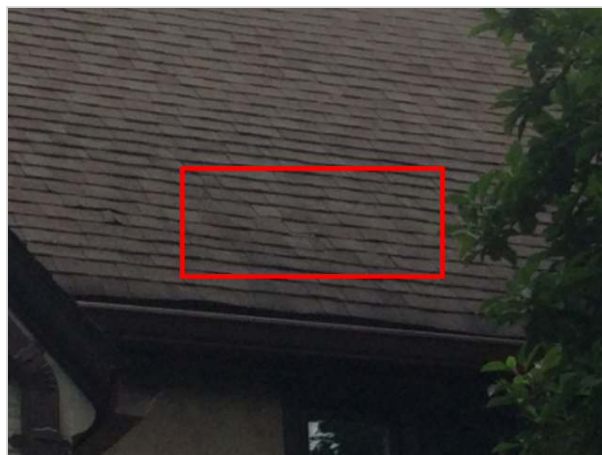
One or more loose shingles were noted on the roof at the time of the inspection. Loose shingle tabs are not necessarily a sign of a roof leak. Consult with a qualified roofer to make repairs.

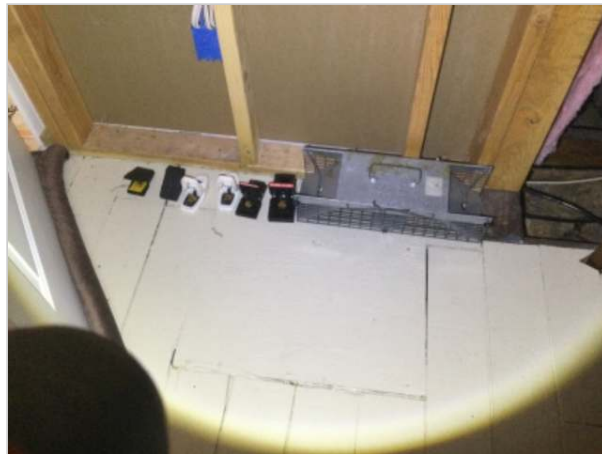
Evidence of rodent activity was noted in the attic at the time of the inspection. We couldn't determine if this was active. Monitor for possible future pest control needs.

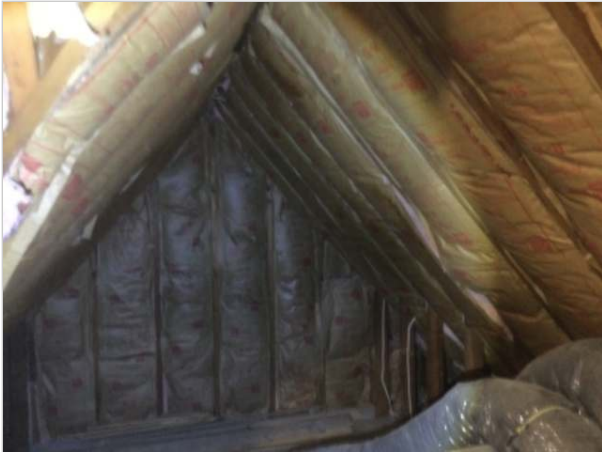
The attic did not appear to have adequate ventilation. There were no vents installed. Proper ventilation in the summer helps extend the life of asphalt / fiberglass roofing, as well as reducing radiated heat from the attic to the living space. Proper ventilation in the winter allows heat loss from the living area to exit the home, preventing the possibility of condensation forming in the attic, which could create mold conditions. Consult with a qualified roofer for further recommendations.

Insulation has been applied directly to the roof rafters in the attic storage areas. Insulation applied directly to the roof deprives the roof deck of proper ventilation and can cause the roof to overheat resulting in shortened roofing life. Additionally, condensation can form between the insulation causing damage to the roof deck. The insulation should be removed from the roof rafters. Walls adjacent to or below the attic spaces should be insulated.

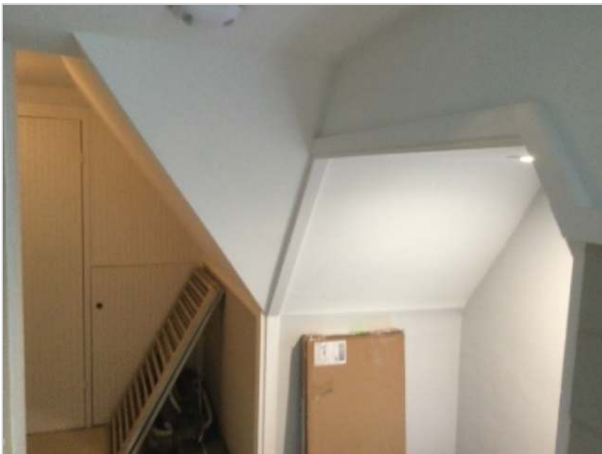
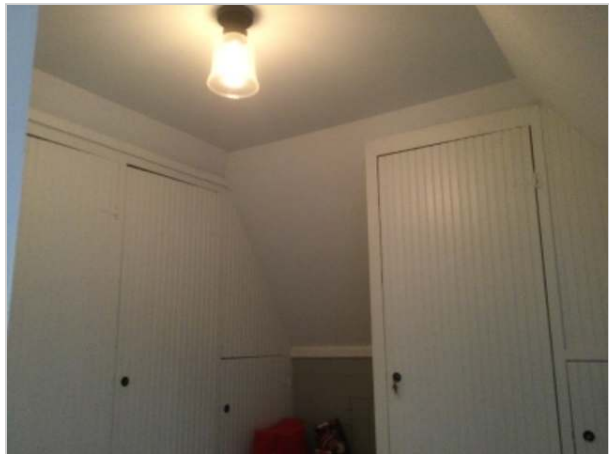
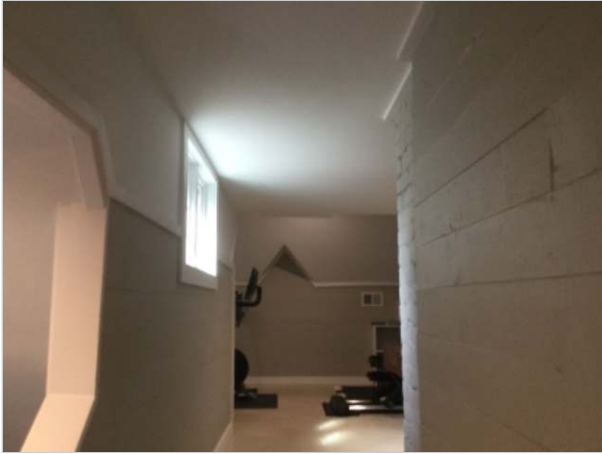
There was limited access to the attic area at the time of the inspection. As a result, it was not possible to inspect the majority of the underside of the roof for signs of leaks, or to determine the type of roof construction. Special attention was paid to the visible finished ceiling surfaces for evidence of active leaks. There was no evidence of active leaks at the time of the inspection.

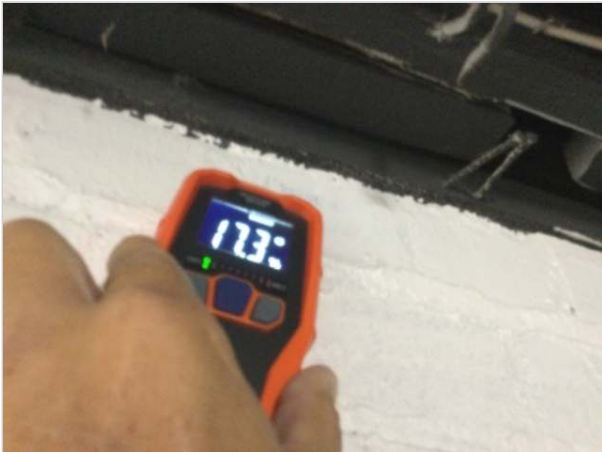
There was Efflorescence on portions of the basement walls. This indicates water is entering the foundation walls. By improving the grade, keeping the gutters clean and having six foot downspout extensions on can help with this condition.

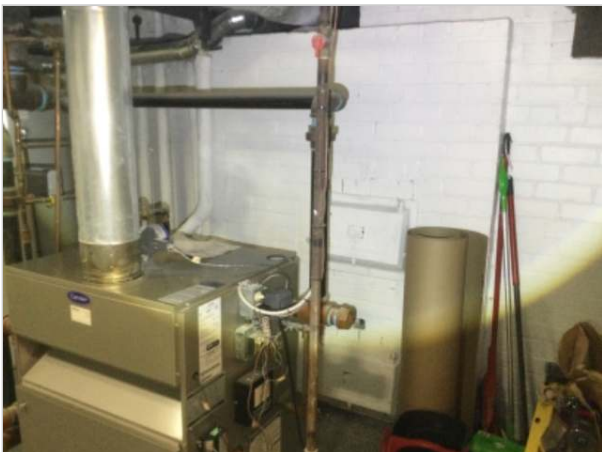
The block foundation has been painted. This may have hidden some deficiencies.

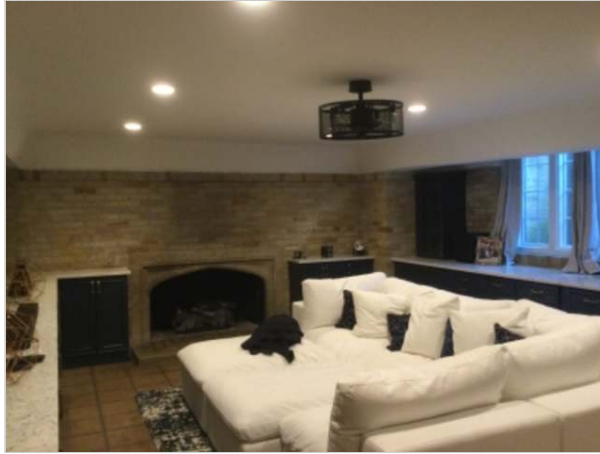
Most of the basement ceiling was finished, which restricts a clear view of the floor joists. As a result, we were not able to see the entire floor structure during the inspection. Determining the presence of concealed defects is beyond the scope of the inspection.

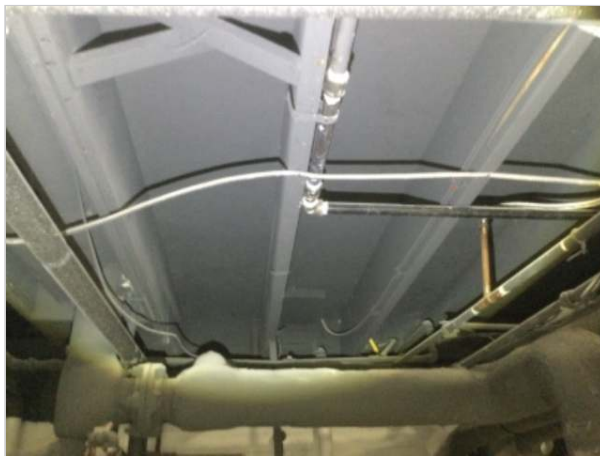
The floor structure was painted. This may have hidden some deficiencies.

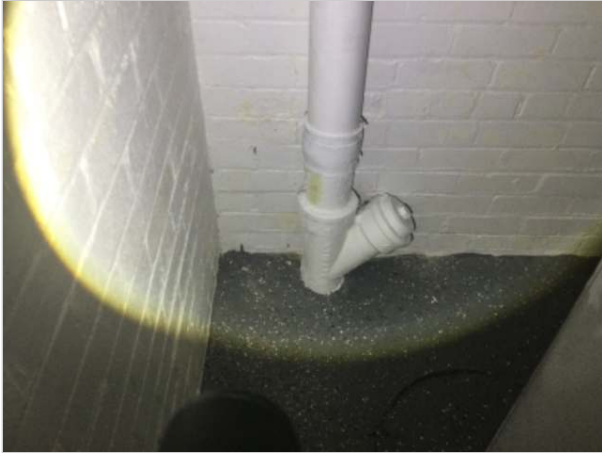
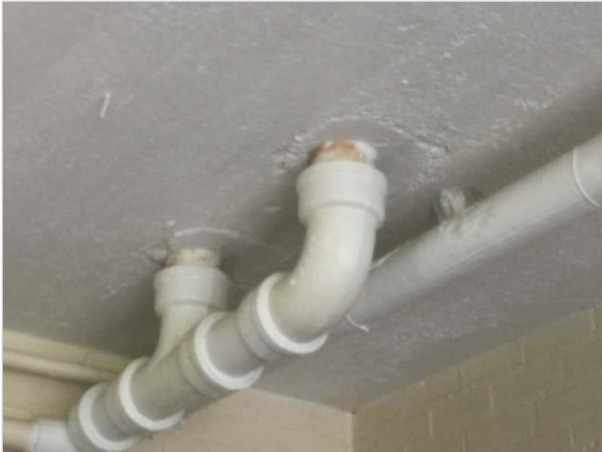
The main waste lines were corroded at the time of the inspection. Repairs may be necessary in the near future. If this is a concern, further evaluation should be conducted by a licensed plumber.

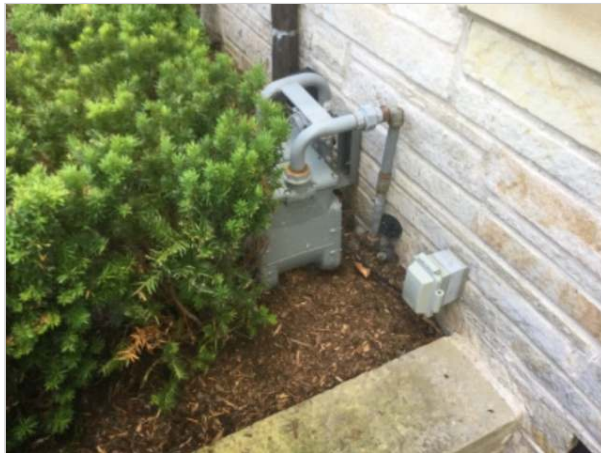
The main shut off is covered by landscaping material. The area should be regraded so easy access to the gas valve is possible.

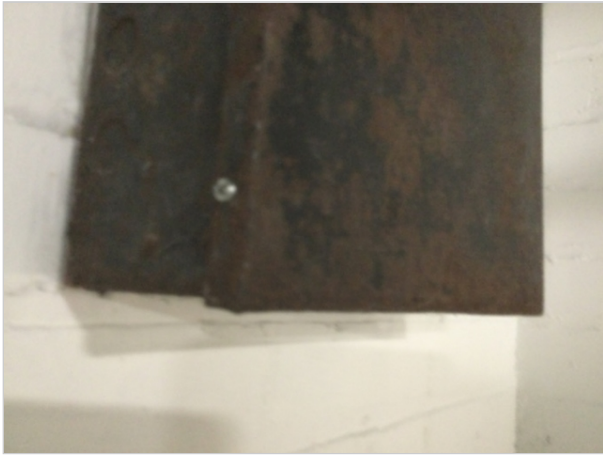
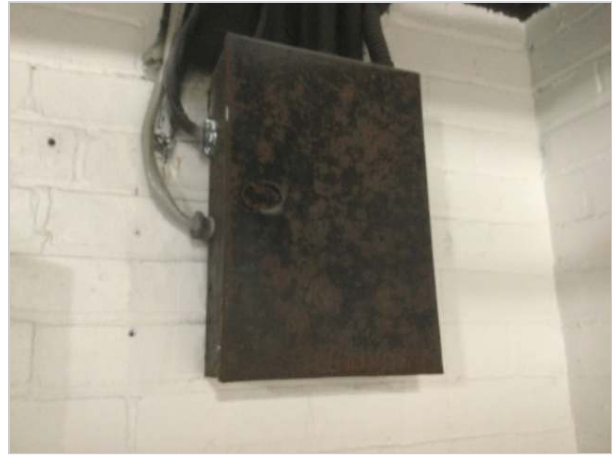
We were unable to open the electric box on the basement wall due to a striped screw. This box appears to be a junction

box but may be a sub panel.

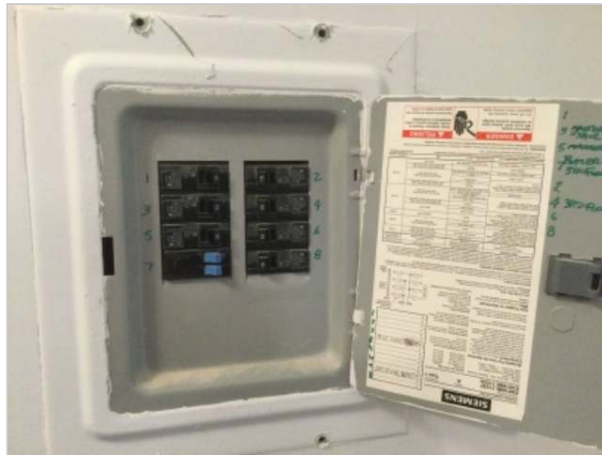
We could not view into the main electrical panel due to the the cover being sealed to the wall by paint.. Our inspection

was limited as we couldn't view the condition of the internal components and wiring.

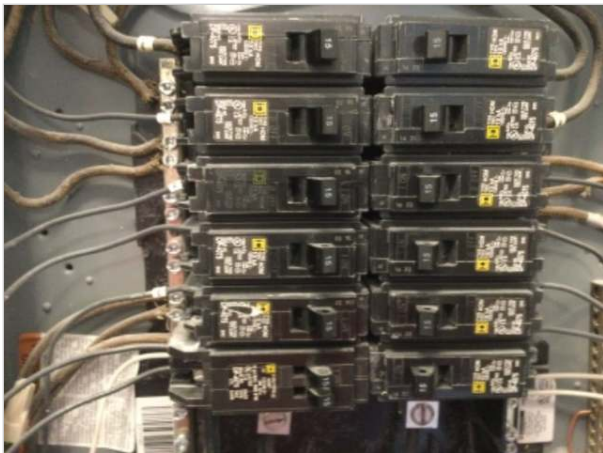
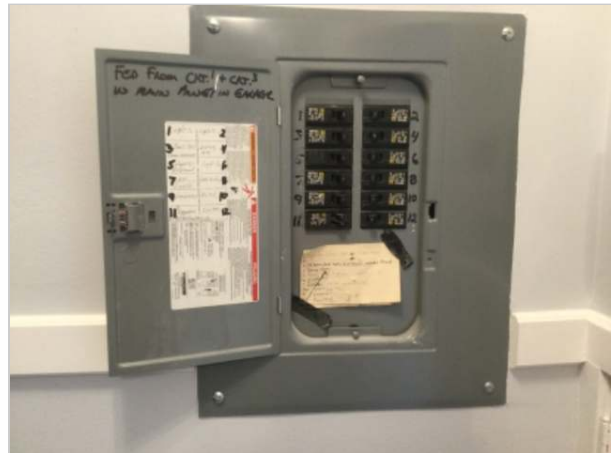
An electric service sub-panel was located first floor, and was manufactured by Square D. The service disconnect switch for this panel was located in the main panel. The branch circuits within the panel were copper and aluminum in the 240 volt circuits. These branch circuits and the circuit breaker to which they were attached appeared to be appropriately matched. The visible wiring consisted primarily of the Romex type and appeared to be in fair condition.

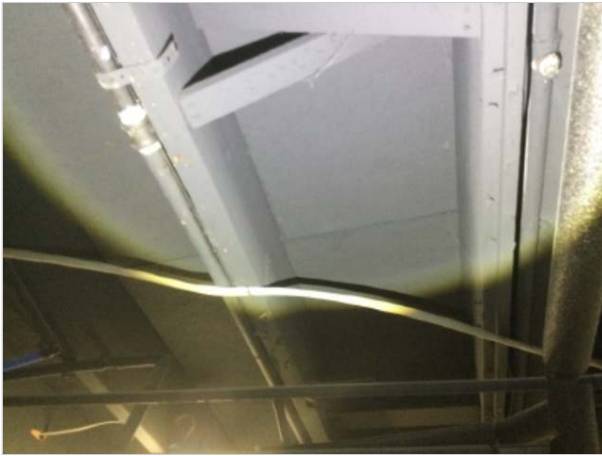
Evidence of amateur wiring was noted in the basement. Amateur wiring does not conform to standards methods and could be a safety concern. Consult with a qualified electrician for evaluation and repairs as required.

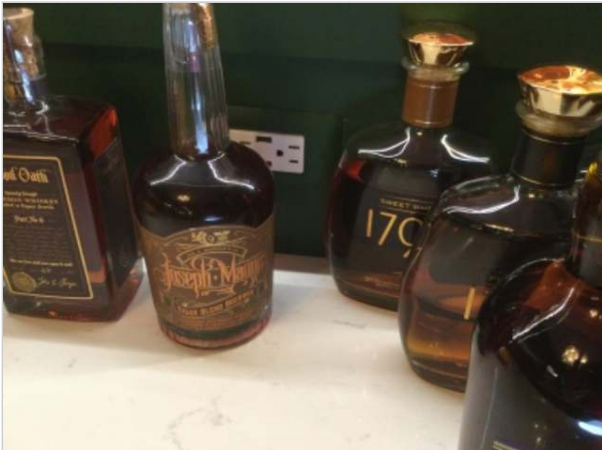
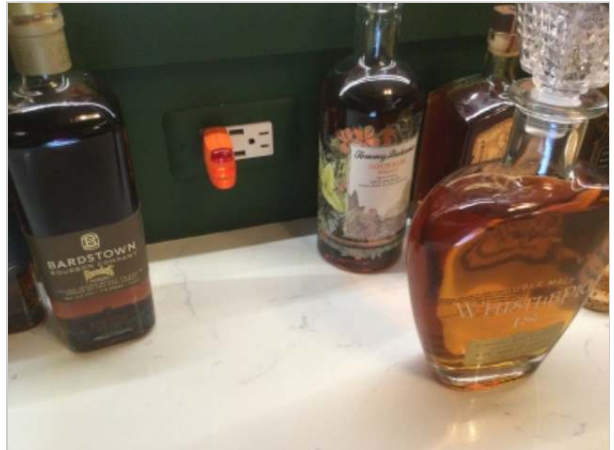
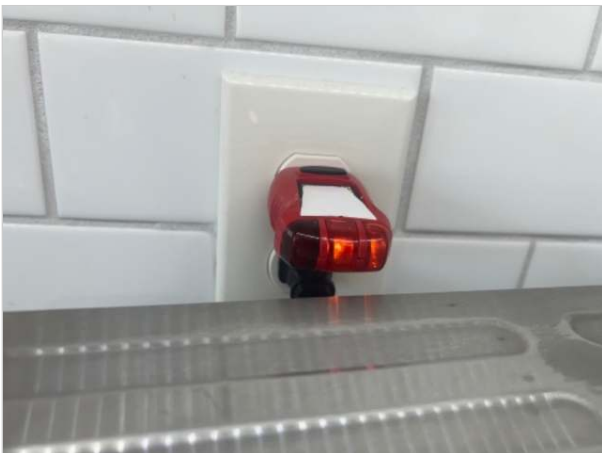
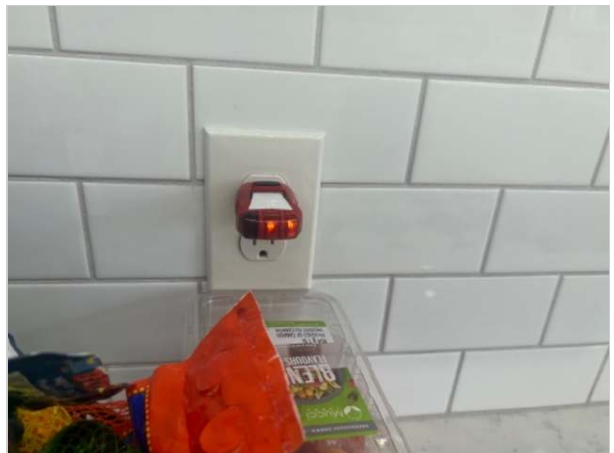
Kitchen

GFCI plugs need to be installed in the following locations for safety. The basement wet bar.

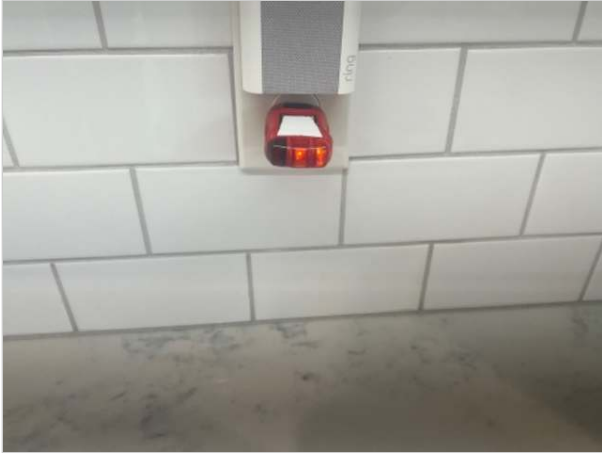
Kitchen

One or more three prong type outlets in the home tested as having an open ground. This means that the third prong, also known as the ground prong is not doing its job. This is usually caused by a missing ground connection at an electrical device in the circuit. This condition is usually easily correctable by an electrician. Open grounds in wet locations is considered a safety issue and should be corrected. Please note that we only test outlets that are visible and readily accessible at the time of the inspection.

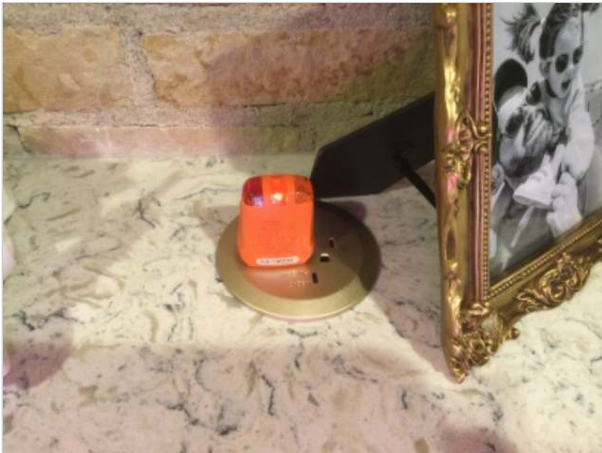
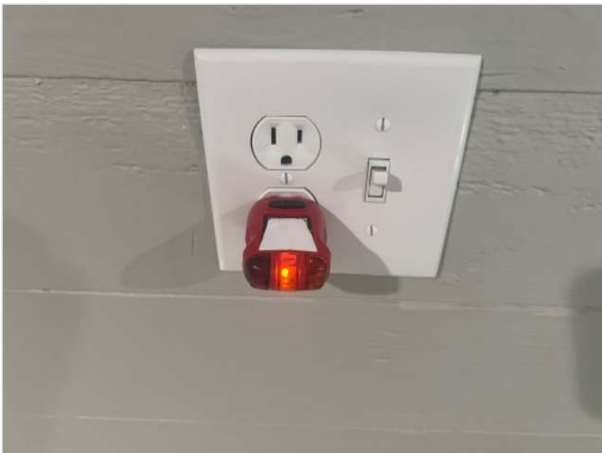
Too attic floor

Two prong outlets were found in one or more locations in the home. At the time this home was constructed, two-prong outlets were the standard construction. Two-pronged outlets were not grounded (open-ground), and are considered to be outdated by today's standards. In many cases, the outlets can be easily upgraded to three-prong type. In cases where the outlets cannot be easily upgraded, the installation of GFCI's in kitchens, baths, garages, basements, outdoor receptacles, and any other high-risk areas, will increase the overall safety of the electrical system. A qualified electrician

should be consulted when working on or updating the electrical system in your home.

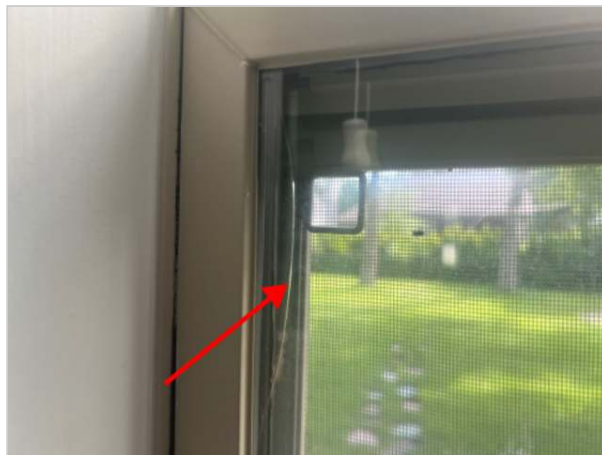
Cracked glass was noted on the Back sun room window(s). For safety and security all cracked and broken glass should be replaced.

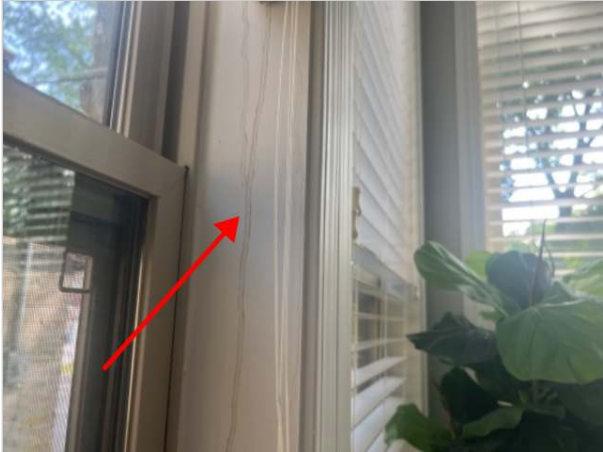
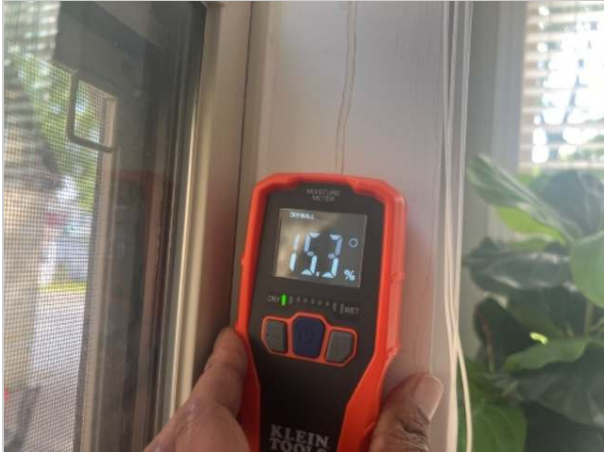
Water marks with no surface damage was noted on the windows The back sun room. The water marks appeared to be the result of previous leaks. Consult with a qualified contractor for evaluation and repairs as required.

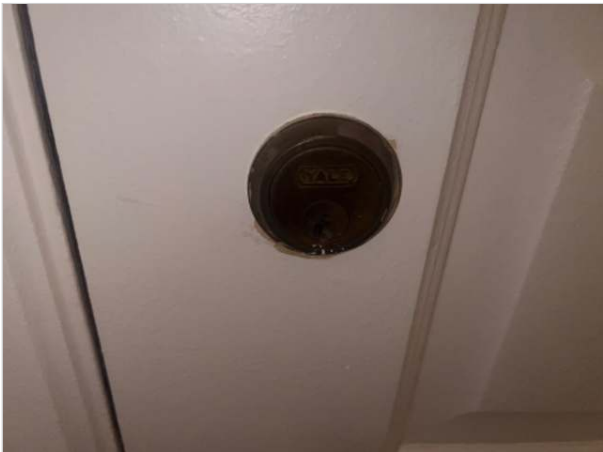
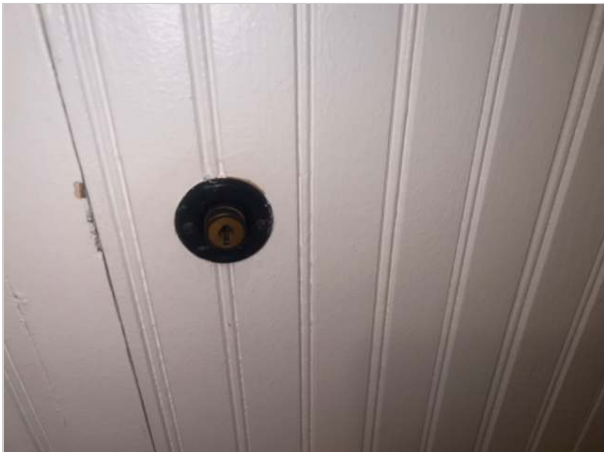
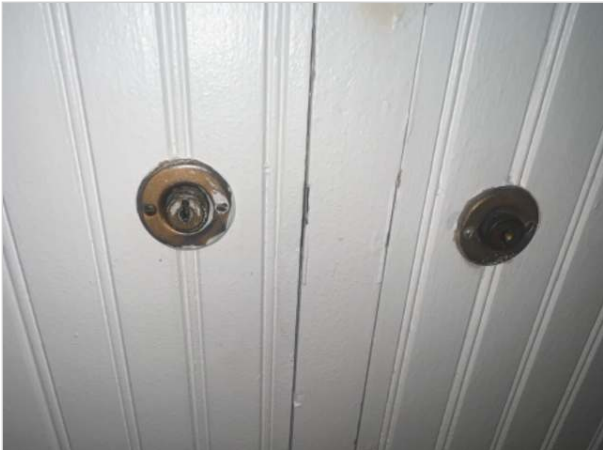
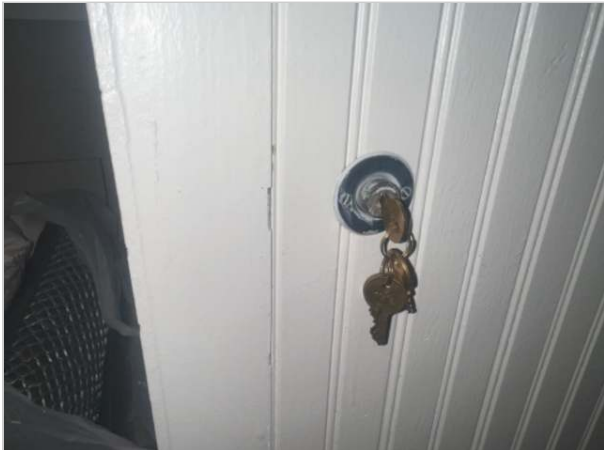
We recommend replacing interior keyed deadbolt with a thumb turn for safety.

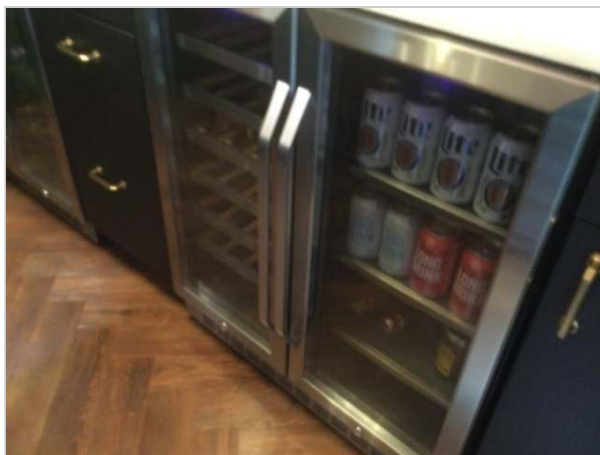
The basement refrigerator was inspected and did appear to be functional. The temperature setting and ice maker, if present, are not within the scope of the inspection.

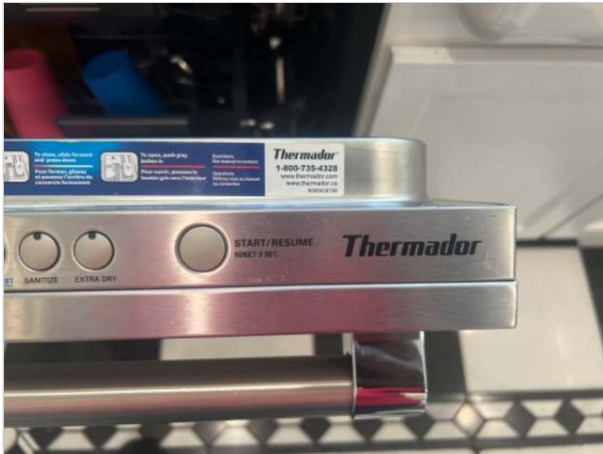
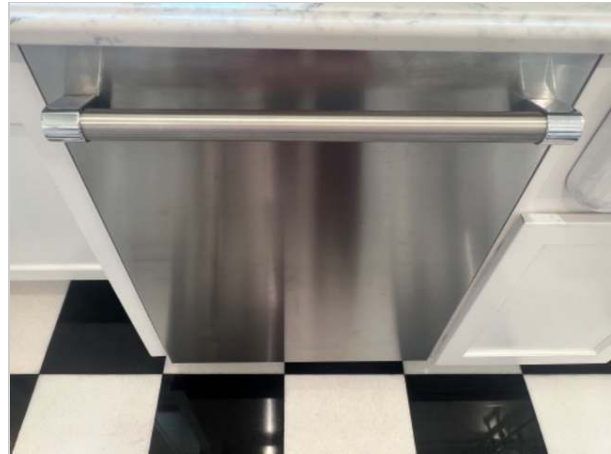
The Thermador dishwasher was tested and did appear to be functional.

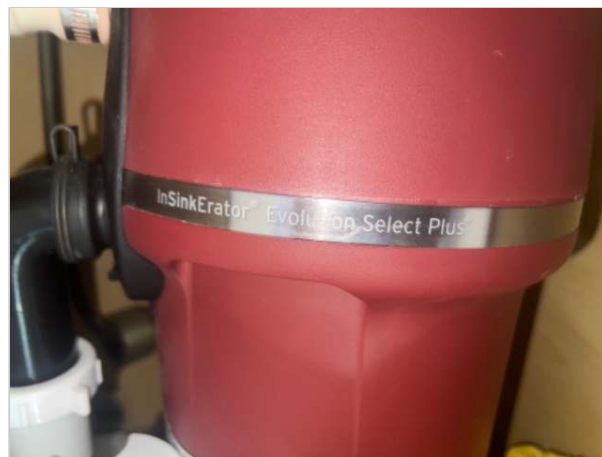
The In-Sink-Erator disposal was inspected and did appear to be functional. The efficiency rating and chopping / grinding ability of the unit is not within the scope of the inspection.

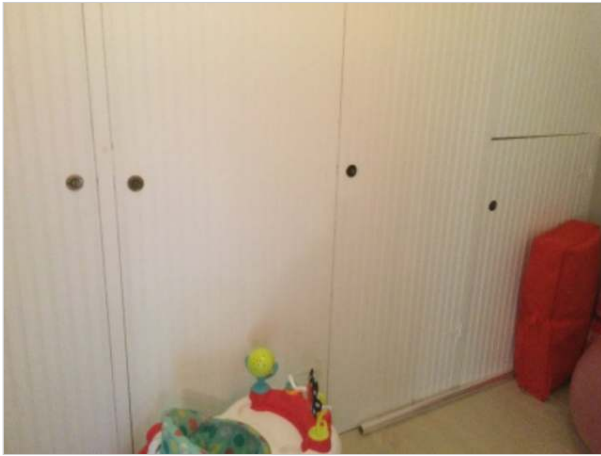
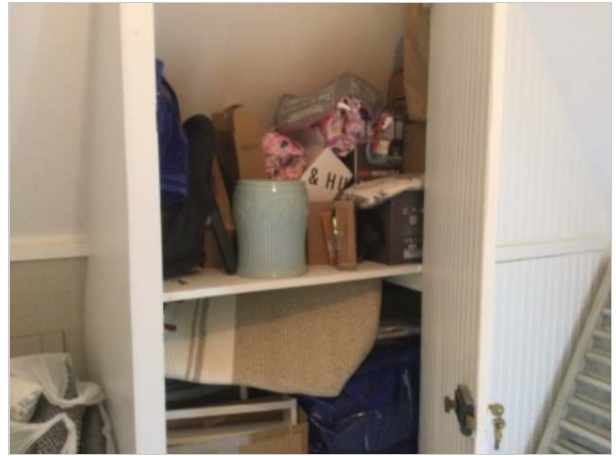
The closet on the third level were locked. We were only able to open one of the closets due to the locks being difficult to operate.

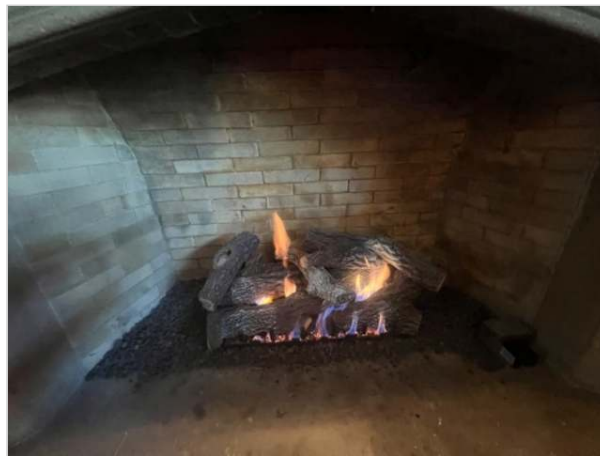
An vented gas fireplace was located in family room. The unit was visually inspected and did appear to be functional. Many of these units are controlled by a wall mounted switch. Some operate by remote control, while others are controlled from the base of the unit. These units usually come with an instruction plate that is attached to the unit inside the control access panel. Be sure to read and understand the operating procedures prior to operating the unit. There were no material defects observed on the gas fireplace.

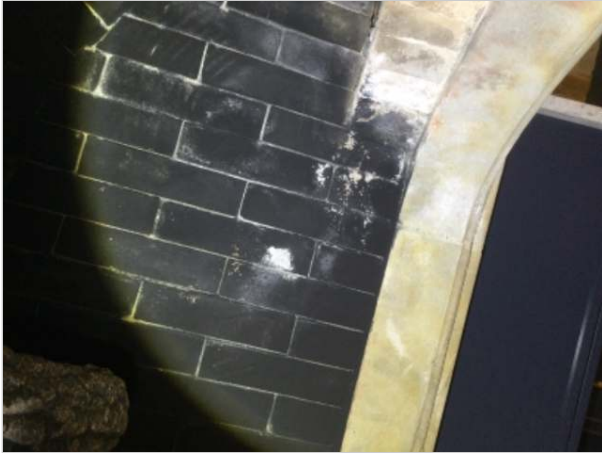
Cracks were noted in the firebox of the fireplace located in the basement. The bricks and mortar inside the firebox are designed to act as a heat and spark shield and should be free of any voids. Efflorescence was also noted. Consult with a qualified, reputable chimney and fireplace service for evaluation and repair.

- Cracks were noted in the firebox of the fireplace located in the basement. The bricks and mortar inside the firebox are designed to act as a heat and spark shield and should be free of any voids. Efflorescence was also noted. Consult with a qualified, reputable chimney and fireplace service for evaluation and repair.

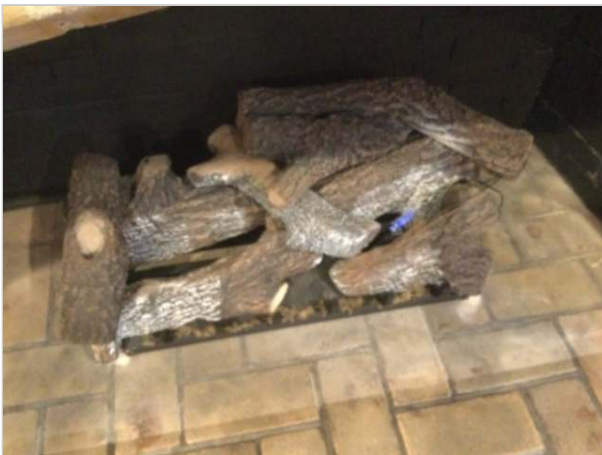
The owner states the fire place logs are vent less. We are unable to confirm that information. The flue is sealed with a metal cover. Recommend further evaluation by a fireplace specialist.

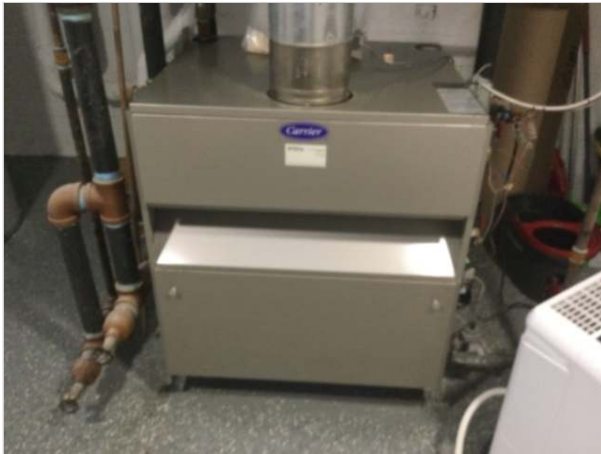
The home was heated by a Carrier natural gas boiler, which was manufactured five to ten years ago. The unit was located in the basement of the home.

Have the furnace cleaned and inspected.

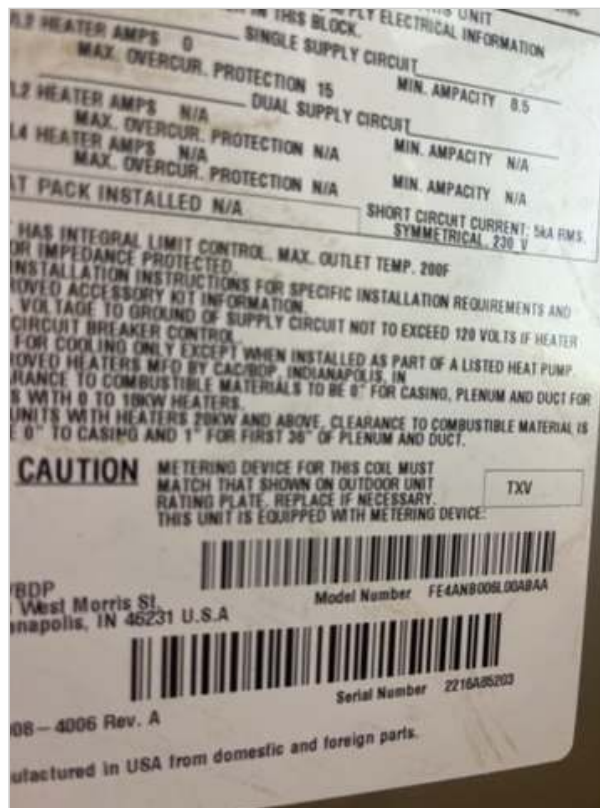
The home was heated by a Carrier natural gas forced air furnace, which was manufactured five to ten years ago. The unit was located in the attic of the home.

Without removing the burners to gain complete access, and with the limited viewing area of the boiler sections, a thorough inspection is not possible.

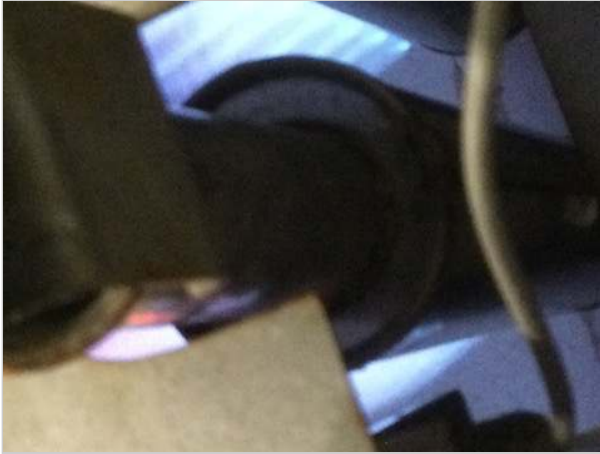
The heating system was found to be functional. The boiler does not appear to have been recently serviced. It is recommended that the furnace be cleaned and serviced by a qualified contractor upon taking ownership of the property. The furnace should be serviced annually to maintain safe and efficient operation.

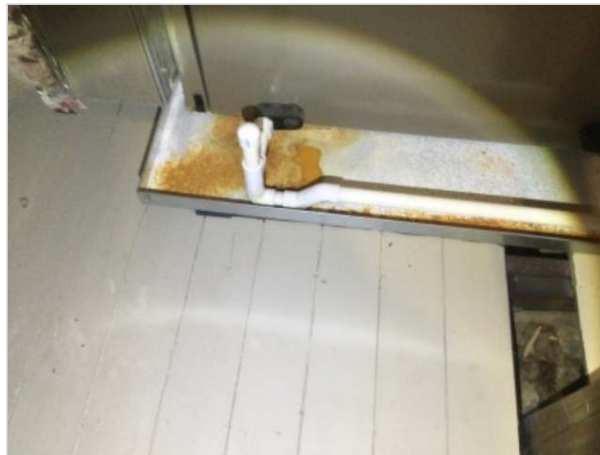
Termination of HVAC condensate lines was raised above the floor drain or drain inlet. The condensate lines were trapped. HVAC condensate lines must be trapped and not in contact with wet drain inlets to prevent the possible migration of bacteria and mold into the air-handling system.

Trapped condensate line.

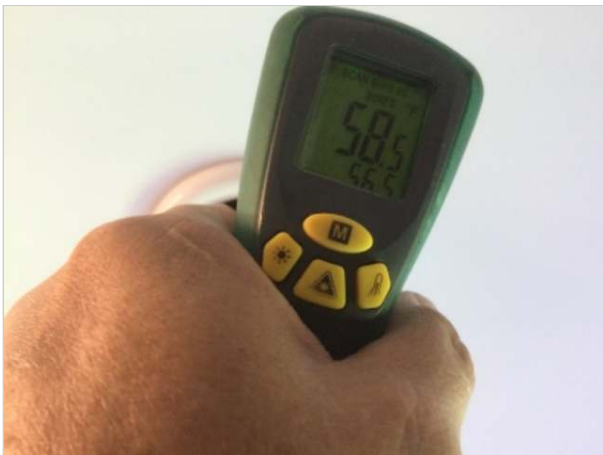
The electric outdoor air conditioner condensing unit was a Carrier, The unit is located on the right side of the home. This unit was manufactured in 2016. Periodic preventive maintenance is recommended to keep this unit in good working condition. The forced air cooling system was tested and found to be functional. The home inspection does not include a heat-gain analysis, cooling design or adequacy evaluation, energy efficiency assessment, installation compliance check or refrigerant evaluation.
