HOME INSPECTION REPORT

Wednesday, July 3, 2024

John Doe
123 Anywhere St.
City, ST 12345

The inspected property consisted of a two story wood-framed structure with brick, stucco, and wood siding that was occupied at the time of the inspection. There were no material defects on the visible portions of the siding.

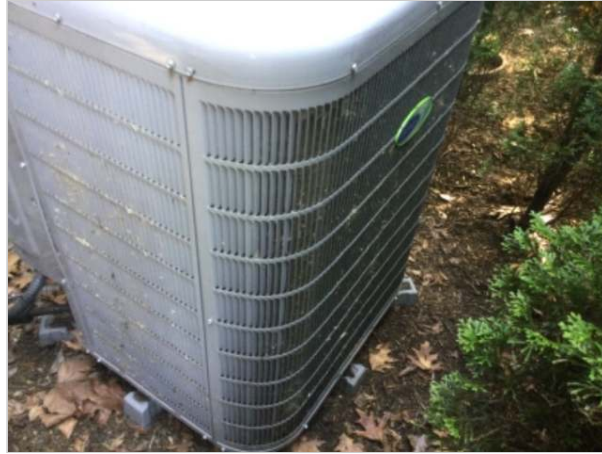
The A/C exterior condenser coil needs to be cleaned.

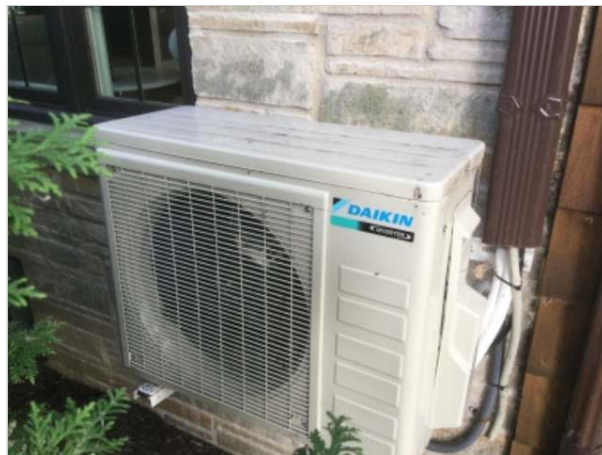
The electric outdoor air conditioner condensing unit was Daikin, The unit is located on the right side of the home. This unit was manufactured in 2002. Periodic preventive maintenance is recommended to keep this unit in good working condition. The forced air cooling system was tested and found to be functional. The home inspection does not include a heat-gain analysis, cooling design or adequacy evaluation, energy efficiency assessment, installation compliance check or refrigerant evaluation.

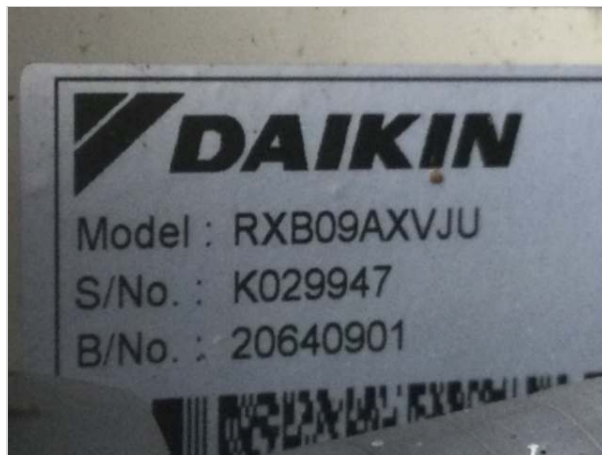
This A/C unit has very limited life remaining due to the age.

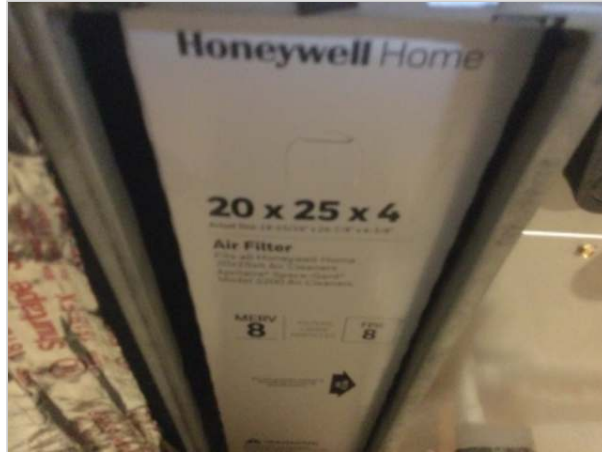
The disposable filter should be replaced on a regular basis to maintain the efficiency of the system. The efficiency rating is not within the scope of this inspection.

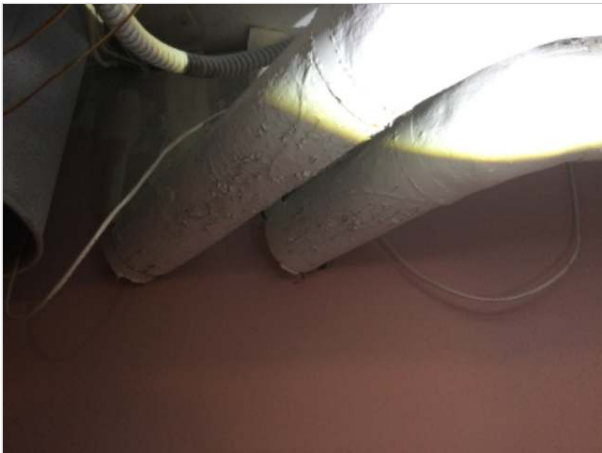
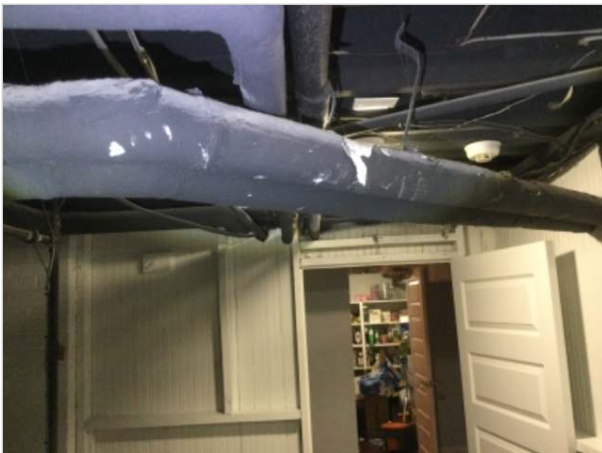
The boiler heating pipes in the basement were covered with a material that has the characteristics of asbestos. The material did appear to be damaged or deteriorating at the time of the inspection. It is advisable to avoid disturbing the substance prior to any testing. The only way to confirm the contents of the material is to have a sample tested by a qualified laboratory. If the substance is of any concern, a qualified asbestos testing firm should be contacted.
