### *HOME INSPECTION REPORT*

Address of Inspection: **123 Sample Drive, Louisville, KY**

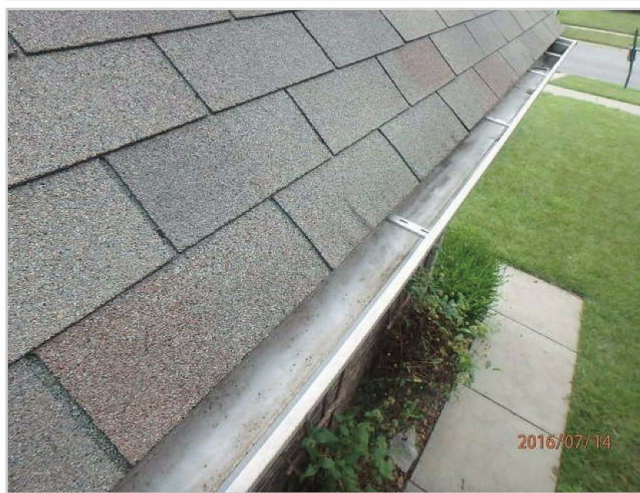
**Photo 7**

gutters

**Several downspouts were draining at or too close to the base of the foundation.** To reduce the likelihood of water problems at the base of the home, all roof drainage should be directed at least six feet from the base of the foundation.

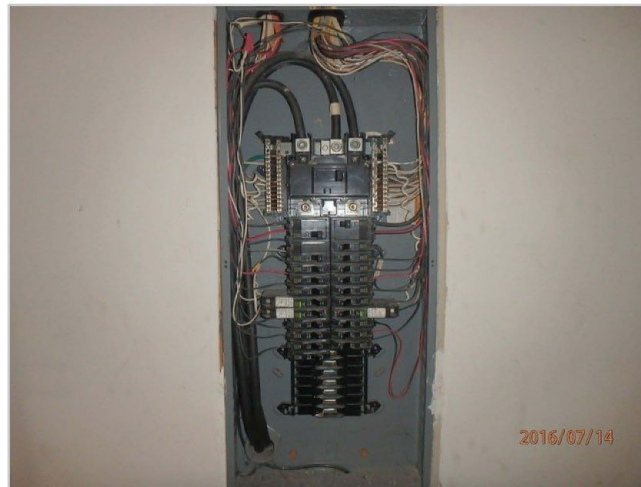
**Photo 17**

The electrical service appeared to be adequate. As a reminder, alarms, electronic keypads, remote control devices, landscape lighting, telephone and television wiring are beyond the scope of this inspection.

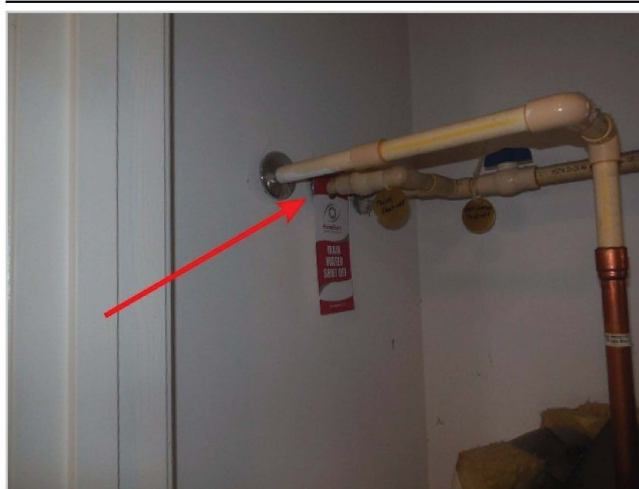
**Photo 21**

Main water shut off.

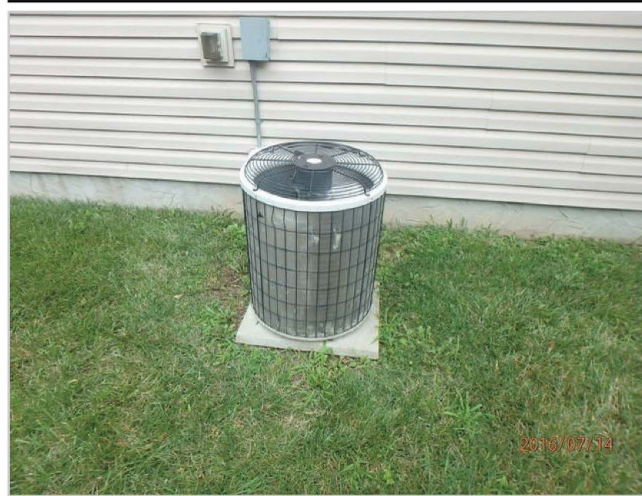
**Photo 27**

The electric outdoor air conditioner condensing unit was a Payne, Model Number PA10JA036C and Serial Number 4104E13255. The unit is located on the left side of the home. This unit is approximately 12 years old. Periodic preventive maintenance is recommended to keep this unit in good working condition, and HomeTeam strongly recommends partnering with a reputable HVAC company for routine maintenance for the heating and cooling systems in the fall and spring. The air conditioning system was tested and found to be functional. As a reminder, this is functionality test and visual inspection only; we do not check suction pressures, contactor amps, or refrigerant levels. If a more detailed inspection is required, please consult with an HVAC company.

The temperature split for the air conditioner was measured at several locations and was approximately 10 degrees F, which is normal.
