### *HOME INSPECTION REPORT*

## **SAMPLE REPORT**

*The purpose of this summary is to provide a "quick view" of the results of the home inspection. Please be sure to read the full body of the inspection report, as it contains much more detail about your new home. Any recommendations for additional evaluation must be performed prior to the conclusion of the inspection contingency period. The following is a summary of the inspection performed at 1234 Fifth Street, HomeTown, OH 67890:*

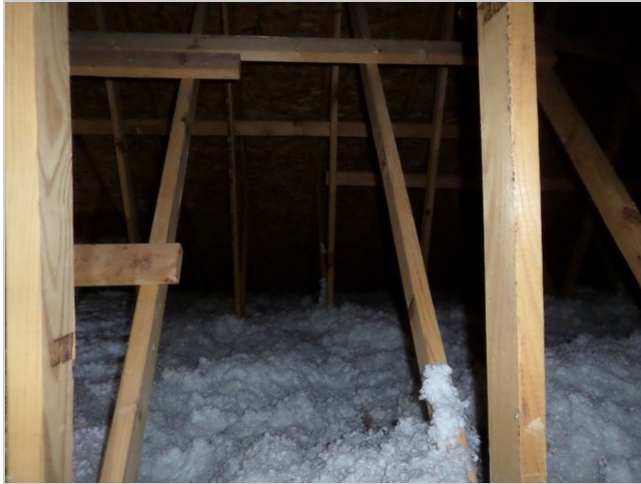
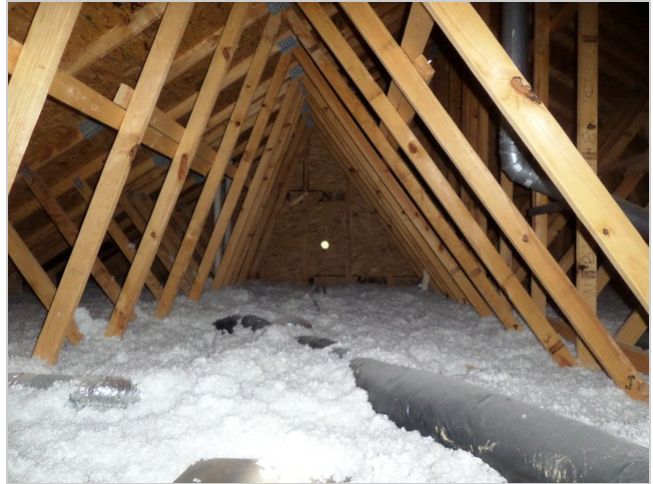
The attic was accessed through a scuttle in the bedroom closet. The attic above the living space was insulated with batted and loose-fill insulation, approximately 12-inches in depth. Ventilation throughout the attic was provided by gable, soffit and roof vents. The roof structure consisted of two-inch by four-inch wood trusses spaced 24 inches on center and OSB (waferboard) sheathing. Because of the configuration of the catwalk or lack thereof, which limited access, it was not possible to inspect all areas of the attic. There was no moisture visible in the attic space. The absence of visible indications of moisture is not necessarily conclusive evidence that the roof is free from leaks. The only way to be sure a roof does not leak is to inspect the underside of the roof during a heavy rain. There were no major visual defects observed in the attic structure.

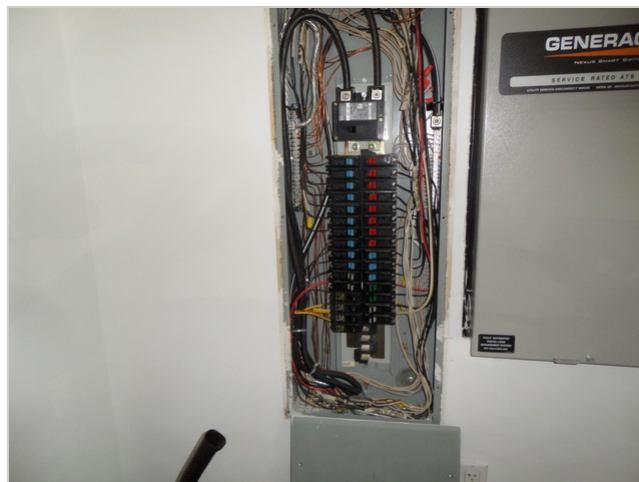
The service wire entered a Cutler Hammer service panel, located on the garage wall with a 200 amp and 120/240 volt rated capacity. The branch circuits within the panel were copper . These branch circuits and the circuit breakers to which they were attached appeared to be appropriately matched.

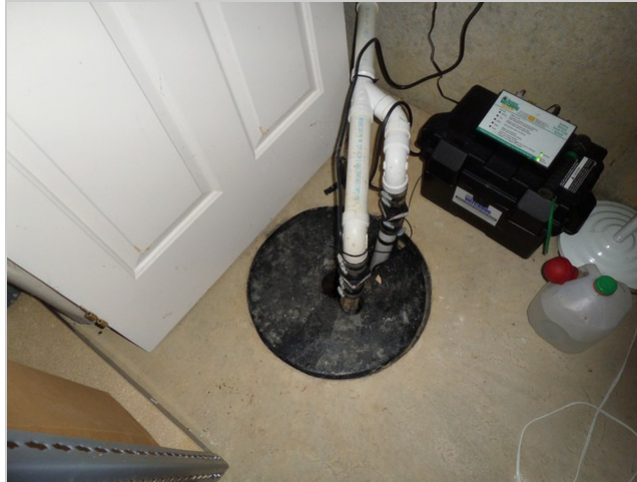
There was a sump pump located in the basement. The sump pump was functional. There was a battery backup system in the sump pit.

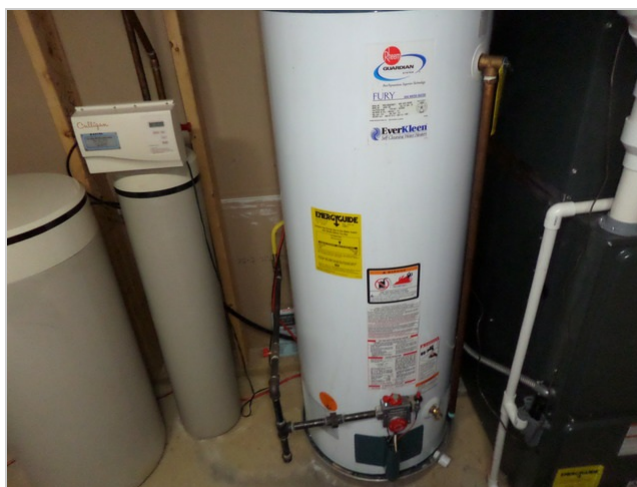
**There was a lot of corrosion on the cold water supply line to the water heater. Recommend further evaluation by a qualified plumber.**

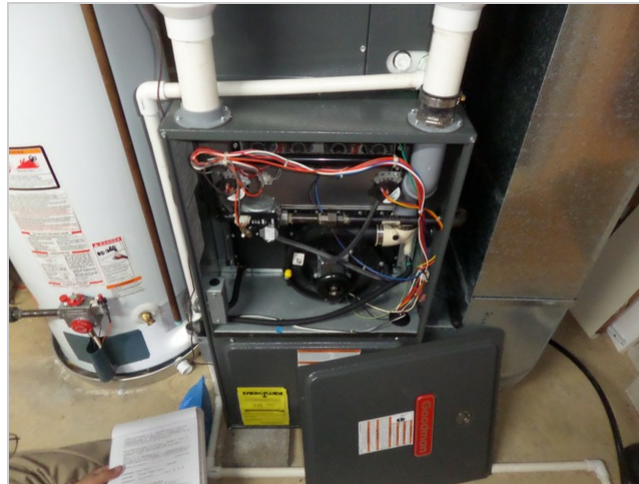
The home was heated by a Goodman natural gas forced air furnace, serial number 0611638294, model number GMH950904CXAVA which is 8 years old. The unit was located in the basement of the home. It has an approximate net heating capacity of 96,000 BTUH.

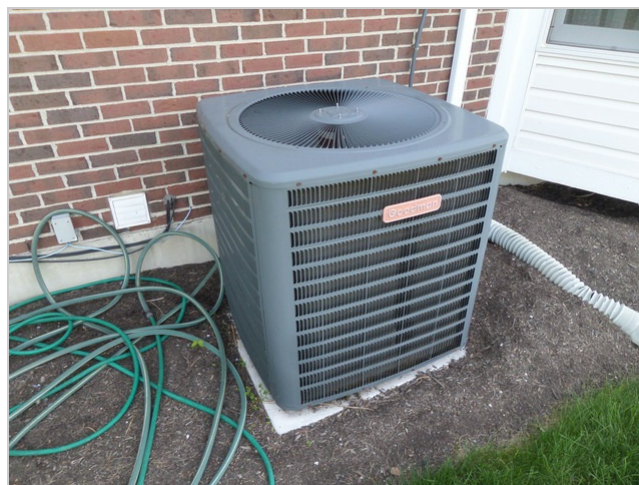
The electric outdoor air conditioner condensing unit was a Goodman, Model Number GSC140421AB and Serial Number 0702047626. The unit is located in the back of the home. This unit is approximately 7 years old. Periodic preventive maintenance is recommended to keep this unit in good working condition. The forced air cooling system was tested and found to be functional. The home inspection does not include a heat-gain analysis, cooling design or adequacy evaluation, energy efficiency assessment, installation compliance check or refrigerant evaluation.
