HomeTeam[®]

HOME INSPECTION REPORT

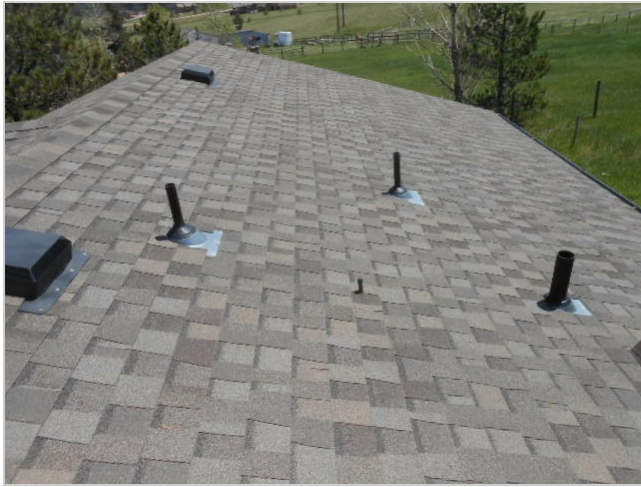
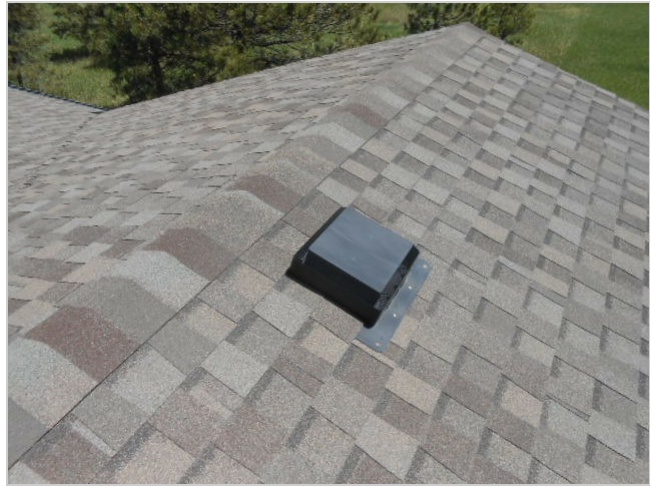
The transition roof flashing (where the house roof meets the patio roof) is loose or is unsecured indicating the need for further evaluation and repairs by a qualified roofer, prior to closing.
