HOME INSPECTION REPORT

SAMPLE REPORT

Address of Inspection: **1234 Fifth Street**

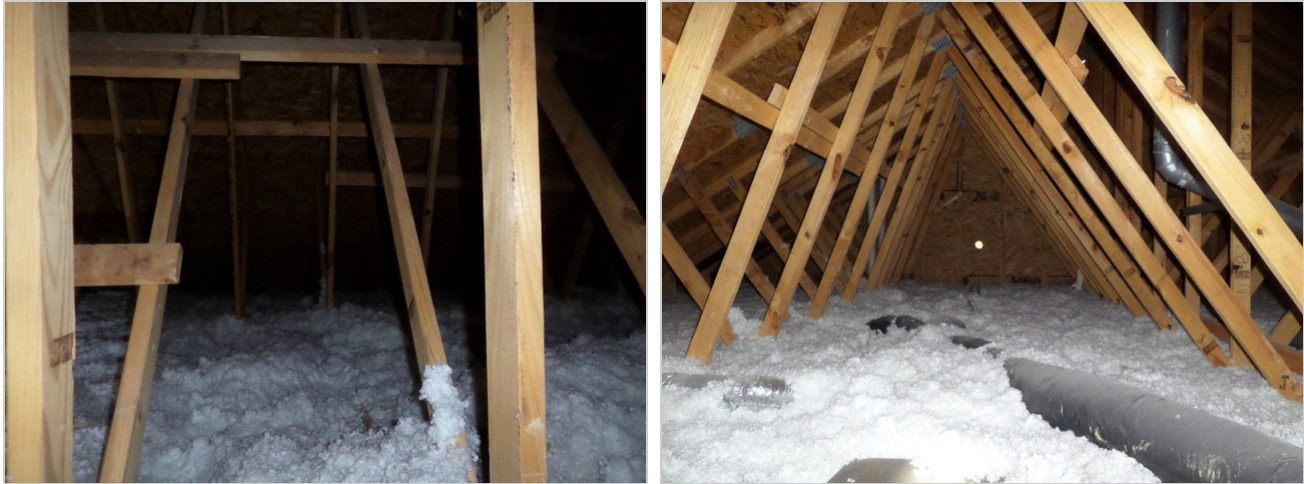
ATTIC STRUCTURE

The attic was accessed through a scuttle in the bedroom closet. The attic above the living space was insulated with batted and loose-fill insulation, approximately 12-inches in depth. Ventilation throughout the attic was provided by gable, soffit and roof vents. The roof structure consisted of two-inch by four-inch wood trusses spaced 24 inches on center and OSB (waferboard) sheathing. Because of the configuration of the catwalk or lack thereof, which limited access, it was not possible to inspect all areas of the attic. There was no moisture visible in the attic space. The absence of visible indications of moisture is not necessarily conclusive evidence that the roof is free from leaks. The only way to be sure a roof does not leak is to inspect the underside of the roof during a heavy rain. There were no major visual defects observed in the attic structure.

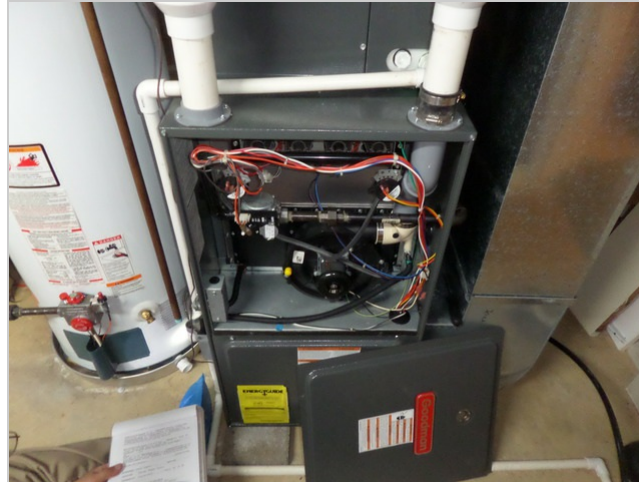
The home was heated by a Goodman natural gas forced air furnace, serial number 0611638294, model number GMH950904CXAVA which is 8 years old. The unit was located in the basement of the home. It has an approximate net heating capacity of 96,000 BTUH.
