# HomeTeam<sup>®</sup>

### *HOME INSPECTION REPORT*

On Monday, February 18, 2019 The HomeTeam Inspection Service made a visual inspection of 123 Sample Drive, Tacoma, WA 55555. Enclosed please find a written, narrative report of our findings in accordance with the terms of our Inspection Agreement.

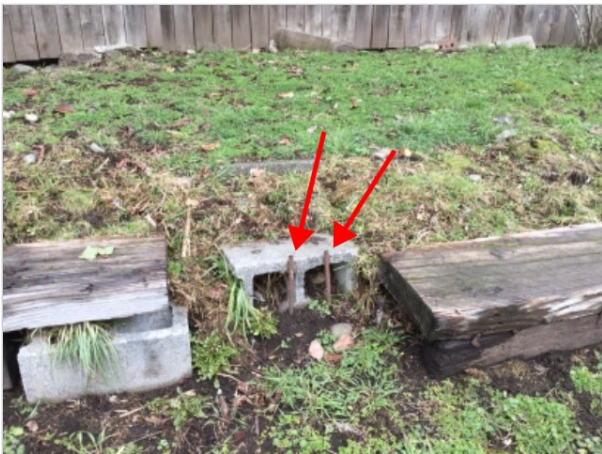
**Photo 1**

Multiple sharp objects sticking out of the ground around the perimeter of the house.

Backyard retaining wall

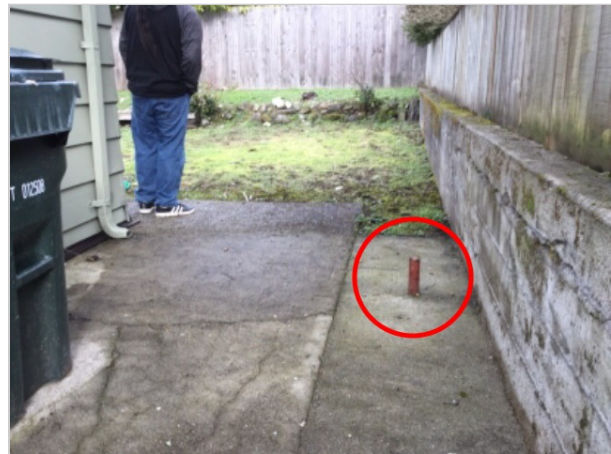
**Photo 2**

Right side yard

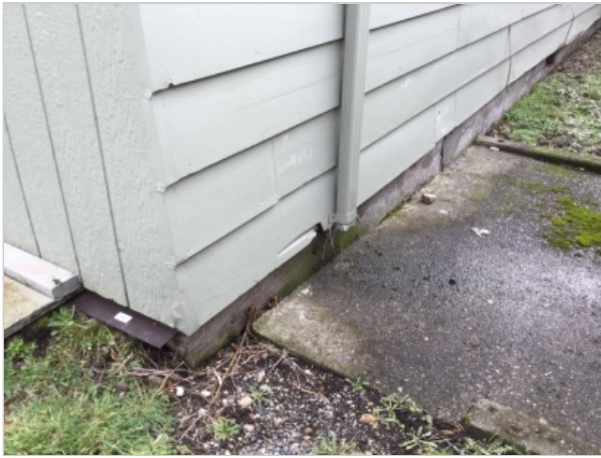
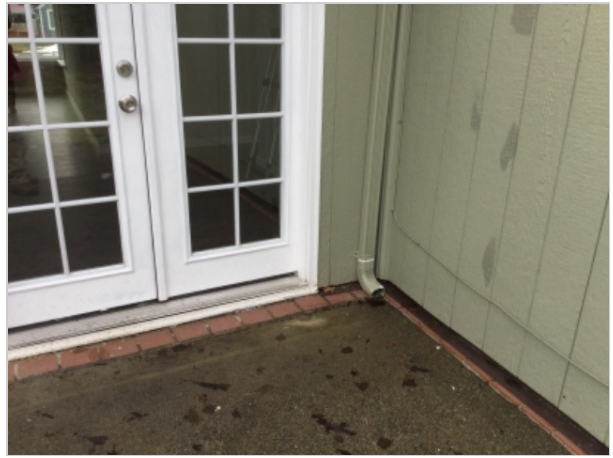
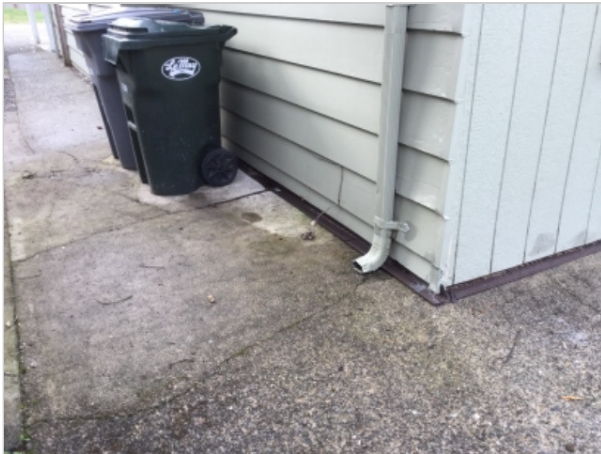
**Some of the downspouts around the structure are draining into the ground with no conclusive termination point.** HomeTeam recommends ensuring termination points for all downspouts is far enough from the structure and configured in such a way as to ensure water flows away from the foundation during periods of rain.

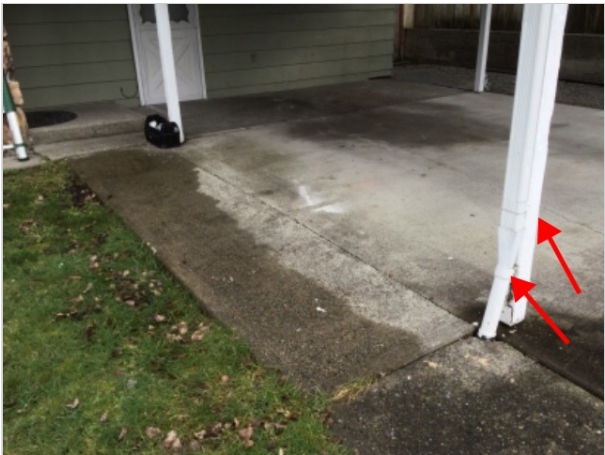
Photo 10

**Gutters appear to be leaking at the seam.** The seams should be sealed with an appropriate gutter sealant.

Carport downspout

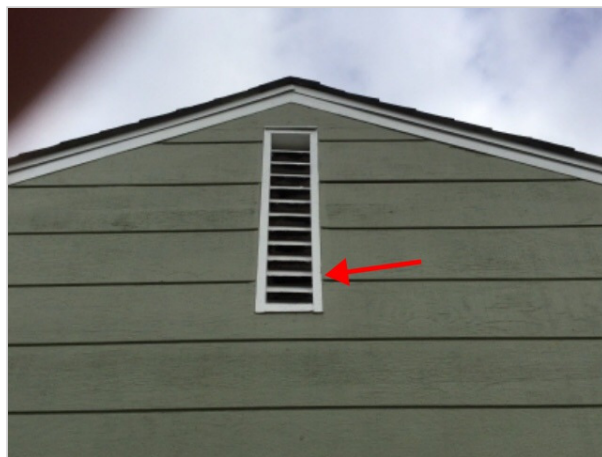
**Photo 14**

**Gable vent cover is damaged.** Without a proper vent cover rodent and insect entry is possible.

Front of the house

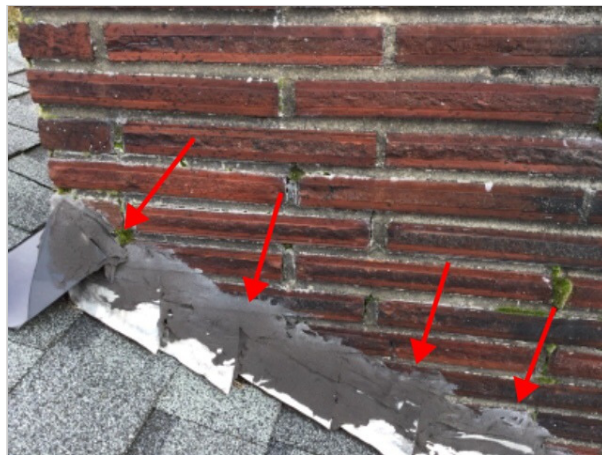
**Photo 21**

**The flashing around the chimney requires repair.** Flashing is a critical component that helps prevent water intrusion. At the time of repair, the technician should investigate the area for any previous water intrusion or damage.

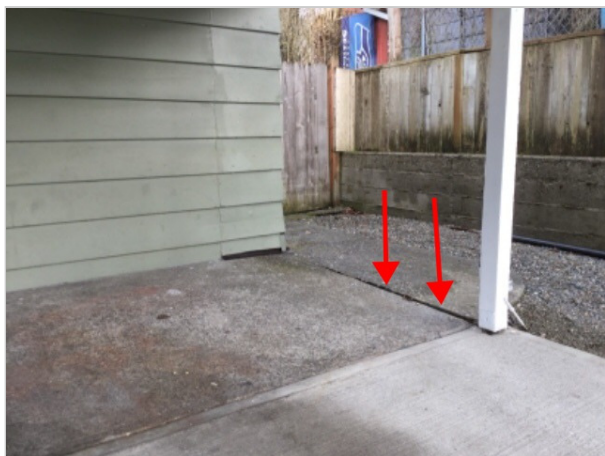
**Photo 23**

**Areas of the driveway have settled.** This condition indicates a possible void under the driveway. Driveway settling has led to potential tripping hazards. The areas should be monitored and repaired as needed.

Front right walkway

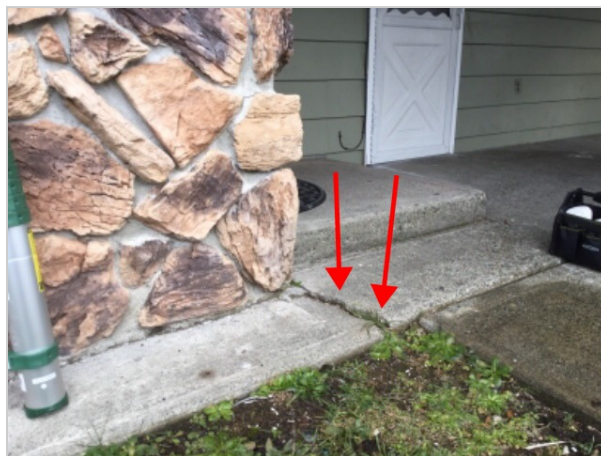
**Photo 24**

Front porch

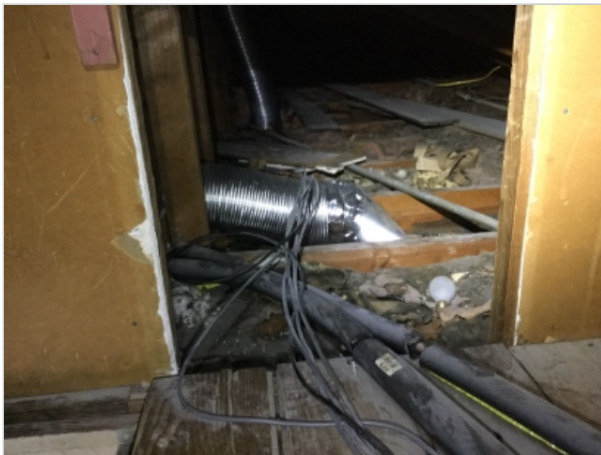
**Photo 28**

Excessive amounts of debris on attic insulation. Recommend general cleaning of attic to remove debris.

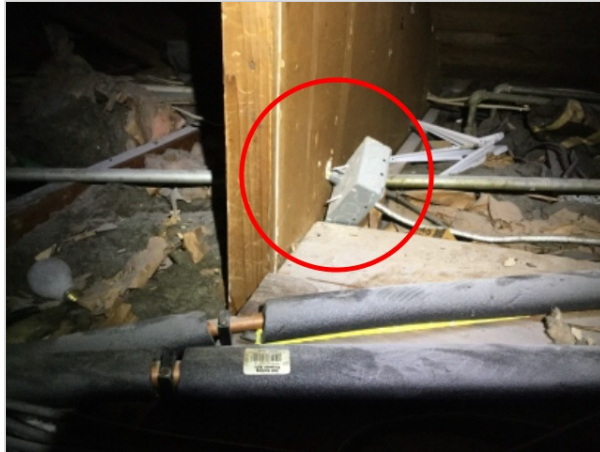
**Photo 30**

Electrical junction box not properly fastened.

Above attic access at water heater

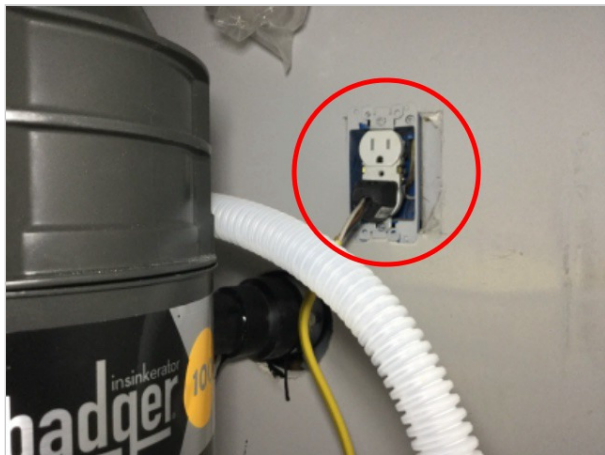
**Photo 36**

**Missing switch or outlet covers were observed in the kitchen.** All switch and outlet boxes should be properly covered to avoid a shock hazard. Electrical repairs should be performed by a qualified electrician.

Dishwasher disposal outlet under kitchen sink

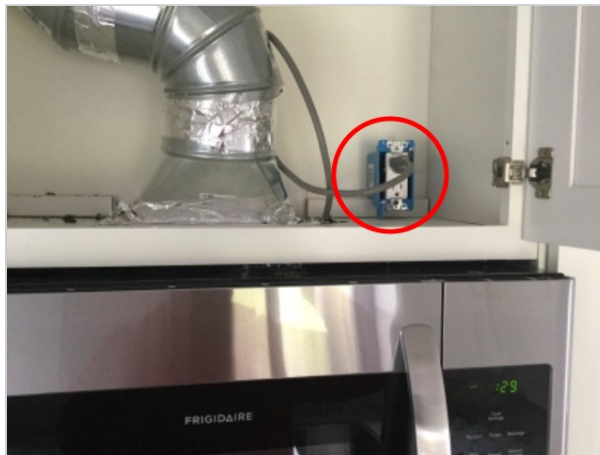
**Photo 37**

Microwave outlet above microwave

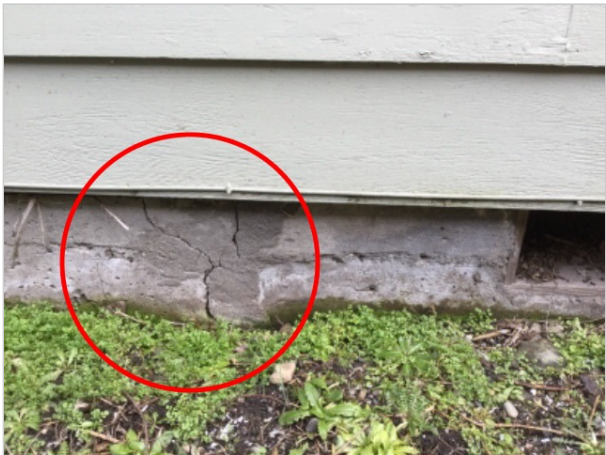
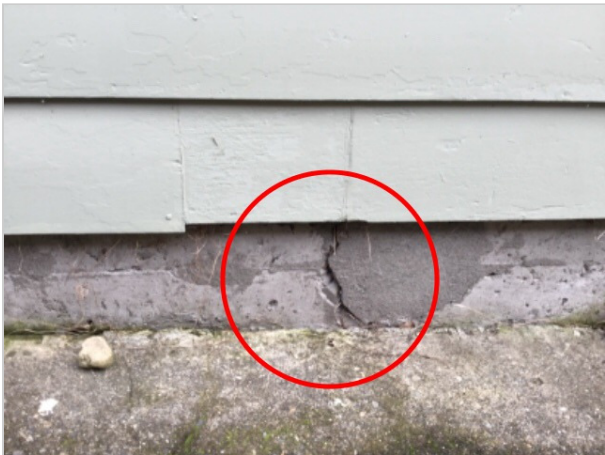
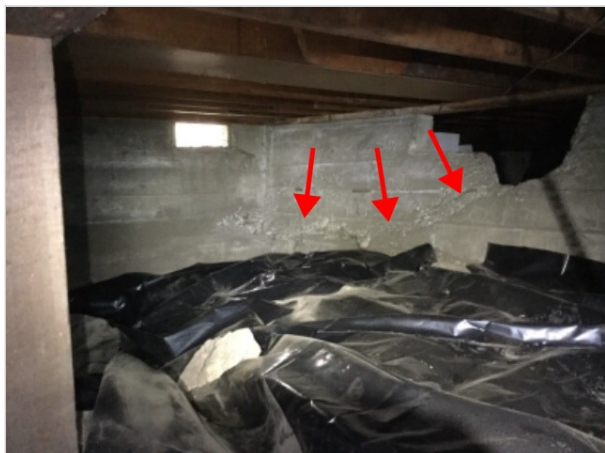
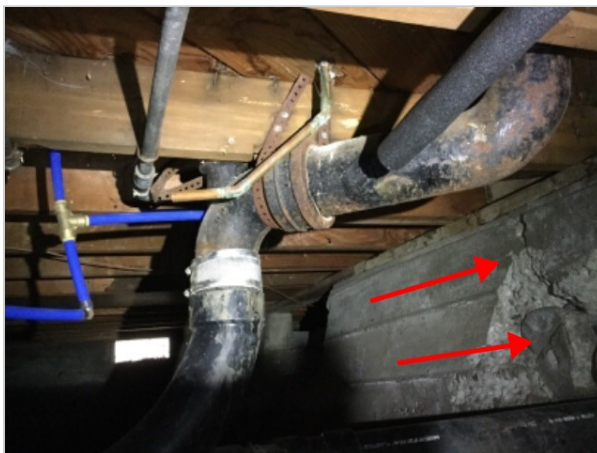
**There were multiple vertical earth-pressure type cracks observed on the left side foundation wall. Consult with structural engineer for further evaluation.** This condition is most often associated with soil and/or water pressures. The displacement occurs incrementally as the wall yields to horizontal earth pressure. This may be a material defect.

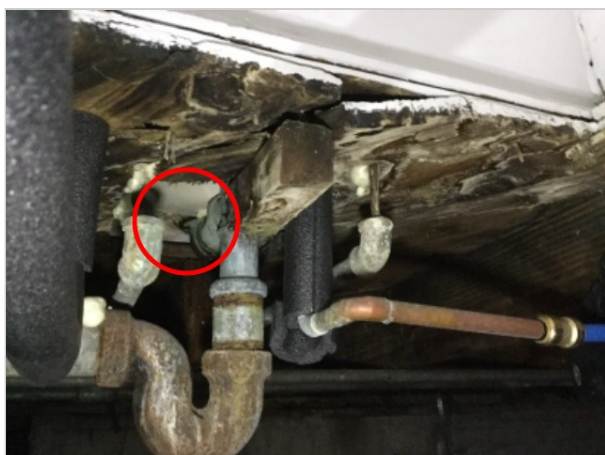
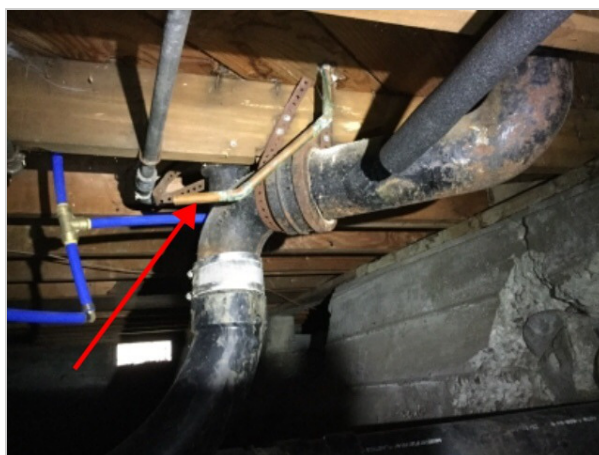
**A leak was observed at multiple drain lines in the crawl space.** The drain line or seals should be repaired or replaced to prevent water intrusion and should be further assessed at the time of repair.

Underneath bathroom left side of house

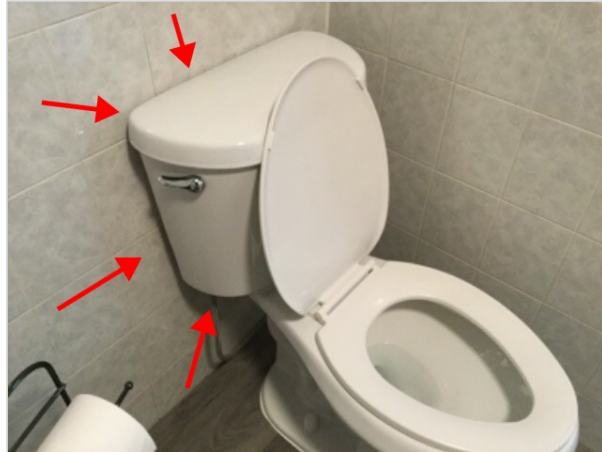
**Photo 52**

**The toilet tank in the master bath is loose.** Failure to secure the toilet may lead to leakage. The toilet should be secured.

Master bath

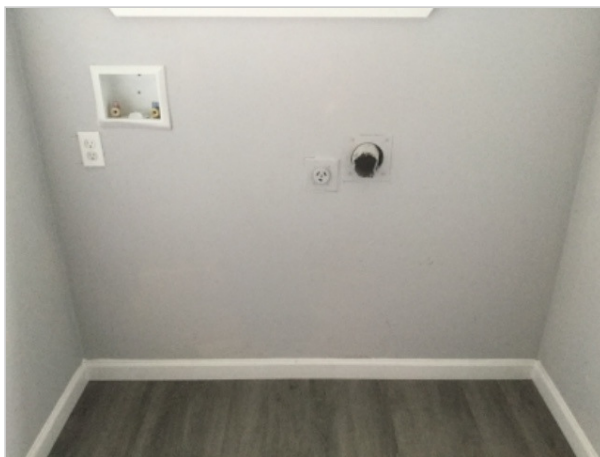
**Photo 70**

A drain for a washing machine was present.

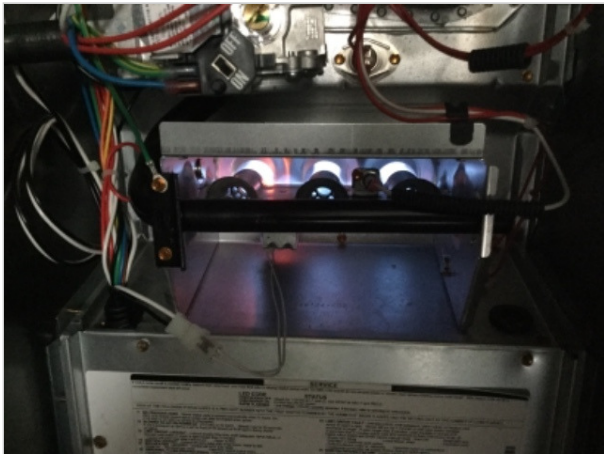
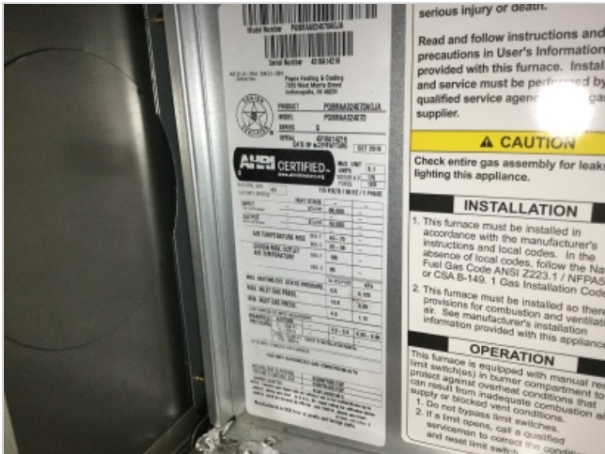
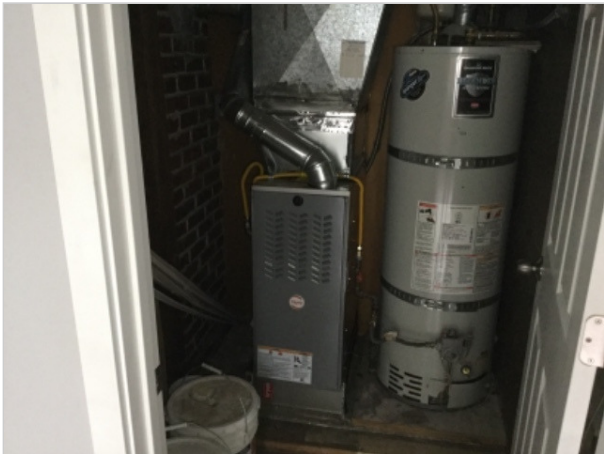
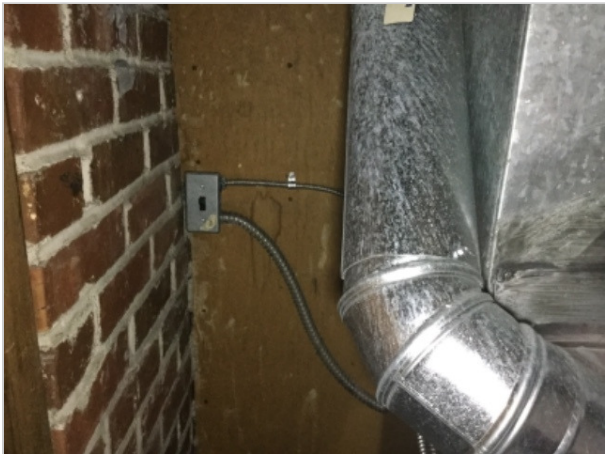
The structure was heated by a Payne natural gas furnace/air handler, Model Number PG8MAA024070 and Serial Number 4318A14216, which is 1 years old. The unit was located in the rear utility room of the structure. It has an approximate net heating capacity of 54,000 BTUH. The automatic safety controls on the unit were tested and found to be functional at the time of the inspection.

The HVAC condensate line was not visible. The heating system was found to be functional.

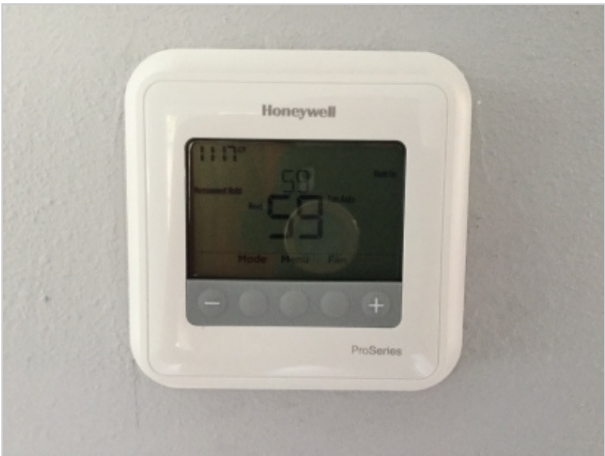
Photo 75

The control for the heating and air conditioning system was a 24 volt digital programmable thermostat located on the hallway wall of the home. The thermostat was manufactured by Honeywell and was found to be in working order.

Thermostat settings at beginning of inspection
