*HOME INSPECTION REPORT*

On Monday, March 31, 2025 The HomeTeam Inspection Service made a visual inspection of 123 Anywhere St., City, ST 12345. Enclosed please find a written, narrative report of our findings in accordance with the terms of our Inspection Agreement.

Tony Erlenbach  
HomeTeam of West Cleveland  
Home Inspector OHI.2025001072

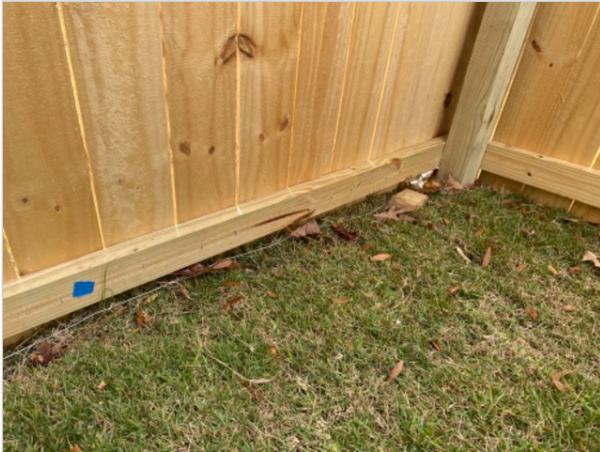
Photo 9

**The screws securing the bottom trim board on the right side privacy fence are sharp and longer than what is needed. Resulting in a safety hazard. They should be replaced with shorter screws.**

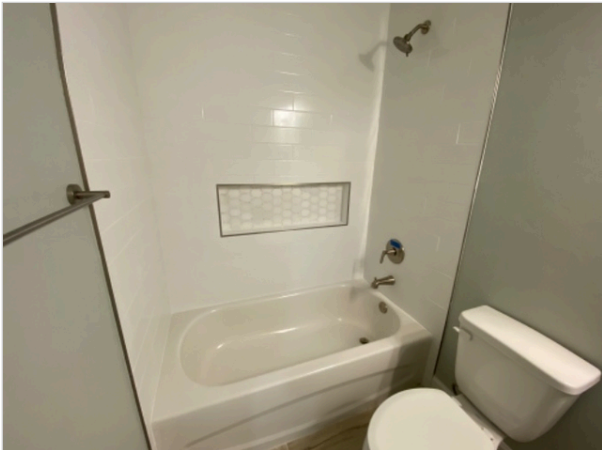
Photo 47

The shower controls in both guest bathrooms had the hot/cold reversed, which is a possible scald issue and should be corrected.

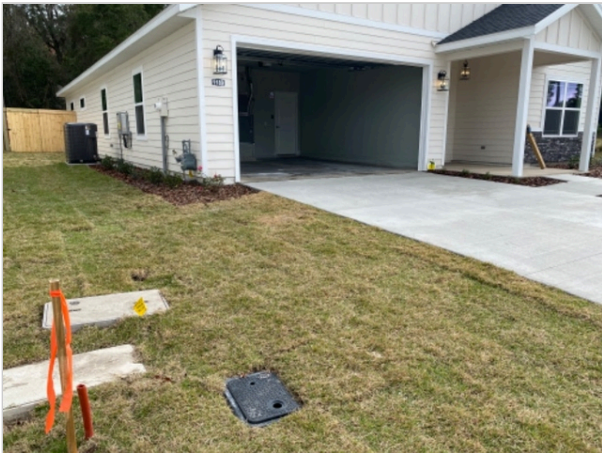
The water meter was located in the front left yard. The main water shutoff valve for the structure was located adjacent to the water service entry point on the left side of the house. Water shutoff valves are visually inspected only. No attempt is made to operate the main or any other water supply shutoff valves during the inspection. These valves are infrequently used and could leak after being operated. The only exception to this policy is made when the main water supply valve is off upon arrival at the inspection. Since it is the buyers right to have all utilities operable for the home inspection, we will attempt to turn the main water valve on for the inspection. The HomeTeam is not responsible for leaks caused by operating the valve.

Water shut off

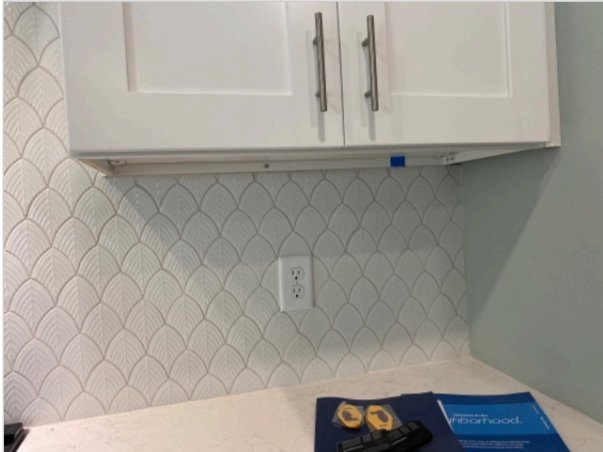
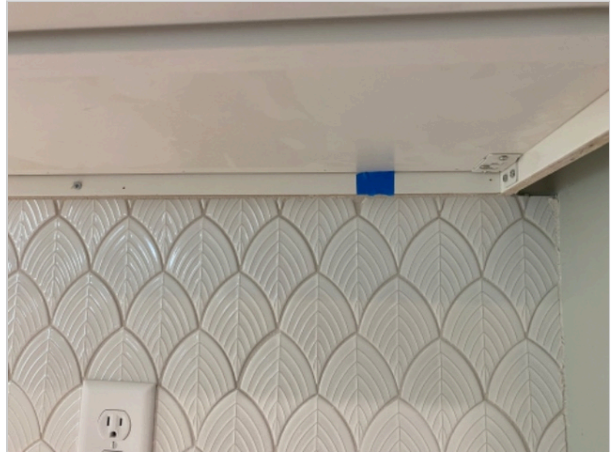
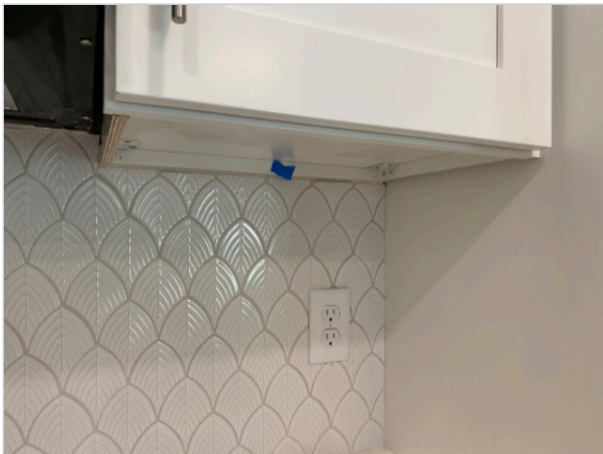
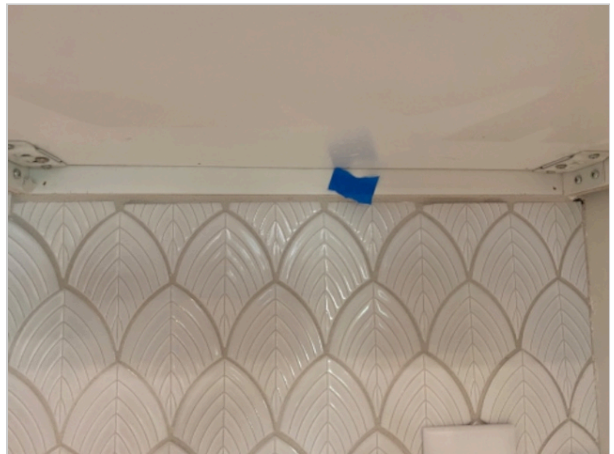
**Portions of the kitchens cabinets were not completely secure to the wall.** The cabinets should be secured to prevent them from falling.

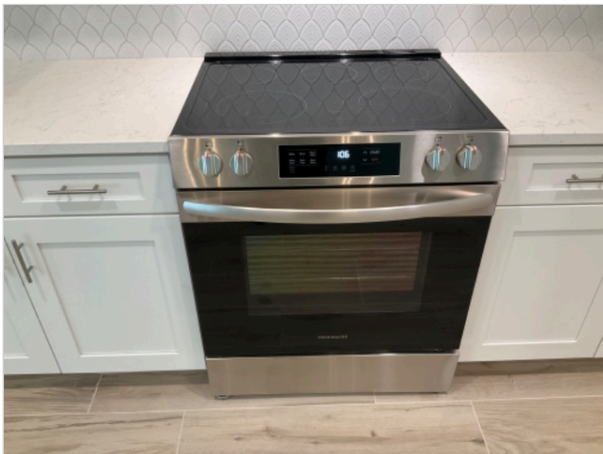
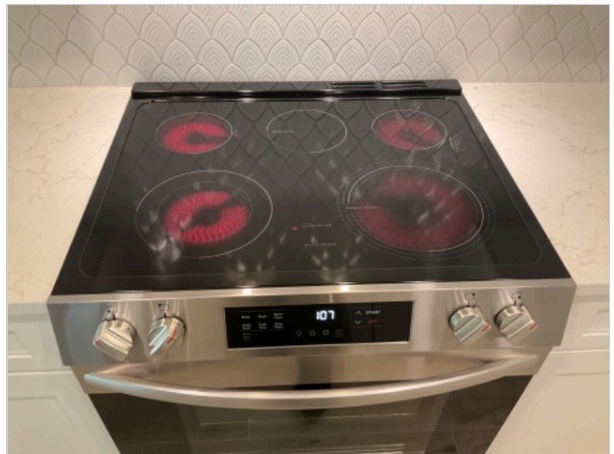
**Photo 75**

The electric oven and range combo was inspected and did appear to be functional. The accuracy of the clock, timers and settings on ovens are not within the scope of this inspection.

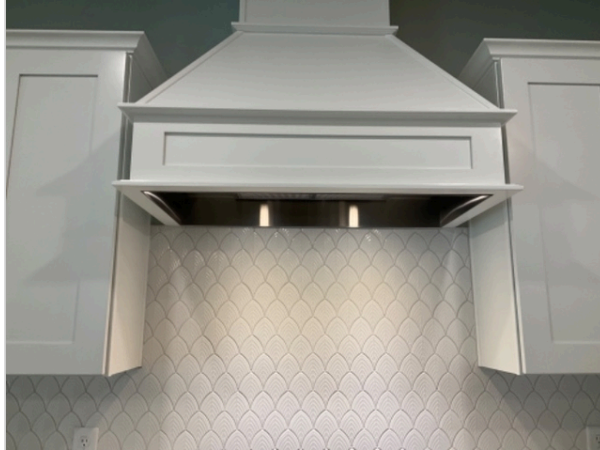
**Photo 77**

The range hood was inspected and did appear to be functional. The exhaust capacity is not within the scope of this inspection. Cleaning the fan and filter may increase the exhaust capability.

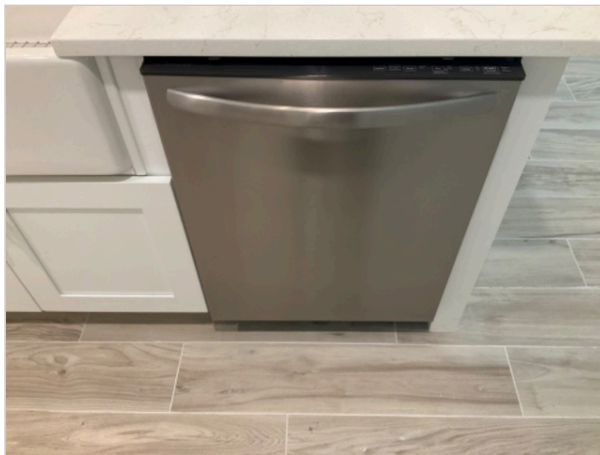
**Photo 78**

The dishwasher was tested and did appear to be functional.

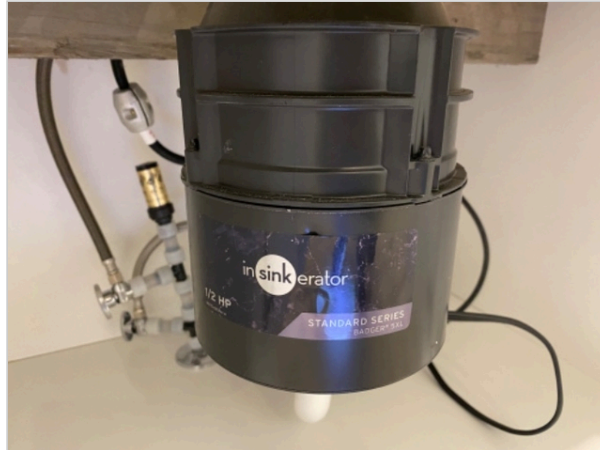
**Photo 79**

The disposal was inspected and did appear to be functional. The efficiency rating and chopping / grinding ability of the unit is not within the scope of the inspection.

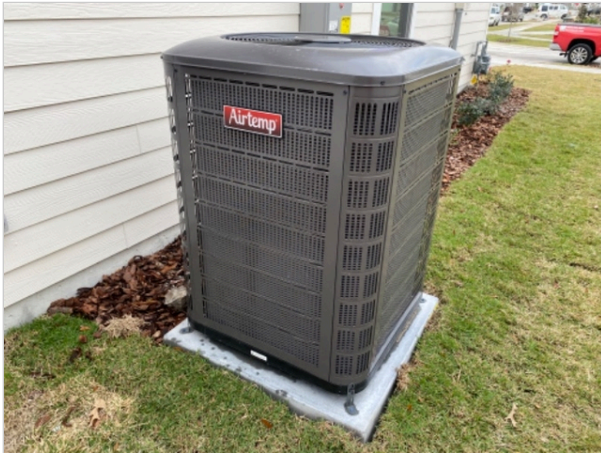
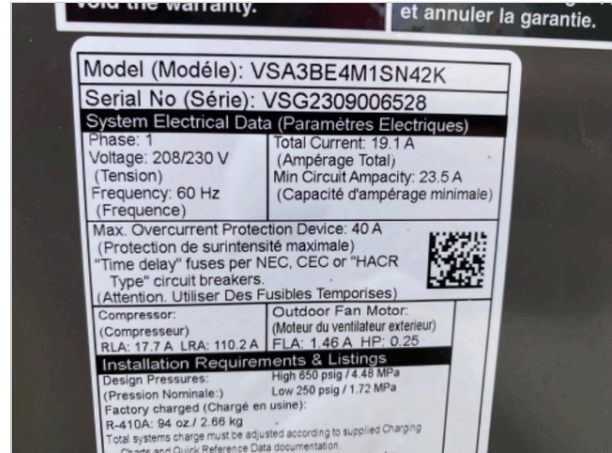
Number VSG2309006528. The unit is located on the left side of the structure. This unit is approximately less than one years old. Periodic preventive maintenance is recommended to keep this unit in good working condition. The cooling system was functional.

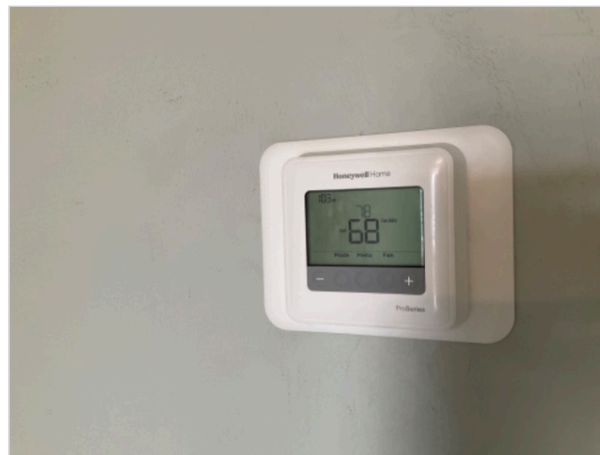
**Photo 84**

The control for the heating and air conditioning system was a 24 volt digital programmable thermostat located on the hallway wall of the home. The thermostat was manufactured by Honeywell and was found to be in working order.
