HomeTeam[®]
INSPECTION SERVICE

RE: 123 Sample Drive
Anytown, IN 46112
Inspection #: XXXX

HOME INSPECTION REPORT

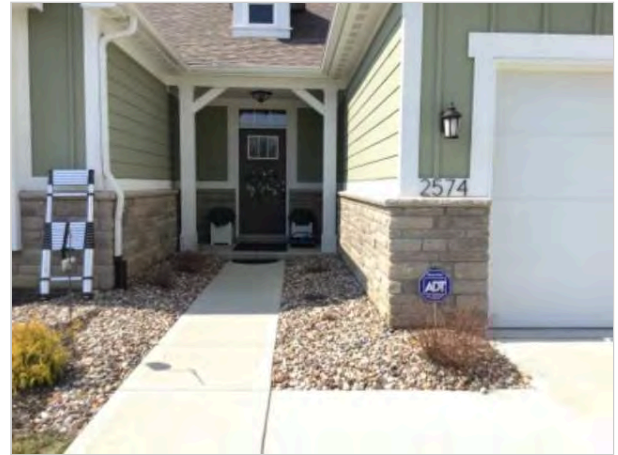
Photo 2

LANDSCAPING MULCH ON SIDING: There are areas where the landscaping mulch is too high and in contact with the siding. Even with exterior brick, mulch that is in contact with the siding can retain moisture and cause damage or insect infestation. Recommend removal of the mulch to an acceptable level.

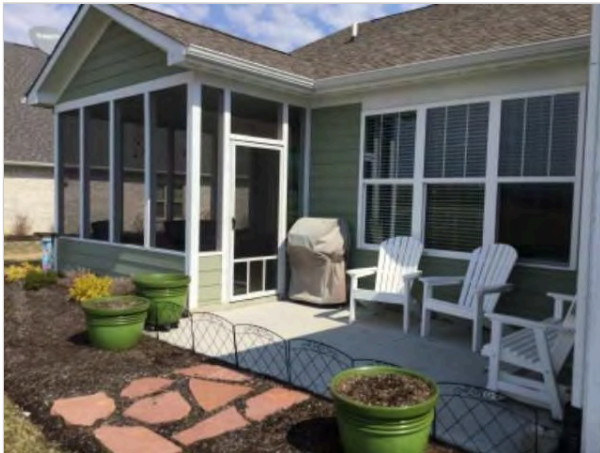
Photo 5

There was a concrete patio located in the back of the home. There were no major visual defects observed to the patio.

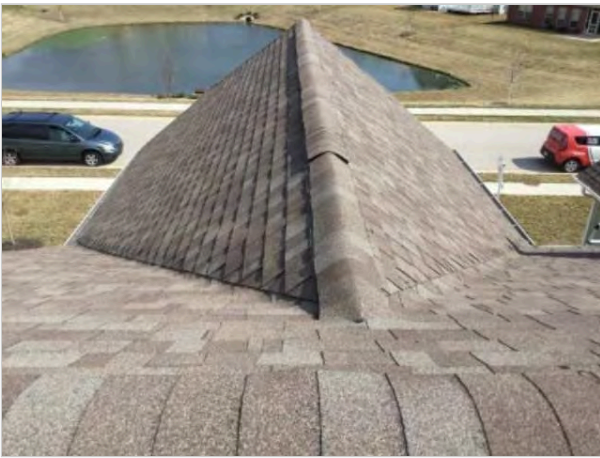
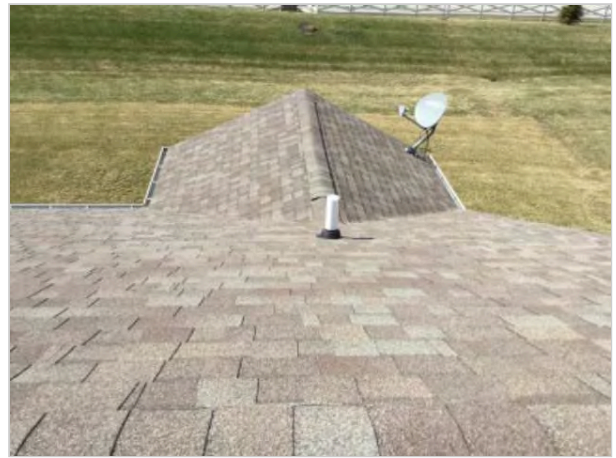
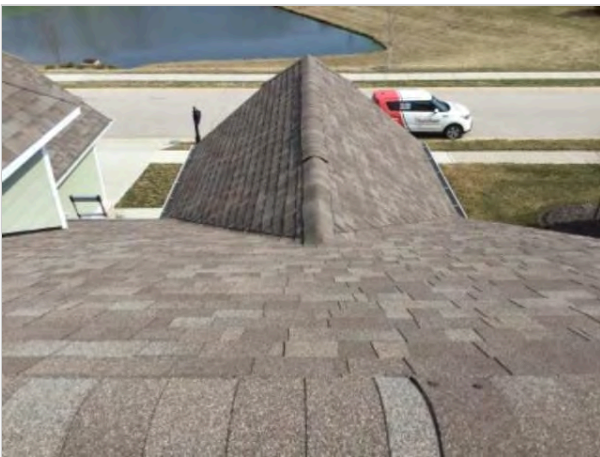
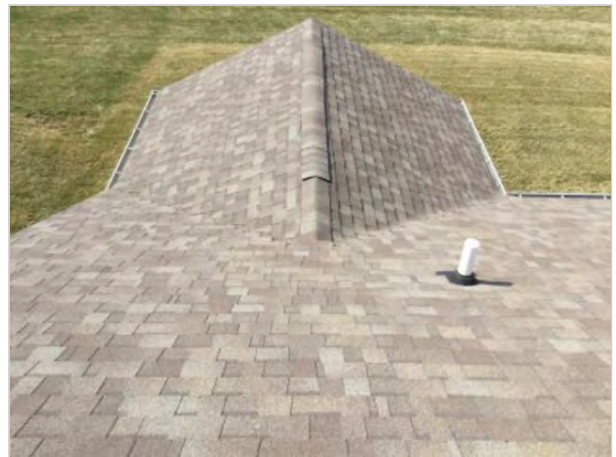
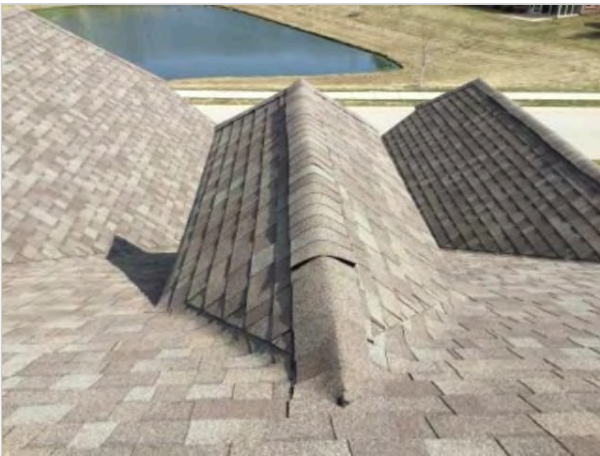
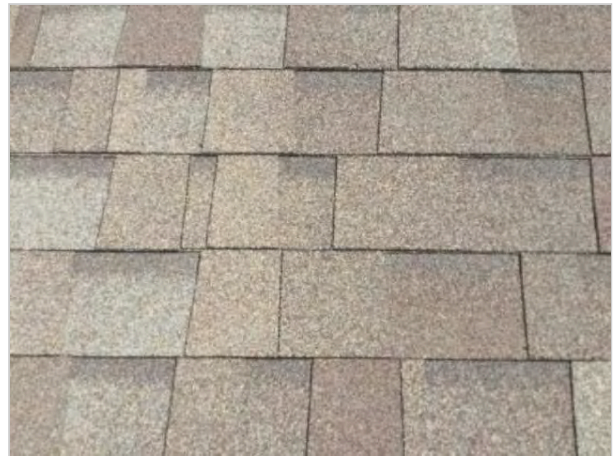
The roof was a gable and hip design covered with asphalt/fiberglass shingles. Observation of the roof surfaces, flashing and penetrations through the roof was performed by walking the roof. The age of the roof covering was approximately less than five years. There was one layer of shingles on the roof at the time of the inspection. There was no curling and light surface wear observed on the roof shingles at the time of the inspection. These conditions indicate the roof shingles were in the first half of their useful life.

This visual roof inspection is not intended as a warranty or an estimate on the remaining life of the roof. There were no major visual defects detected on the exterior of the roof.

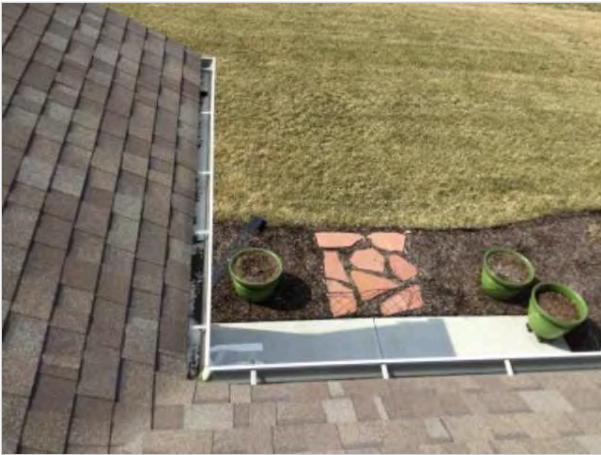
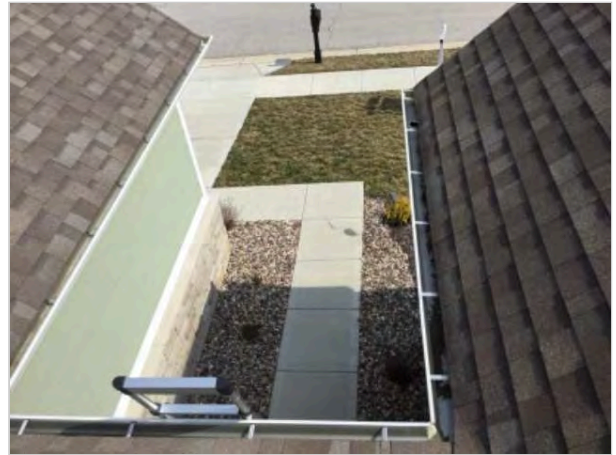
The roof drainage system consisted of aluminum gutters and downspouts which appeared to be functional at the time of the inspection. Gutters and downspouts should receive routine maintenance to prevent premature failure. There were no major visual defects observed on the visible portions of the gutters or downspouts.

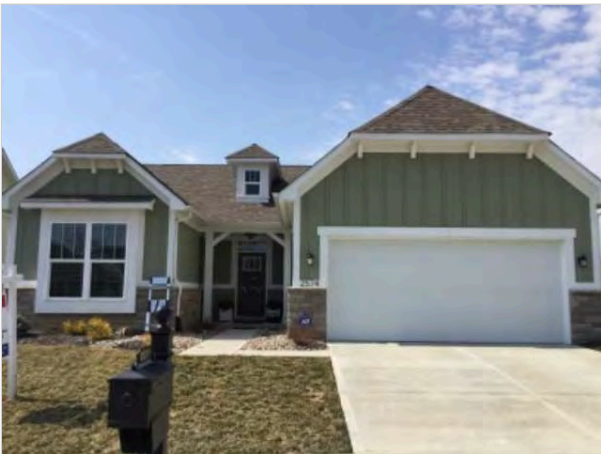
Front

The exterior of the home was covered with stone veneer and cement board siding. There were no major visual defects on the visible portions of the siding.

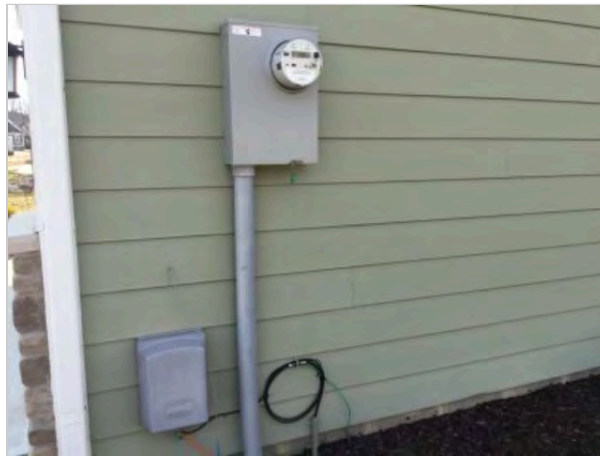
Photo 28

The underground electric service wire entered the home on the right front wall. The electric meter was located on the right exterior wall. There were no major visual defects or safety concerns noted with the electric service.

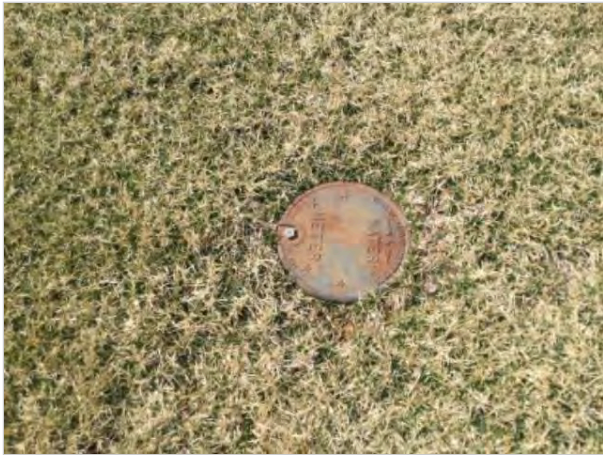
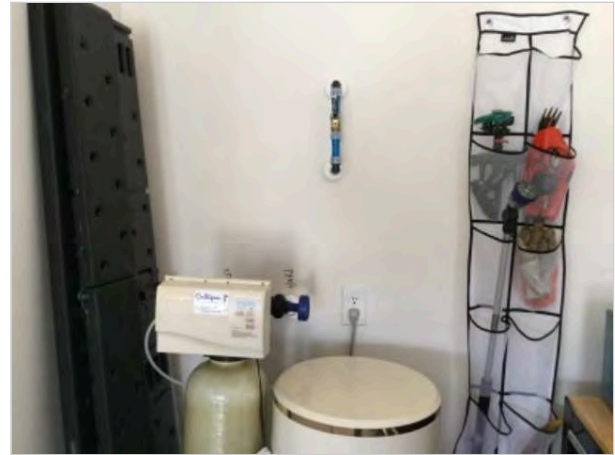
Water was supplied to the home by a municipal water supply. The water meter was located in the front yard. The main water shut off valve was located next to the main water line entry point in the garage.

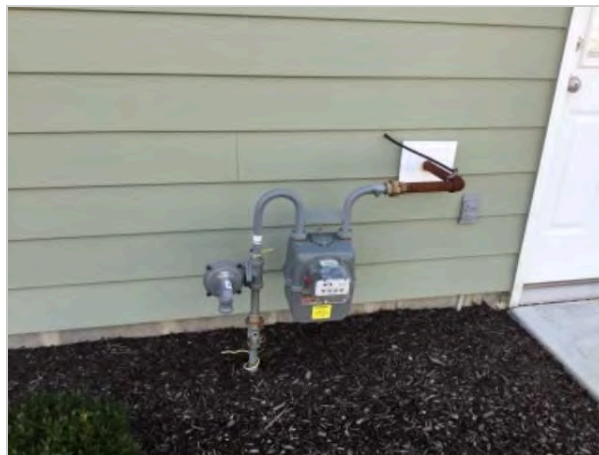
Photo 31

There was gas service to the home. The natural gas meter was located on the right exterior wall.

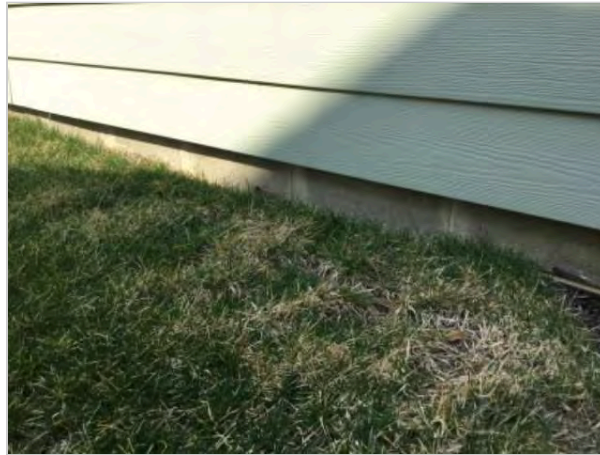
Photo 32

The foundation was constructed of concrete block. A single inspection cannot determine whether movement of a foundation has ceased. Any cracks should be monitored regularly. There were no major visual defects observed on the visible portions of the foundation.

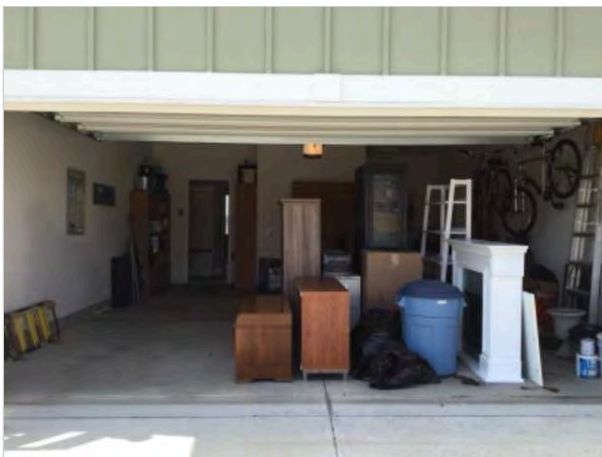
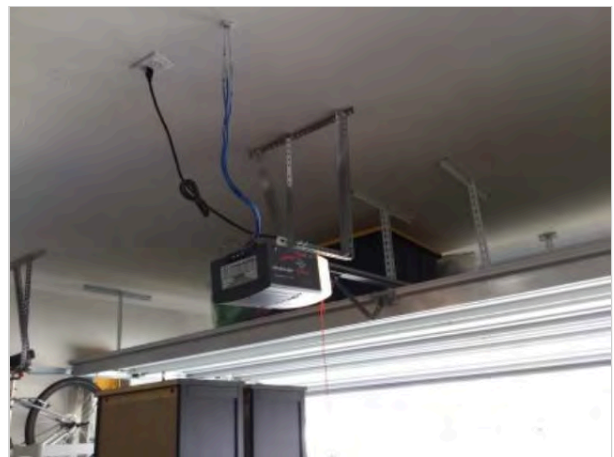
The attached garage was designed for two cars with access provided by one overhead door. The Garage Doors of Indianapolis brand electric garage door opener was functional. The light beam automatic safety reverse feature on the garage door was functional. The concrete garage floor was not fully evaluated due to stored items. There were no major visual defects observed in the garage or the door mechanisms.

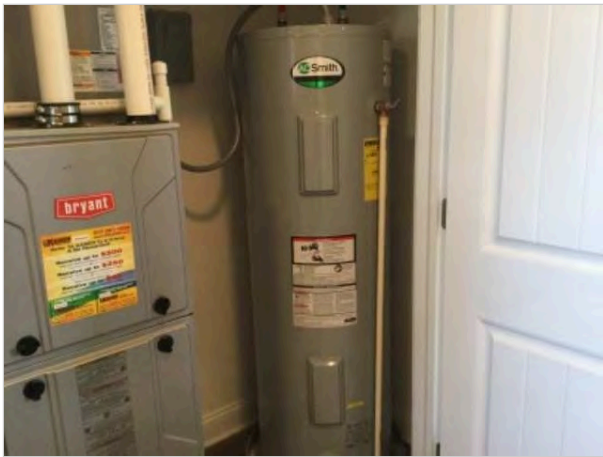
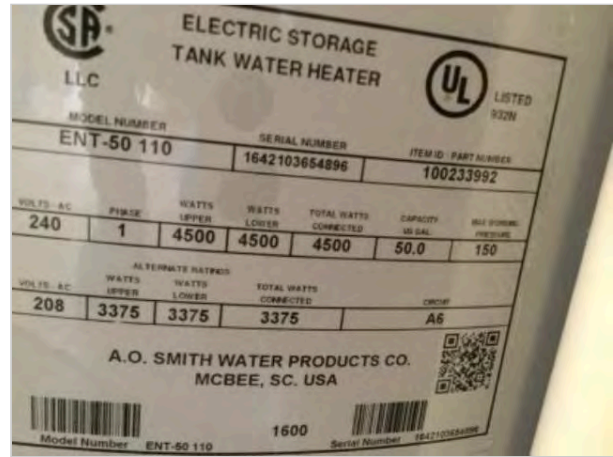
There was a 50 gallon, electric water heater located in the closet. The water heater was manufactured by A. O. Smith, model number ENT 50 110 and serial number 1642103654896. Information on the water heater indicated that it was manufactured 3 year(s) ago. A temperature and pressure relief valve (T & P valve) was present. Because of the lime build-up typical of T & P valves, we do not test them. Your safety depends on the presence of a T & P valve and a properly sized overflow pipe that terminates close to the floor. The water heater was functional.

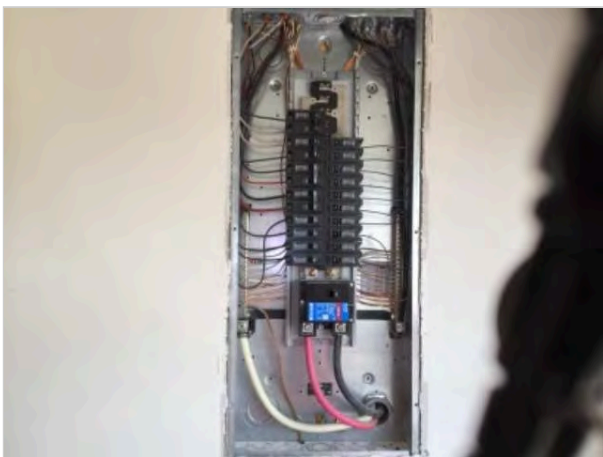
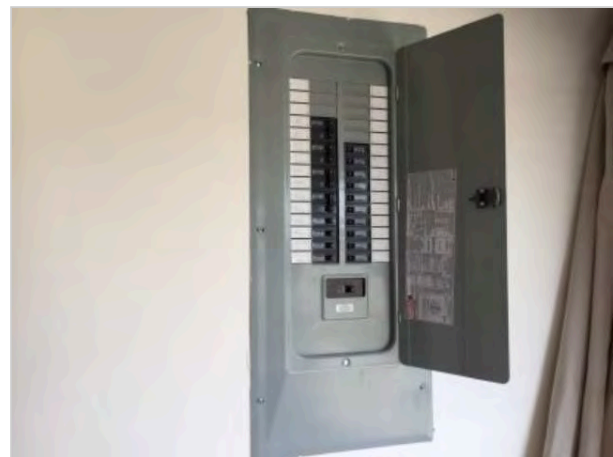
The main electric service panel was a Eaton service panel, located on the garage wall with a 200 amp rated capacity. The branch circuits within the panel were copper wire. These branch circuits and the circuit breakers to which they were attached appeared to be appropriately matched. The visible wiring consisted primarily of the Romex type and appeared to be in good condition.

The electrical service appeared to be adequate. Alarms, electronic keypads, remote control devices, landscape lighting, telephone and television, and all electric company equipment were beyond the scope of this inspection. There were no major visual defects or safety concerns observed in the electrical system.

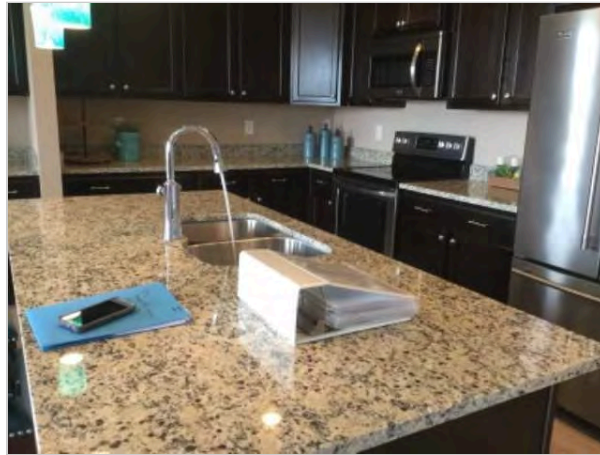
Photo 46

The kitchen cabinet doors and drawers were inspected and appeared to be functional.

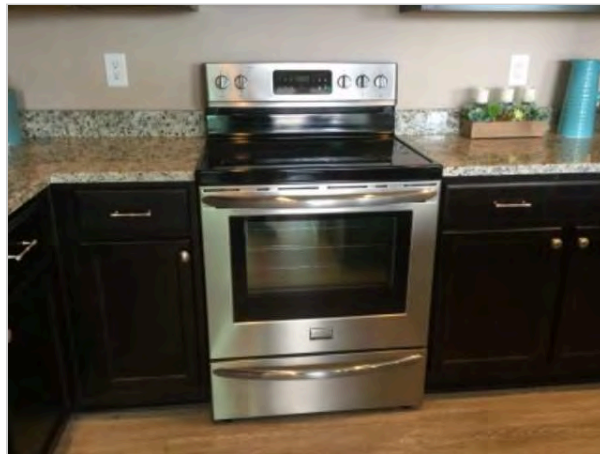
Photo 47

The Frigidaire electric range was inspected and did appear to be functional. The accuracy of the clock, timers and settings on ovens are not within the scope of this inspection.

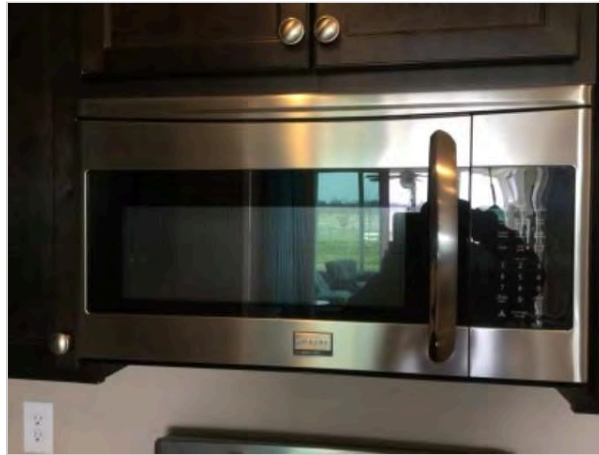
Photo 48

The Frigidaire range hood and microwave combination was inspected and did appear to be functional. The exhaust capacity is not within the scope of this inspection. Cleaning the fan and filter may increase the exhaust capability. The accuracy of the clocks, timers and settings are not within the scope of this inspection.

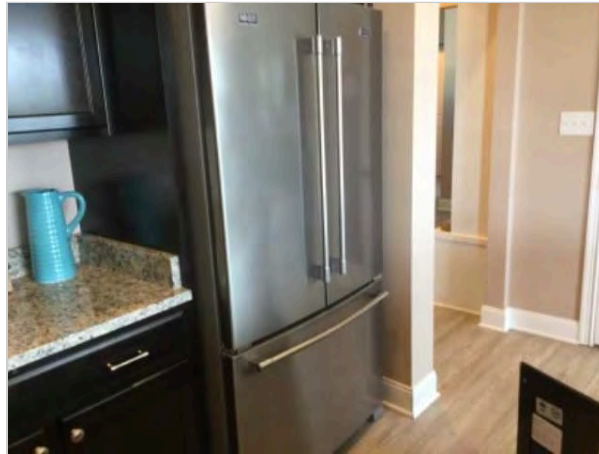
Photo 49

The Maytag refrigerator was inspected and did appear to be functional. The temperatures in the refrigerator and freezer section were 38 degrees F and 0 degrees F respectively. The temperature setting, water dispenser and ice maker, if present, are not within the scope of the inspection.

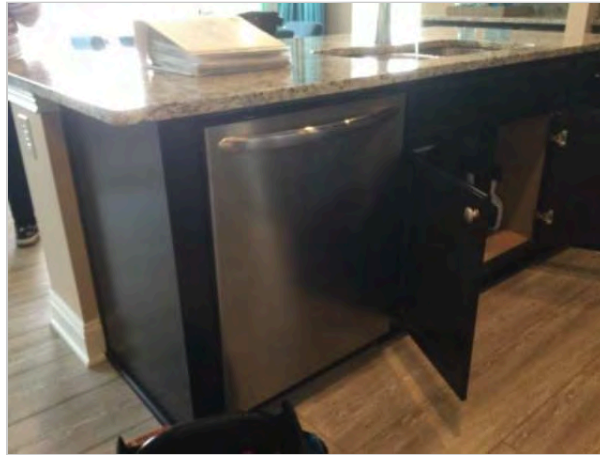
Photo 50

The Frigidaire dishwasher was tested and did appear to be functional. Dishwashers are observed through a complete cycle and are only checked to see that they fill and drain. The efficiency of the wash cycle is not within the scope of this inspection.

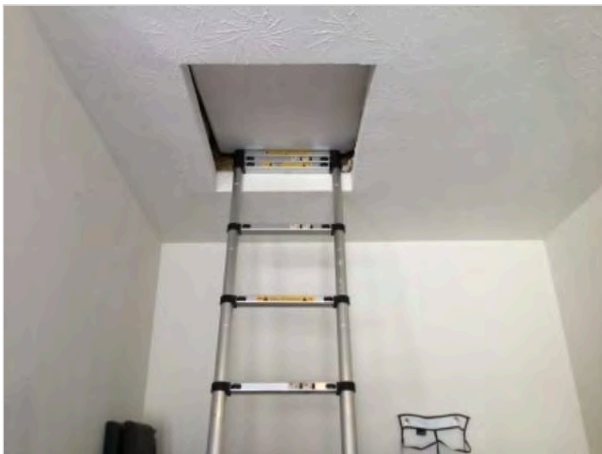
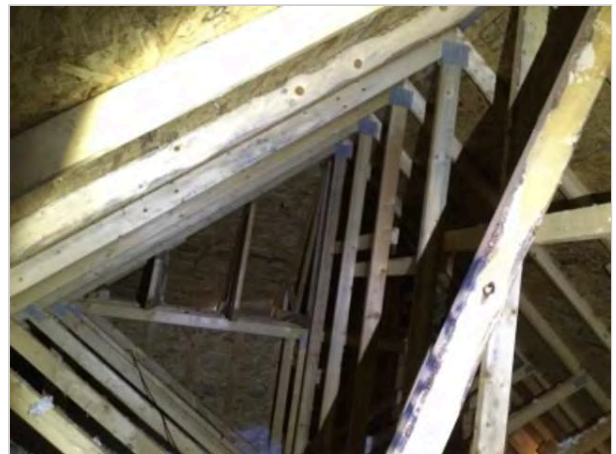
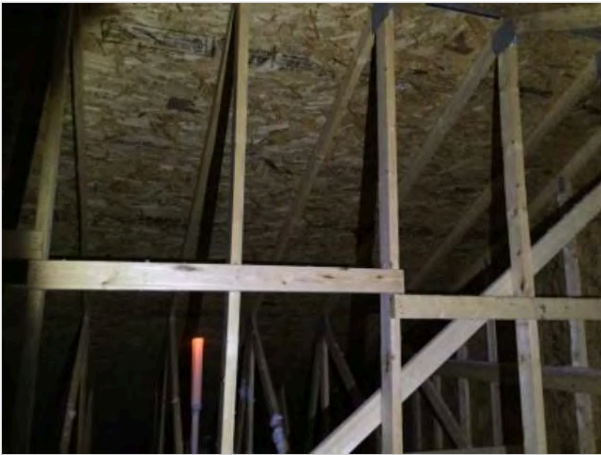
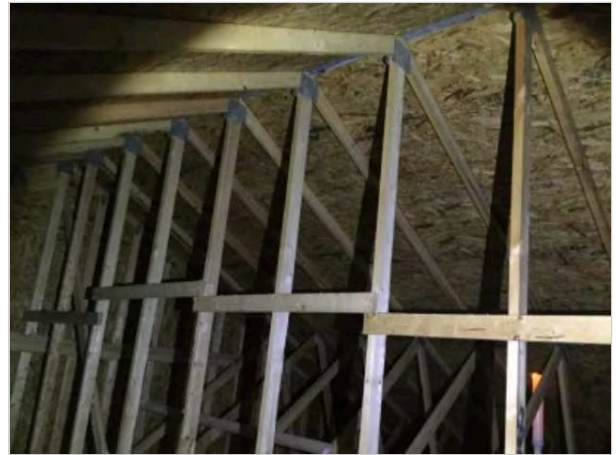
Because of the configuration of the trusses and the ductwork, and depth of the insulation, which limited access, it was not possible to inspect all areas of the attic. There was no moisture visible in the attic space. The absence of visible indications of moisture is not necessarily conclusive evidence that the roof is free from leaks. The only way to be sure a roof does not leak is to inspect the underside of the roof during a heavy rain. There were no major visual defects observed in the attic or roof structure.

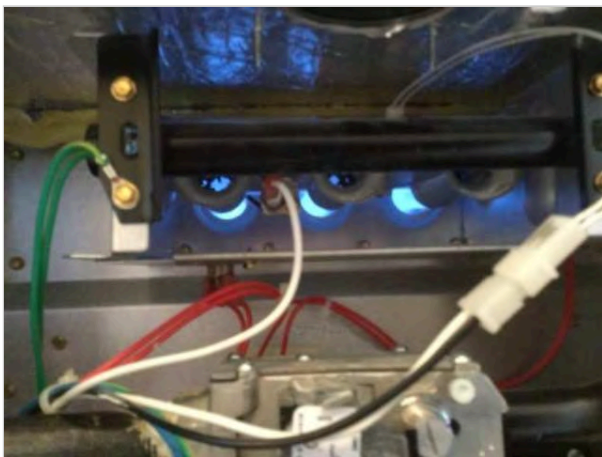
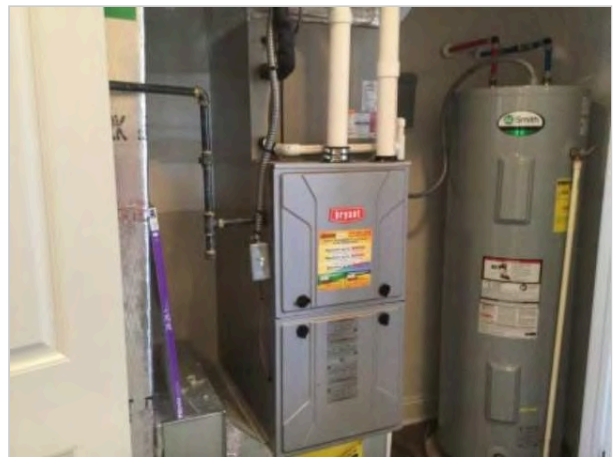
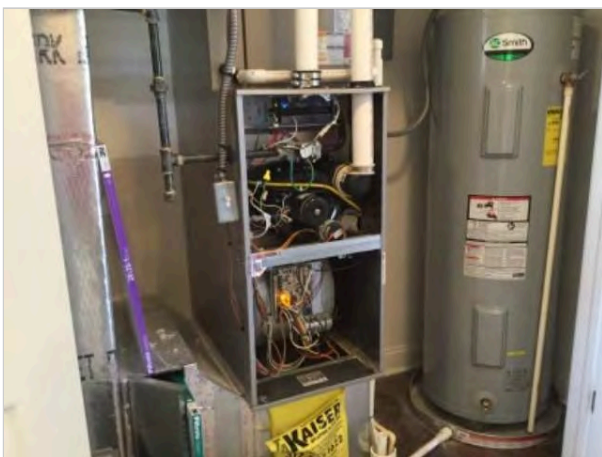
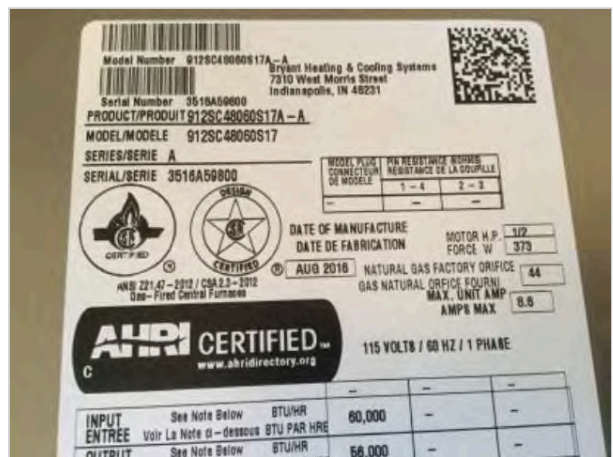
The heating system was functional.

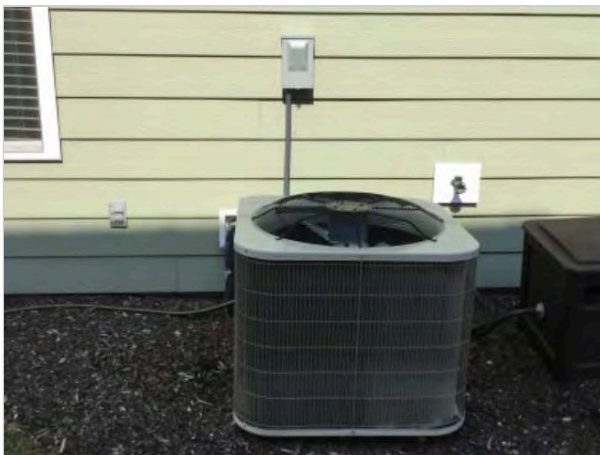
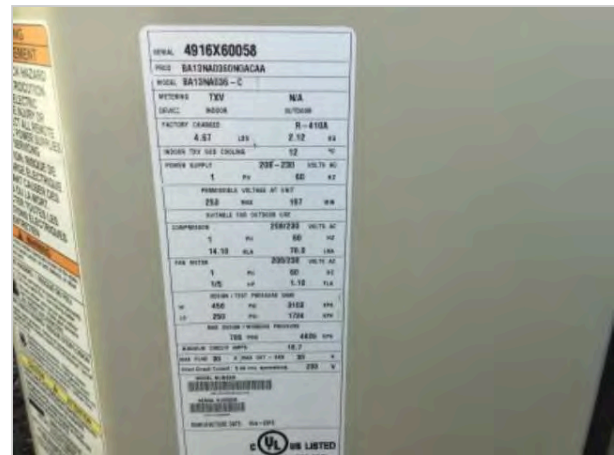
Photo 66

The electric outdoor air conditioner condensing unit was a Bryant, Model Number BA13NA036-C and Serial Number 4916X60058. The unit is located on the left side of the home. This unit is approximately 3 year(s) old. Periodic preventive maintenance is recommended to keep this unit in good working condition.

The cooling system was not tested.

AIR CONDITIONING NOT TESTED: The cooling system was visually inspected but was not operated due to cold outdoor temperatures. When outdoor temperatures have been below 60 degrees Fahrenheit within the past 24 hours, operation of the cooling system could damage the compressor. It is recommended that the system be cleaned and serviced in the spring.
