### *HOME INSPECTION REPORT*

On Sunday, November 9, 2025 The HomeTeam Inspection Service made a visual inspection of 1234 Anywhere Rd., Anytown, USA 12345. Enclosed please find a written, narrative report of our findings in accordance with the terms of our Inspection Agreement.

Michael Burton  
HomeTeam Inspection Service of Central Panhandle  
Florida Home Inspector # HI12530

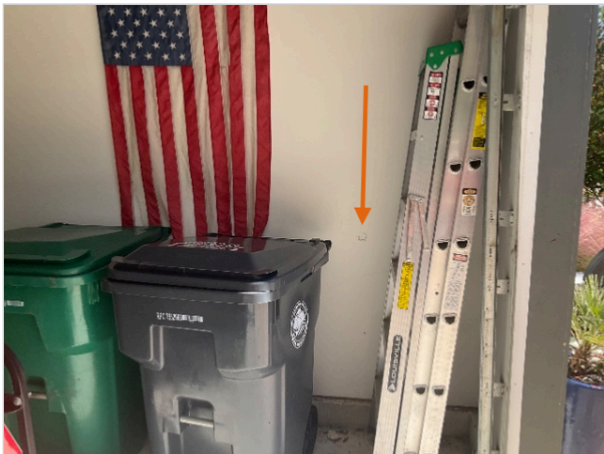
**Photo 92**

Dent in drywall

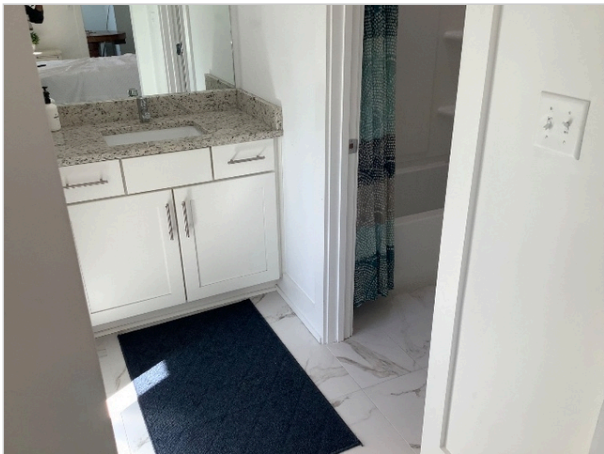
**Photo 164**

2nd floor front bathroom

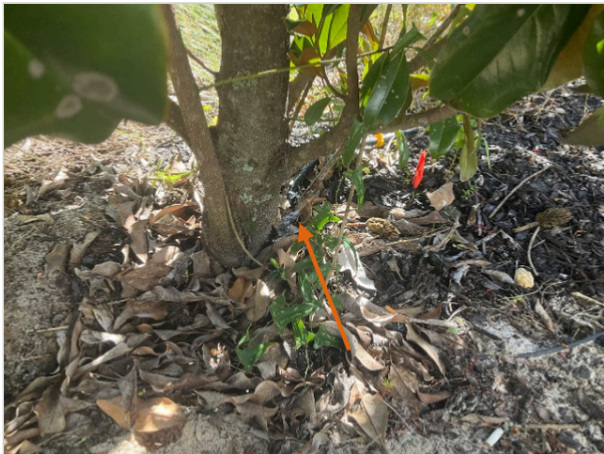
**Photo 285**

Water coming out - appears to be functional
