Wednesday, November 5, 2025

RE: 1234 Anytown Rd. Anywhere, USA 12345

HOME INSPECTION REPORT

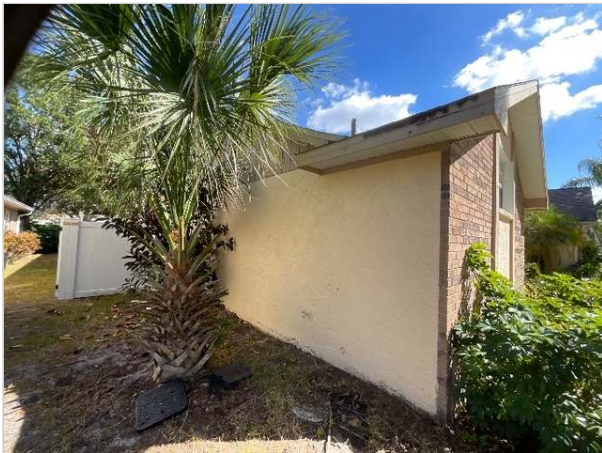
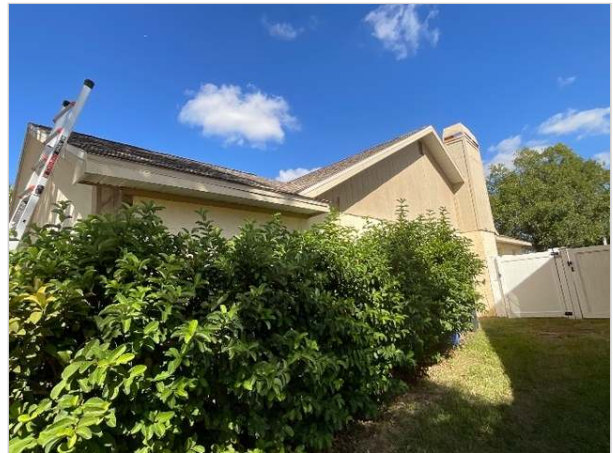
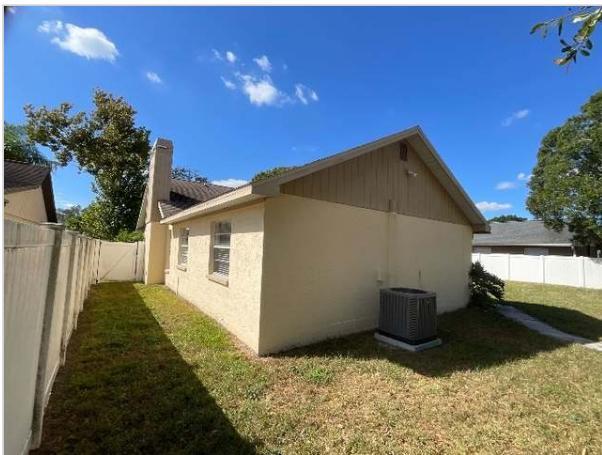
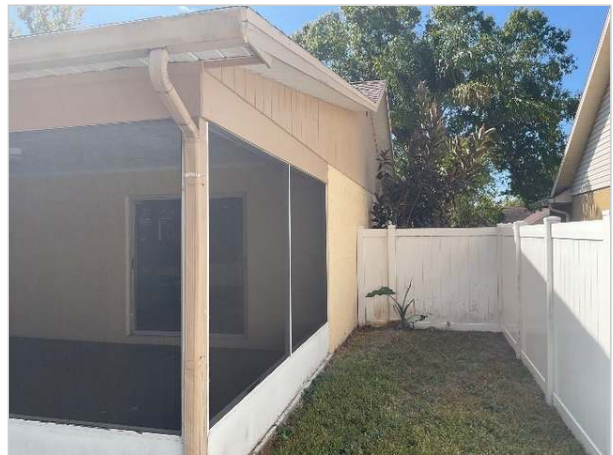
THERE WAS DETERIORATION TO THE FACIA BOARDS AND SIDING IN THE FOLLOWING LOCATIONS: NUMEROUS AREAS. FURTHER EVALUATION FOR LICENSED CONTRACTORS RECOMMENDED.

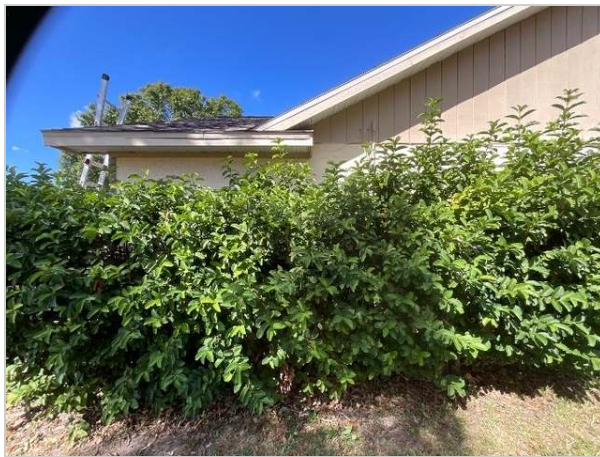
THE SIDING AROUND THE AC CONDENSATE LINE WAS NOT SEALED.

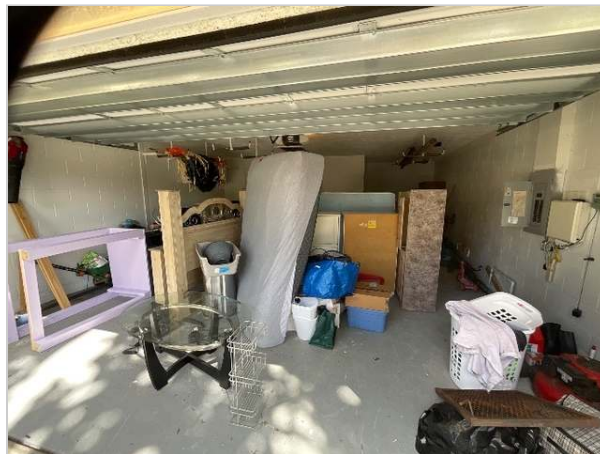
THE DRYWALL TAPE LOCATED AT THE GARAGE CEILING WAS CRACKED.

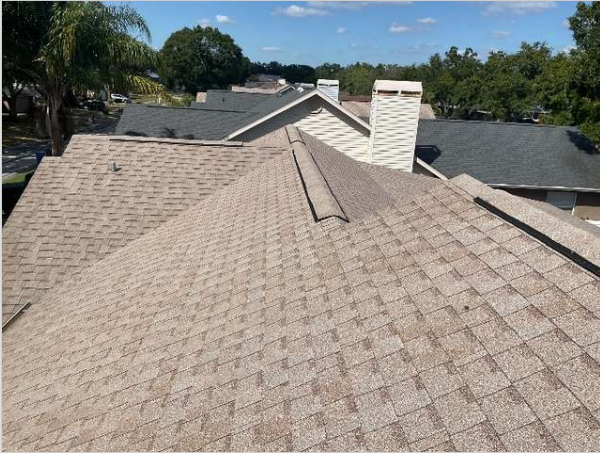
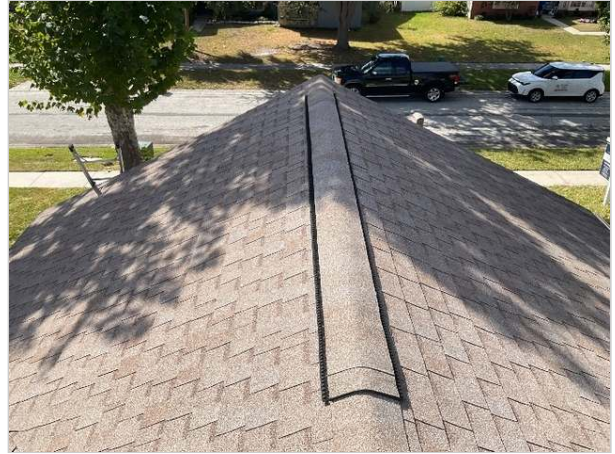
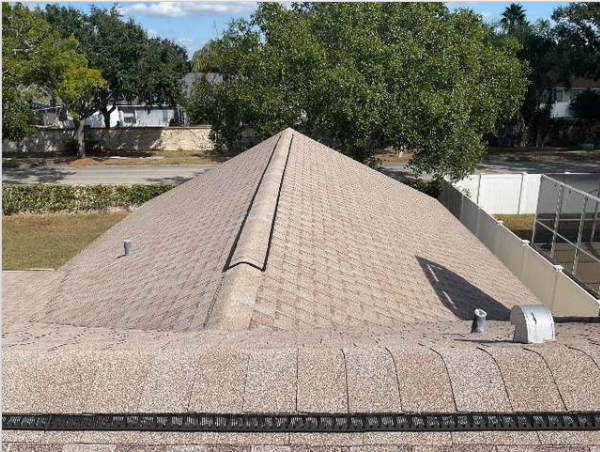
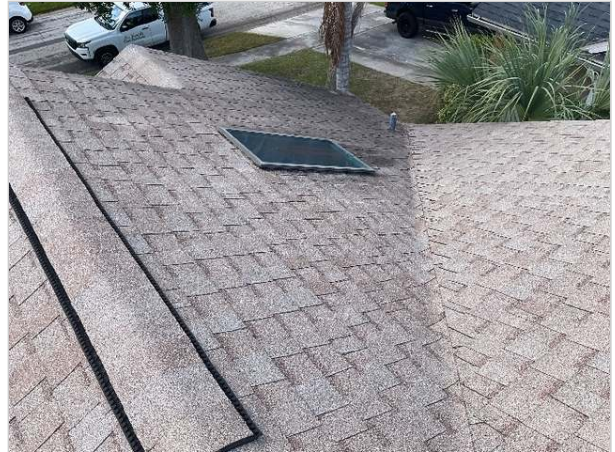
THE FLASHING AT THE PLUMBING VENT PIPE WAS DAMAGED. THE FLASHING SHOULD BE REPAIRED BY A QUALIFIED LICENSED CONTRACTOR TO PREVENT WATER INTRUSION TO THE HOME.

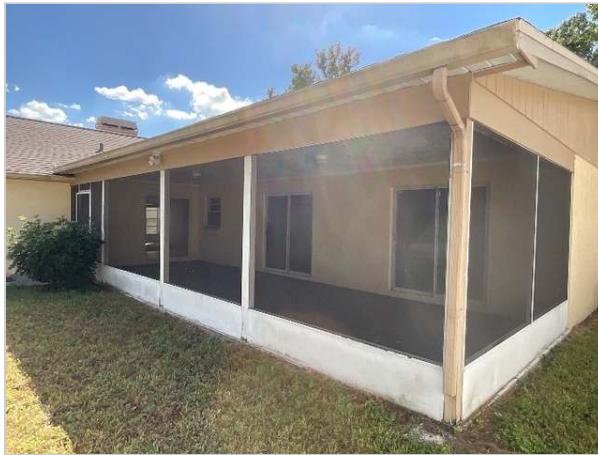
THE SUPPORT POSTS FOR THE SCREENED IN LANAI OR DETERIORATED. FURTHER EVALUATION FROM A LICENSED CONTRACTORS IS RECOMMENDED. FURTHER EVALUATION FROM LICENSED CONTRACTOR IS RECOMMENDED.

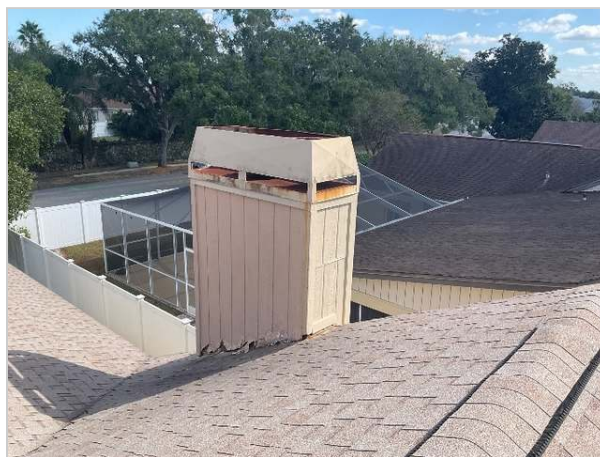
THE SIDING AROUND THE CHIMNEY WAS DETERIORATED.

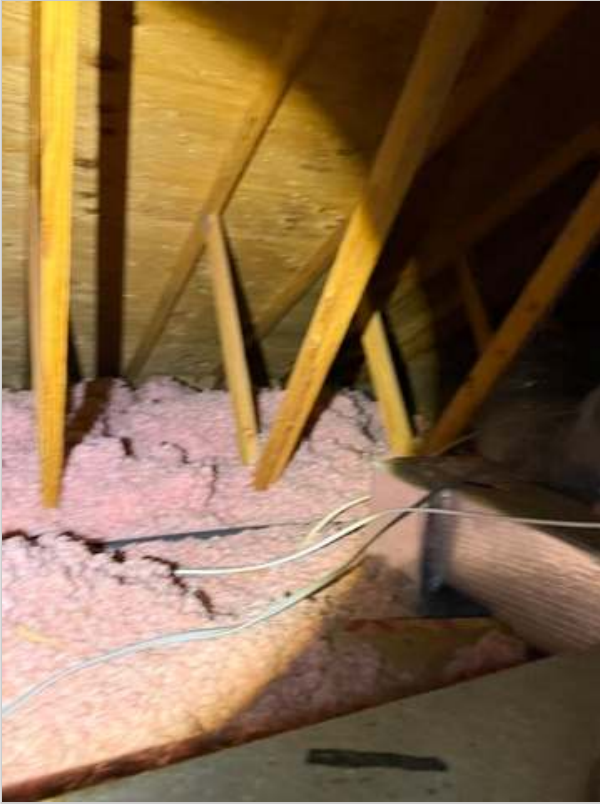
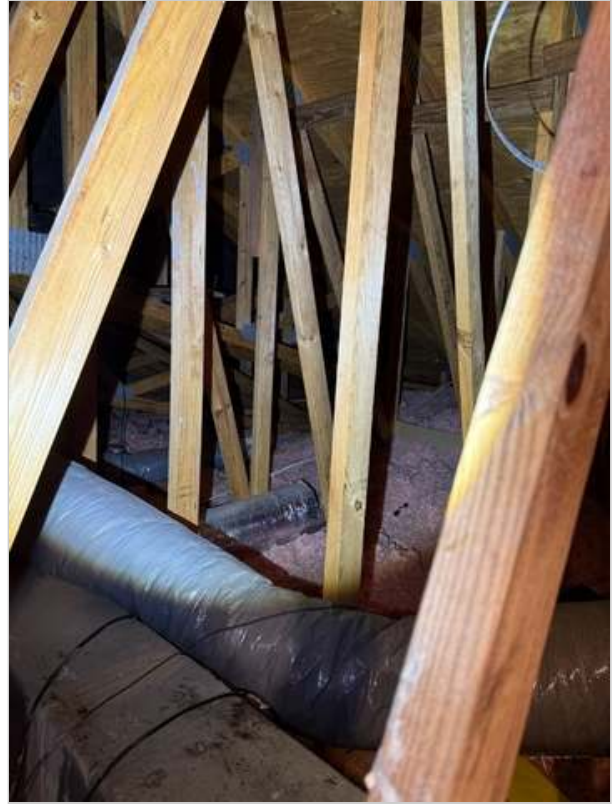
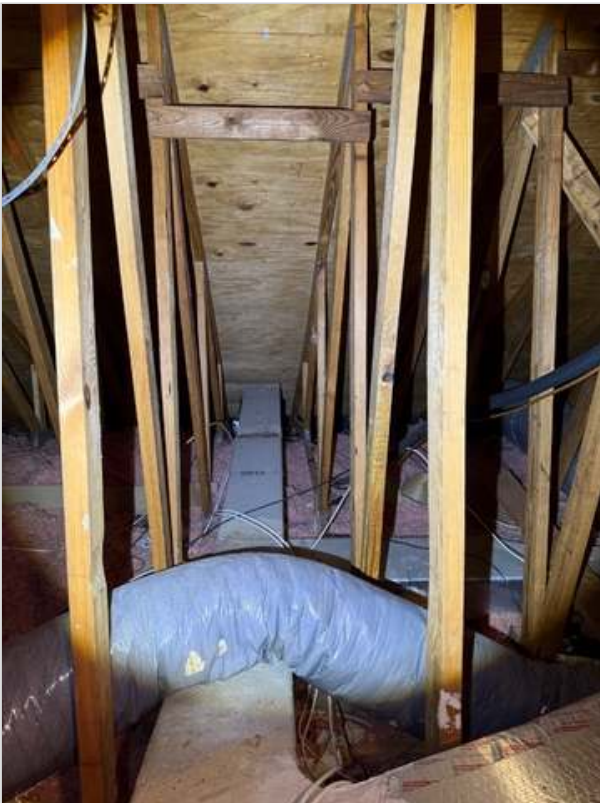
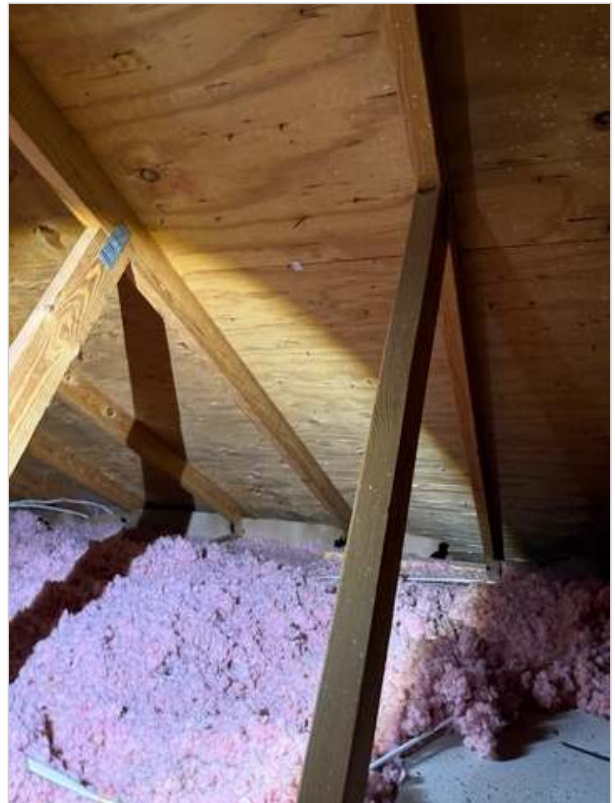
THE SOFFIT SCREENS FOR THE HOME HAD BEEN PAINTED. THIS IS A POTENTIAL HAZARD, AS IT MAY RESTRICT AIRFLOW INTO THE ATTIC SPACE. THE SOFFITS ARE A CRITICAL COMPONENT OF THE ATTIC VENTILATION SYSTEM, AND IMPAIRED VENTILATION CAN LEAD TO ELEVATED MOISTURE LEVELS AND POSSIBLE MOLD OR STRUCTURAL ISSUES. EVALUATION AND CORRECTION BY A QUALIFIED CONTRACTOR IS RECOMMENDED.

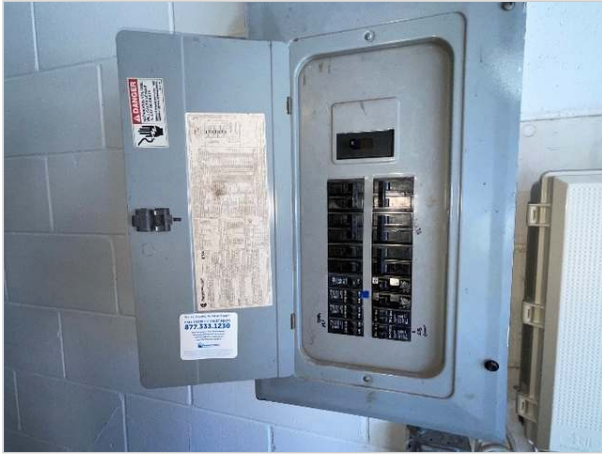
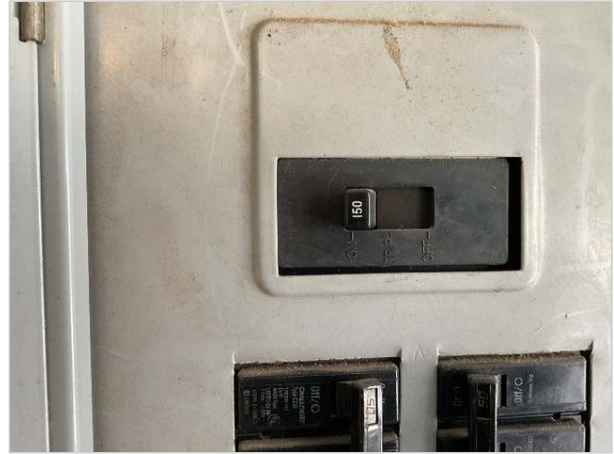
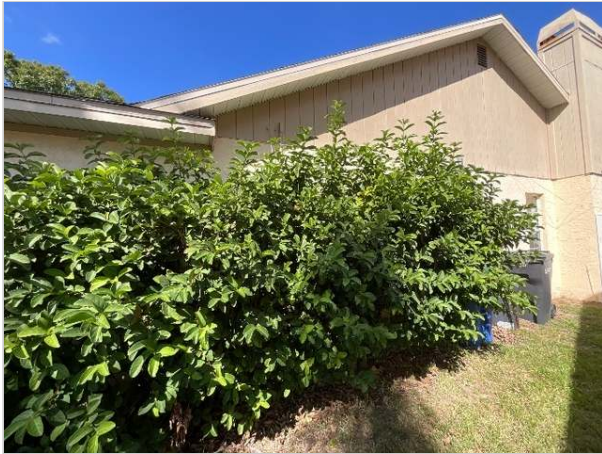
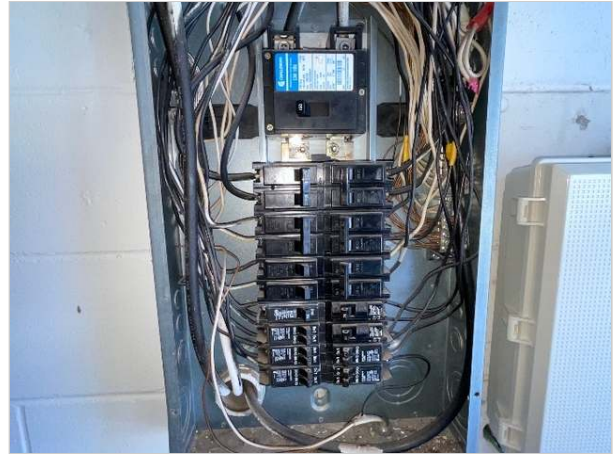
THE ELECTRICAL PANEL IS A CHALLENGER BRAND PANEL. THERE HAVE BEEN REPORTS OF FAILURE WITH SOME CHALLENGER PANELS. IT IS RECOMMENDED THAT A LICENSED ELECTRICIAN EVALUATE THE CONDITION OF THE SERVICE PANEL. MANY INSURANCE COMPANIES ARE NO LONGER UNDERWRITING HOUSES WITH THIS TYPE OF PANEL. [4-POINT ISSUE](#).

MISSING/DAMAGED OUTLET COVERS WERE OBSERVED IN THE HOME. THESE SHOULD BE REPLACED TO ENSURE SAFETY AND PREVENT EXPOSURE TO ELECTRICAL COMPONENTS. [THIS IS A 4-POINT ISSUE](#).

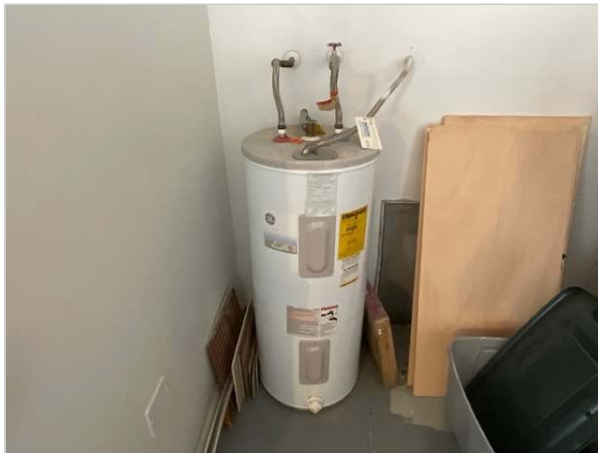
DUE TO THE AGE OF THE WATER HEATER, THERE MAY BE LIMITED LIFE REMAINING.

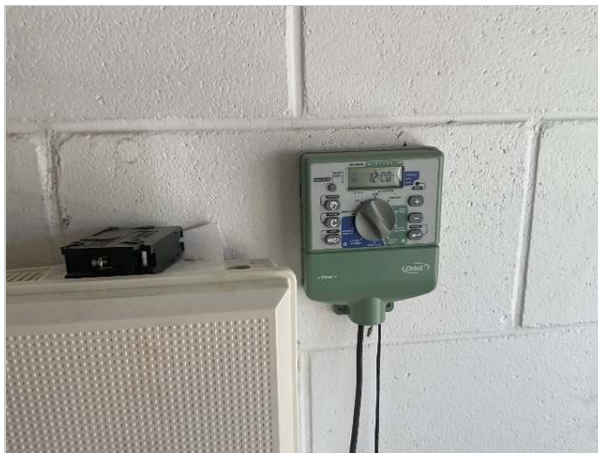
THE FOLLOWING DEFECTS WERE OBSERVED IN THE IRRIGATION SYSTEM: WOULD NOT TURN ON IN THE MANUAL MODE. FURTHER EVALUATION OF THE IRRIGATION SYSTEM SHOULD BE PERFORMED BY A LICENCED IRRIGATION CONTRACTOR.

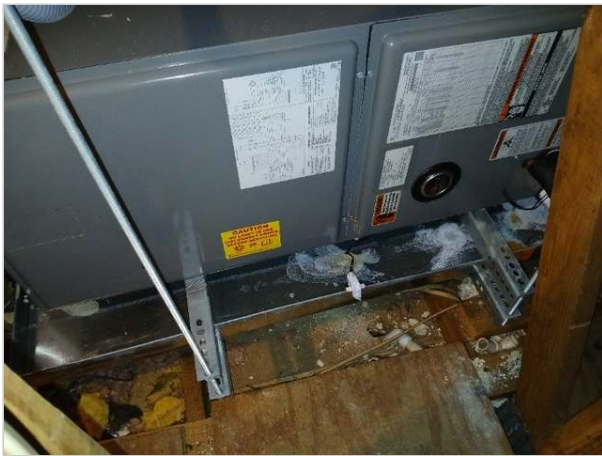
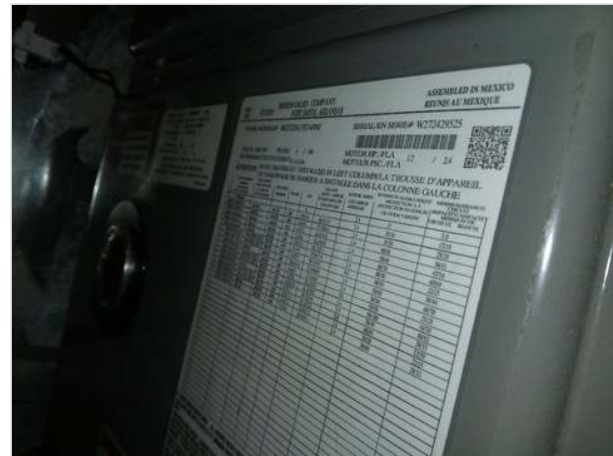
The temperature drop across the evaporator coil is 21. degrees F. It is within industry guidelines.

The drain(s) are installed properly to provide adequate condensate discharge.

It is recommended to check air filter monthly and change as necessary. Also, pour a 1/4 to a cup of white vinegar down the drain monthly.
