# HomeTeam<sup>®</sup>

### *HOME INSPECTION REPORT*

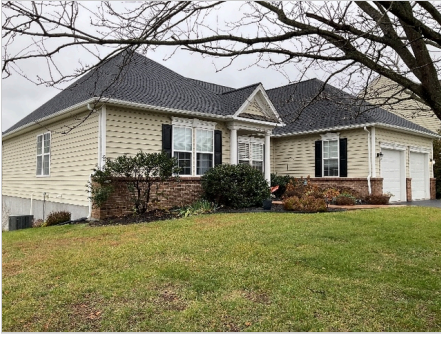
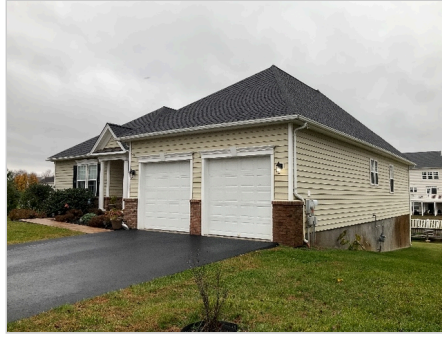
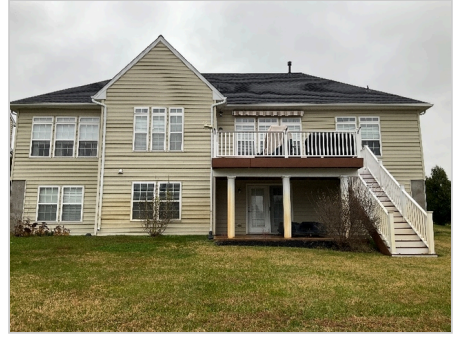
**A hose bib on the rear of the structure has a constant drip when operated.** The drip should be repaired.

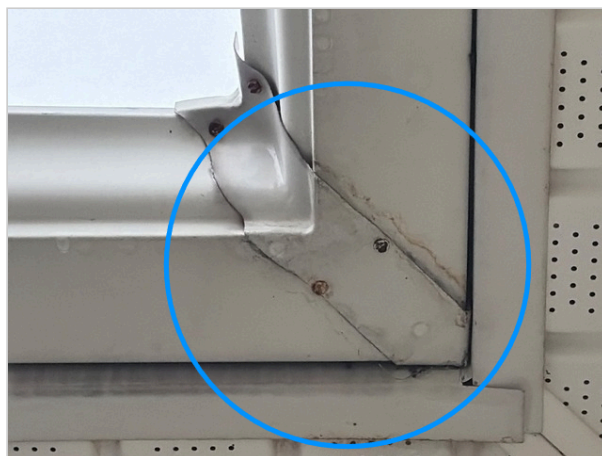
Front right side of the front door

**Gutters appear to be leaking at the corners.** The seams should be sealed with an appropriate gutter sealant.

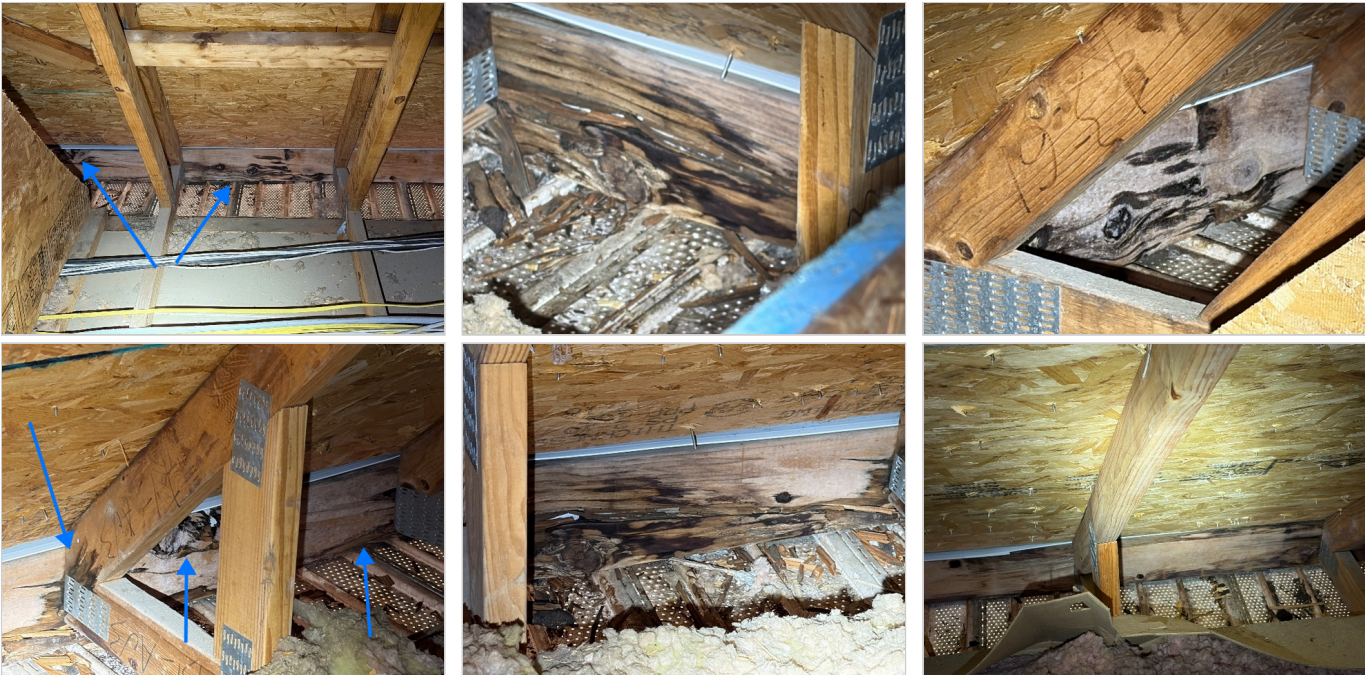
Water-damaged and deteriorated wood was observed on the exterior header board located behind the fascia on the right side of the house. This damage is not visible from the exterior and was only identifiable from within the garage attic space. The deterioration indicates moisture intrusion that may be ongoing and could compromise the structural integrity of the affected framing if not addressed. I recommend further evaluation and repairs by a licensed contractor. Corrections may include removing the fascia, replacing damaged wood, and identifying and repairing the source of moisture to prevent recurrence.

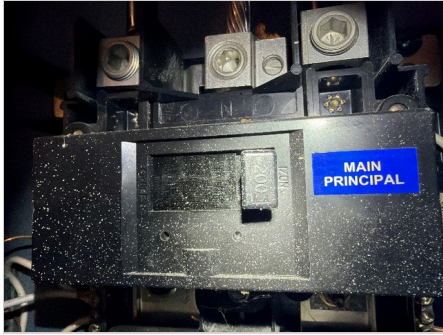
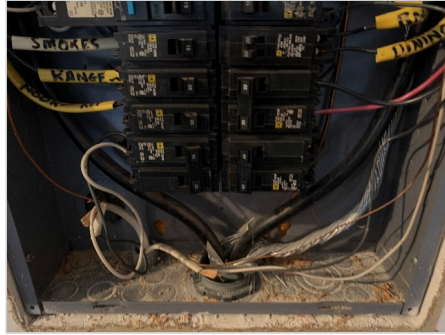
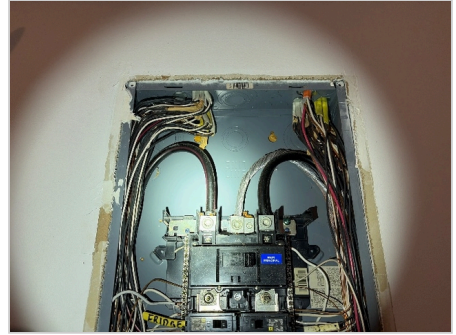
There was missing electrical panel cover screws. Recommend to provide hardware to properly attach the cover.

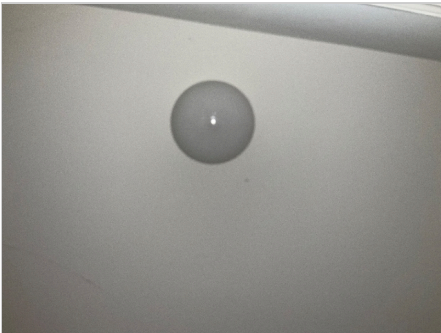
Closet bedroom light inoperable.  
Bedroom facing street.

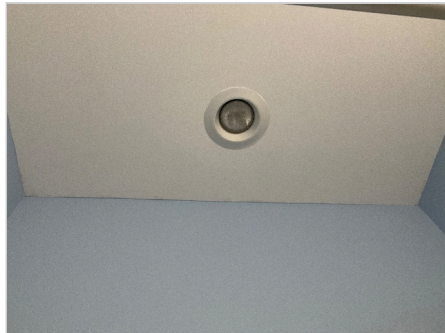
Shower light in hallway bathroom.

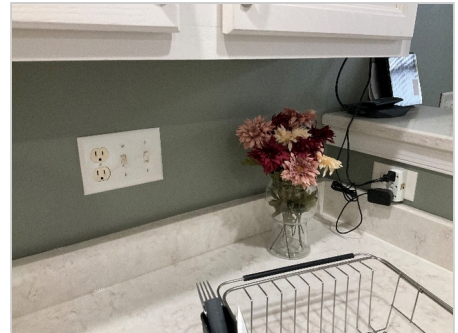
Switch keeps lights on despite being in off position. The center of the switch is where the light turns off. Recommend consulting with an electrician for repair.

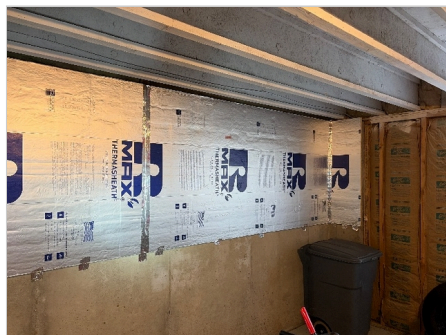
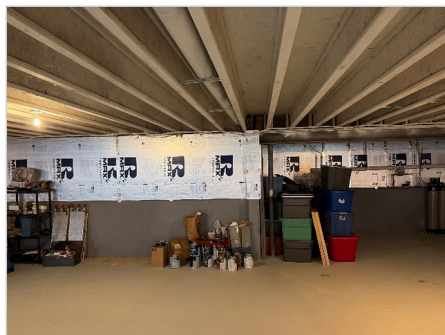
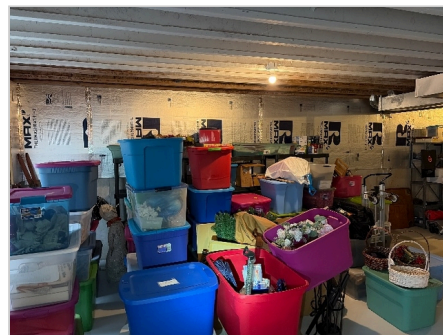
Small cracks were observed on the foundation. The homeowner should monitor these cracks for any changes, and if changes are noted, should contact a structural repair company for further analysis. Below-grade cracks are highly susceptible to water intrusion during times of heavy rain. Water staining from previous water intrusion was visible. HomeTeam recommends sealing these cracks if a watertight basement is desired.

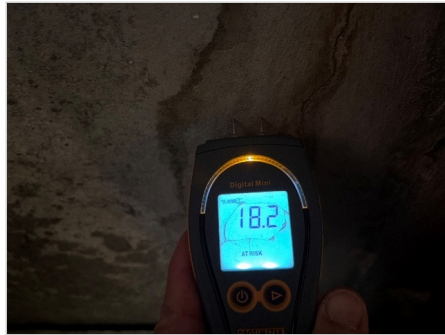
17% is considered "at risk", 20% is considered "wet"

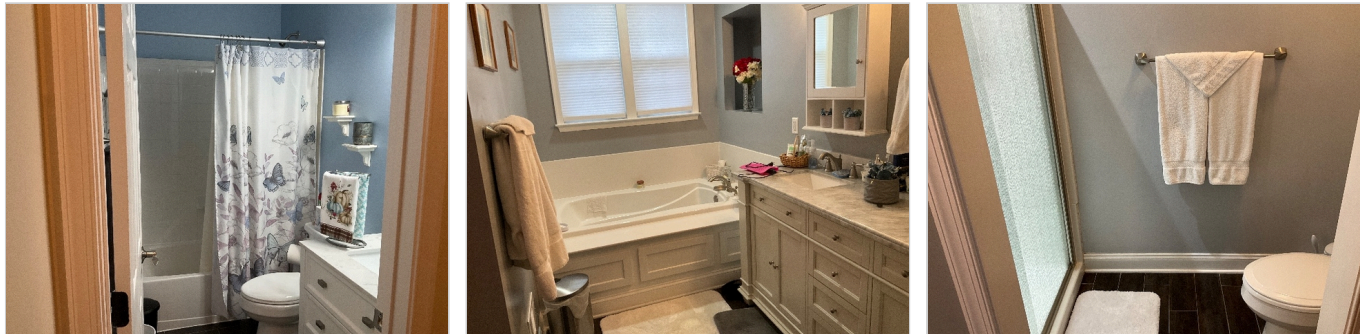
**The shower head for the master bathroom shower is loose where it attaches to the wall. The pipe should be secured and the area sealed in order to prevent water intrusion.**

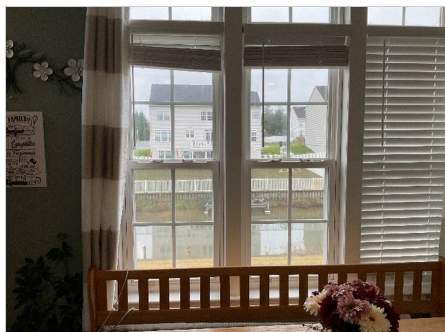
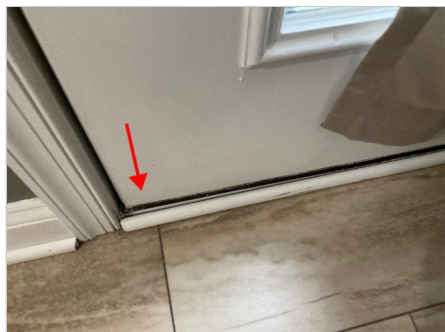
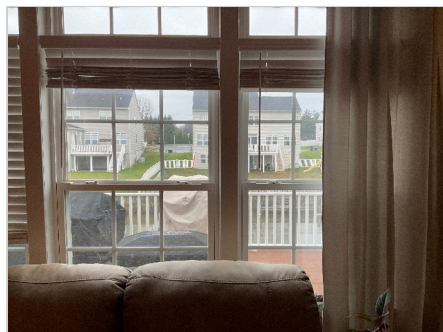
Trim coming off door

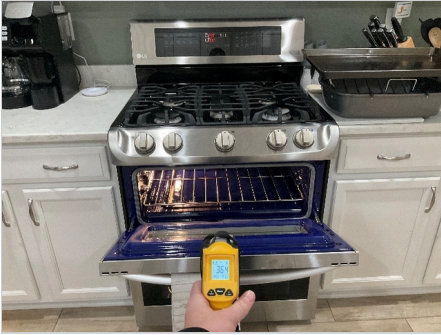
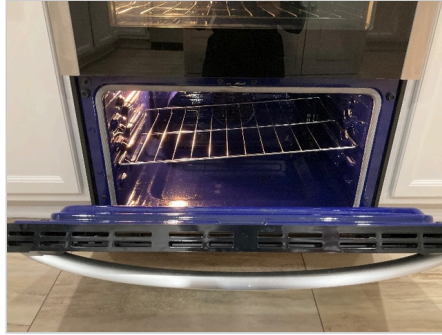
The anti tip bracket was not installed on range. If weight or pressure is applied to open oven door range can tip causing serious harm or injury. Recommend to install bracket.

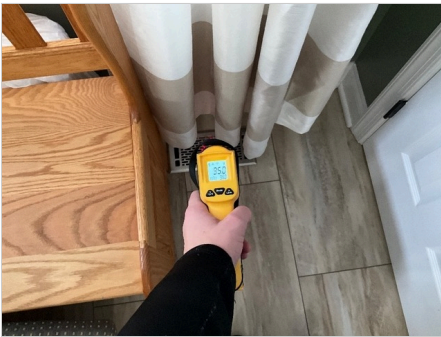
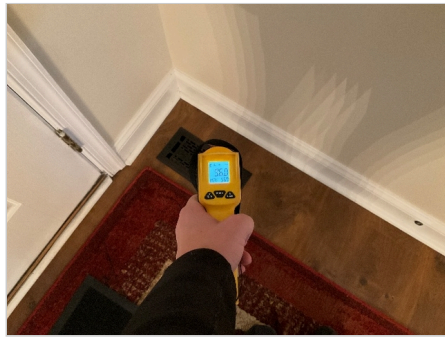
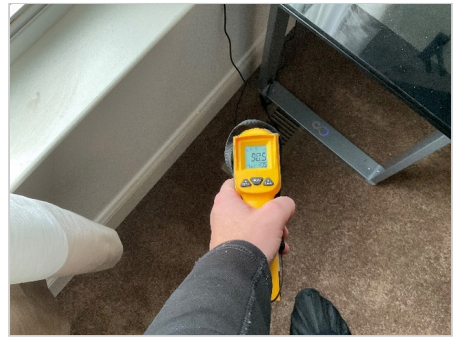
The structure was heated by a Trane natural gas forced air furnace, Model Number TUX100C948D3 and Serial Number 4294Y137G, which is 21 years old. The unit was located in the basement of the structure. It has an approximate net heating capacity of 90,000 BTU/H. The automatic safety controls on the unit were tested and found to be functional at the time of the inspection.

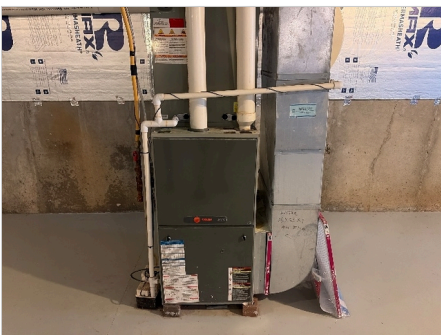
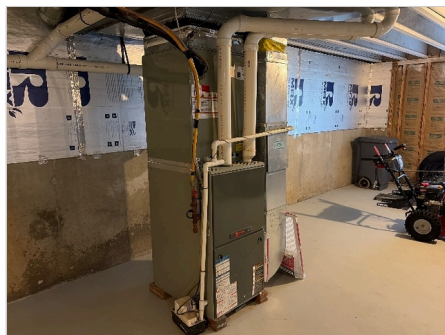
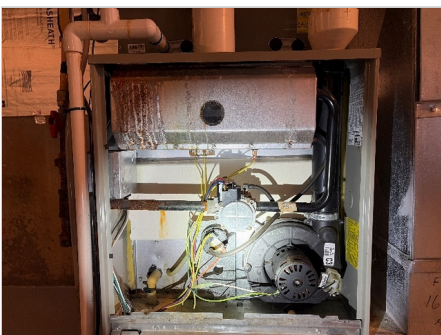
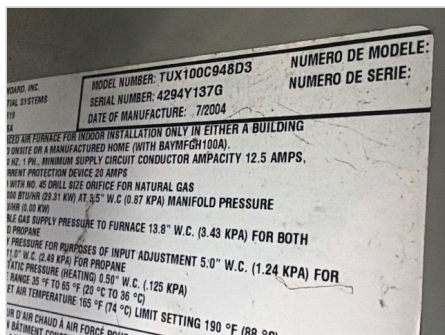
The HVAC condensate line terminated in floor drain raised above the floor drain or drain inlet. The condensate line was trapped. The HVAC condensate line must be trapped and not in contact with wet drain inlets to prevent the possible migration of bacteria and mold into the air-handling system. The heating system was found to be functional.

The furnace may be past its design life. This is an informational note only to help give an idea of future budgeting considerations. The system was functional at the time of the inspection unless noted otherwise. Please note that since codes change, it is possible the configuration for the flue and/or condensate lines may need to be altered at the time of a future replacement.

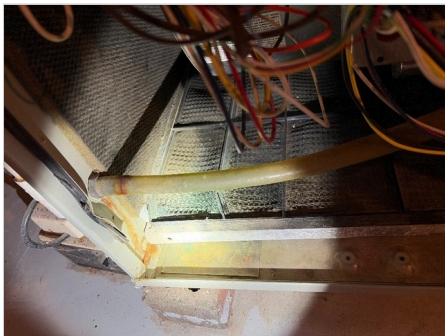
Bottom compartment

Rust was observed within both the upper and lower furnace compartments. Corrosion inside the unit may indicate past or ongoing moisture intrusion and can impact the safe and efficient operation of the furnace. Recommend further evaluation and servicing by a licensed HVAC contractor to determine the extent of damage and perform any necessary repairs.

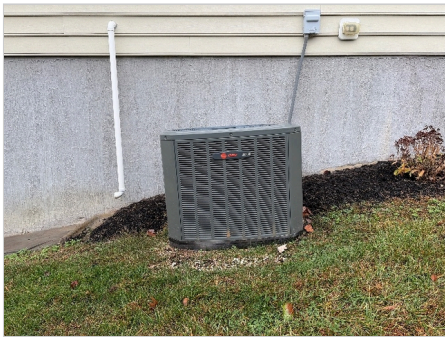
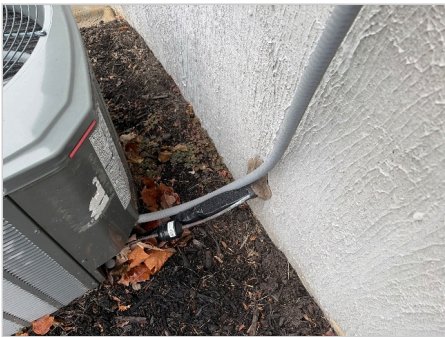
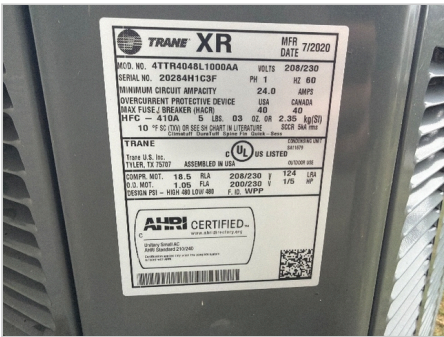
The electric outdoor air conditioner condensing unit was a Trane, Model Number 4TTR4048L1000AA and Serial Number 20284H1C3F. The unit is located on the left side of the structure. This unit is approximately 5 years old. Periodic preventive maintenance is recommended to keep this unit in good working condition. The cooling system was functional.

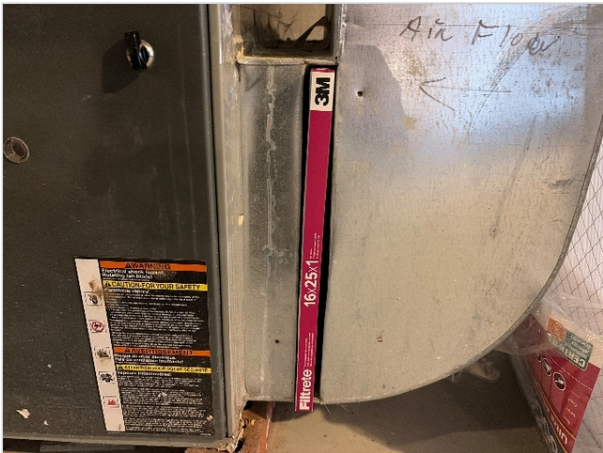
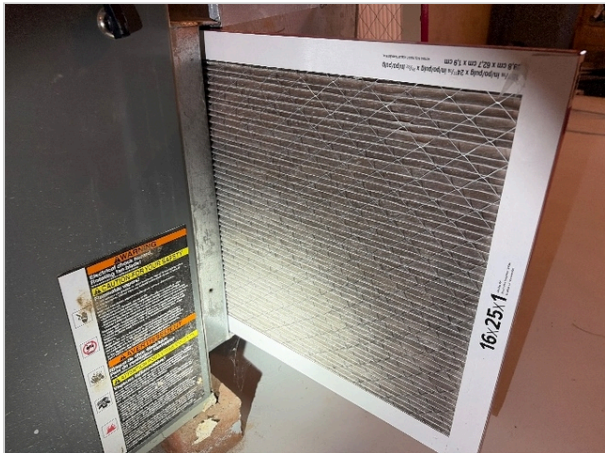
The disposable/washable filter should be replaced/cleaned on a regular basis to maintain the efficiency of the system. The efficiency rating is not within the scope of this inspection. A 16x25x1 filter(s) was installed at the side of the furnace.

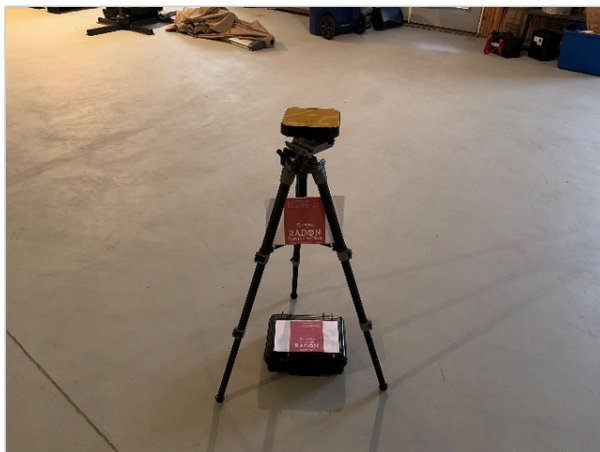
The radon test was not complete at the time of the inspection. The test must run for a minimum of 48 hours. The radon test results will be sent under separate cover.
