### *HOME INSPECTION REPORT*

On Tuesday, January 13, 2026 The HomeTeam Inspection Service made a visual inspection of 123 Anywhere St, Anytown, ST 12345. Enclosed please find a written, narrative report of our findings in accordance with the terms of our Inspection Agreement.

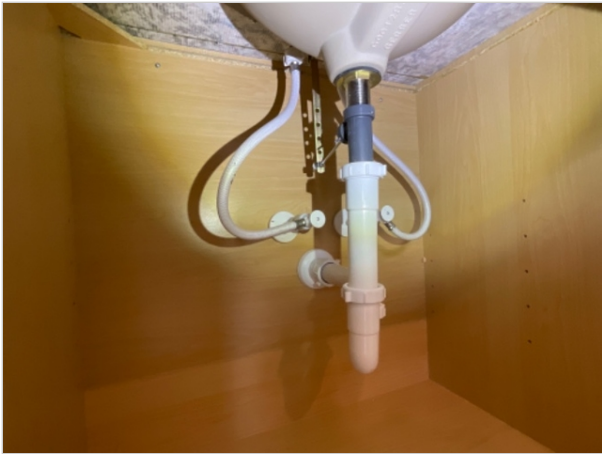
**Photo 44**

Master bath right

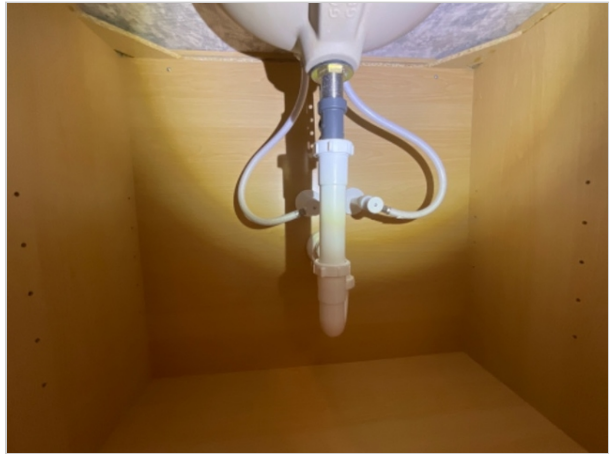
**Photo 45**

Master bath left

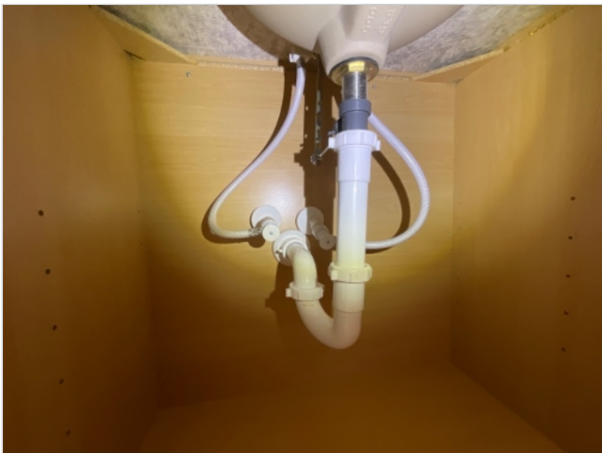
**Photo 46**

Half bath

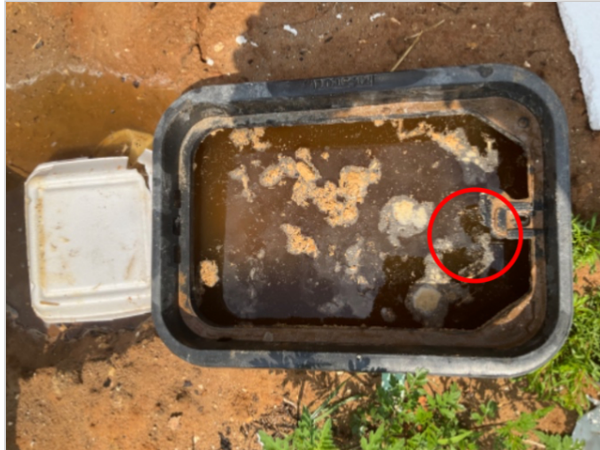
**Photo 49**

The water meter was located in the front left yard. The main water shutoff valve for the structure was located adjacent to the water service entry point at the meter. Water shutoff valves are visually inspected only. No attempt is made to operate the main or any other water supply shutoff valves during the inspection. These valves are infrequently used and could leak after being operated. The only exception to this policy is made when the main water supply valve is off upon arrival at the inspection. Since it is the buyers right to have all utilities operable for the home inspection, we will attempt to turn the main water valve on for the inspection. The HomeTeam is not responsible for leaks caused by operating the valve.

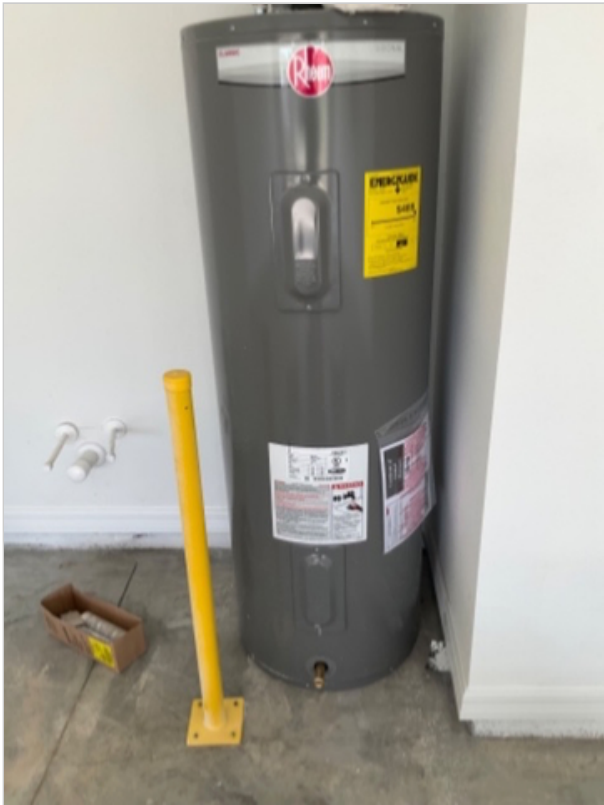
**Photo 50**

A 50 gallon capacity, electric water heater was located in the garage. The water heater was manufactured by Rheem, model number PROE50T2RH95 and serial number Q022433722. Information on the water heater indicated that it was manufactured Less than 1 years ago. Hot water temperature was approximately 108 degrees F.

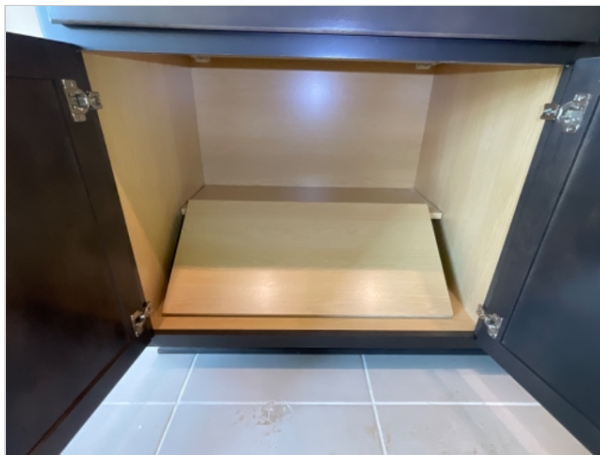
**Photo 60**

**Portions of the kitchens cabinet shelving were not completely secure to the wall.** The cabinets should be secured to prevent them from falling.

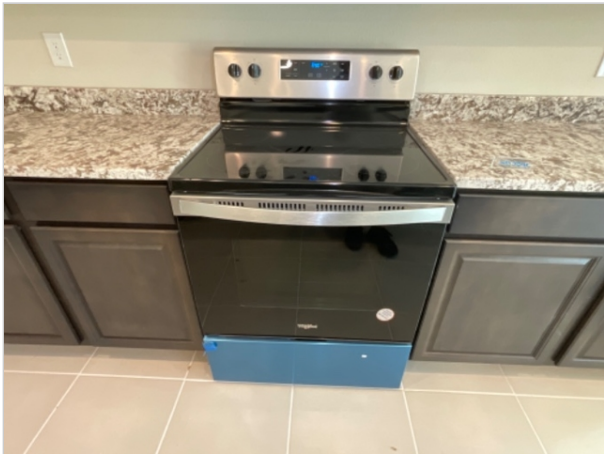
**Photo 61**

The electric oven and range combo was inspected and did appear to be functional. The accuracy of the clock, timers and settings on ovens are not within the scope of this inspection.

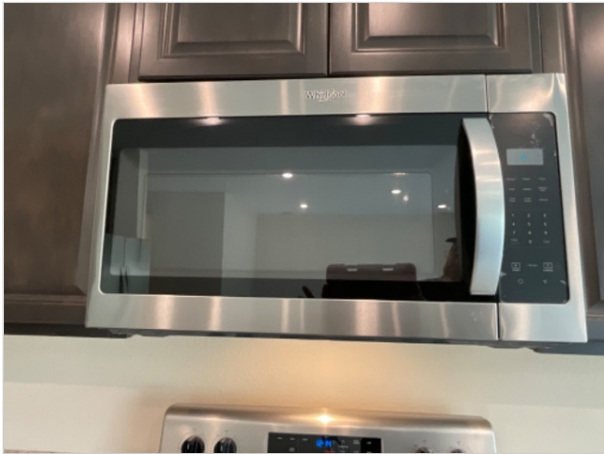
**Photo 64**

The range hood and microwave combination was inspected and did appear to be functional. The exhaust capacity is not within the scope of this inspection. Cleaning the fan and filter may increase the exhaust capability.

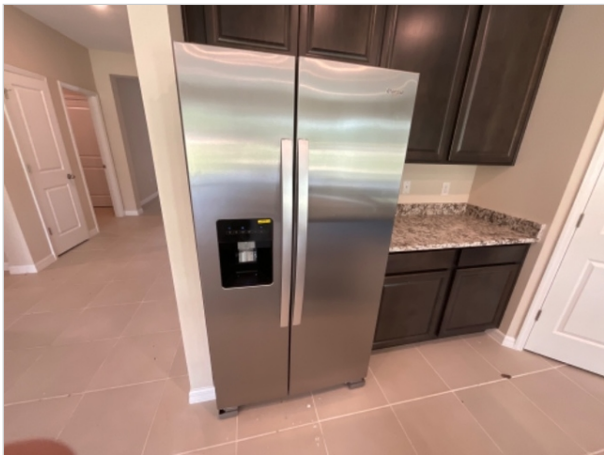
**Photo 67**

The refrigerator was inspected and did appear to be functional . The ice maker operation and hookups, if present, are not within the scope of the inspection.

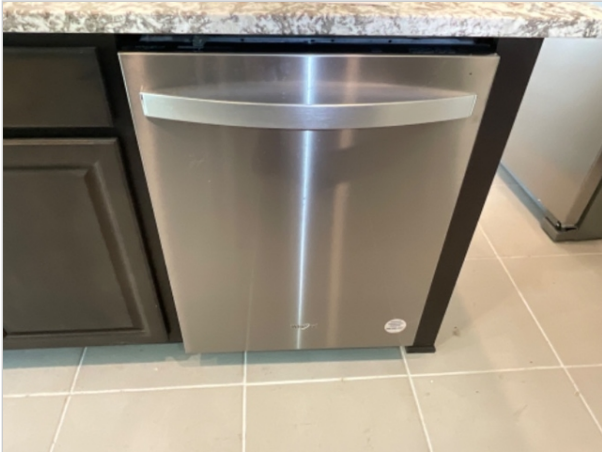
**Photo 70**

The dishwasher was was not tested because it was not connected to either the power source or plumbing.

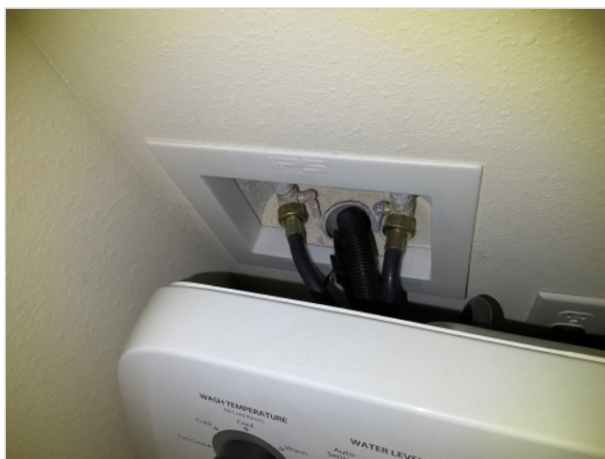
**Photo 74**

A drain for a washing machine was present.

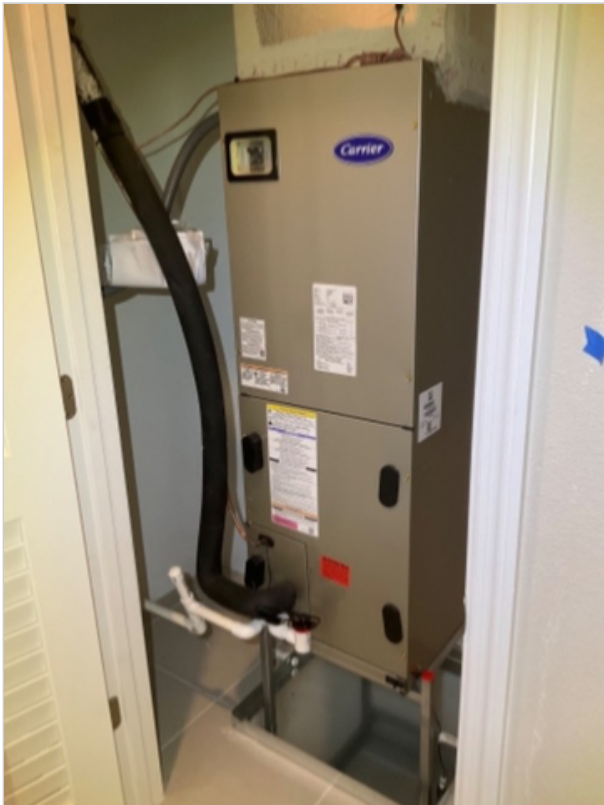
Photo 76

The HVAC condensate line terminated in floor drain raised above the floor drain or drain inlet. The condensate line was trapped. The HVAC condensate line must be trapped and not in contact with wet drain inlets to prevent the possible migration of bacteria and mold into the air-handling system. The heating system was found to be functional.

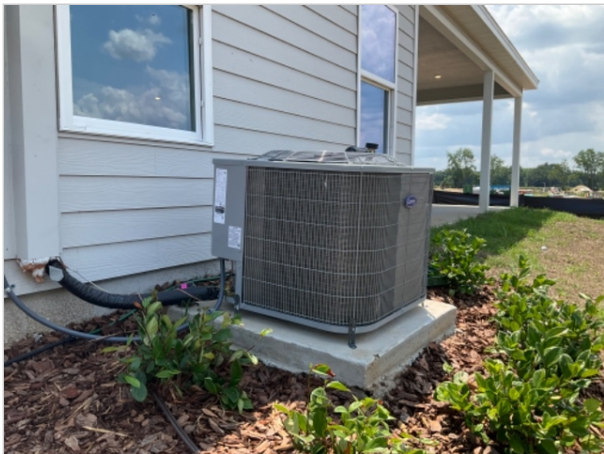
Photo 79

The electric outdoor air conditioner condensing unit was a Carrier, Model Number GH5SAN436 - A and Serial Number 0824X66287. The unit is located in the back of the structure. This unit is approximately less than one years old. Periodic preventive maintenance is recommended to keep this unit in good working condition. The cooling system was functional.

average of 54 degrees F, which is normal.

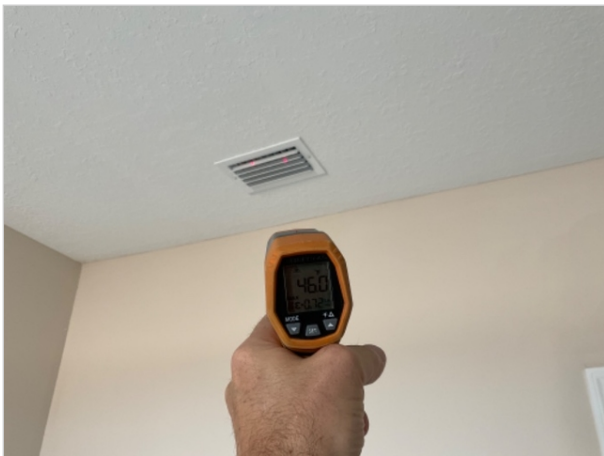
Photo 81

Supply 46

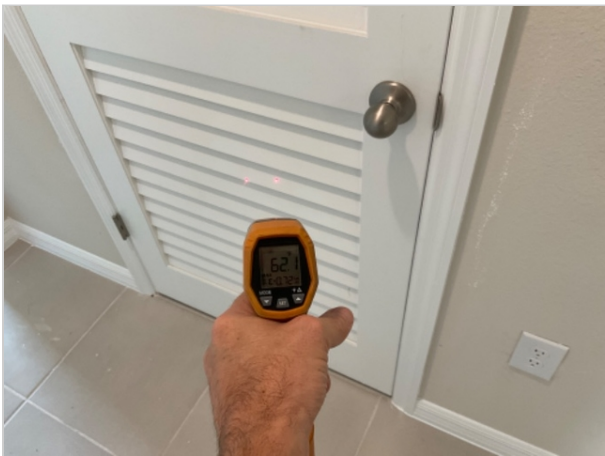
Photo 82

Return. 62.1

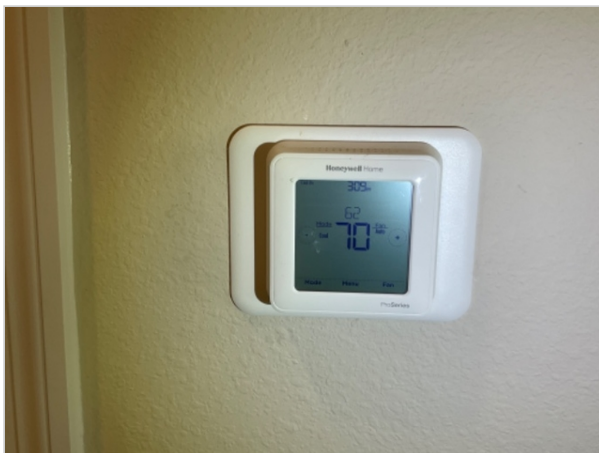
**Photo 83**

The control for the heating and air conditioning system was a 24 volt digital thermostat located on the hallway wall of the home. The thermostat was manufactured by Honeywell and was found to be in working order.

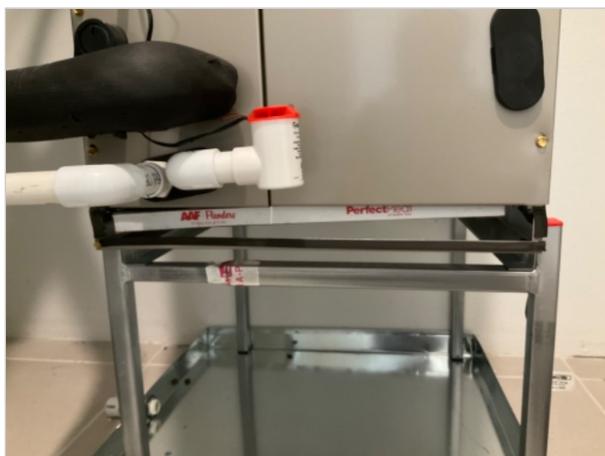
**Photo 84**

The disposable/washable filter should be replaced/cleaned on a regular basis to maintain the efficiency of the system. The efficiency rating is not within the scope of this inspection. A 16x20x1 filter(s) was installed at the bottom of the furnace/air handler.
