# HomeTeam<sup>®</sup>

### *HOME INSPECTION REPORT*

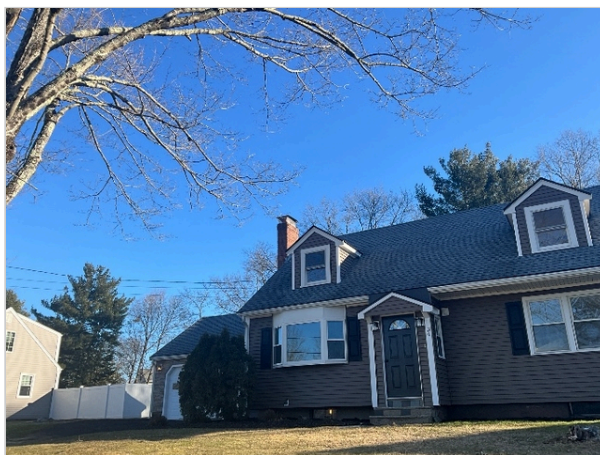
**Photo 1**

The approximate temperature at the time of the inspection was 25 to 30 degrees Fahrenheit, and the weather was clear. The utilities were on at the time of the inspection. The age of the structure appeared to be 68 years. The inspection began at 10 a.m. and was completed at about 12 p.m.

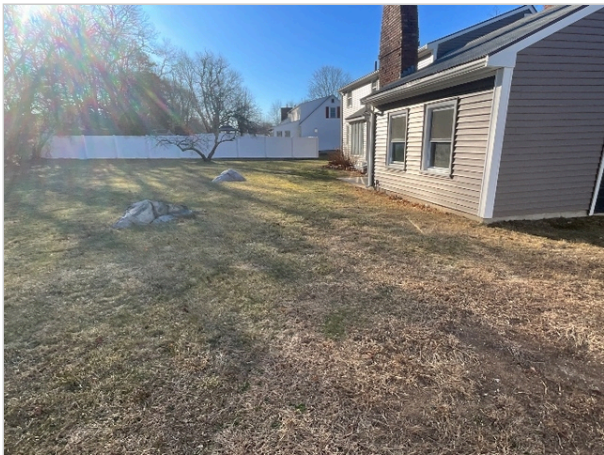
**Photo 5**

The structure was situated on a lightly sloped lot. The general grade around the structure appeared to be adequate on all sides to direct rain water away from the foundation, assuming normal drainage and downspout, gutter, and other systems are functioning properly.

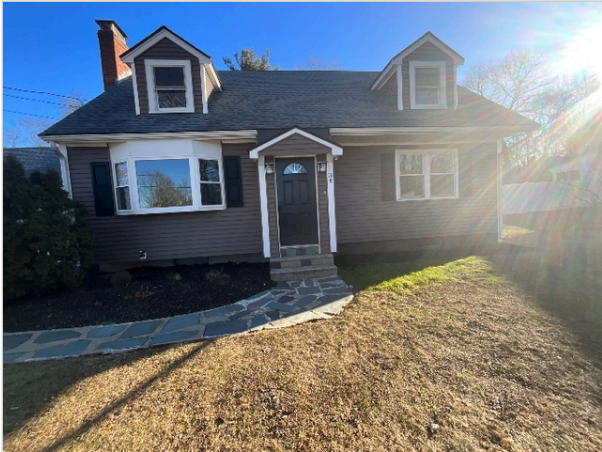
**Photo 12**

The inspected property consisted of a two story wood-framed structure with stone veneer and vinyl cladding that was vacant at the time of the inspection.

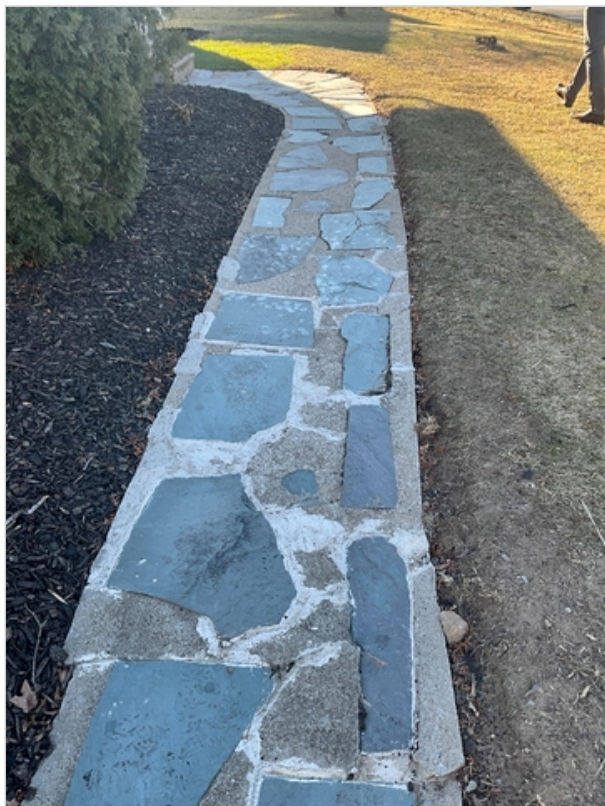
**Photo 17**

There was a stone walkway leading to a concrete entry way in the front of the home. Surface defects in walkways develop and progress with age and are considered normal as long as they do not create a safety hazard.

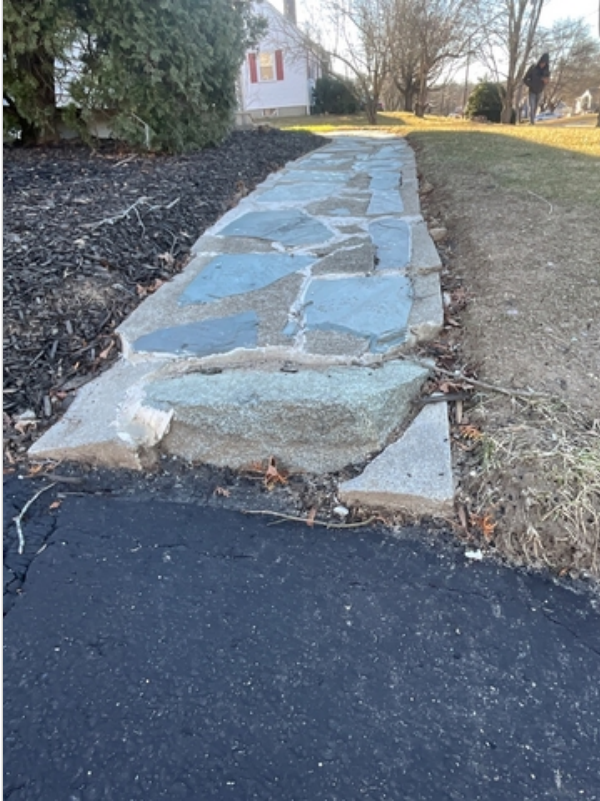
**Photo 19**

**Trip hazards were present on the walkways** around the house. The hazards can be repaired using a suitable or similar surfacing material to "feather" the out-of-level condition to make a smooth transition.

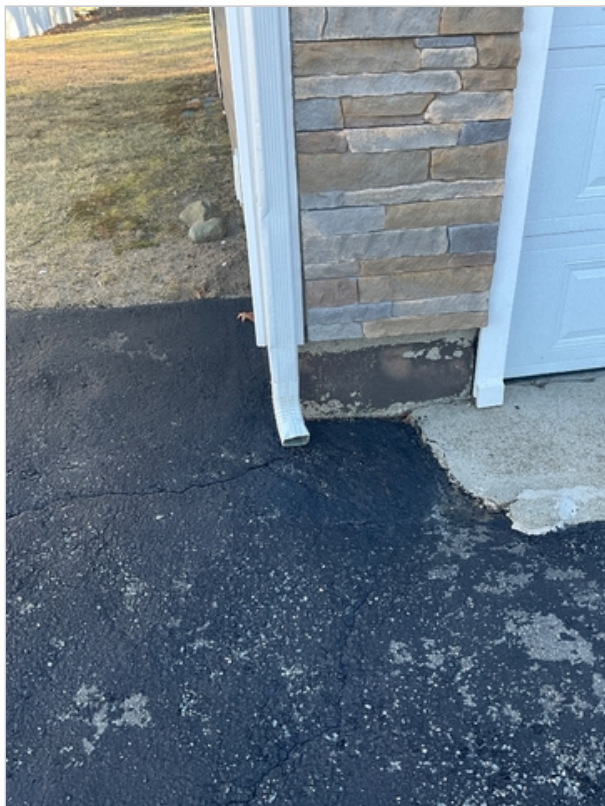
**Photo 25**

**Downspouts were draining at or too close to the base of the foundation.** To reduce the likelihood of water problems at the base of the structure, all roof drainage should be directed at least six feet from the base of the foundation.

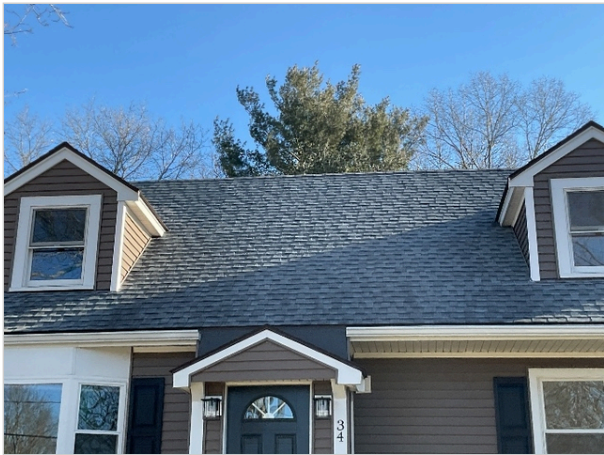
**Photo 29**

The roof was a gable with dormers design covered with architectural and 3 tab asphalt/fiberglass shingles . Observation of the roof surfaces and flashing was performed from the ground level with the aid of binoculars. There was one layer of shingles.

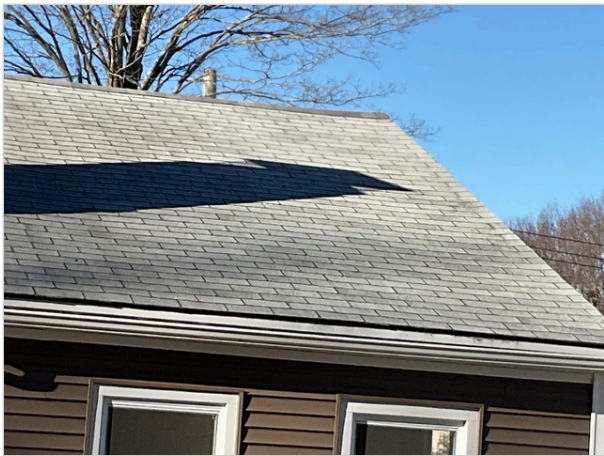
**Photo 34**

The back of the roof was in the second half of its life span

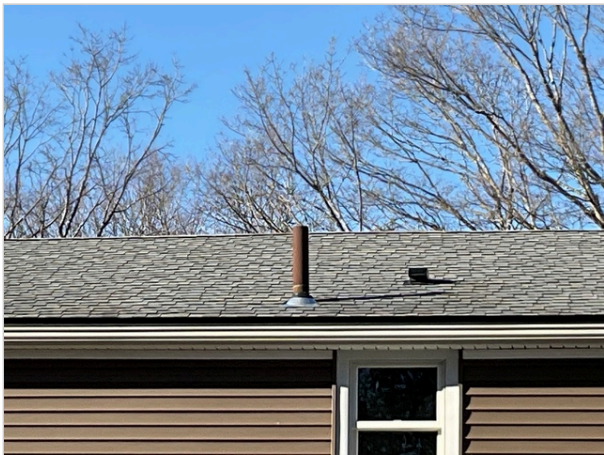
**Photo 36**

The structure had two chimneys and two vents. Observation of the chimneys and vents was made from the ground with the aid of binoculars. The flashing around the roof penetration point appeared to be adequate.

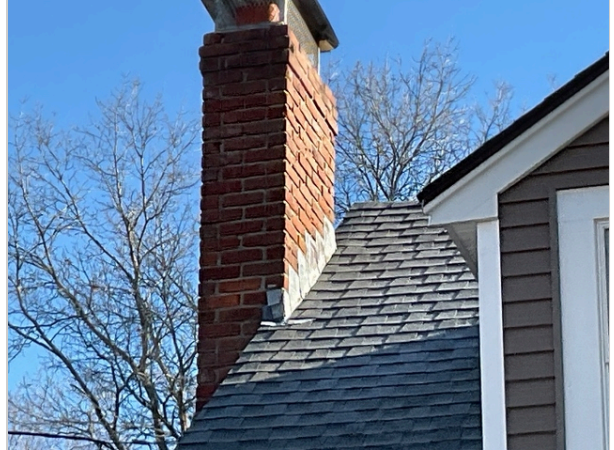
**Photo 43**

**The chimney on the back appeared to be leaning a bit outward.** Recommended monitoring in the future and, if necessary, further evaluation with a licensed contractor.

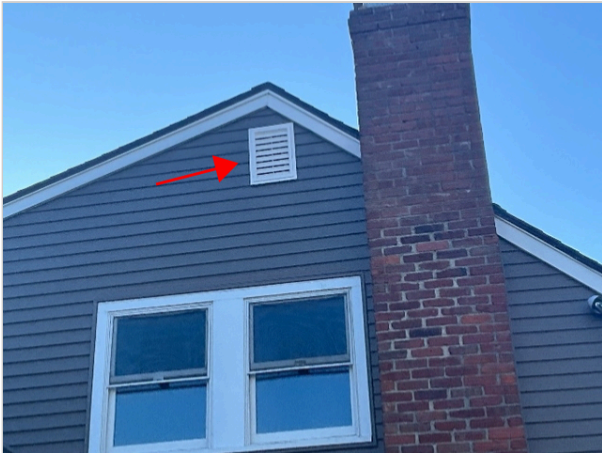
**Photo 46**

Gable ventilation

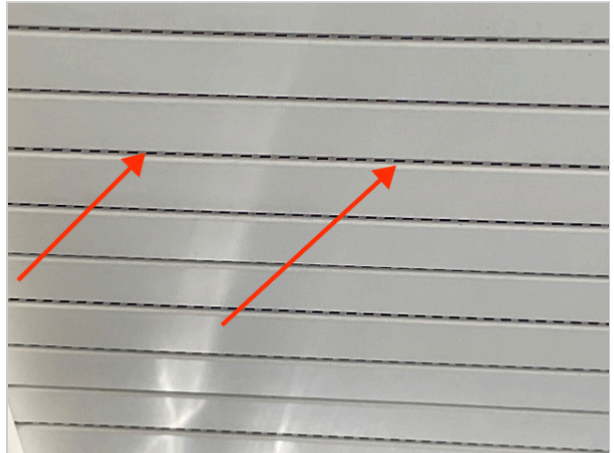
**Photo 47**

Soffit ventilation

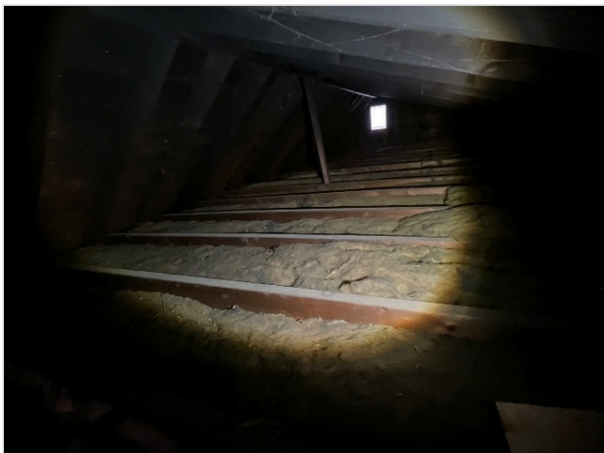
**Photo 58**

**Areas of the attic were not properly insulated.** This can lead to excessive energy bills and undesirable temperature variations within the structure. Insulation should be added to the affected areas.

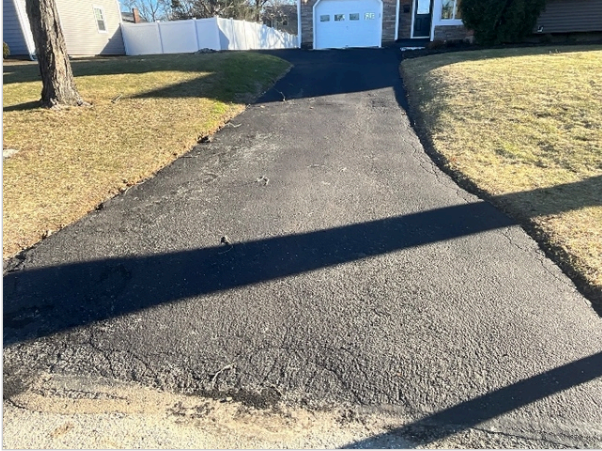
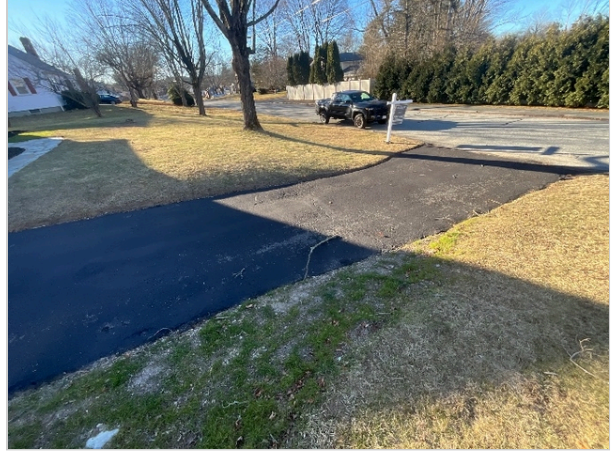
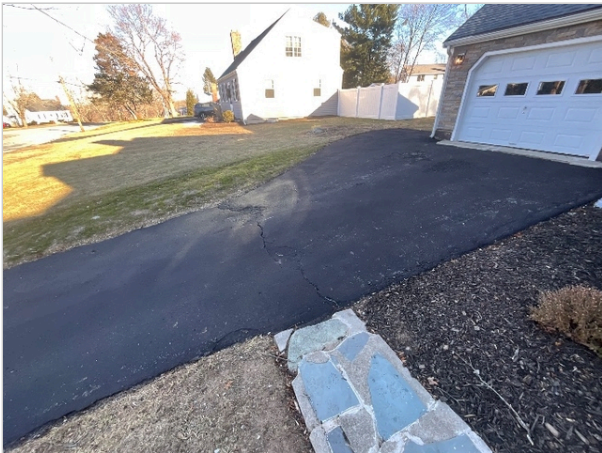
An asphalt driveway is present in the front side of the structure. Cracks and spalling were observed on the driveway. Surface defects in driveways develop and progress with age and are considered normal as long as they do not create a safety hazard. Sealing defects may help slow the rate of deterioration.

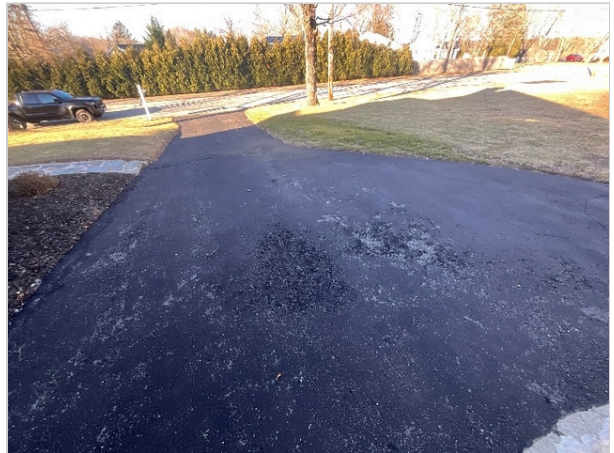
**Photo 66**

**A few areas of the driveway have settled.** This condition indicates a possible void under the driveway. Driveway settling has led to potential tripping hazards. The areas should be monitored and repaired as needed.

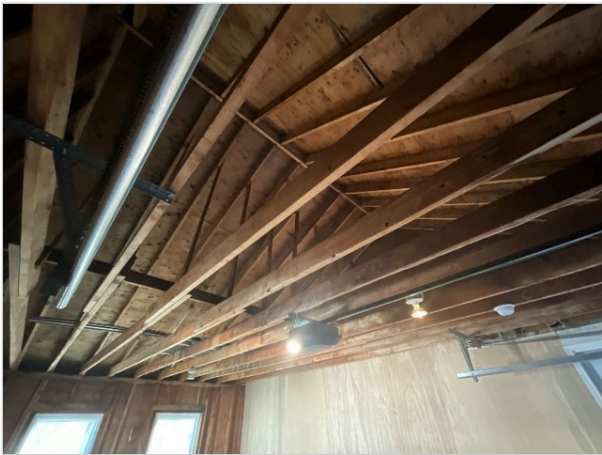
**Photo 77**

**Broken glass was observed on the garage window.** For safety and security all cracked and broken glass should be replaced or repaired.

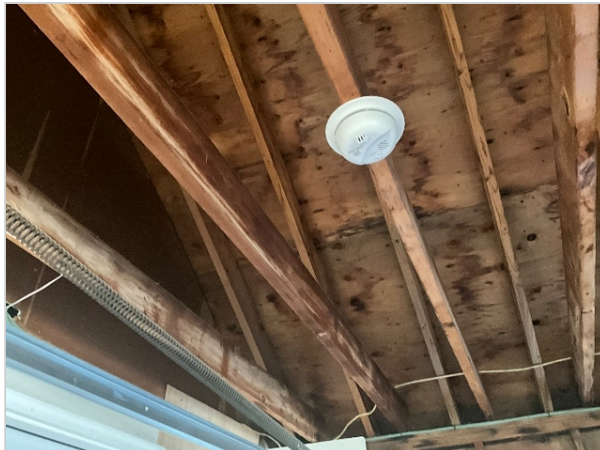
**Photo 79**

**Parts of the garage show signs of previous water intrusion.** The areas were dry at the time of the inspection. The buyer should maintain vigilance in monitoring the areas for any recurrence of the previous issue and should rectify any issues immediately upon observing them.

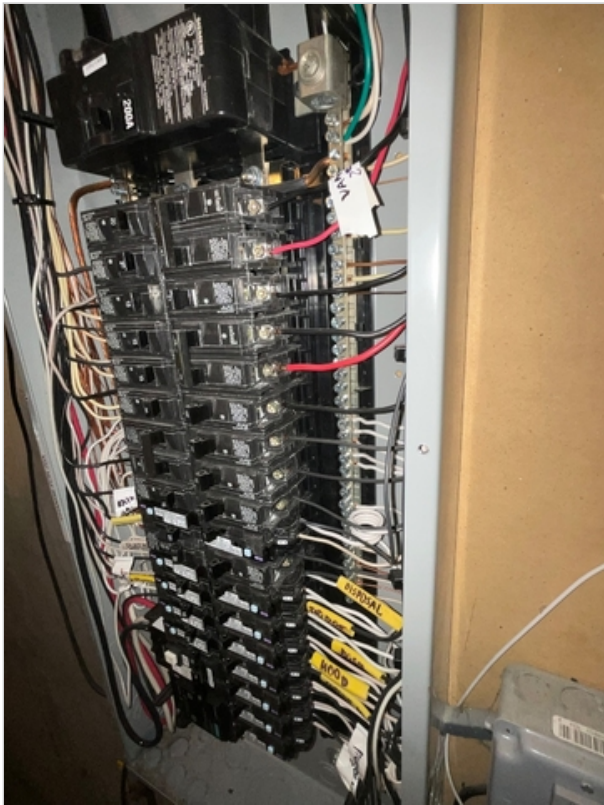
**Photo 91**

Missing screws to attached panel cover. Recommend having a licensed electrician repair.

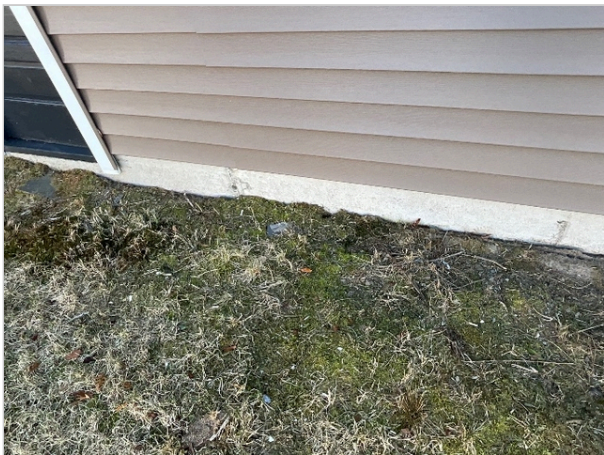
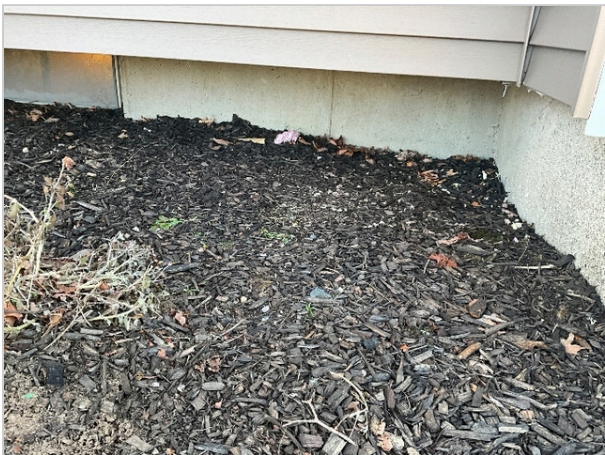
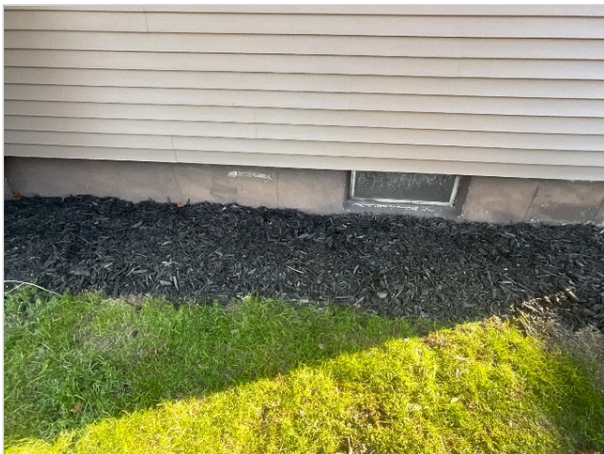
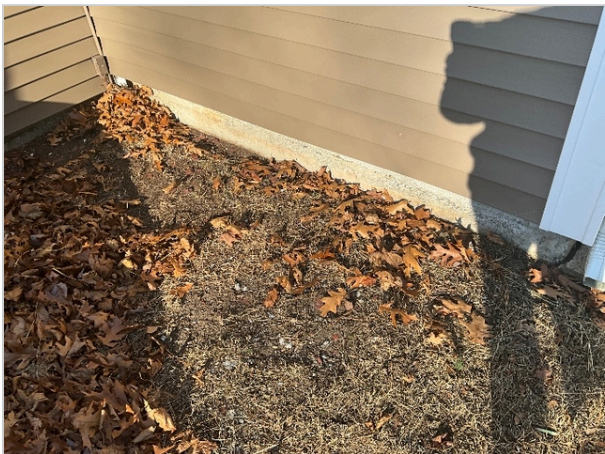
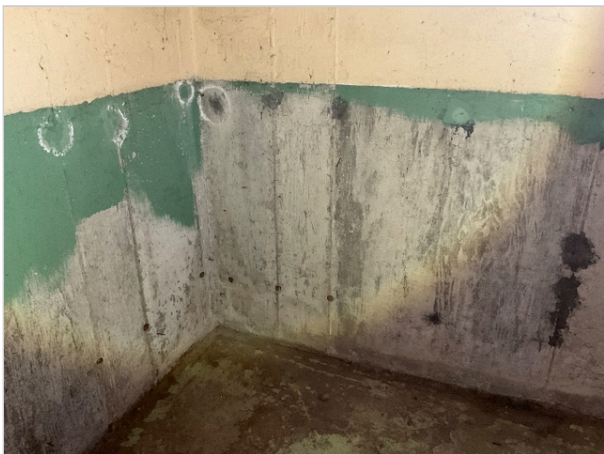
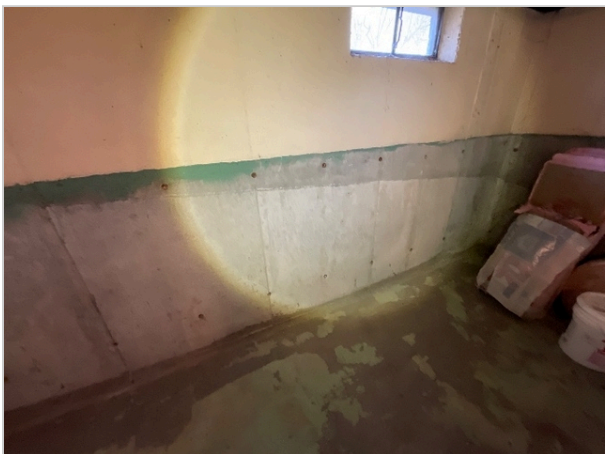
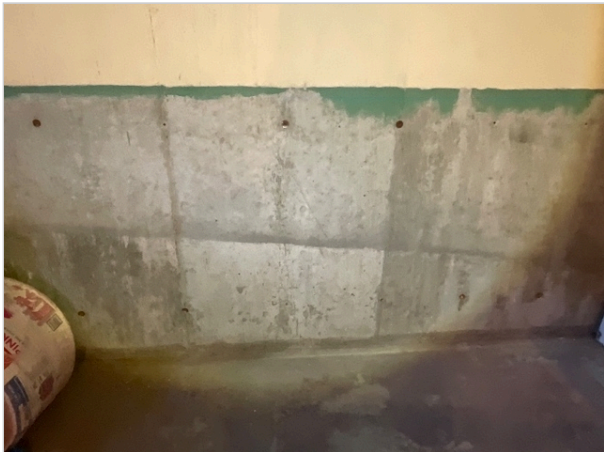
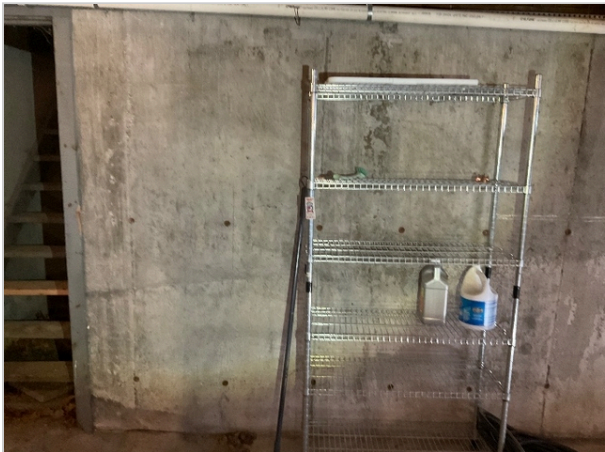
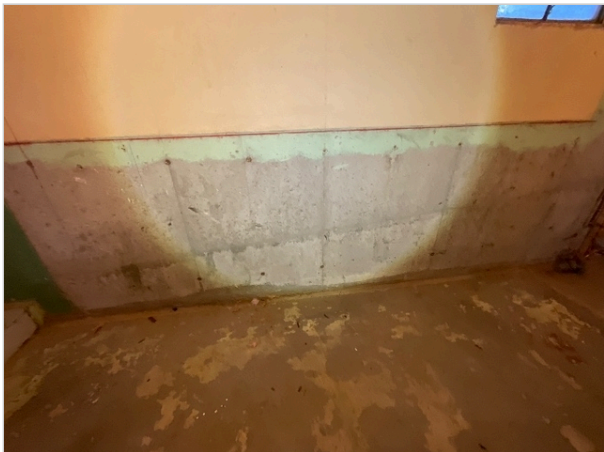
Cracks were observed on the foundation. HomeTeam recommends having these cracks professionally sealed by a foundation repair company. Cracks greater than 1/8" wide should be reviewed by foundation professional. Below-grade cracks are highly susceptible to water intrusion during times of heavy rain. HomeTeam recommends sealing these cracks.

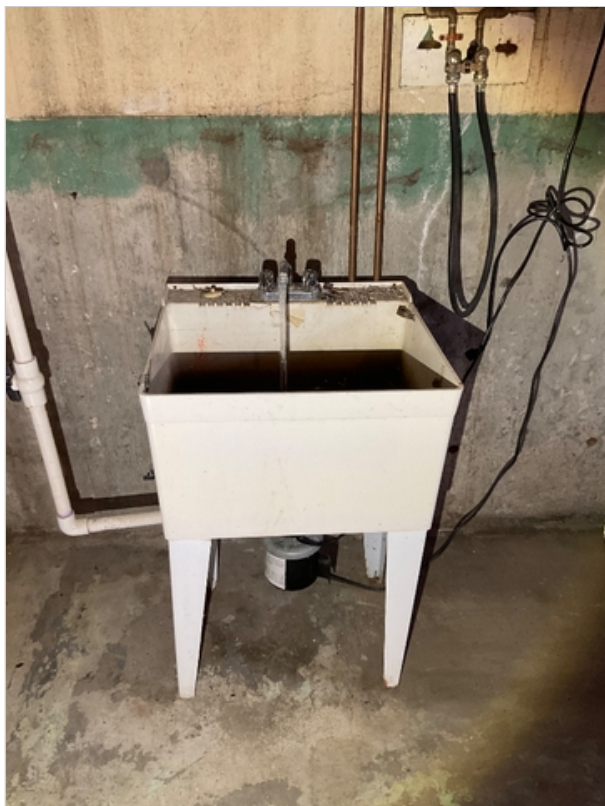
**Photo 115**

An ejector pump was present underneath the basement sink. The ejector pump was tested and found questionable .

Recommended further evaluation of the ejector pump in the basement.

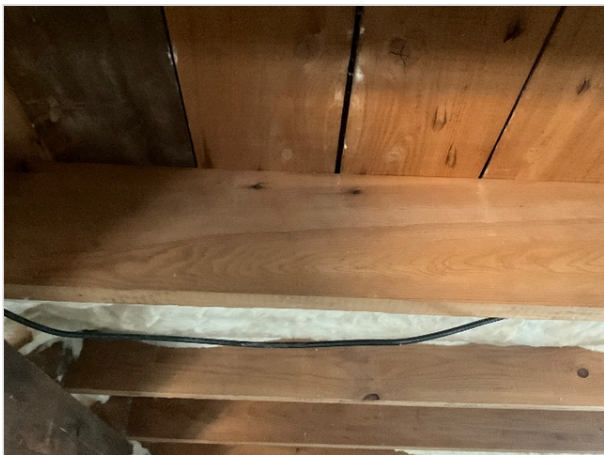
**Photo 126**

Main support beam is notched and drilled through. Consult with a qualified contractor for repair and further assessment

of this beam.

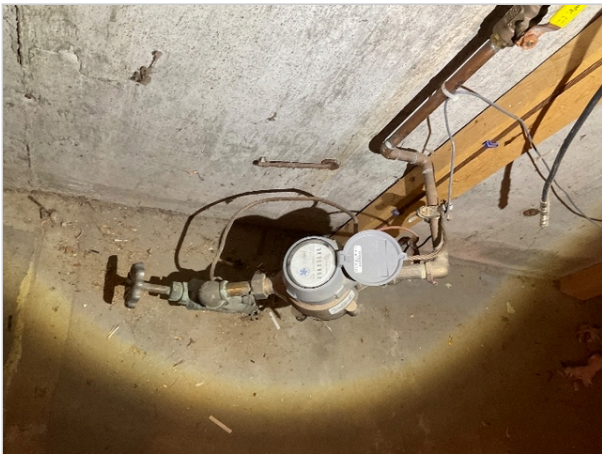
**Photo 130**

The water meter was located in the basement. The main water shutoff valve for the home was located adjacent to the water service entry point in the basement. Water shutoff valves are visually inspected only. No attempt is made to operate the main or any other water supply shutoff valves during the inspection. These valves are infrequently used and could leak after being operated. The only exception to this policy is made when the main water supply valve is off upon arrival at the inspection. Since it is the buyers right to have all utilities operable for the home inspection, we will attempt to turn the main water valve on for the inspection. The HomeTeam is not responsible for leaks caused by operating the valve.

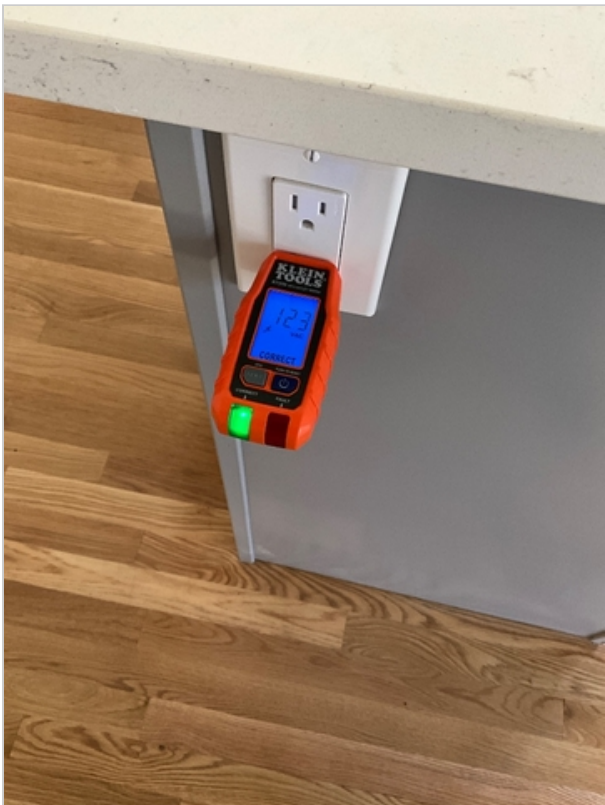
**Photo 183**

One of the three prong type outlets in the structure had an open ground. The affected outlet(s) should be

**grounded, replaced with two-prong outlets, or connected to GFCI circuits to improve safety.** This condition means that the third prong, also known as the ground prong, is not doing its job. This is often caused by a missing or disconnected ground connection at an electrical device in the circuit. Consult with an electrician for the best course of action.

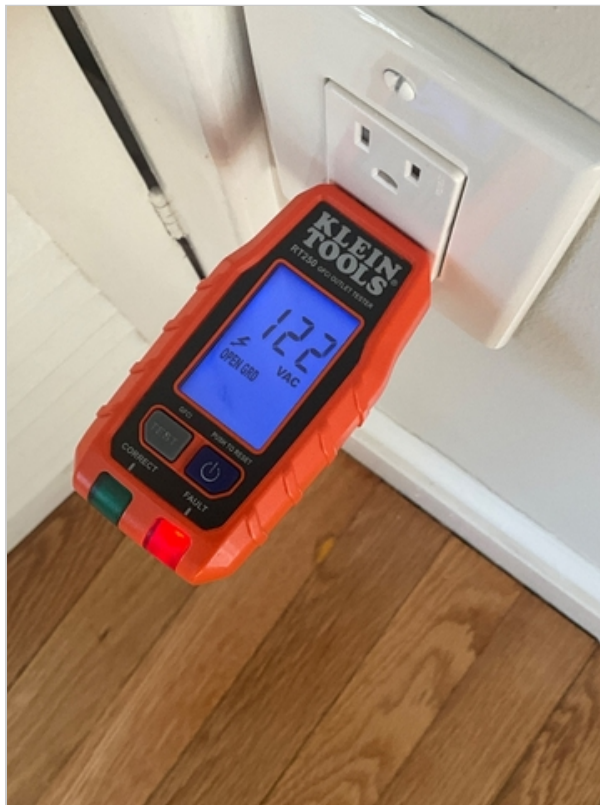
**Photo 185**

**Interior outlets in the structure had open neutral wiring.** An electrician should repair and further assess the outlets.

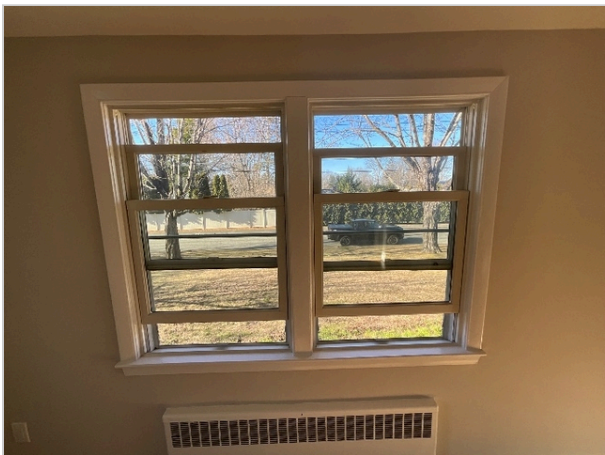
**Photo 216**

Broken hardware on some windows.

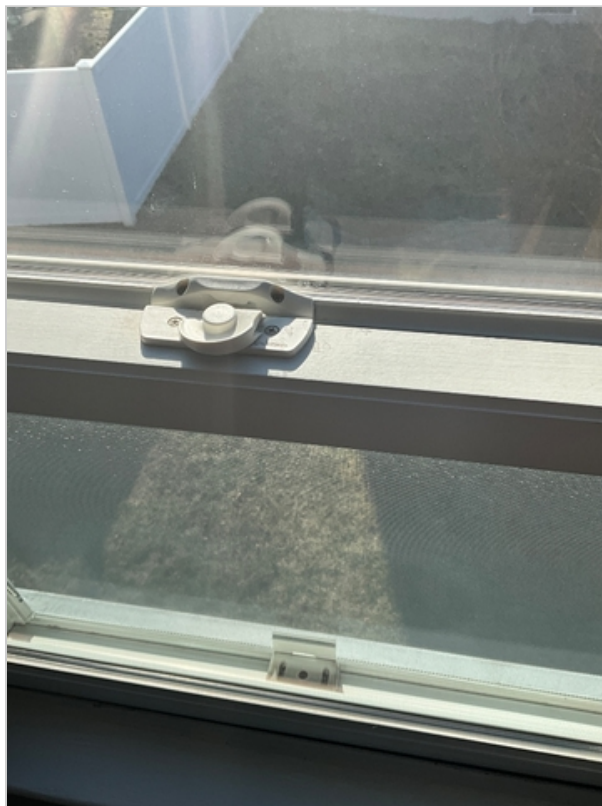
**Photo 218**

Casement windows are present in the structure. We test a representative number of these windows due to their configuration and the possibility of damage during normal operation. Casement windows present unique challenges, including swelling of wood and stress on cranks and arms that require diligence, maintenance, and care when opening. Ensure the areas around the casement windows remain free of debris, moisture, and damage. All casement windows should be opened prior to closing.

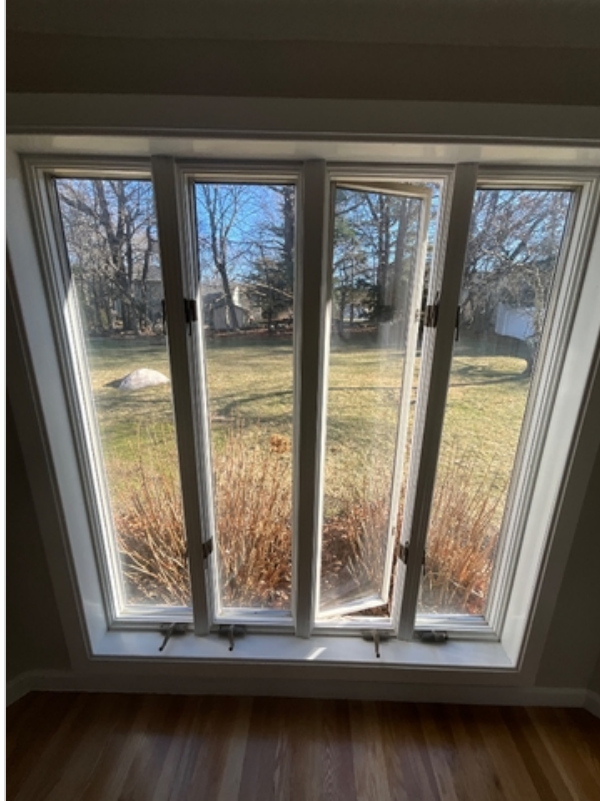
**Photo 219**

**One of the windows in the structure had a broken thermal seal.** A window with a defective thermal seal will show a slow but gradual "fogging" effect, and the insulation value of the window is marginally reduced. HomeTeam recommends having the affected window(s) repaired or replaced and further assessed.

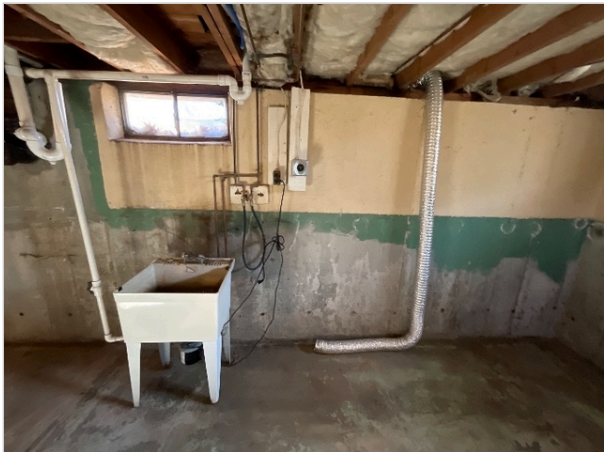
Photo 296

A drain for a washing machine was not present.
