# HomeTeam<sup>®</sup>

### *HOME INSPECTION REPORT*

File Number: **MI0111111**  
Address of Inspection: **123 Main  
Street**

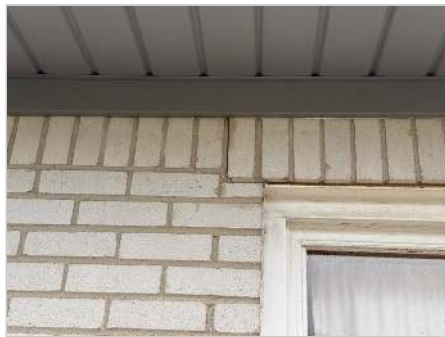
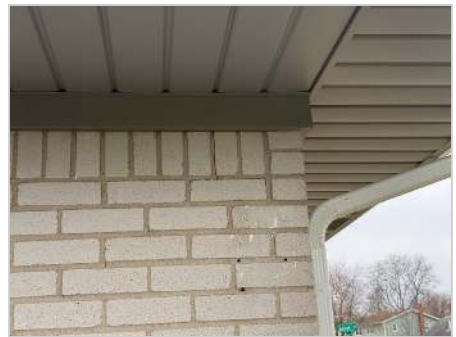
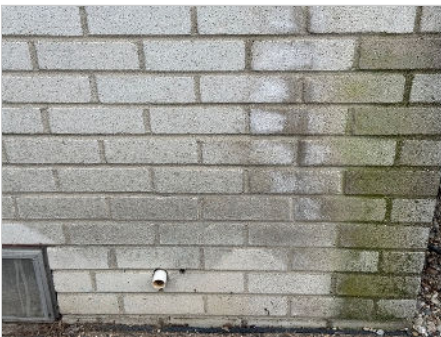
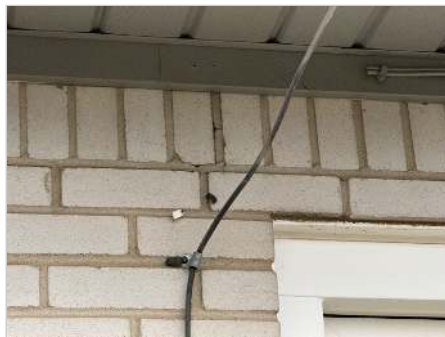
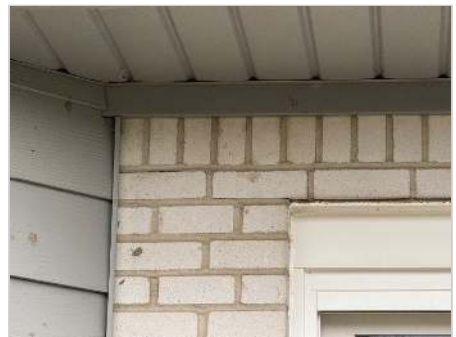
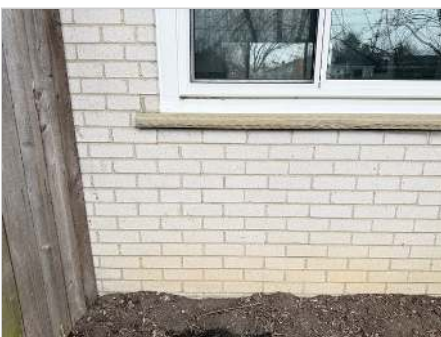
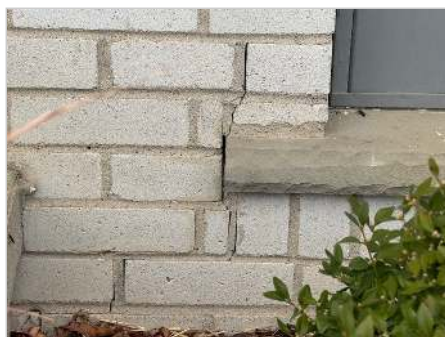
Cracks were observed on the exterior brickwork in multiple areas of the home. Tuck pointing and sealing cracks will help prolong the life of the brick and help prevent water penetration.

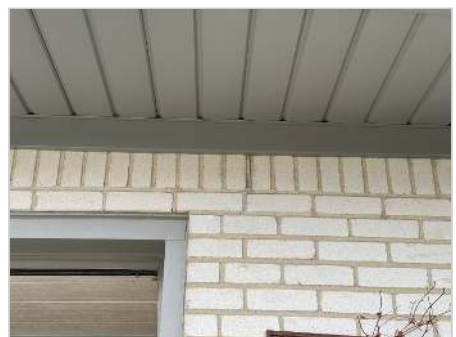
**Photo 81**

The caulking on the exterior of the home was cracked or missing in one or more areas. The caulking should be replaced to ensure the exterior of the home remains weather and watertight.

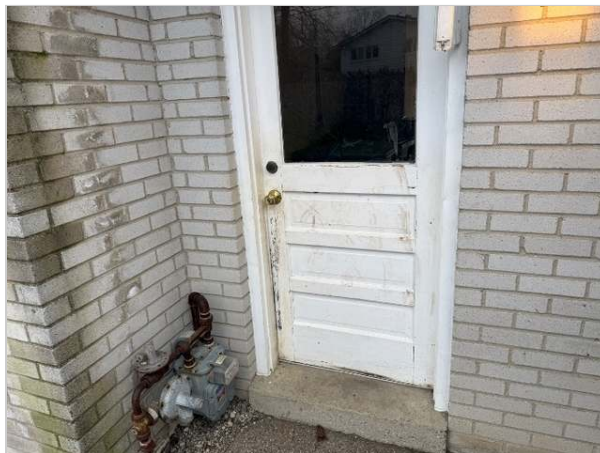
**Photo 84**

Peeling paint was noted in multiple areas of the home. To maintain the integrity and longevity of the exterior surfaces and materials, it is advisable to scrape and repaint all affected areas.

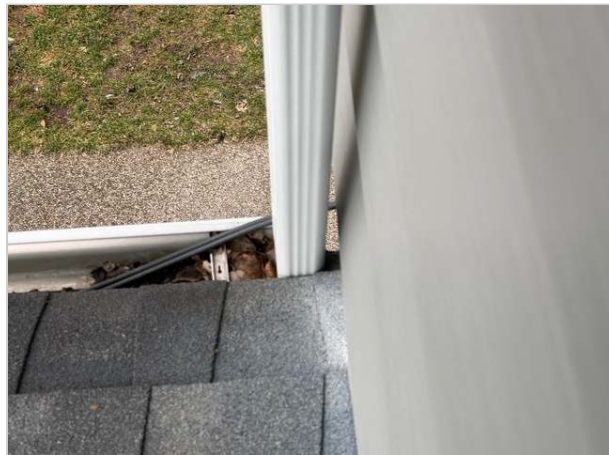
**Photo 87**

The downspout serving the upper roof was not properly aligned with the lower gutter at the left rear corner of the home. As a result, roof runoff is discharging directly onto the adjacent brick wall rather than into the gutter system. Evidence of moisture staining and organic growth was observed on the brick in this area, indicating prolonged water exposure. Corrections are recommended to properly align and secure the downspout to direct water into the gutter system and help reduce the potential for continued moisture-related deterioration of the exterior wall.

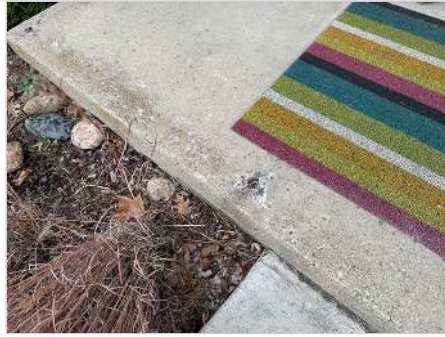
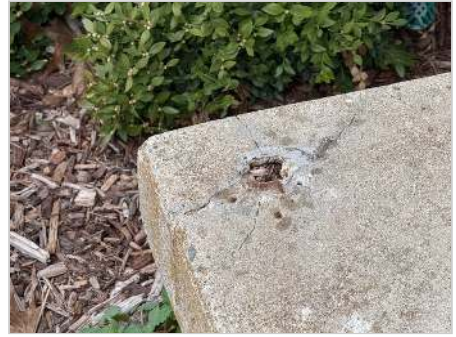
Cracks were observed in the concrete porch cap at the time of the inspection. Monitoring and sealing of the cracks are recommended to help prevent moisture intrusion and further deterioration.

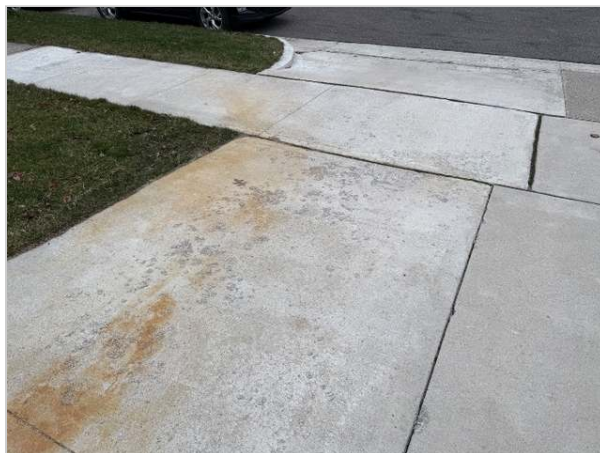
**Photo 93**

The surface of the driveway showed signs of deterioration at the time of the inspection. Deterioration can worsen over time and may lead to an uneven or damaged surface. Repairs or resurfacing may be necessary to maintain durability and function.

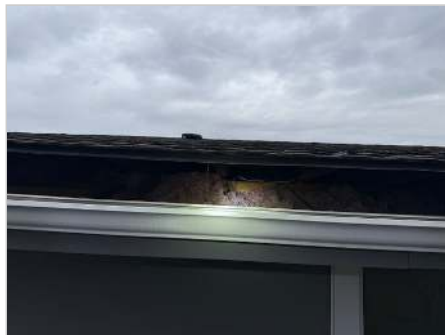
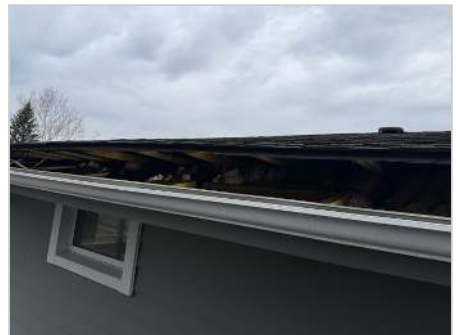
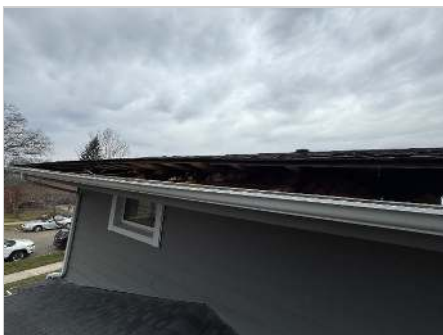
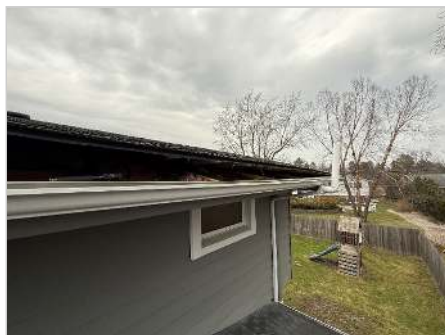
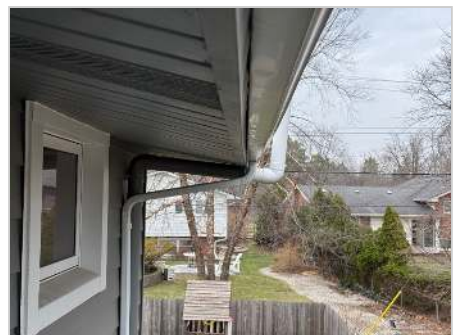
The soffit along the right side of the second-floor roof was sagging and partially detached, with open sections allowing direct visibility into the attic space. This condition can allow moisture, pests, and cold air to enter the attic and may contribute to insulation disturbance or reduced energy efficiency. Repair and securement of the soffit is recommended to restore proper enclosure of the roof structure.

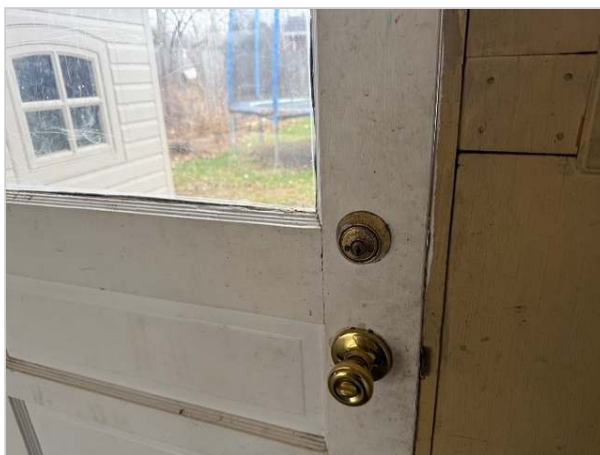
**Photo 124**

One or more exterior doors have a deadbolt that requires a key to unlock it from the interior of the structure. For safety during emergency egress, all exterior doors should be operable without a key from the interior. The affected locks should be repaired or replaced to allow for manual, keyless operation from the interior.

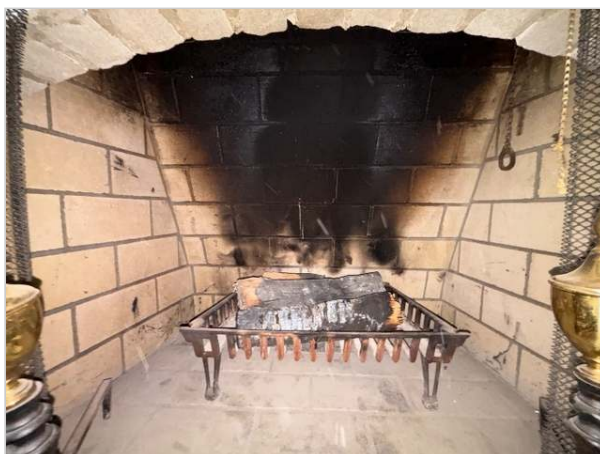
**Photo 125**

For safety reasons, the wood-burning insert and the chimney or pipe to which it is vented should be cleaned and re-inspected before using as there may be hidden defects not fully visible at the time of the inspection.

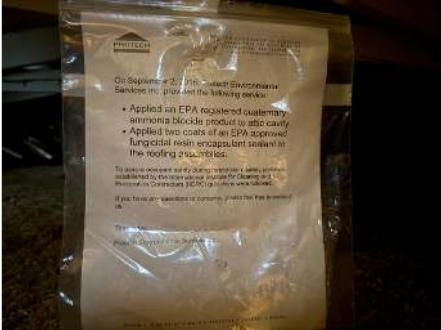
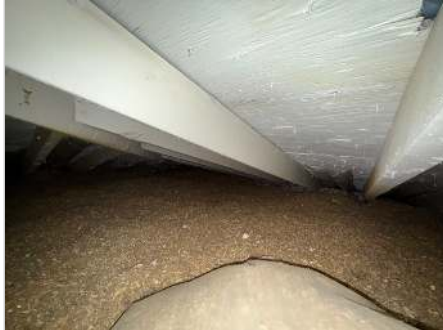
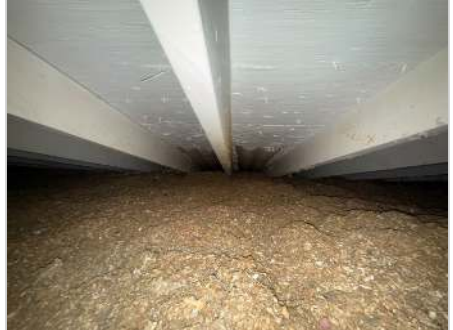
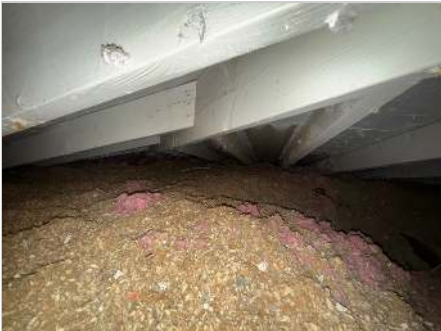
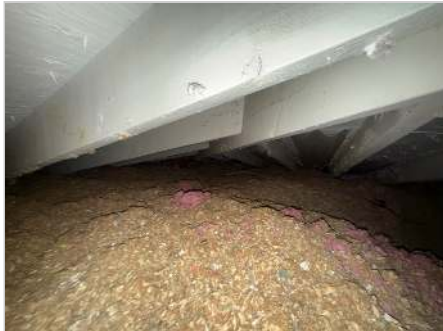
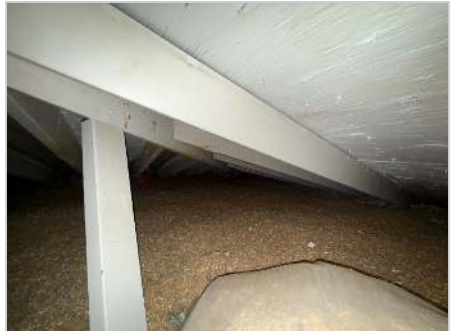
The roof sheathing and/or trusses have been painted white. This is usually an indication of mold mitigation and/or smoke damage. Obtain documentation from sellers of any prior issues or repairs.

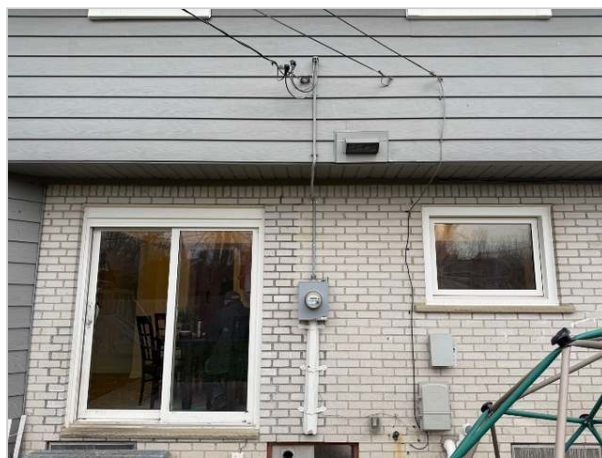
**Photo 138**

The overhead electric service wire entered the home on the rear exterior wall. The electric meter was located on the rear exterior wall.

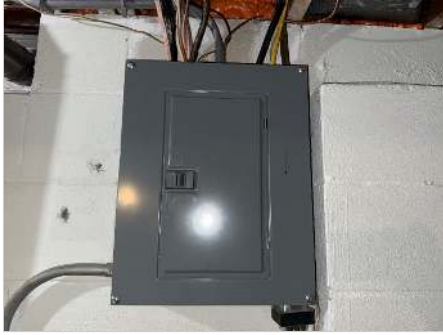
**Photo 139**

The service wire entered a Square D service panel, located on the basement wall with a 100-amps and 120/240 volt rated capacity. The main service disconnect switch was located in the main panel. The branch circuits within the panel were copper. These branch circuits and the circuit breaker to which they were attached appeared to be appropriately matched. The service panel appeared to be adequate by today's standards.

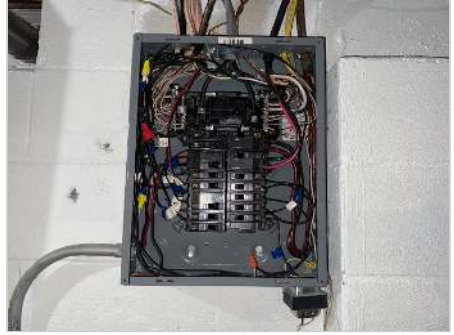
**Photo 141**

A Square D circuit breaker with two conductors connected at a single terminal (commonly referred to as a “double tap”) was observed in the electrical panel. Some Square D breakers are designed and listed to accommodate two conductors under a single terminal, depending on the specific model and labeling. No deficiencies were confirmed at the time of inspection. If there are any concerns regarding compatibility or installation, consultation with a qualified electrician is recommended.

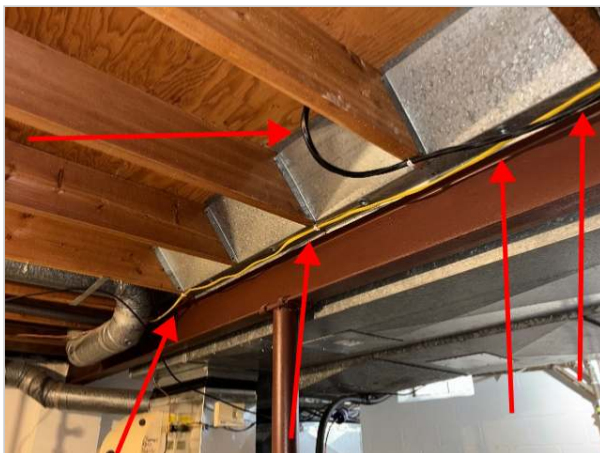
**Photo 143**

Exposed or surface wiring was observed in one or more places in the home. Exposed wiring, also called surface wiring, refers to wiring that is installed without protection from physical damage. Examples include when an electric wire is run under floor joists or rafters, along the front of wall joists, or down walls. Appropriate installations include: installing the wire through holes in the floor joists, above rafters, or enclosing the wire in conduit to meet the requirements for protection from physical damage. Certain other requirements may apply. Corrections are recommended.

Basement

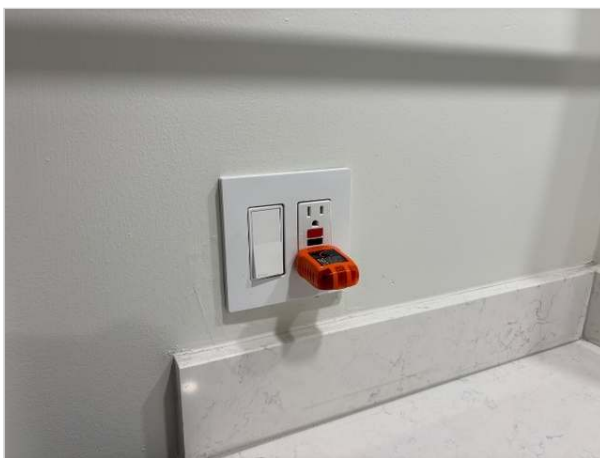
**Photo 144**

One or more GFCI receptacles or circuits in the home appear to be wired incorrectly because power is still present at the GFCI even after the device trips. Further evaluation is recommended.

Hallway bathroom

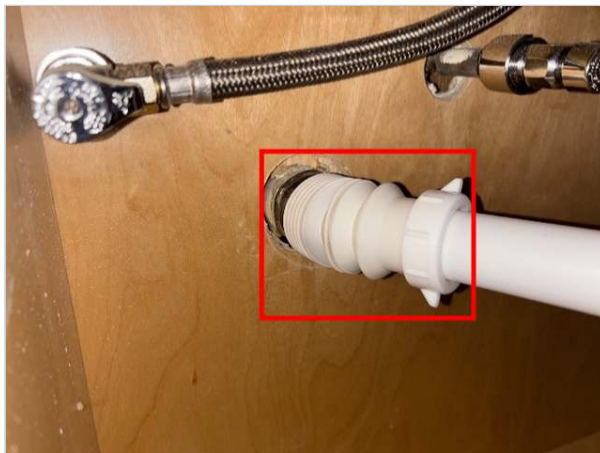
**Photo 150**

During the inspection, accordion-style drain lines were observed in use. While these lines are functional, they are more prone to clogging and may not be as durable as other types of drain lines. It is recommended to monitor these lines

regularly for signs of blockage or wear, and consider replacing them with more robust options to ensure long-term reliability and efficiency.

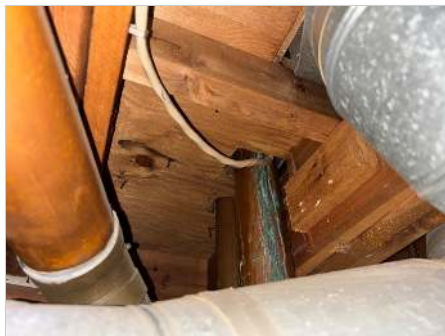
**Photo 151**

Bedroom bathroom sink

Corrosion and scabbing is evident on drain lines. Active water leaks were not observed at the time of the inspection. Corrosion or scabbing may indicate the affected plumbing lines have leaked in the past and may leak in the future. In some cases, corrosion or scabbing may be an indication the affected plumbing lines are at or near the end of their useful lives. In others, simple patches or repairs may be necessary. Further evaluation is recommended.

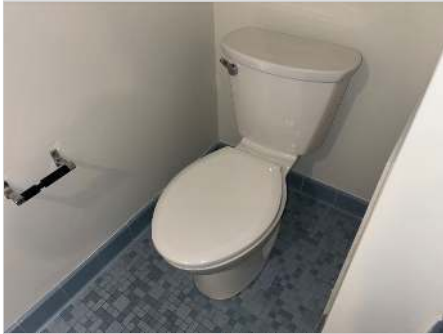
**Photo 154**

Several toilets in the home were loose at the base. Securing the base will help prevent damage and possible leaks. Further evaluation would be necessary to determine if leaks are present or have occurred in the areas not accessible during an inspection.

Hallway bathroom

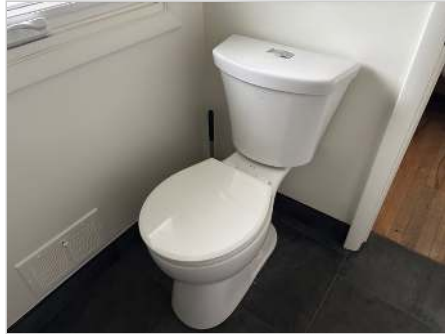
**Photo 155**

Bedroom bathroom

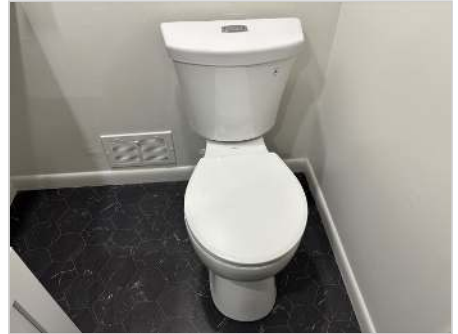
**Photo 156**

Half bathroom

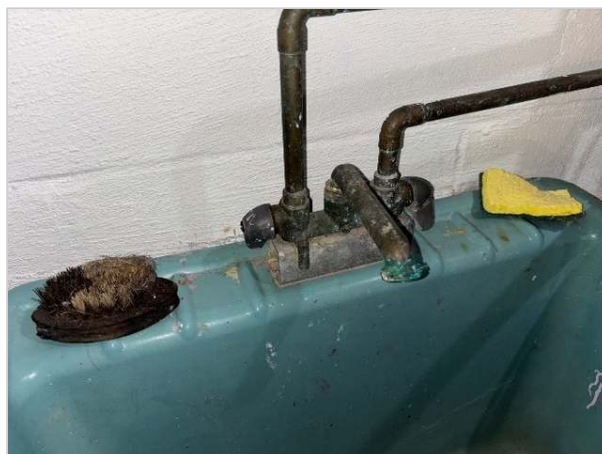
**Photo 158**

There were leaks noted at one or more faucets in the home. Corrections are recommended.

Utility tub

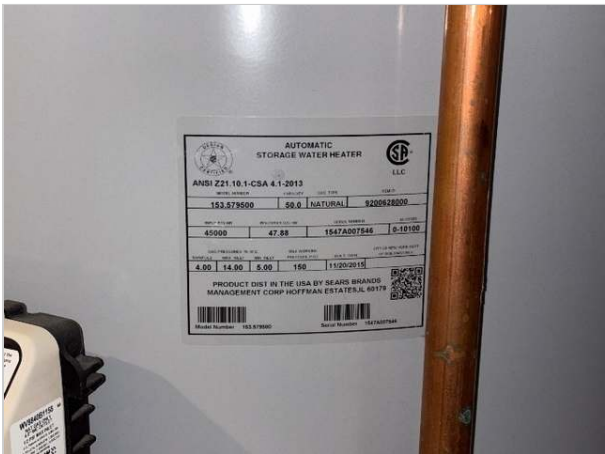
**Photo 161**

There was corrosion at the fittings above the water heater. Although there were no leaks at this time, this is an

indication that there was a leak or leaks could occur. Corrections are recommend.

- There was creosote build up inside the chimney.
- There was corrosion at the fittings above the water heater.
- Several toilets in the home were loose at the base.

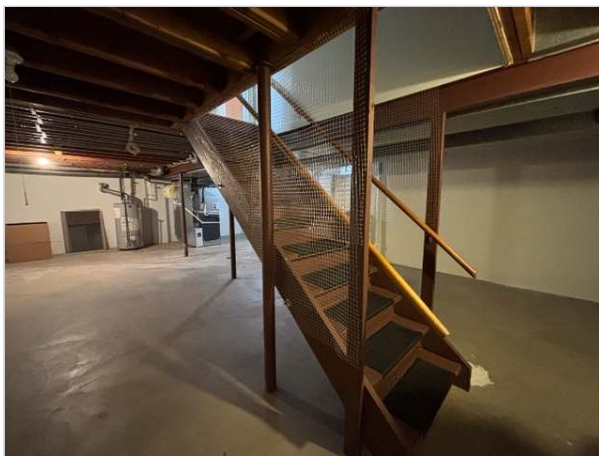
**Photo 165**

There were missing balusters at one or more sets of stairs on the property. As a safety precaution, stairs should have continuous handrails extending from the top to the bottom, along with securely spaced balusters on open sides to prevent falls. Corrections are recommended to improve safety.

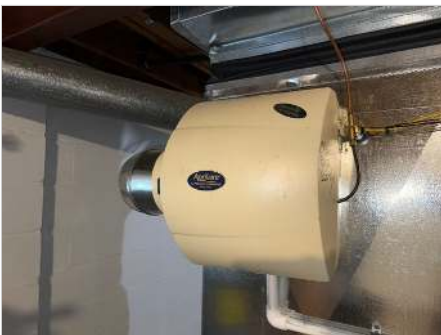
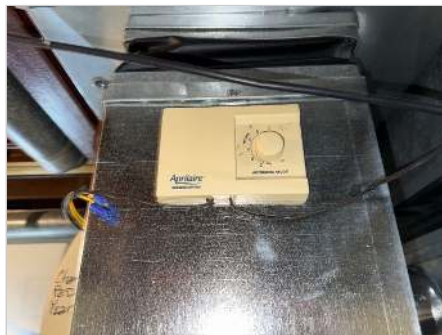
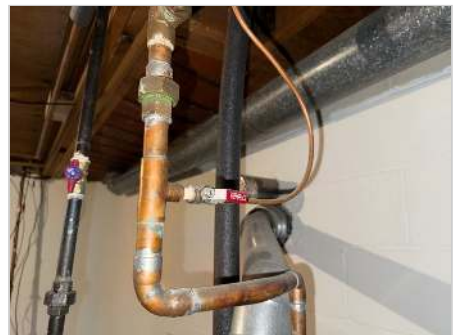
The humidifier did not appear to be functional.

The humidifier did not appear to be functional, it did not respond the the humidistat. Consult and HVAC technician for necessary repairs or maintenance.
