### *HOME INSPECTION REPORT*

On Sunday, January 01, 2000 The HomeTeam Inspection Service made a visual inspection of 123 Sample Drive, Boulder , CO 80302. Enclosed please find a written, narrative report of our findings in accordance with the terms of our Inspection Agreement. Although general maintenance items may have been addressed verbally at the time of the inspection, they may not be included in the enclosed report.

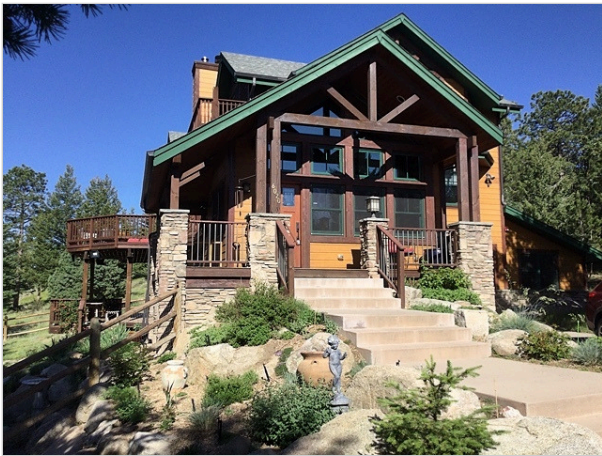
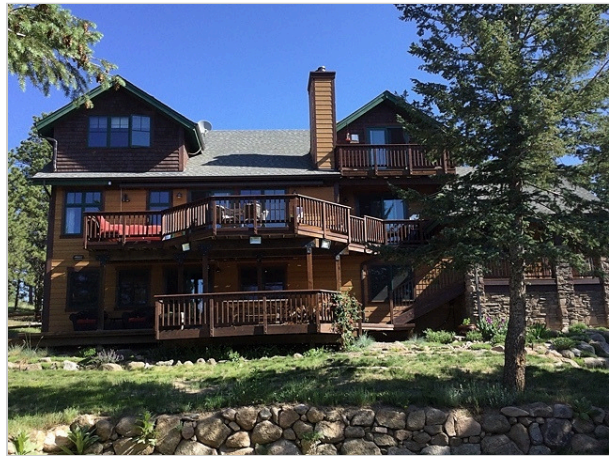
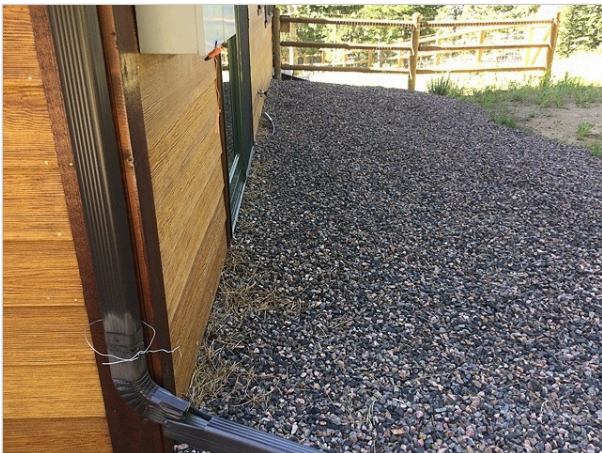
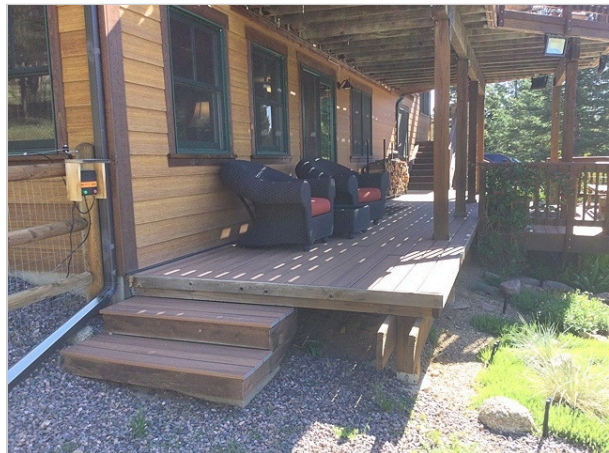
The structure was situated on a moderately sloped lot. The general grade around the structure appeared to be inadequate on the right side to direct rain water away from the foundation, assuming normal drainage and downspout, gutter, and other systems are functioning properly.

**The grading around the structure appears to be insufficient to carry water away from the foundation.**

HomeTeam recommends having the soil regraded on the right side of the structure and further assessed at the time of regrading.

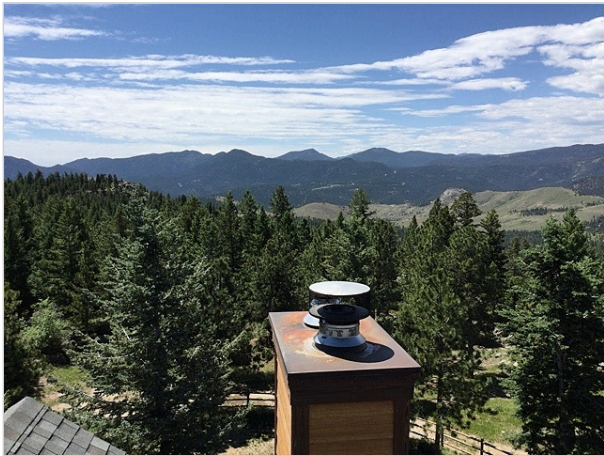
**Photo 14**

The structure had one chimney. Observation of the chimney was made from the roof. The flashing around the roof penetration point appeared to be adequate.

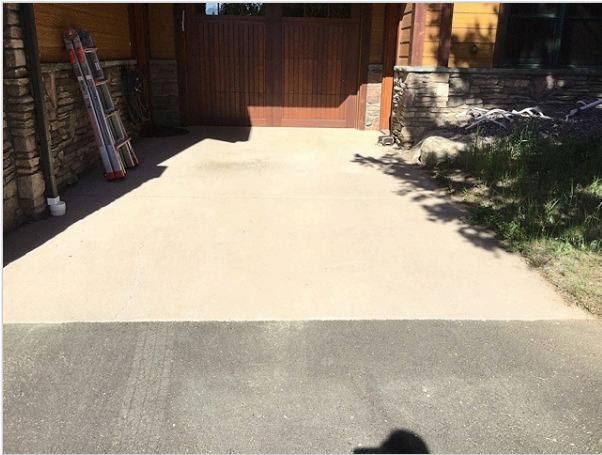
**Photo 18**

An asphalt driveway is present in the front of the structure. Cracks and spalling were not observed on the driveway. Surface defects in driveways develop and progress with age and are considered normal as long as they do not create a safety hazard. Sealing defects may help slow the rate of deterioration.

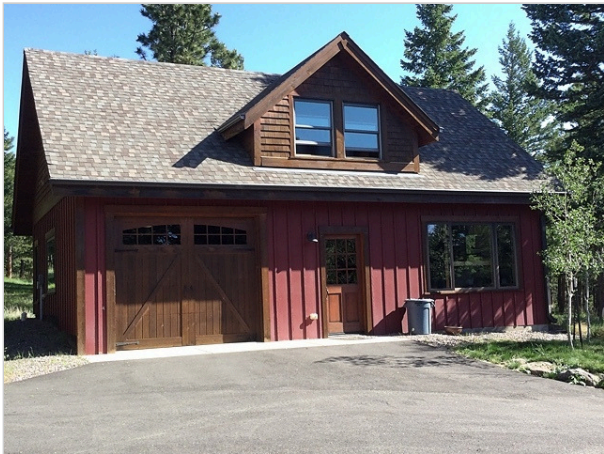
**Photo 20**

The detached one car wood framed garage with wood exterior was located on the right side of the home with vehicle access through one overhead-style door. There was one man door(s) for access independent of the drive-through door(s). The man door was tested and found to be functional.

A LiftMaster automatic garage door opener was present and was functional

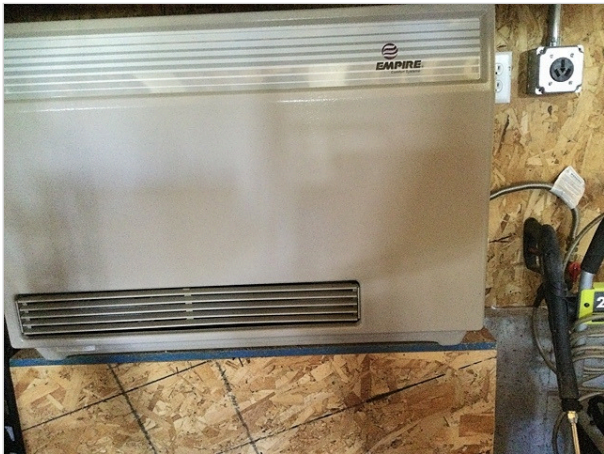
**Photo 24**

The garage was heated by a propane forced air furnace. The control for this heating system was located in the unit. The thermostat was found to be in working order. The garage heating system was functional.

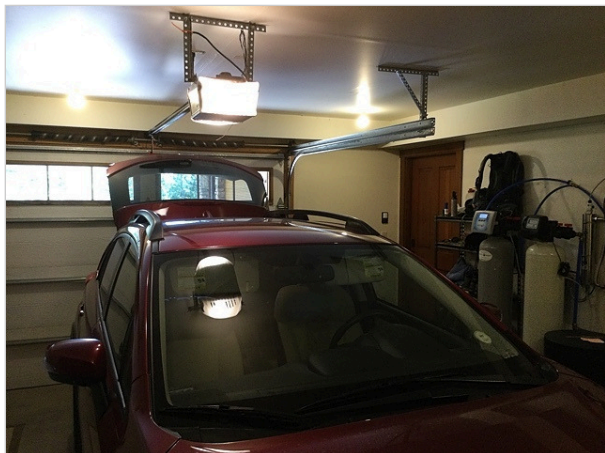
**Photo 26**

The attached garage was designed for one car with access provided by one overhead-style door. A functional Lift

Master brand electric garage door opener was present. The beam automatic safety reverse on the garage door was tested and found to be functional. The garage floor was in good condition.

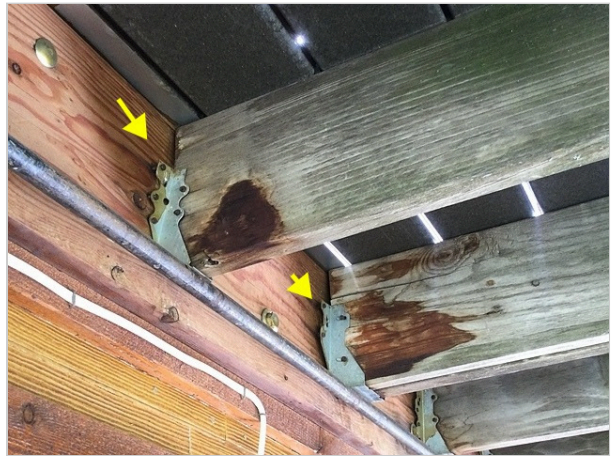
**Photo 39**

A few of the joist hangers on the middle deck appear to be coming loose. Recommend repairs by a qualified contractor.

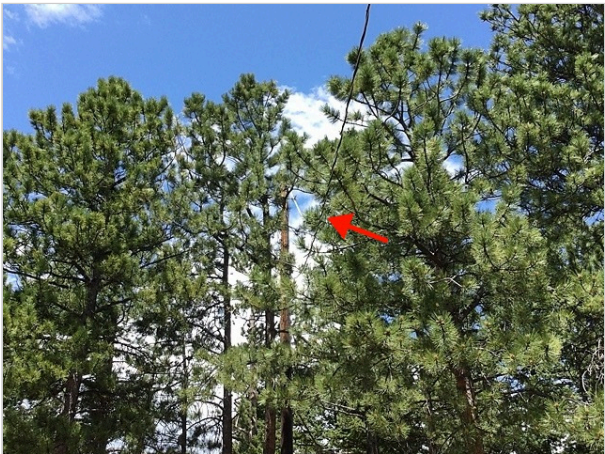
**Photo 44**

**The main electrical service wire feeding this structure was in contact with tree branches.** For safety, the local power company should be contacted to trim away the branches from the power line.

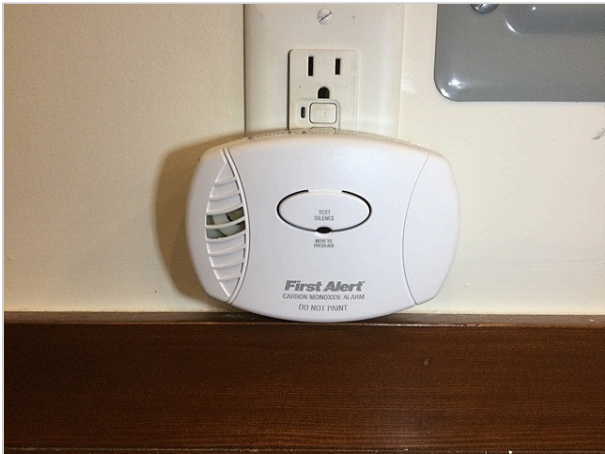
**Photo 65**

Per Colorado state law, carbon monoxide detectors are required to be installed within 15 feet of all sleeping areas. No carbon monoxide detectors were observed installed within 15 feet of the sleeping areas on the upper level.

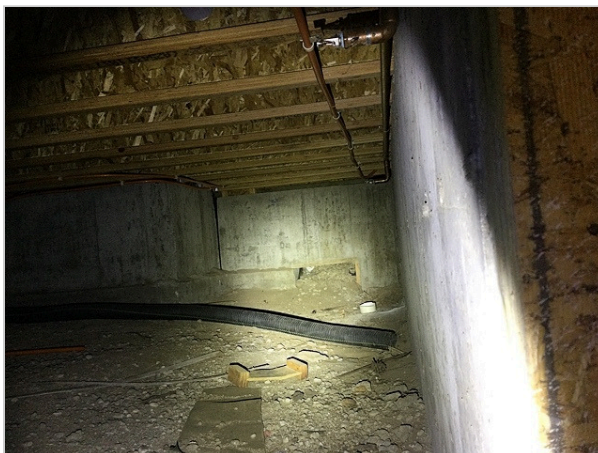
**Photo 70**

**The sub-floor above the crawlspace lacks insulation.** Adding insulation may help regulate the temperature of the living space above the crawlspace and may assist in preventing moisture intrusion.

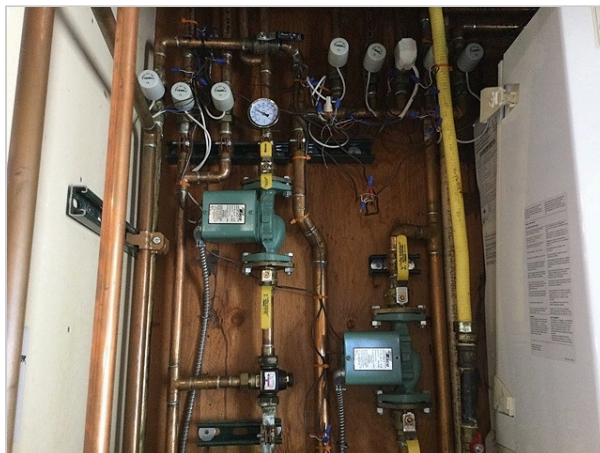
**Photo 88**

Corrosion was observed on the water pipes for the water heater. No water leaks were observed at the time of the inspection.

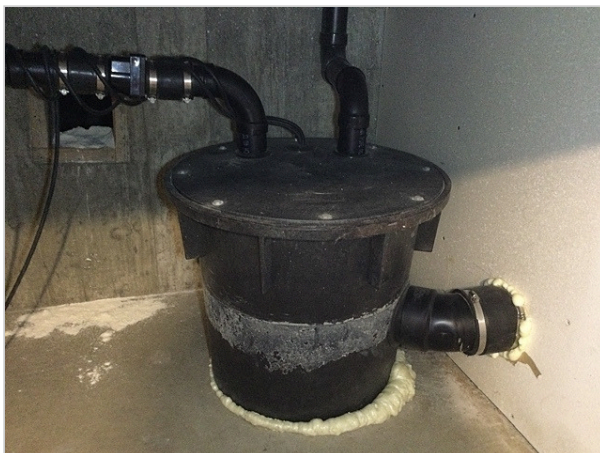
**Photo 90**

Note: sewage extractors are not opened by the inspector. We recommend servicing annually by a plumber and installing a moisture alarm.

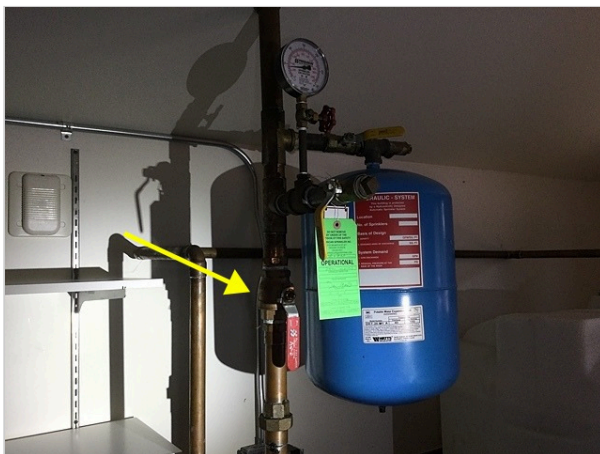
**Photo 91**

The main water shutoff valve for the structure was located adjacent to the water service entry point in the utility room. Water shutoff valves are visually inspected only. No attempt is made to operate the main or any other water supply shutoff valves during the inspection. These valves are infrequently used and could leak after being operated. The only exception to this policy is made when the main water supply valve is off upon arrival at the inspection. Since it is the buyers right to have all utilities operable for the home inspection, we will attempt to turn the main water valve on for the inspection. The HomeTeam is not responsible for leaks caused by operating the valve.

main water shut off

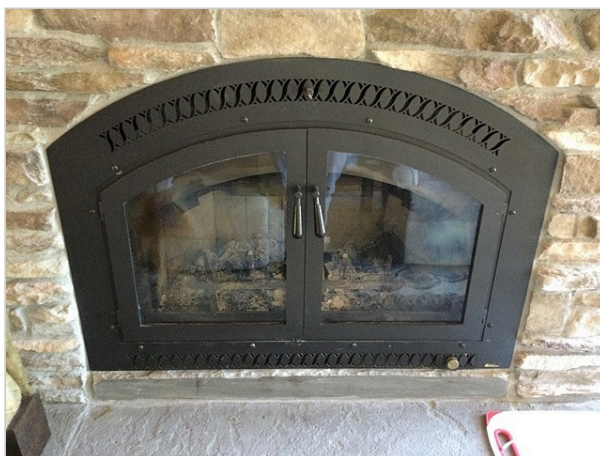
**Photo 96**

A wood-burning fireplace was located in the basement family room. There was no visual evidence of creosote buildup in the firebox and/or chimney. There were no cracks observed in the firebox or visible portions of the chimney. The fireplace was not tested for operation.

Note: a home inspection of the fireplace and chimney/flue exhaust is limited to the readily visible portions only. The inner reaches of a flue are mainly inaccessible. Our view was not adequate to discover possible deficiencies or damage, even with a strong light. For safe and efficient operation we recommend annual inspections by a qualified fireplace professional. A qualified chimney sweep will clean the interior if necessary, using specialized tools, testing procedures, mirrors and video cameras as needed to evaluate the fireplace system. If the fireplace has not been cleaned and inspected by a qualified fireplace professional within the past year, we recommend this be done prior to use.

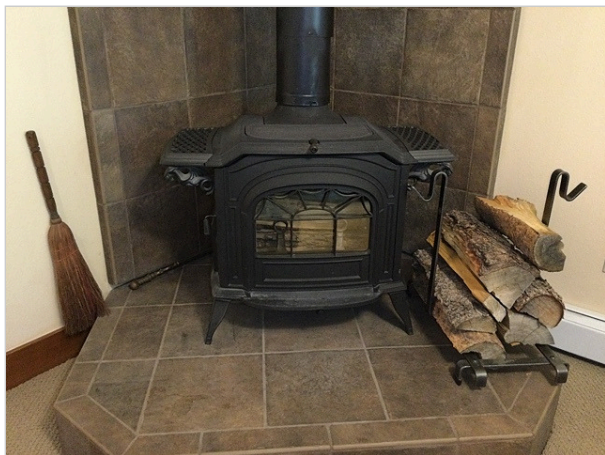
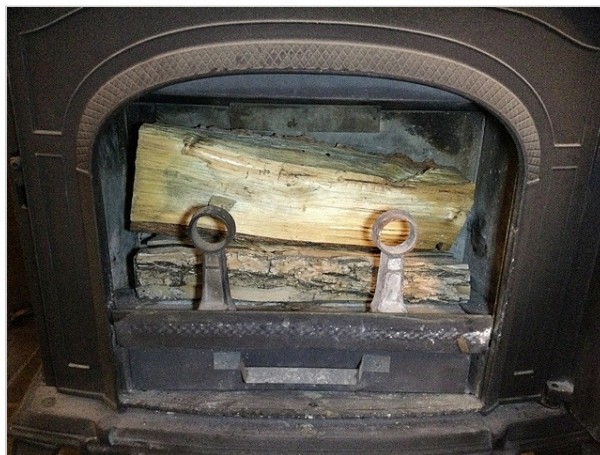
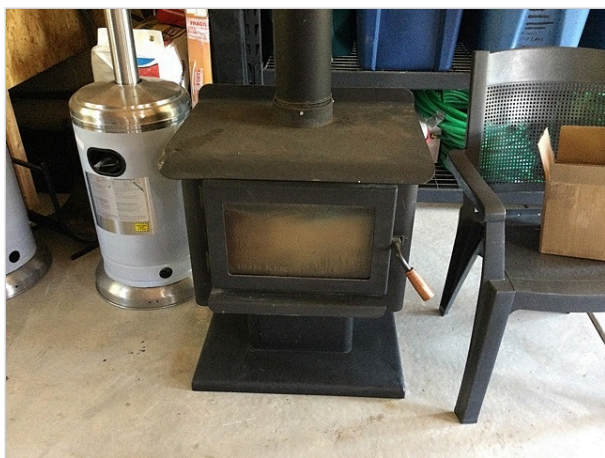
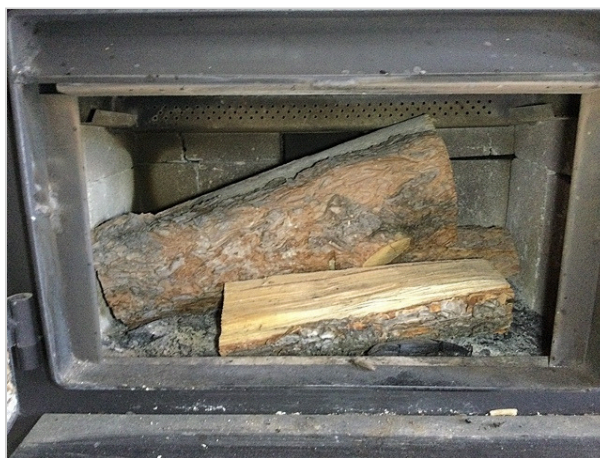
There were two wood-burning stoves located in the lower level family room and garage. For safety reasons, recommend that the wood-burning stove and the chimney or pipe to which it is vented be cleaned and re-inspected before using as there may be hidden defects not fully visible at the time of the inspection. Although not actually tested, the stove appeared to be functional. The stove appeared to have adequate clearances from combustible materials.

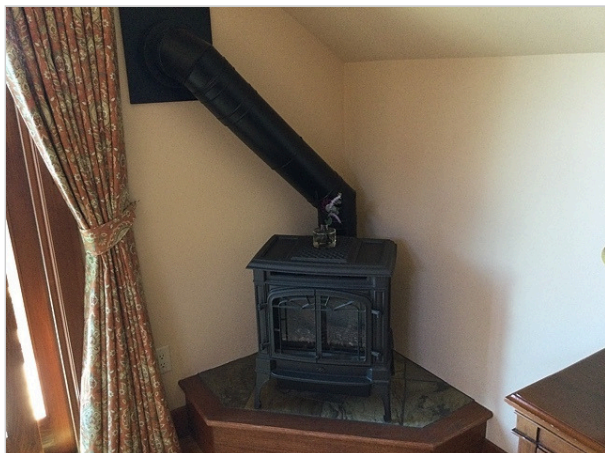
**Photo 101**

There was a propane-burning stove located in the primary bedroom. For safety reasons, recommend that the gas-burning stove and the chimney or pipe to which it is vented be cleaned and re-inspected before using as there may be hidden defects not fully visible at the time of the inspection. The stove was non-functional at the time of inspection. The stove appeared to have adequate clearances from combustible materials.

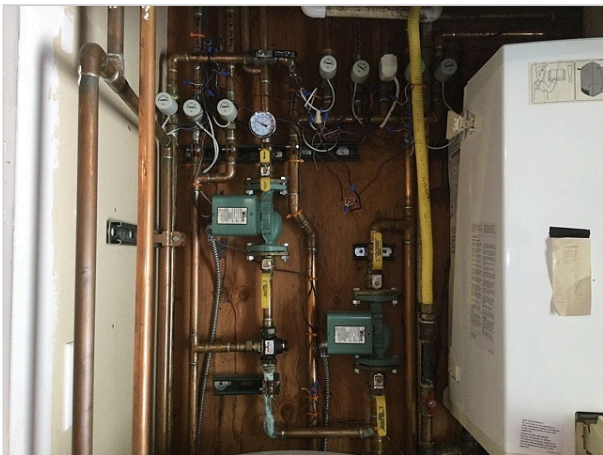
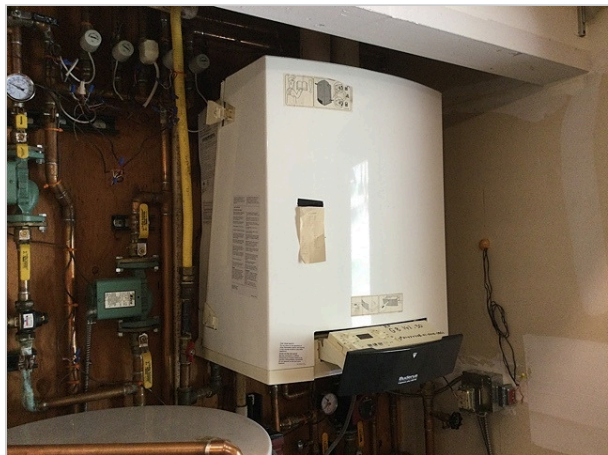
The structure was heated by a Buderus propane tankless water heater, which is 16 years old. The unit was located in the utility room of the structure. The heating system was found to be functional.

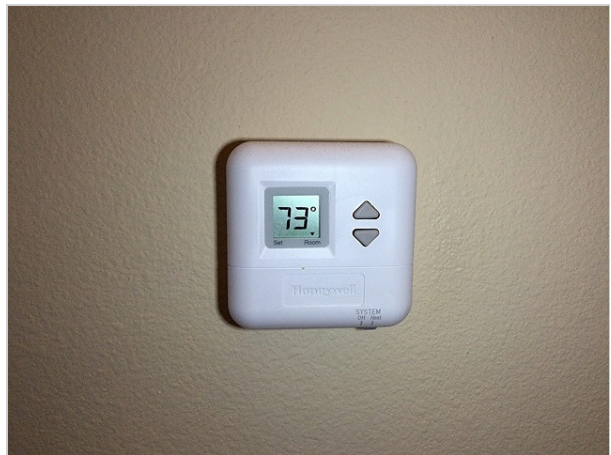
**Photo 109**

family room

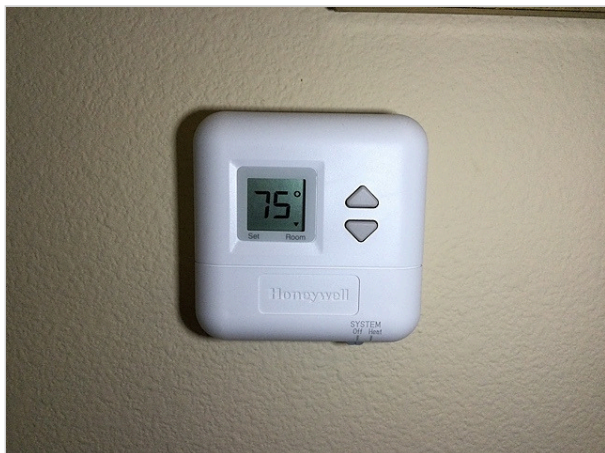
**Photo 110**

upper loft

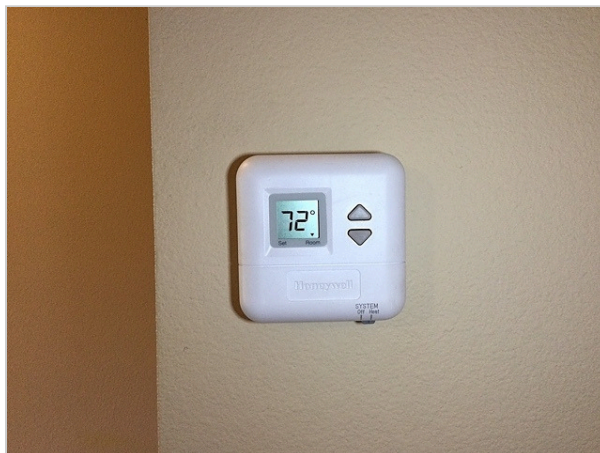
**Photo 111**

first floor office

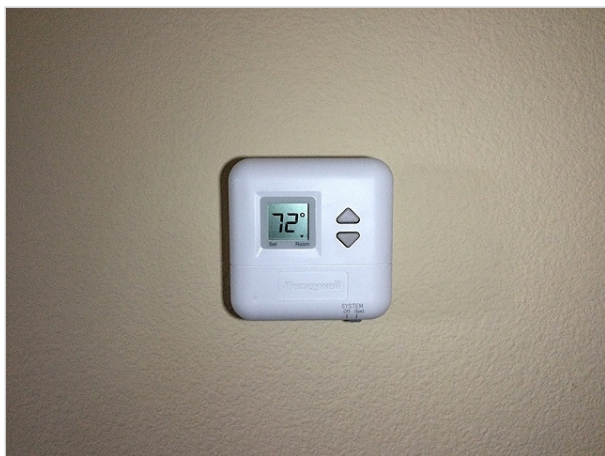
**Photo 112**

first floor loft

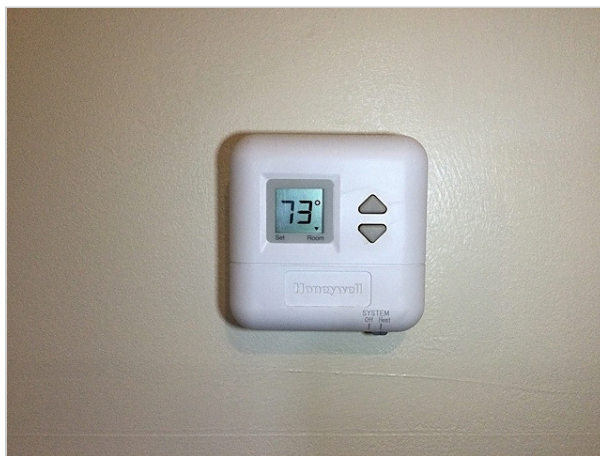
**Photo 113**

garage
