### HOME INSPECTION REPORT

File Number: **6549**

Address of Inspection: **123 Sample Drive**

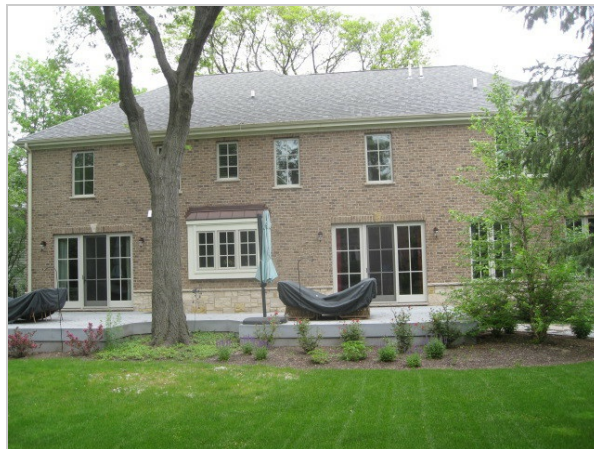
- ***We recommend monitoring the area in back by the house, between the sections of deck, to ensure water does not pool in this area.***

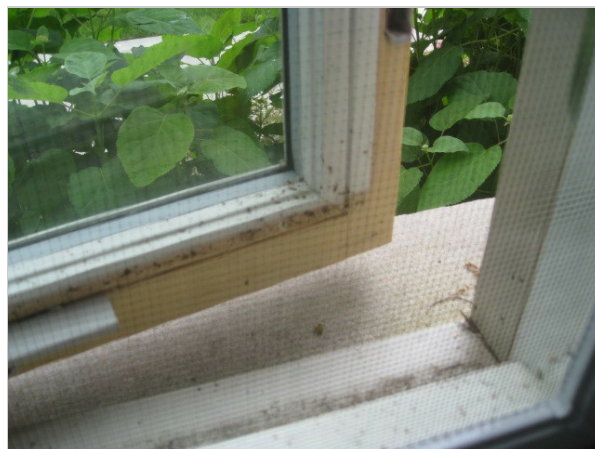
- *The attached garage front window edges were bare wood that should be treated to prevent eventual wood rot.*

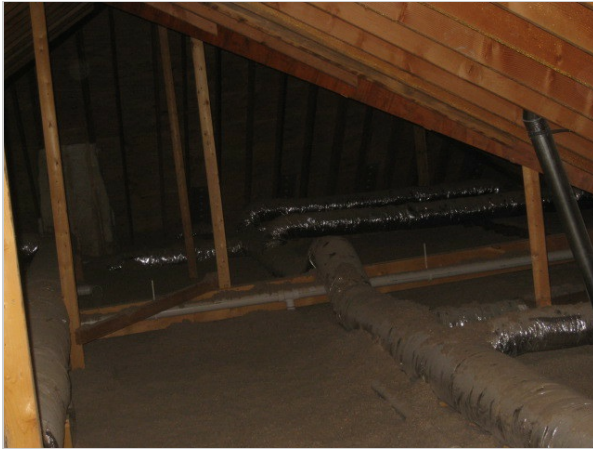
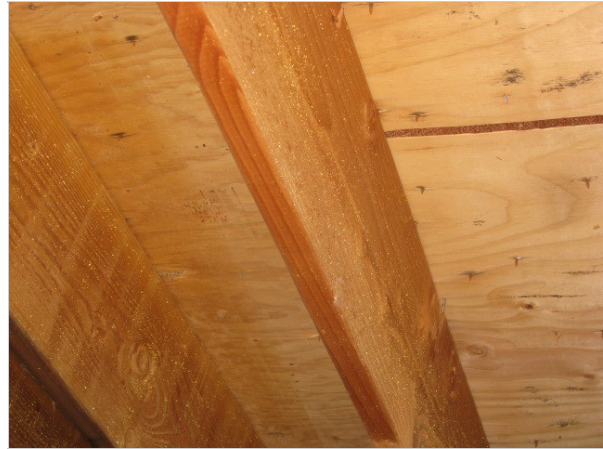
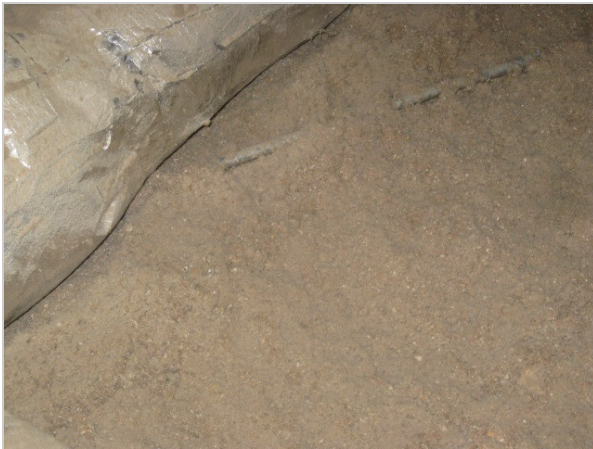
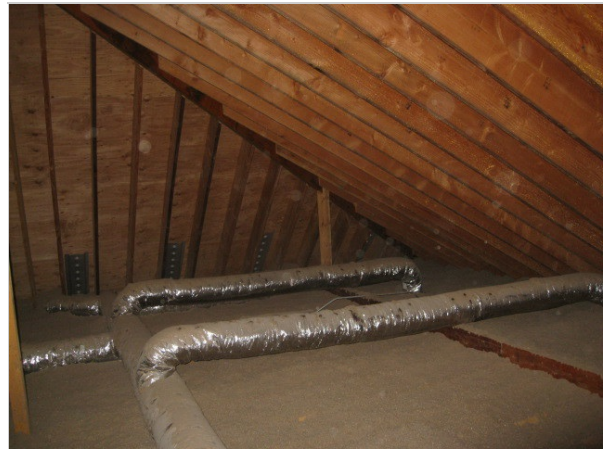
- ***There was darkened sheathing, with possible light mold growth, in the right front section of the attic that should be further evaluated and treated as necessary.***

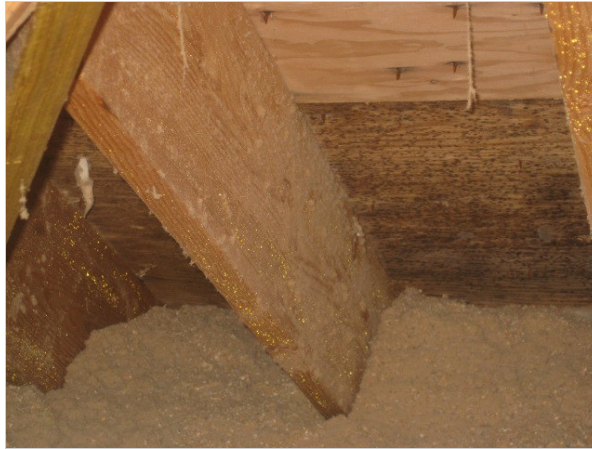
- ***One of the support columns on the far left side of the attic space was completely loose and needs to be secured.***
