### HOME INSPECTION REPORT

File Number: **xxxx**  
Address of Inspection: **123 Sample Drive**

**John Doe**  
**123 Sample Drive**  
**Anytown, NC**

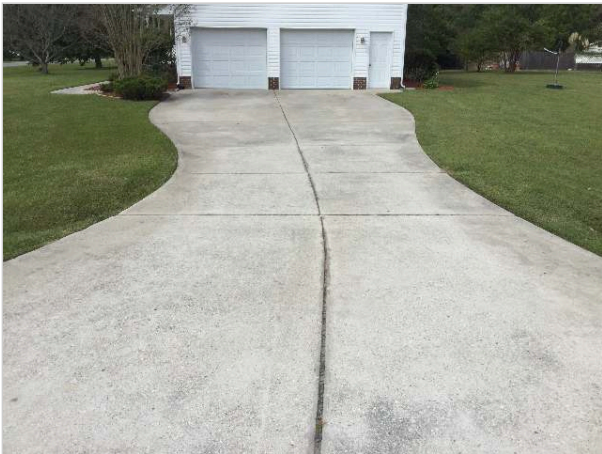
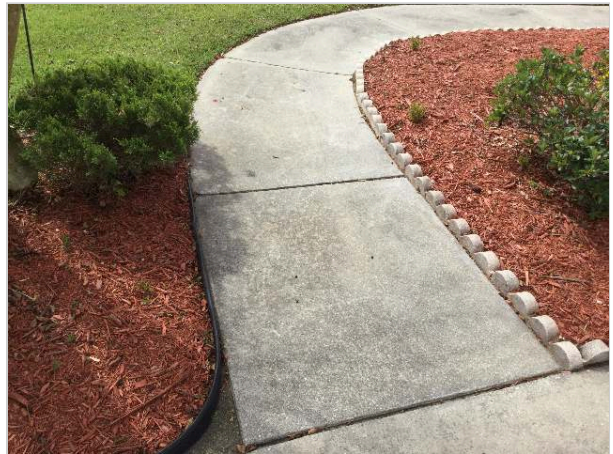
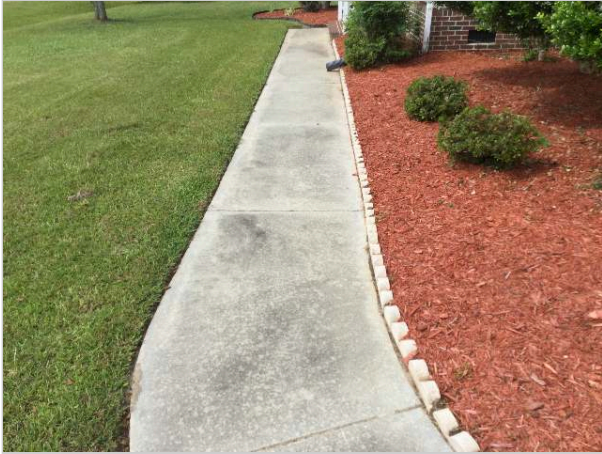
***The driveway has several cracks with slight separation. Freezing moisture here may create further cracks and spalling. Have a qualified contractor seal these cracks.***

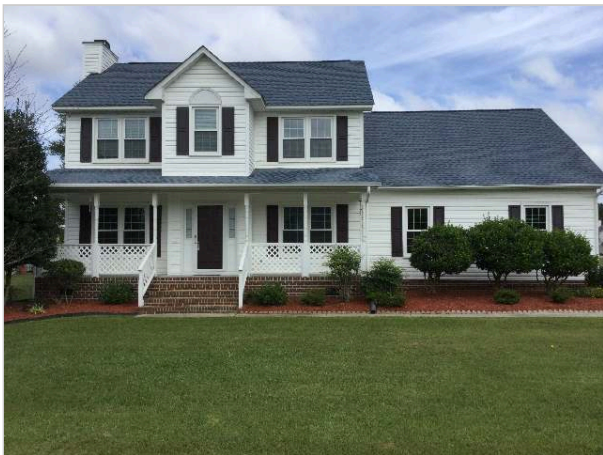
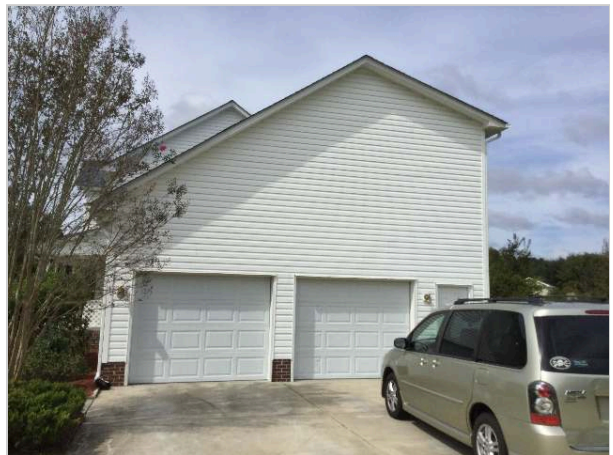
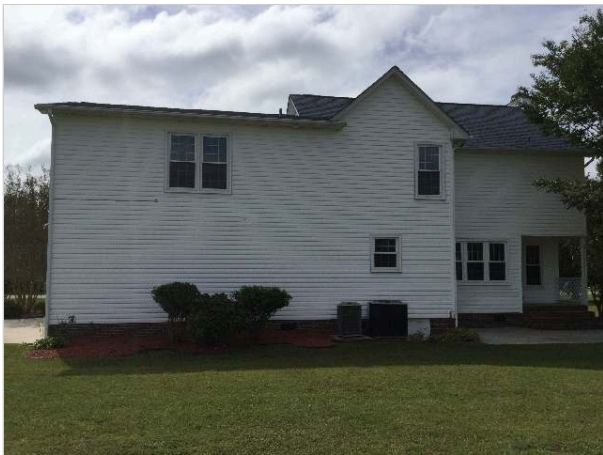
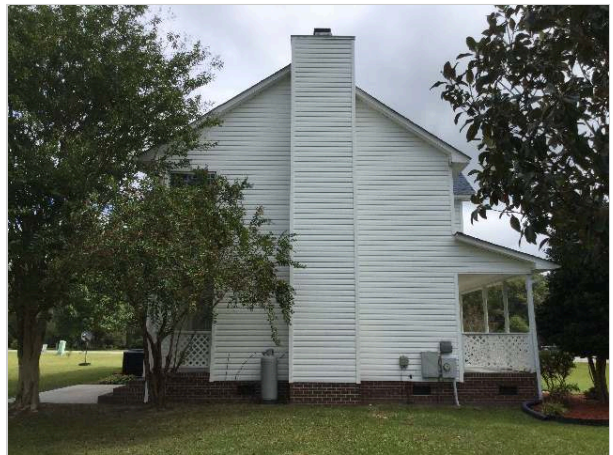
***There is one area on the left side of the home where the vinyl siding is damaged, apparently by lawn equipment. If left, this can allow moisture to penetrate and damage structural components. Have a qualified contractor evaluate and repair as required.***

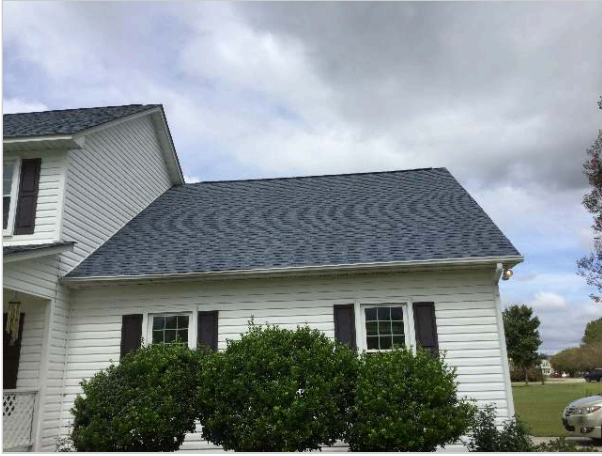
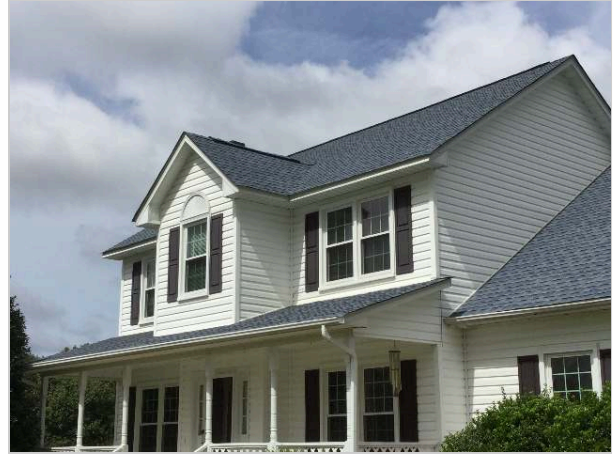
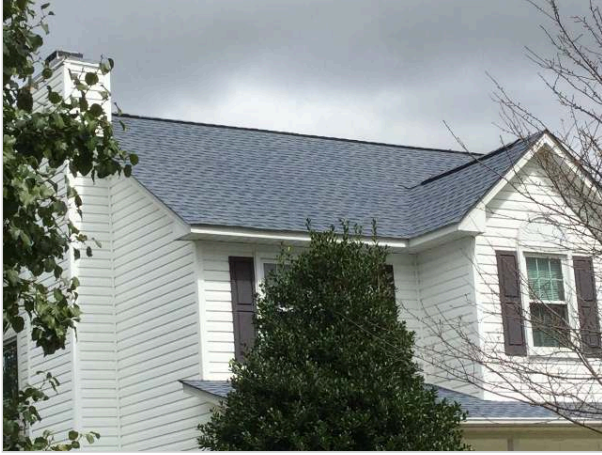
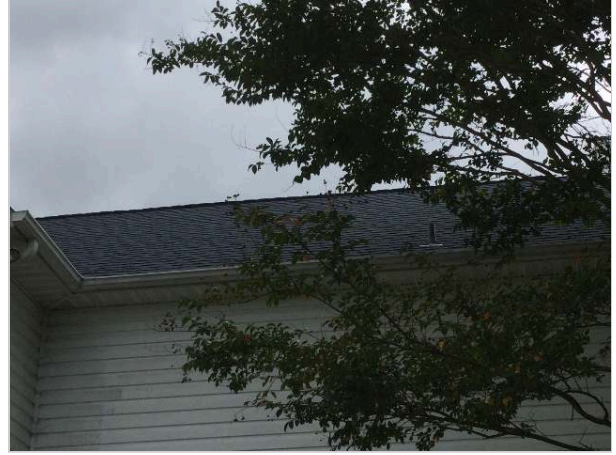
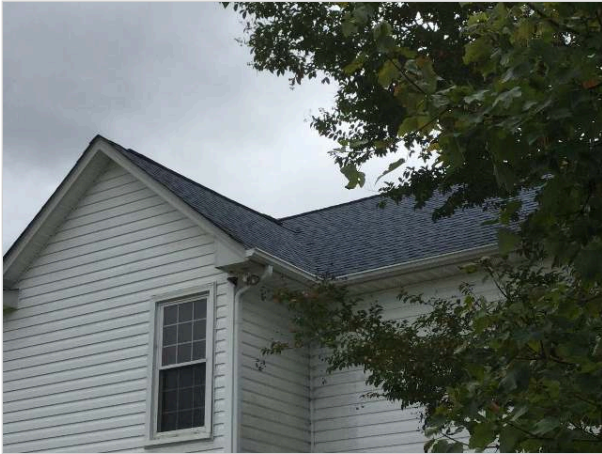
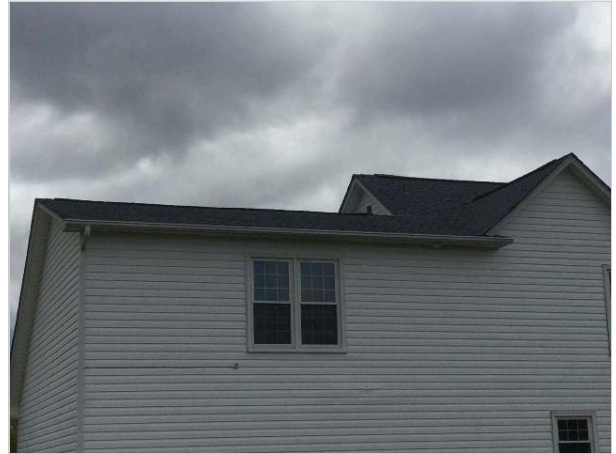
***On this roof, several shingles appeared to be in poor condition at the rear left corner of the home. Broken, loose and/or cracked shingles can allow the infiltration of water and lead to damaged structural components. Have a qualified contractor to evaluate and repair as required.***

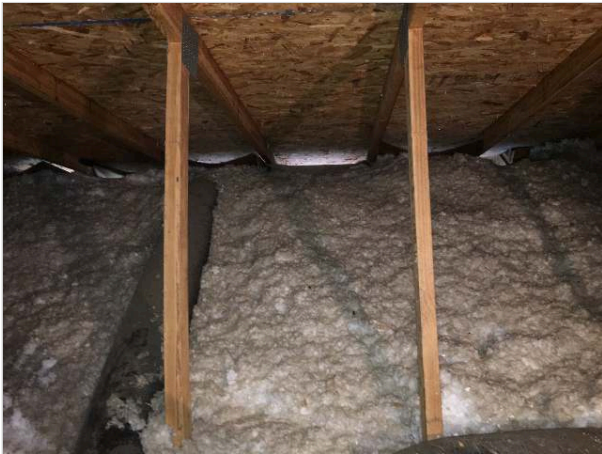
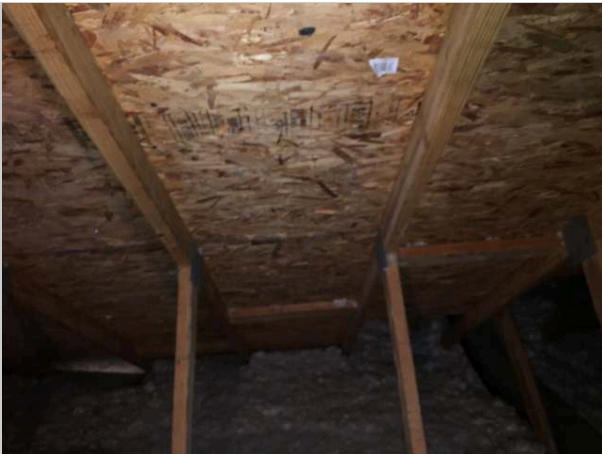
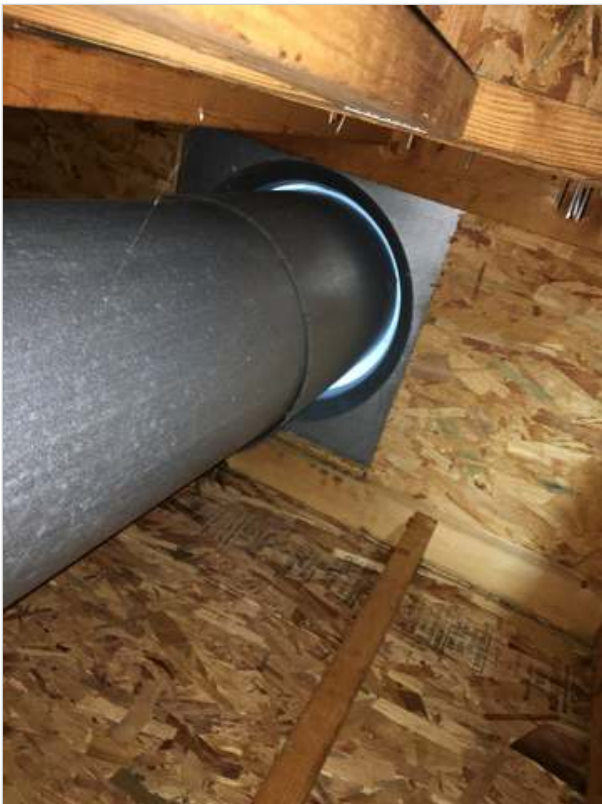
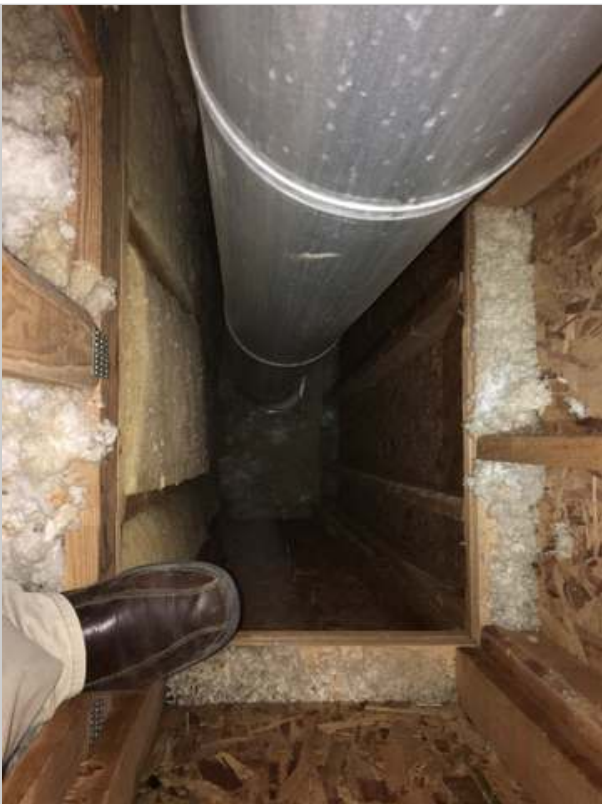
*The attic inspection was limited by the configuration. It was not possible to view all areas.*

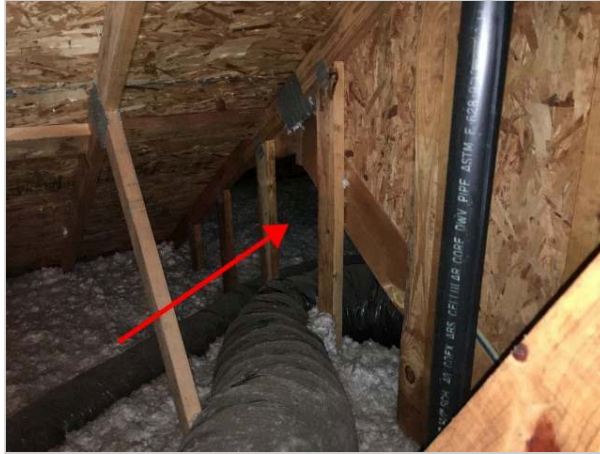
Area over bonus room

***In the attic there is evidence of moisture staining to the roof sheathing at the plumbing vent. If the roof is actively leaking, this can lead to further damage to structural components. Have a qualified roofing contractor evaluate and repair as required.***

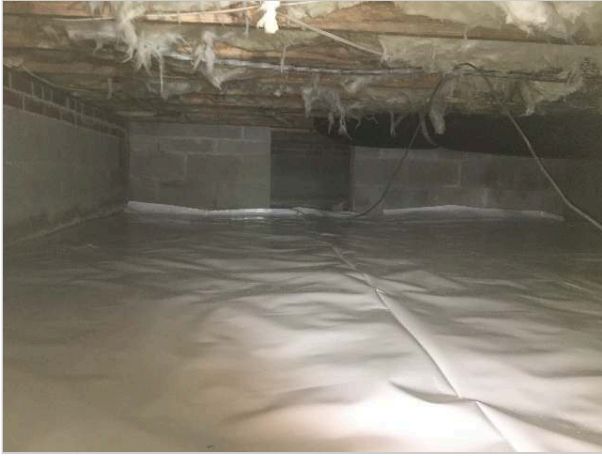
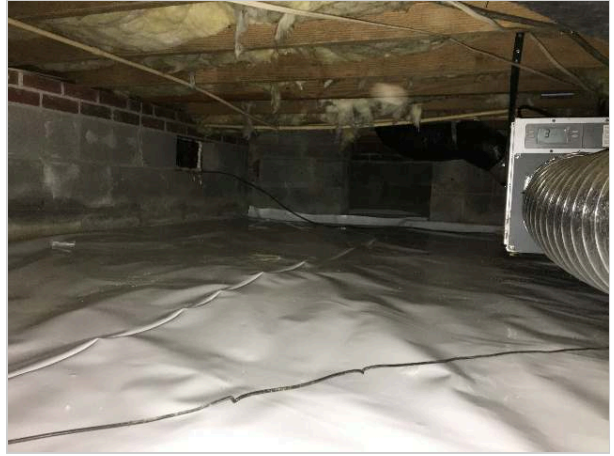
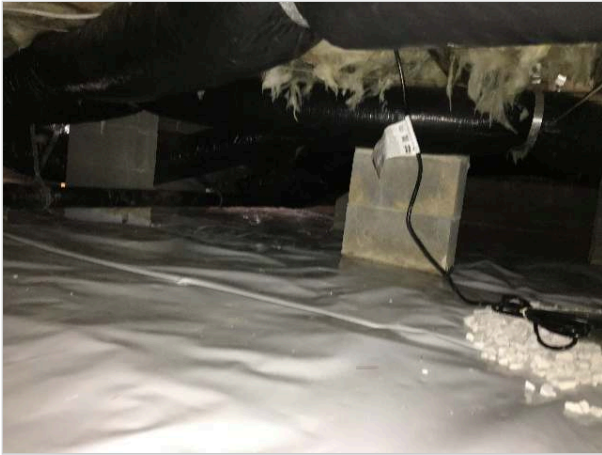
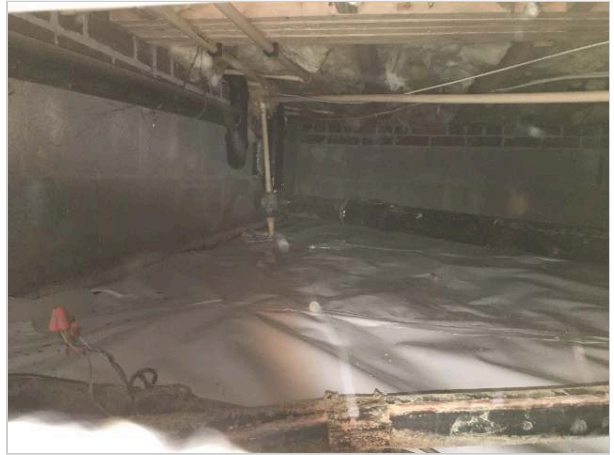
A vapor barrier is installed. Crawl space was insulated with blanket/batt insulation. There were concerns observed in the crawl space.

***In this sealed crawl space, there is a dehumidifier operating. A DH unit is beyond the scope of this inspection. There is evidence of a past problem with microbial growth on the wood floor structure that now appears to be dormant. It appears the DH unit, the sealed vents and the new vapor barrier were in response to this past problem. It is critical that the DH unit be kept operating in this sealed environment. Ask for seller disclosure on the past issues including the microbial growth and if the area was evaluated by a qualified contractor for any required mitigation. If necessary, have a qualified industrial hygienist evaluate and advise.***

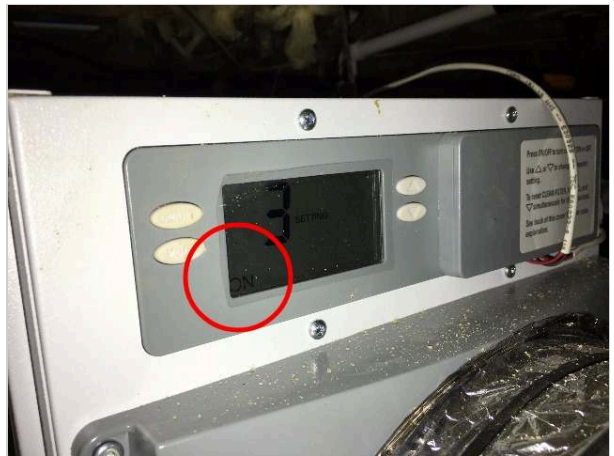
DH unit

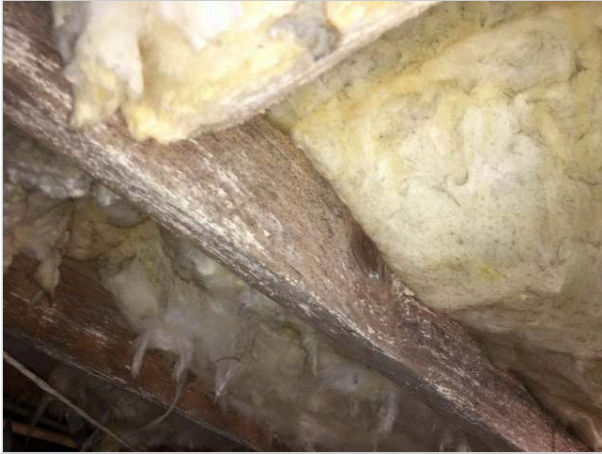
DH unit on

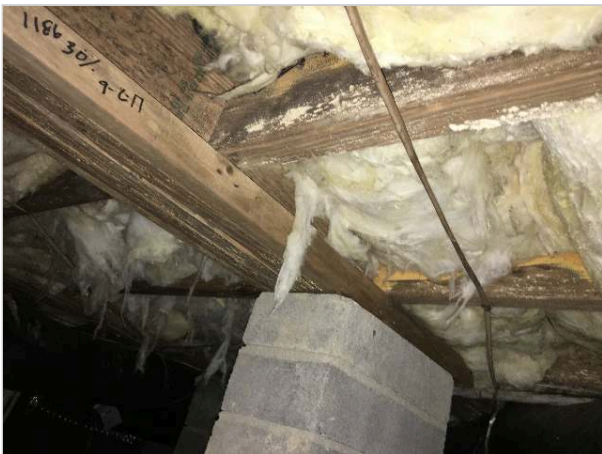
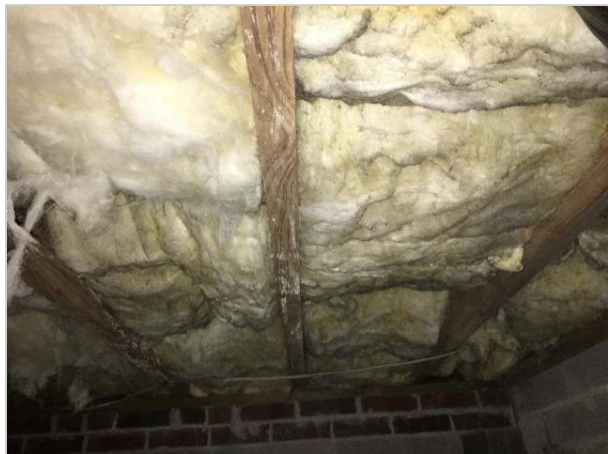
The floor structure was visible from the crawl space. Flooring was supported by traditional framing on top of piers. There were concerns observed in the visible portions of the flooring and/or the supports. **See the CRAWL SPACE section for further remarks.**

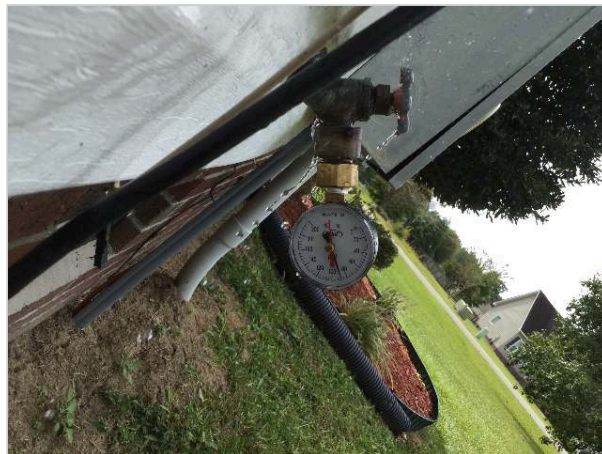
***The left outdoor faucet leaks from the valve stem when turned on. If left, this valve could fail completely and run large amounts of water. Have a qualified plumbing contractor repair or replace this faucet.***
