On Friday, May 22, 2026 The HomeTeam Inspection Service made a visual inspection of 123 Sample Street, Charlotte, NC 28217. Enclosed please find a written, narrative report of our findings in accordance with the terms of our Inspection Agreement.

HomeTeam Inspection Service
NCHI 3979 / SCHI 49320

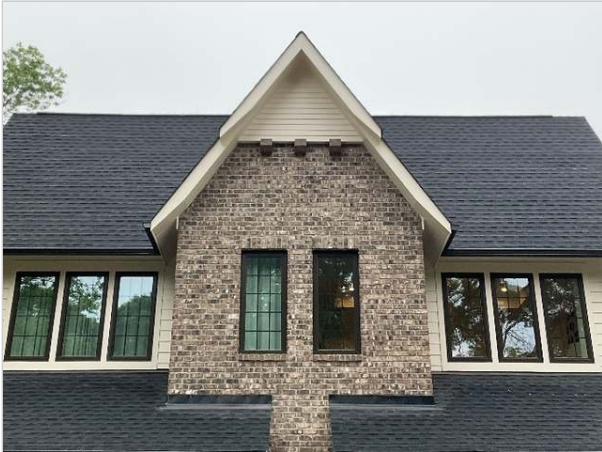
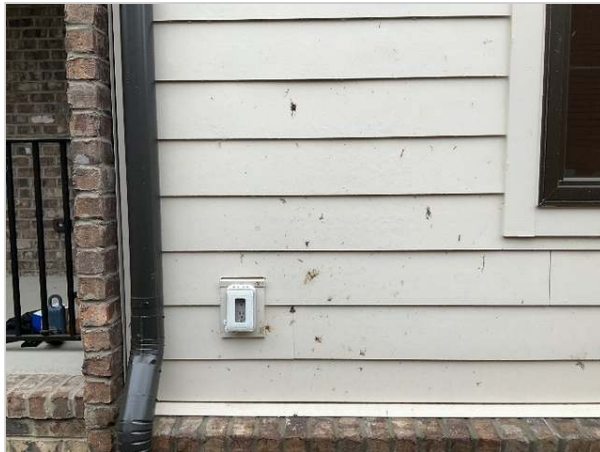
At the exterior, at places the siding is dirty. If not cleaned and repaired as needed this may result in damage to the siding and adjacent wood trim. Have a qualified cleaning contractor clean the siding and repair as needed (Not limited to photos).

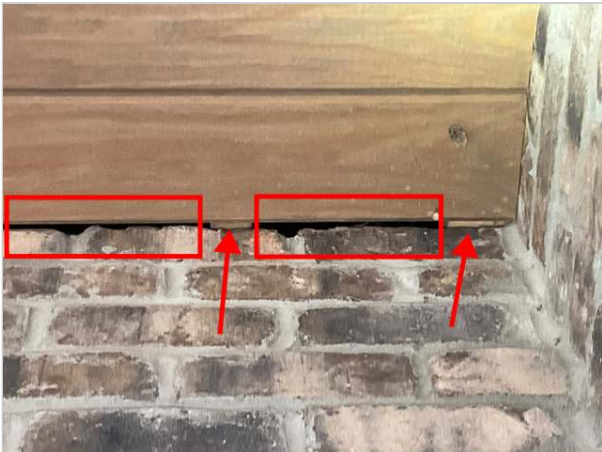
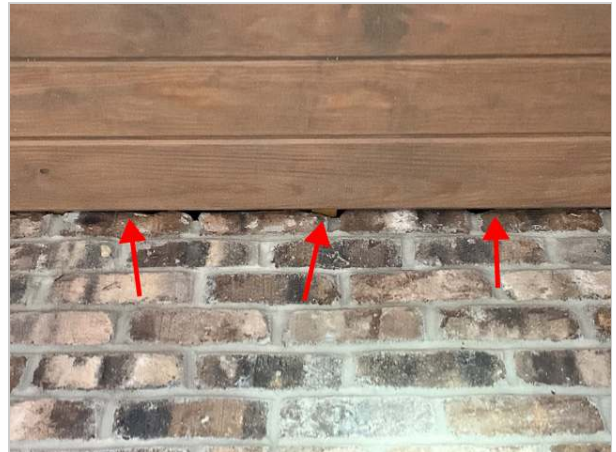
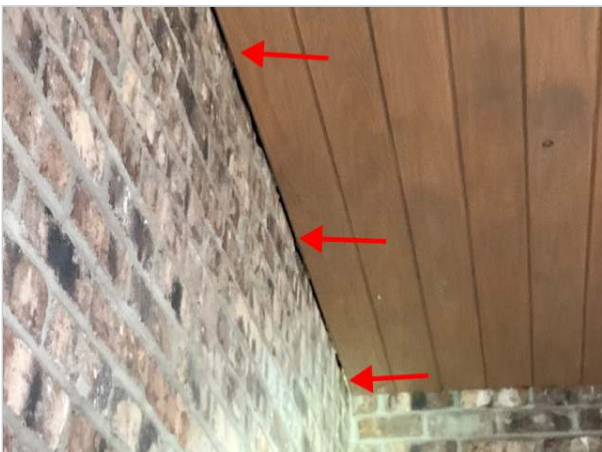
At the front porch the ceiling has gaps at the edges where moisture, pests and small animals could infiltrate. Some gaps are wide enough to view the trusses. If not repaired moisture infiltration, pests and animals can ultimately damage the wall sheathing and structural components. Have the builder make repairs. .

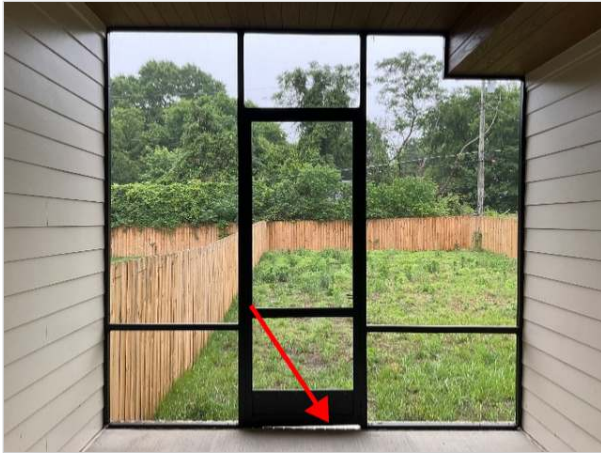
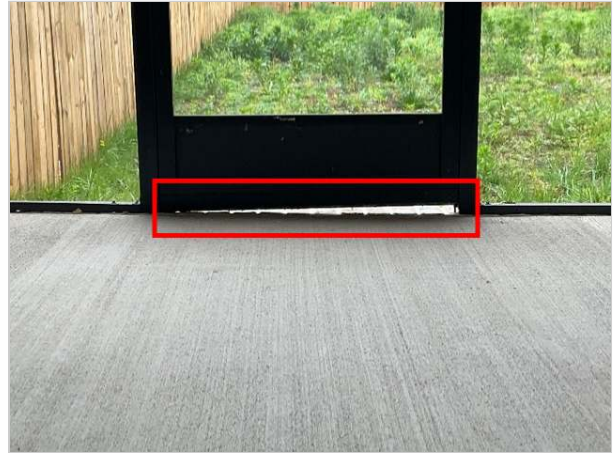
opening at the bottom. If not repaired this gap will permit bugs and pests entry into the screened porch. Have the builder repair this door.

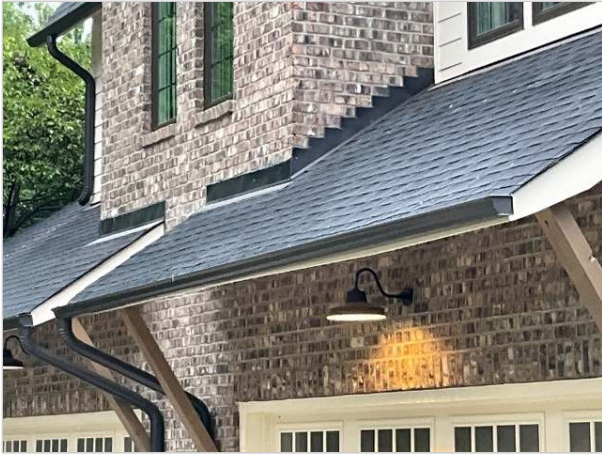
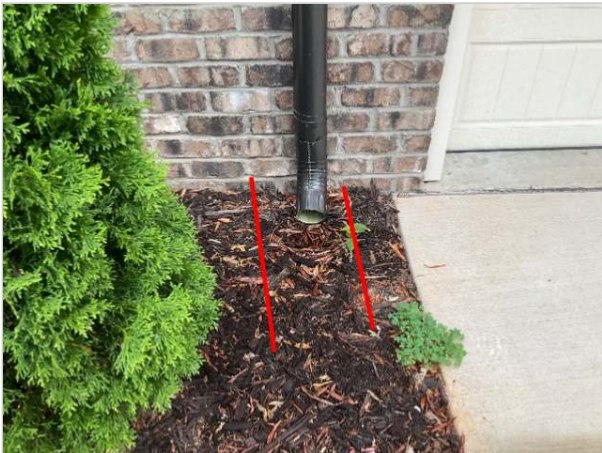
Two gutter downspouts have no splash guards. If not repaired the lack of splash pads allows the flow of water to accumulate at the foundation. This can lead to damage at the foundation. Have a qualified gutter and downspout contractor install splash pads as required.

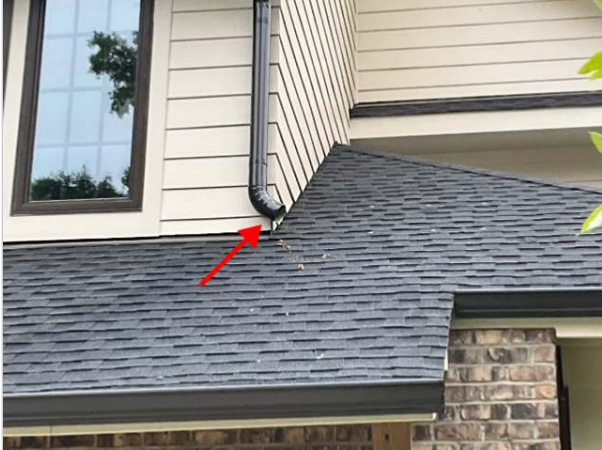
Two gutter downspouts located above the front porch appear to require modifications. The elbows appear to be too short or not directed in a way to adequately drain rain water away from flashing and wall structure. If not reviewed and repaired this may lead to damage at walls and adjacent structures. Additionally, this can lead to excessive gutter overflow. Have the builder evaluate these downspouts and repair to ensure proper installation and function.

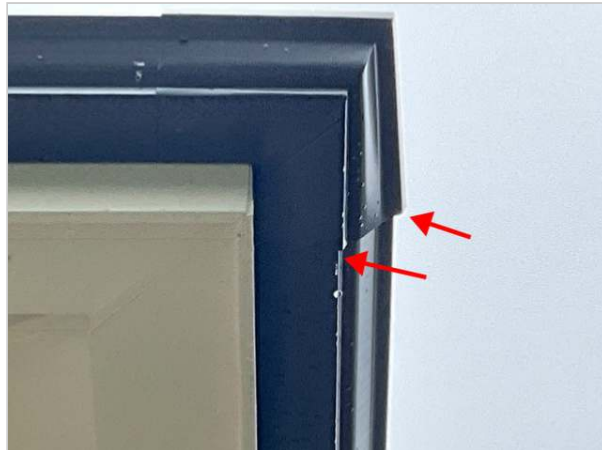
On this rainy day the gutter appears to be leaking at the corner of the front porch. If not repaired, this can allow water to run down the siding resulting in possible water damage to siding and structural components. Have the builder or a qualified gutter and downspout contractor evaluate gutters.

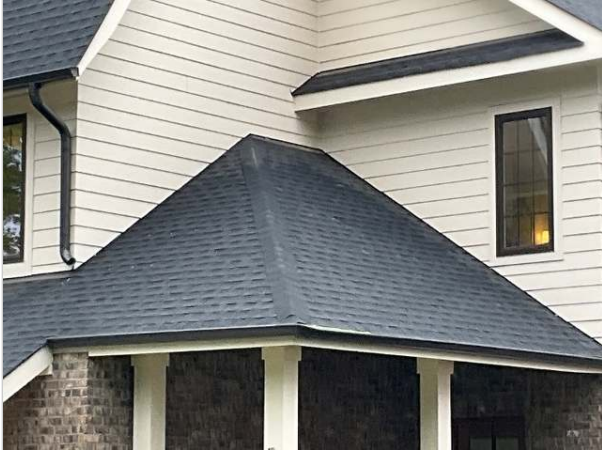
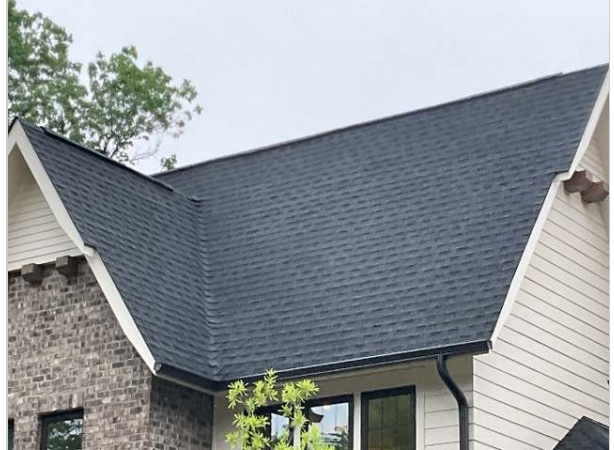
LIMITATION: Due to heavy rain fall and wet conditions the inspection of the roof system including shingle evaluation was limited. We suggest that the buyer have a qualified roofing contractor evaluate the roof system when weather conditions improve.

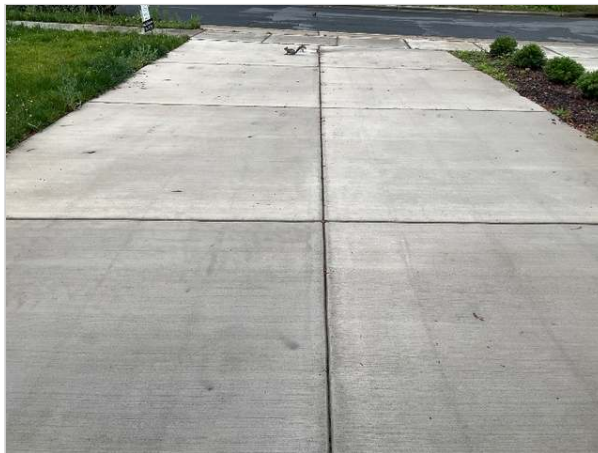
A concrete driveway is present in the front of the structure. Cracks and spalling were observed on the driveway. Surface defects in driveways develop and progress with age and are considered normal as long as they do not create a safety hazard. Sealing defects may help slow the rate of deterioration.

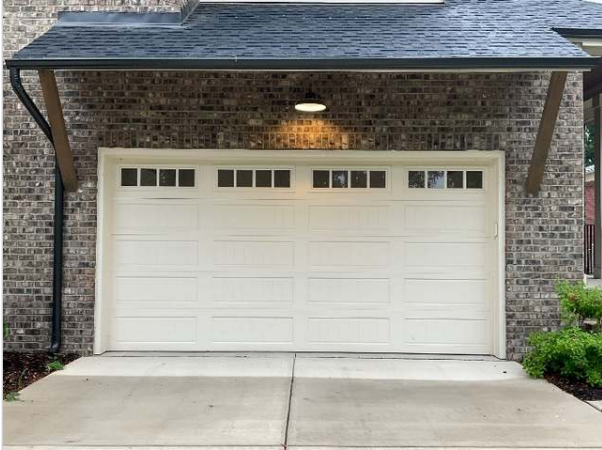
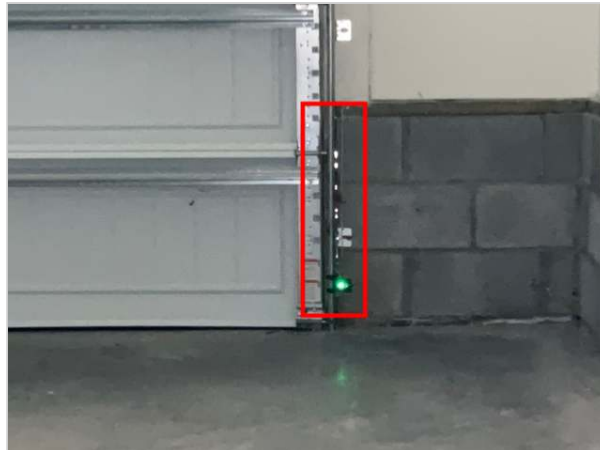
At the garage daylight was observed between the door framing and block foundation wall. If not repaired or sealed this could allow moisture, pests and small animals to enter into the garage. Have the builder repair and or seal this opening.

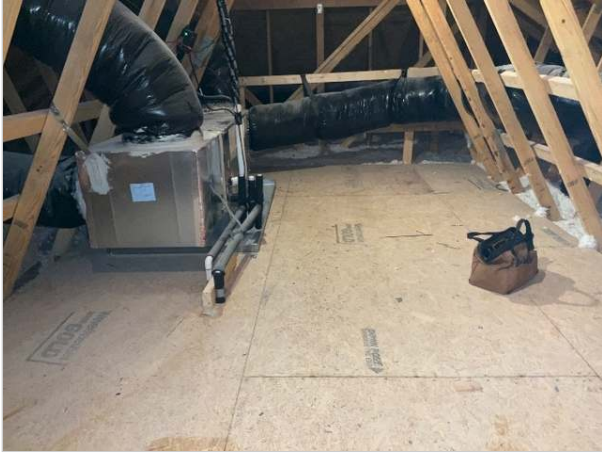
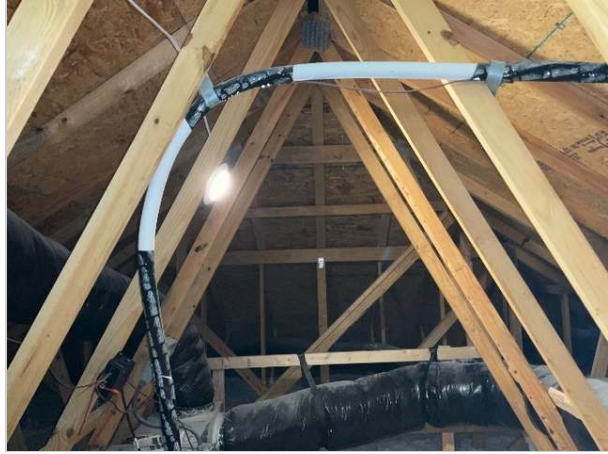
LIMITATION: *The attic inspection was limited by the configuration of duct work and structure. Due to the inability to view the entirety of the attic, determining the condition of vent/flue penetration points, structural components, and overall attic condition was not possible.*

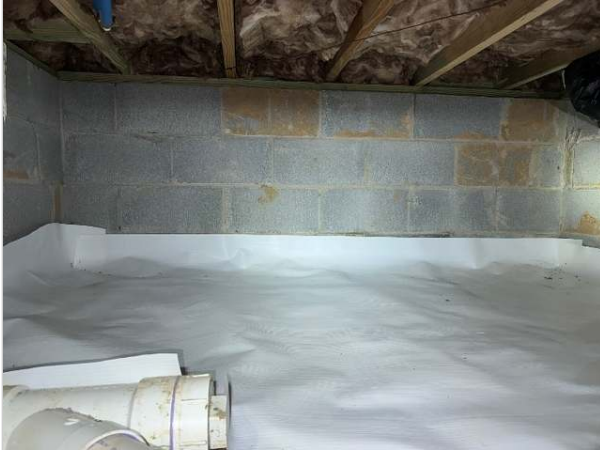
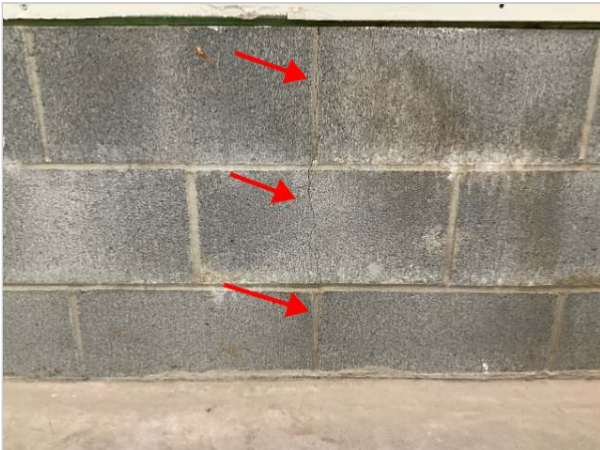
Rear Garage Wall

At the rear garage foundation wall a crack was observed. This crack was also visible on the opposite side in the crawlspace. If not evaluated and repaired this crack can worsen resulting in additional damage to the foundation and adjacent areas. Have a qualified structural engineer evaluate and advise.

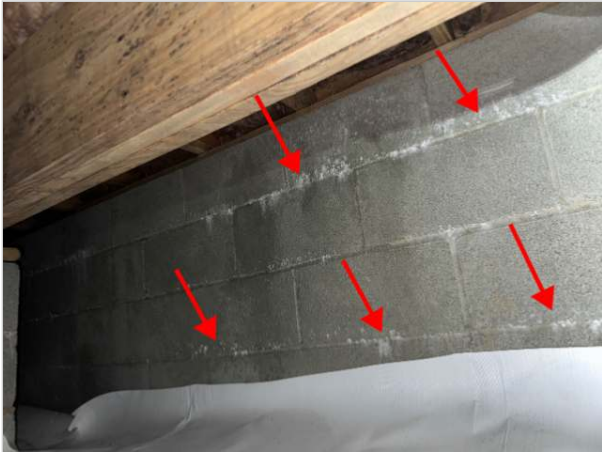
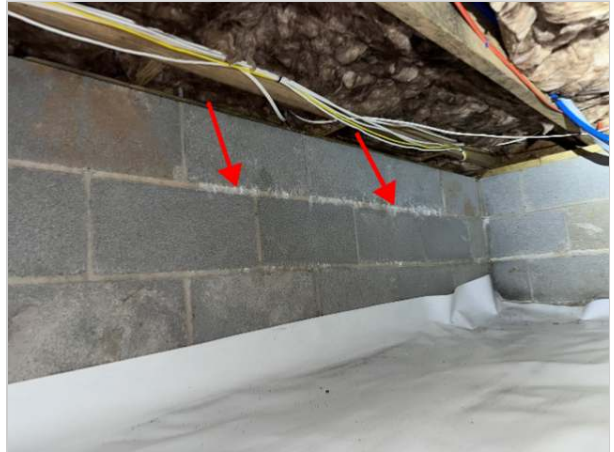
There is evidence of efflorescence on the inside of the block foundation walls. Efflorescence is caused by moisture entering from the exterior of the foundation and weeping through. The white residue that is left behind on the inside of the block foundation when drying occurs are mineral deposits. Efflorescence is evidence of water penetration and or elevated moisture levels. If not evaluated and repaired water intrusion and or elevated moisture levels can damage the foundation and adjacent structural components. Have a qualified contractor evaluate and make appropriate repairs to prevent future water penetration (Not limited to photos).

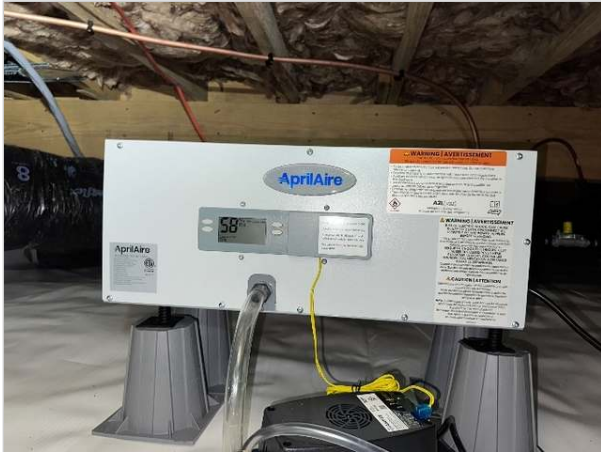
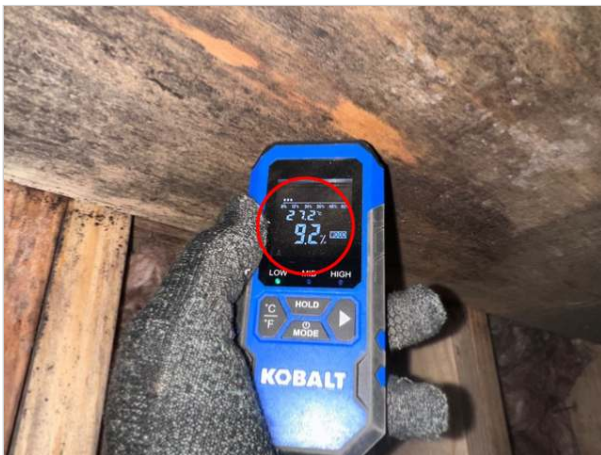
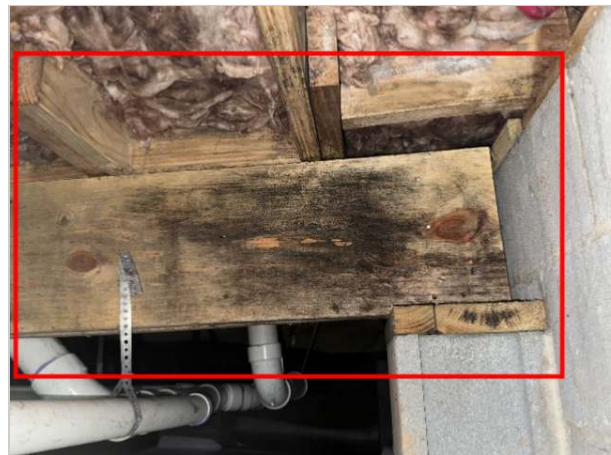
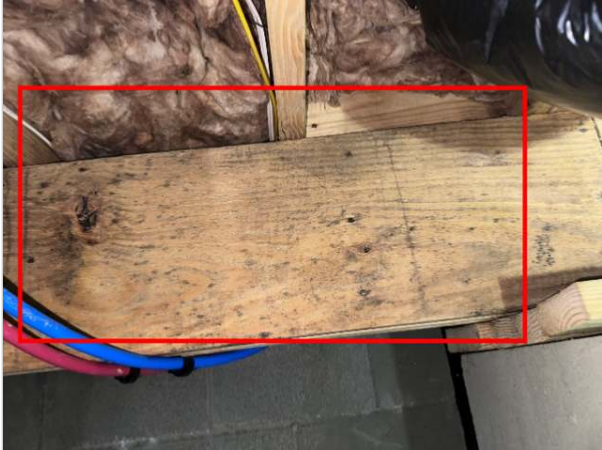
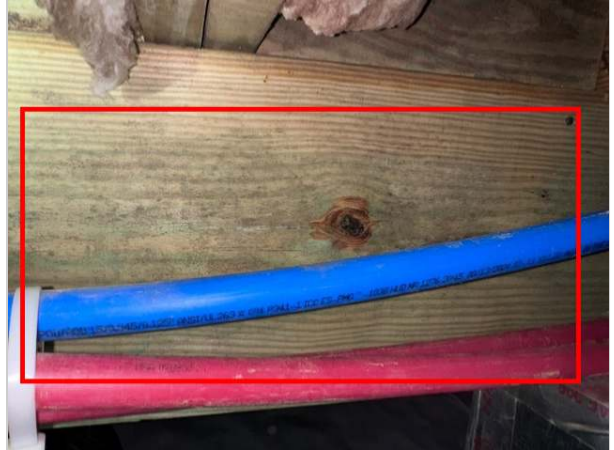
In the crawl space, there is evidence of possible microbial growth on the floor structure. This is often evidence of higher than normal moisture levels in the area. If not mitigated high moisture levels (above 18%) can lead to the growth of harmful mold, mildew, fungus and make the wood more susceptible to wood destroying insects and rot. At the time of this inspection moisture meter readings indicated that the wood moisture content was below 18% (9.2%). Moisture levels in crawl spaces can be cyclical. Therefore it is recommended that a qualified contractor evaluate the condition of the crawl space regularly and repair / mitigate conditions when necessary (Not limited to photos).

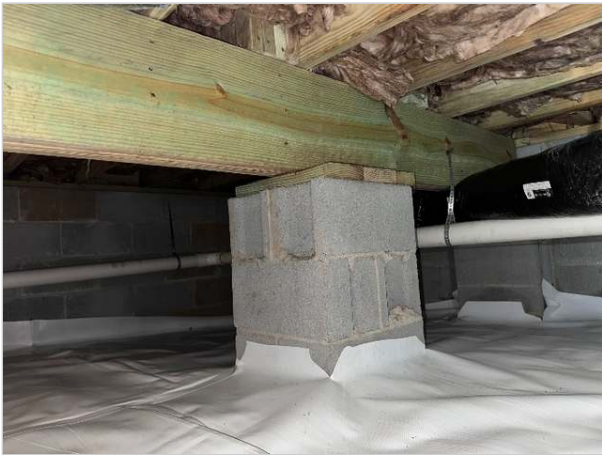
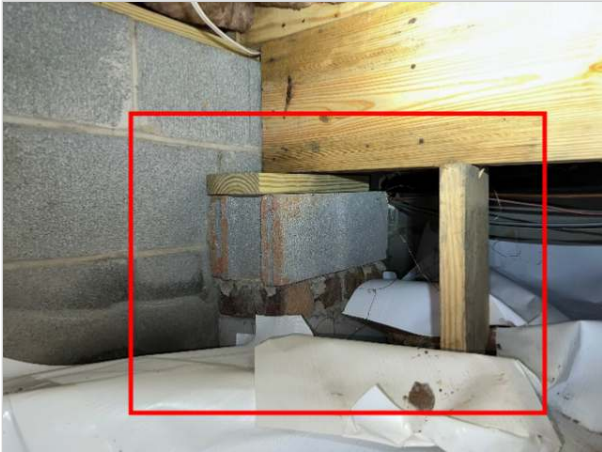
At one support pier there appears to be missing and or inadequate support between the top of the pier and the floor structure. Additionally, it appears that a supplemental post was added without adequate footing or support. If not evaluated and repaired this may result in damage to the floor structure. Have the builder evaluate and make repair as needed to ensure proper support (Not limited to photos).

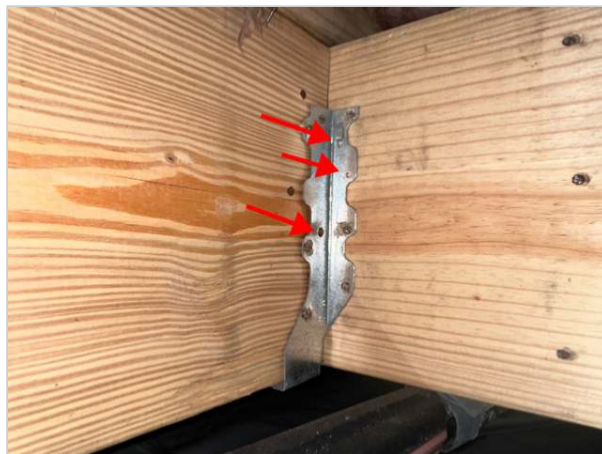
Photo 57

At one place a joist hangers appears to be missing nails, have nails not completely set or are installed incorrectly. If not repaired this may result in structural issues. Have the builder evaluate the joist hangers and ensure that they are installed as directed.

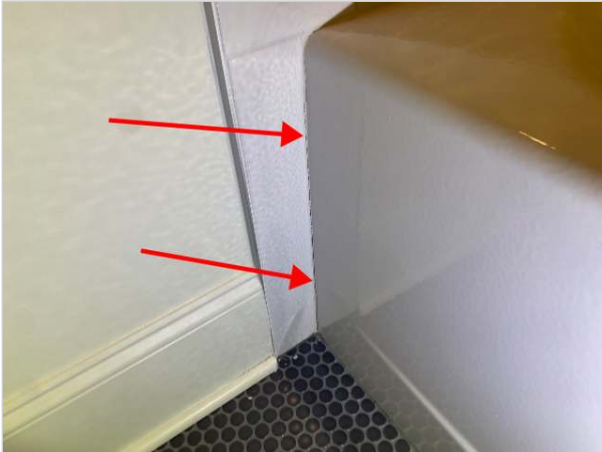
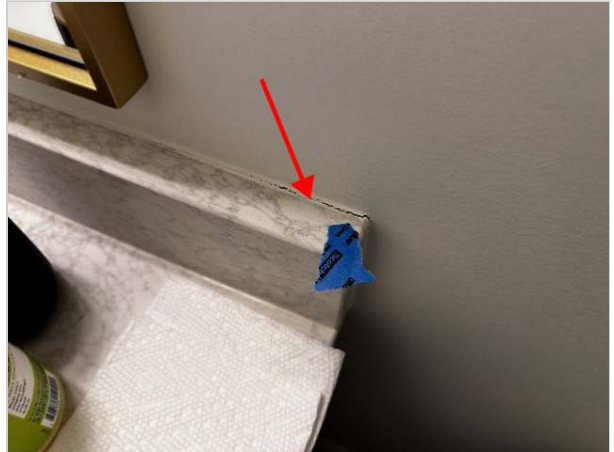
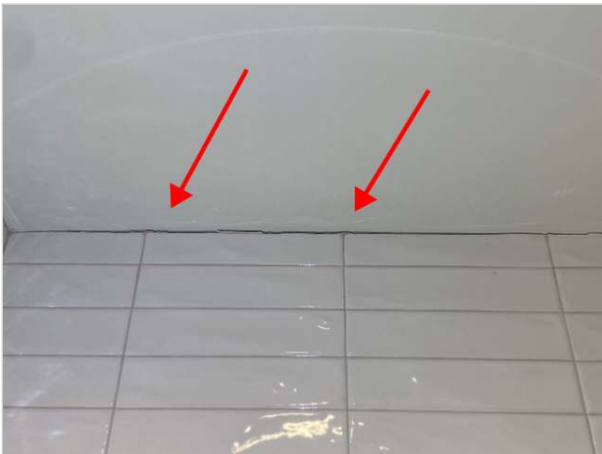
In the bathrooms, around the tub, shower, sinks, and walls, some of the caulk and grout was cracked or missing. If not repaired the failure to keep walls sealed can lead to moisture penetration resulting in moisture damage to adjacent areas. Have the builder re-caulk and re-grout these areas to prevent moisture penetration. (Not limited to photos).

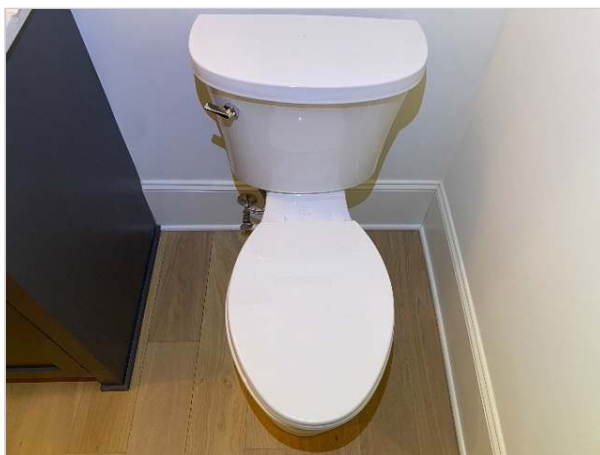
Photo 66

The powder room toilet is loose at the floor. If not repaired a loose toilet and or loose toilet tank may result in water leakage and damage to adjacent areas. Have a licensed plumbing contractor evaluate and repair as required.

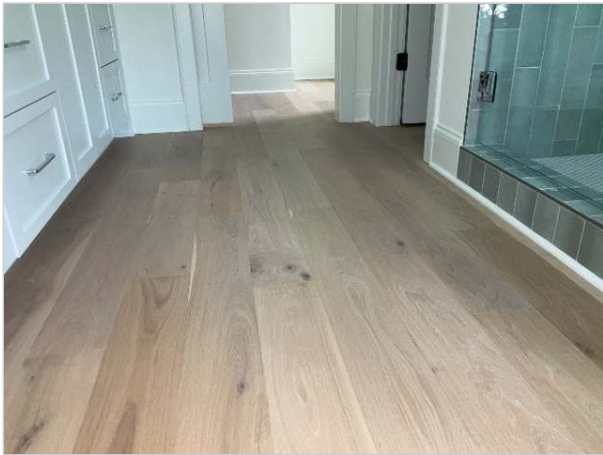
Primary Bathroom

At numerous places the floors are noisy and squeaky. If not repaired this may continue to worsen possibly resulting in damage to the flooring. Have the builder or a qualified general contractor evaluate the flooring and floor structure of this home and repair as needed to ensure proper function (Not limited to photos).

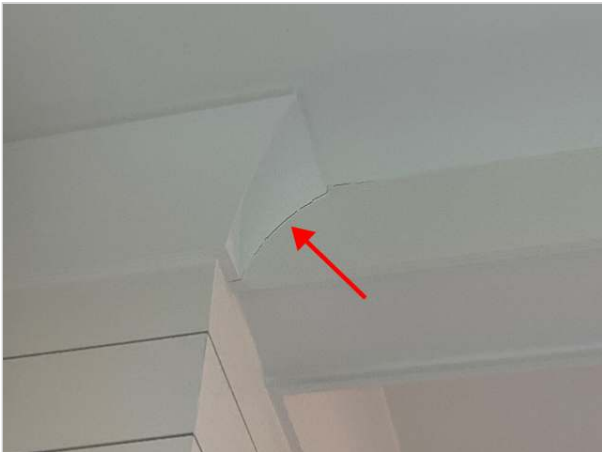
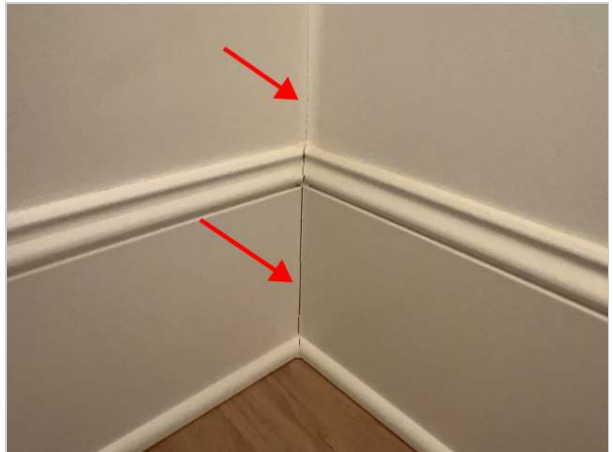
At the interior there are numerous places that require cleaning, painting and or repair. Have the builder evaluate and repair these prior to closing (Not limited to photos).

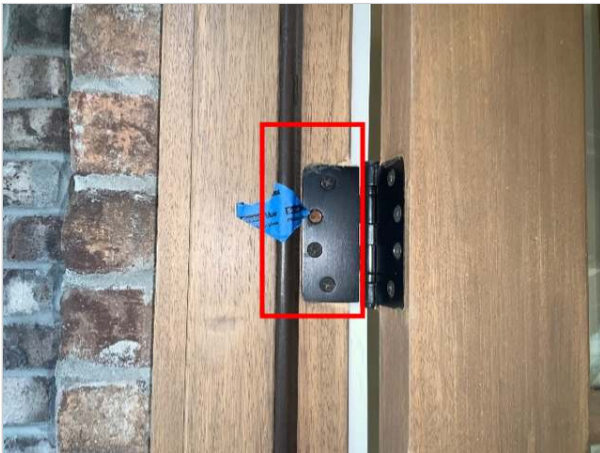
Photo 83

Missing hinge screws were noted at the front door. If not repaired this may predispose these hinges and doors to additional wear and tear and possible failure. Have the builder install proper hinge screws at these locations.

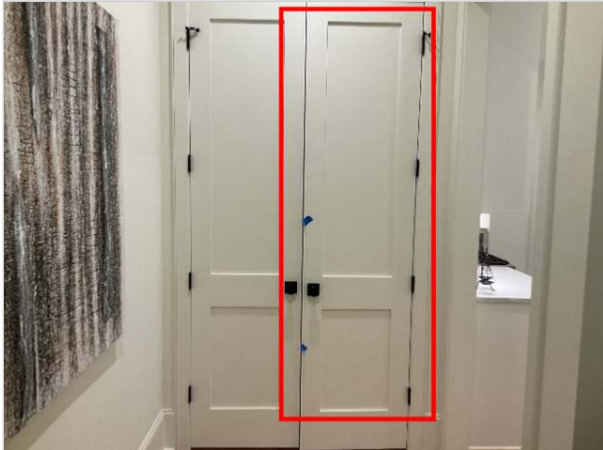
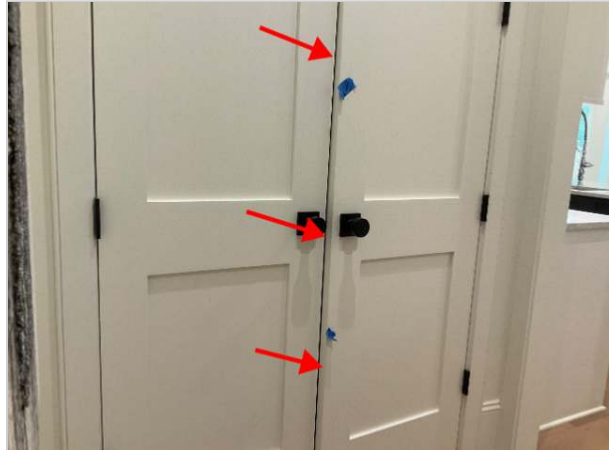
At the kitchen rear garage entry pantry/closet the right side door is warped and or damaged. The door does not close properly. If not repaired this prevents the door from working as intended and this may worsen resulting in door failure. Have the builder repaired or replace this closet door.

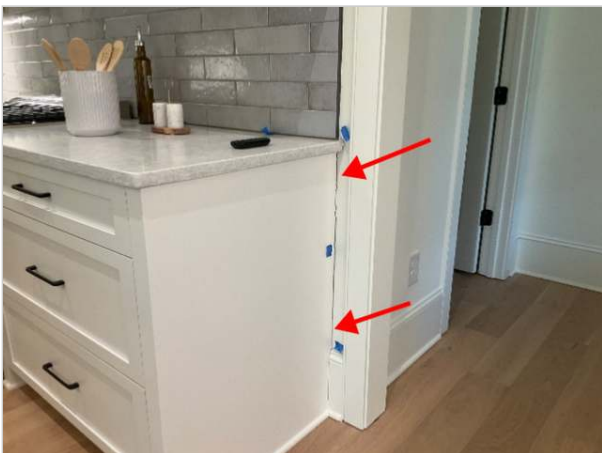
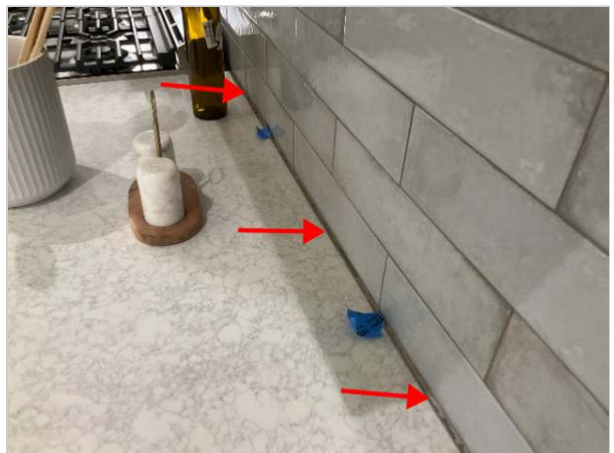
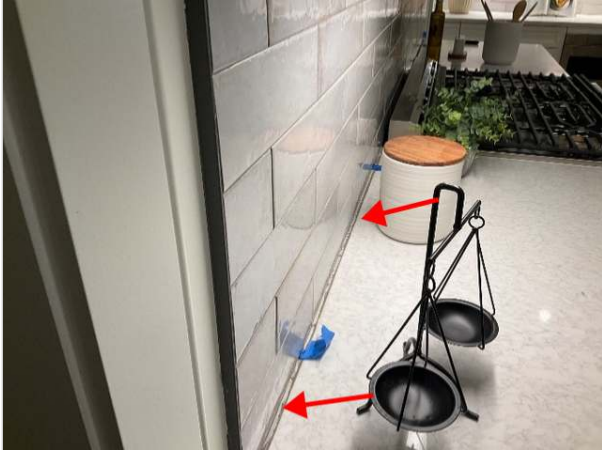
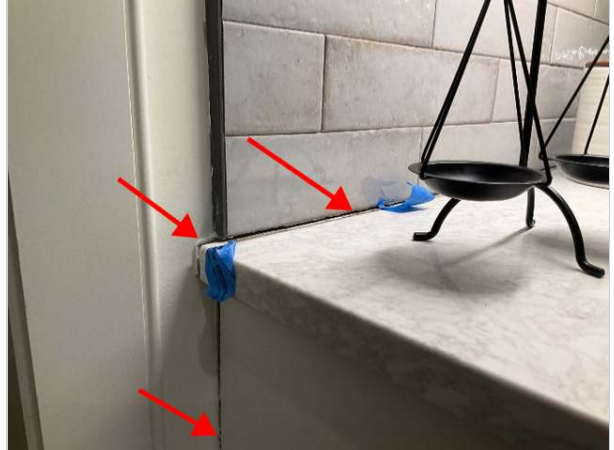
1. The kitchen cabinets near the gas range appear to be separating from the wall and are loose. Gaps were observed in the caulk and grout. If not repaired this will continue to worsen. Have the builder ensure that these cabinets are adequately secured to the walls and make repairs to ensure proper function.

The kitchen cabinets near the gas range appear to be separating from the wall and are loose. Gaps were observed in the caulk and grout. If not repaired this will continue to worsen. Have the builder ensure that these cabinets are adequately secured to the walls and make repairs to ensure proper function.

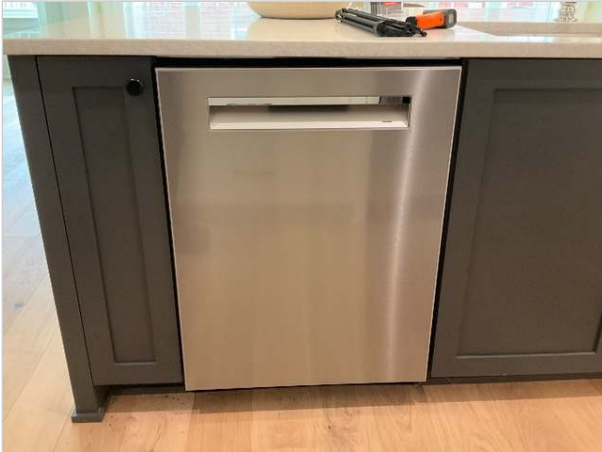
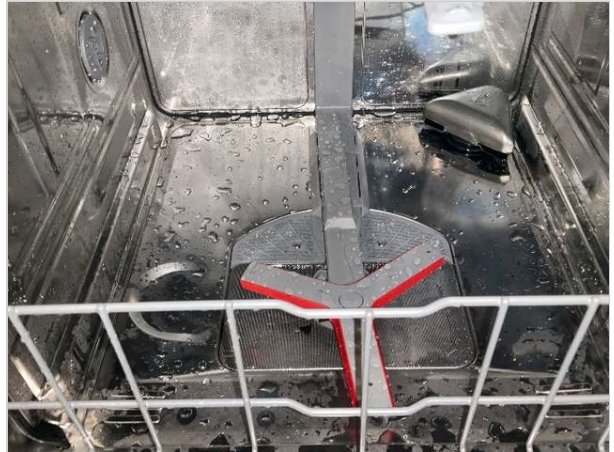
Photo 106

The dishwasher was tested and did appear to be functional.

Manufacturer: Bosch Model Number: SHP78CM5N/28 Serial Number: FD050308545

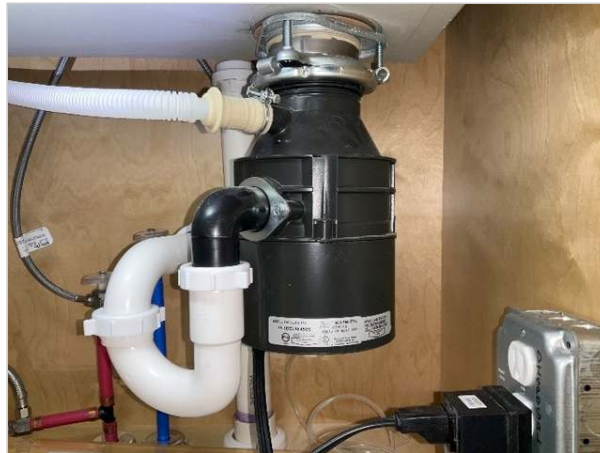
Photo 108

The disposal was inspected and did appear to be functional. The efficiency rating and chopping / grinding ability of the unit is not within the scope of the inspection.

Manufacturer: InSinkErator Model Number: BADGER 5-91A Serial Number: IDE1464505

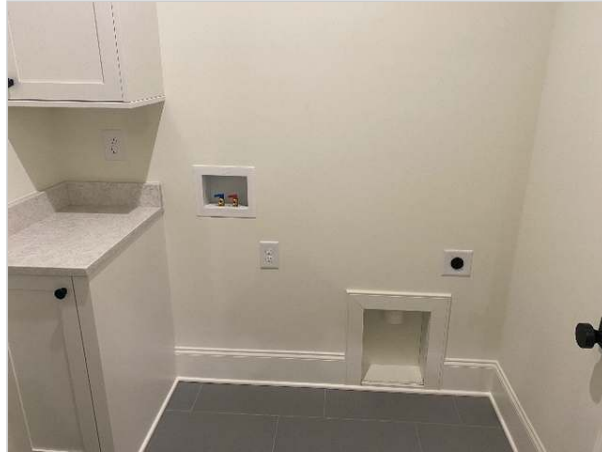
Photo 109

This note is supplied for informational purposes only, as many clients want to know the type of dryer connections available to them. A 240 volt style outlet for an electric clothes dryer was installed in the laundry area. For safety reasons, no attempt was made to verify that the electrical outlet is properly wired or that power is present. Consult with a qualified contractor if the desired type of connection is not available.

A drain for a washing machine was present.

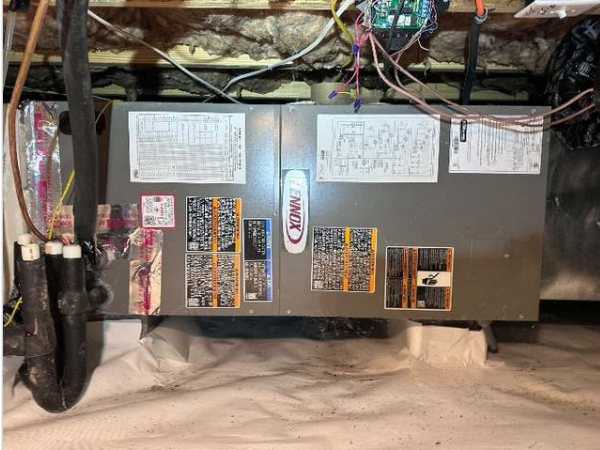
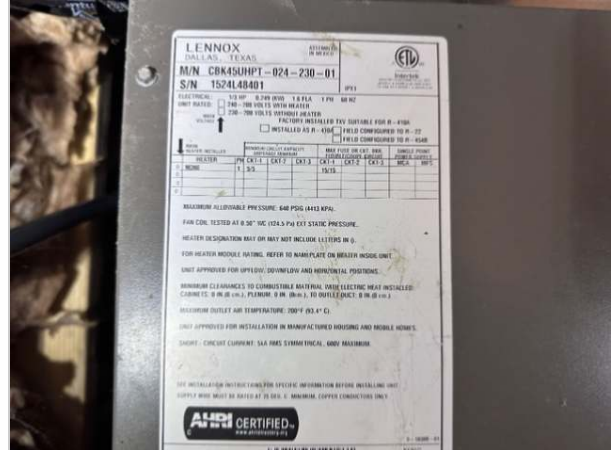
Photo 110

The first floor of the structure was heated by a Lennox electric heat pump, Model Number CBK45UHPT - 024-230-01 and Serial Number 1524L48401, which is 2 years old. The unit was located in the crawl space of the structure. It has an approximate net heating capacity of 60 Hz . The automatic safety controls on the unit were tested and found to be functional at the time of the inspection.

The HVAC condensate line was raised above the floor drain or drain inlet. The condensate line was trapped. The HVAC condensate line must be trapped and not in contact with wet drain inlets to prevent the possible migration of bacteria and mold into the air-handling system. The heating system was found to be functional.

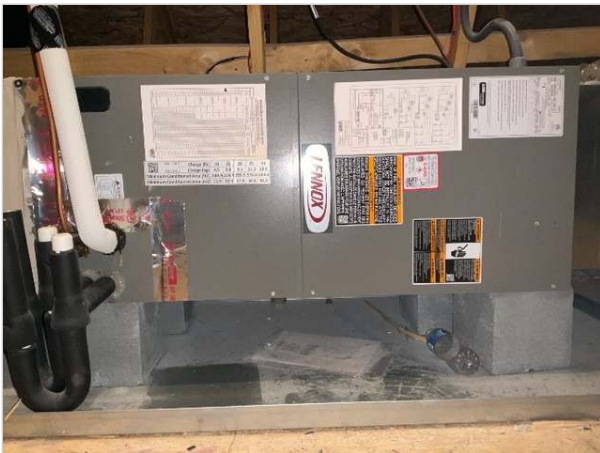
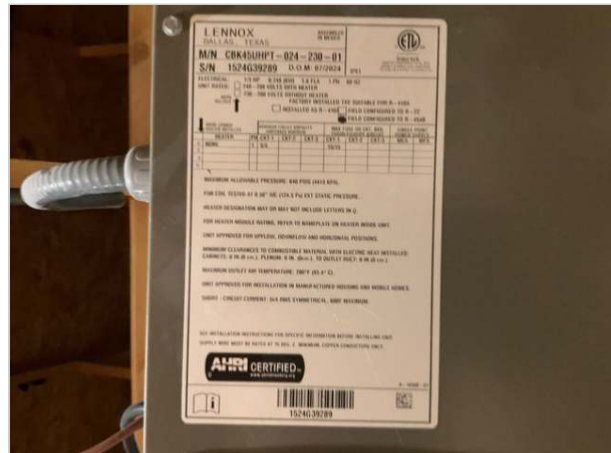
Photo 112

The second floor of the structure was heated by a Lennox electric heat pump, Model Number CBK45UHPT-024-230-01 and Serial Number 1524G39289, which is 2 years old. The unit was located in the attic of the structure. It has an approximate net heating capacity of 60 Hz . The automatic safety controls on the unit were tested and found to be functional at the time of the inspection.

The HVAC condensate line was raised above the floor drain or drain inlet. The condensate line was trapped. The HVAC condensate line must be trapped and not in contact with wet drain inlets to prevent the possible migration of bacteria and mold into the air-handling system. The heating system was found to be functional.

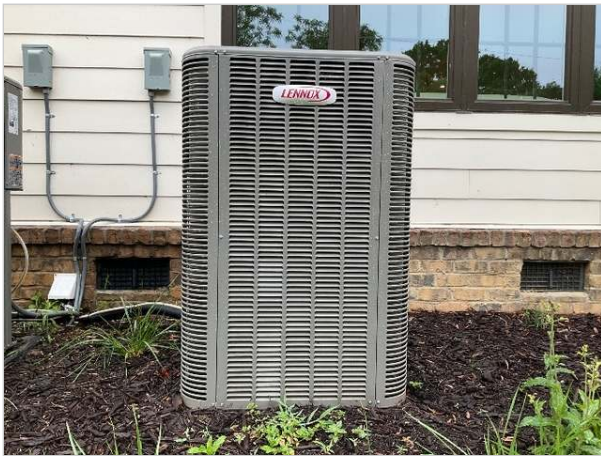
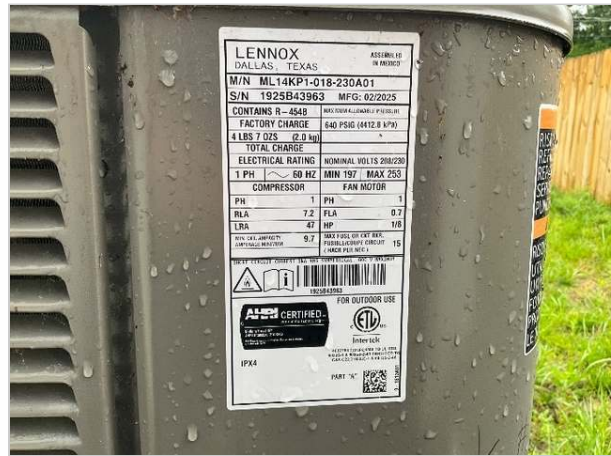
Photo 114

The electric outdoor heat pump condensing unit servicing the first floor was a Lennox, Model Number ML14KP1-018-230A01 and Serial Number 1925B43963. The unit is located in the back of the structure. This unit is approximately 1 years old (02/2025). Periodic preventive maintenance is recommended to keep this unit in good working condition. The heat pump system was functional.

average of 66.5 degrees F, which is normal.

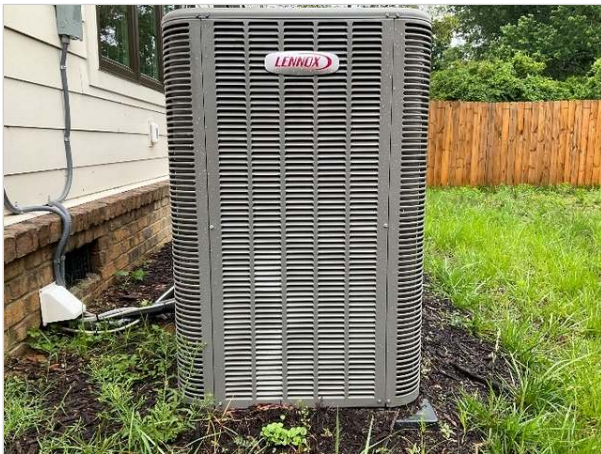
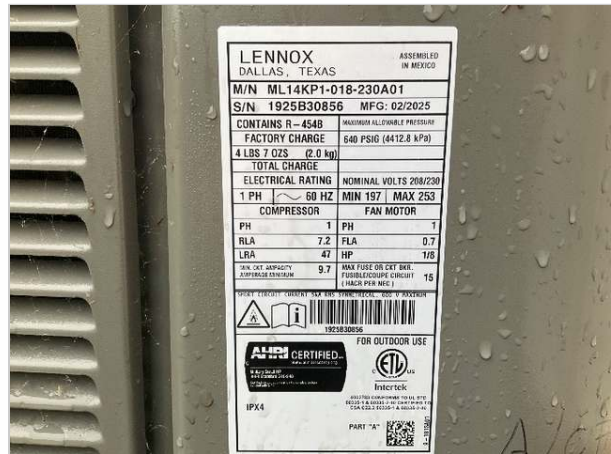
Photo 116

The electric outdoor heat pump condensing unit servicing the second floor was a Lennox, Model Number ML14KP1-018-230A01 and Serial Number 1925B30856. The unit is located in the back of the structure. This unit is approximately 1 years old (02/2025). Periodic preventive maintenance is recommended to keep this unit in good working condition. The heat pump system was functional.

The temperature was measured at several locations. At the supply it was 58 degrees F, and at the return it was 75 for a average of 66.5 degrees F, which is normal.

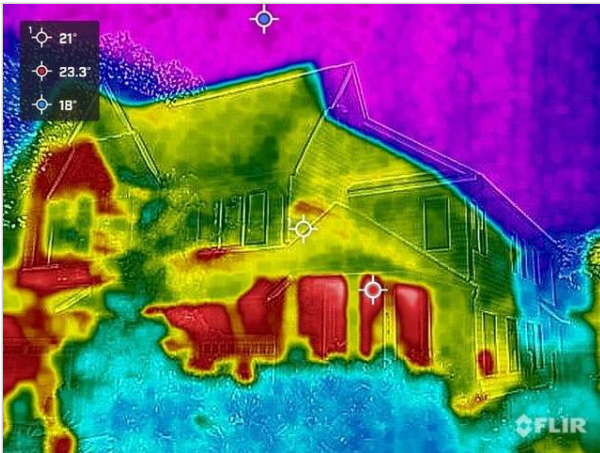
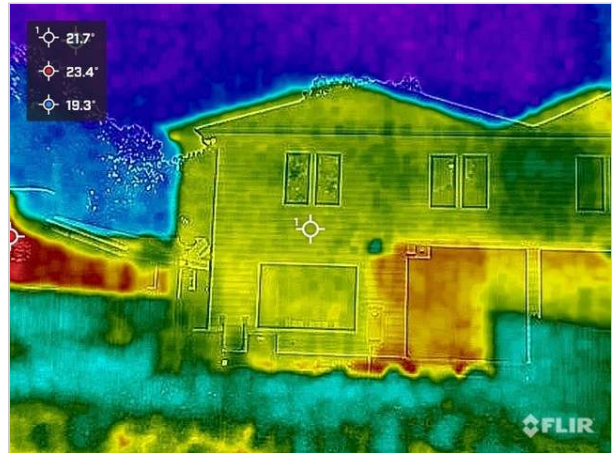
Photo 120

The thermal scanning of the structure did not locate/identify areas with temperature differentials indicating area of concerns related active moisture intrusion, overheating components, and / or the structure's thermal barrier.
