HOME INSPECTION REPORT

On Saturday, January 1, The HomeTeam Inspection Service made a visual inspection of 123 Sample Street, Oro Valley, AZ 85737. Enclosed please find a written, narrative report of our findings in accordance with the terms of our Inspection Agreement.

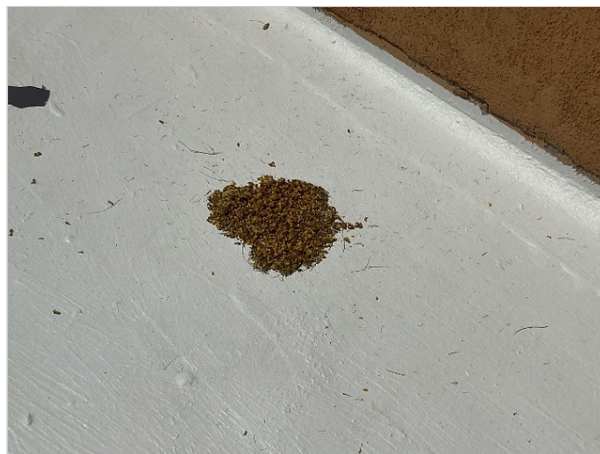
Photo 15

> **Excessive leaves and/ or other debris observed on roof.** This debris can trap moisture on roof and cause deterioration of the roofing material. Suggest that this debris be removed by a qualified party and that this issue be monitored in the future.

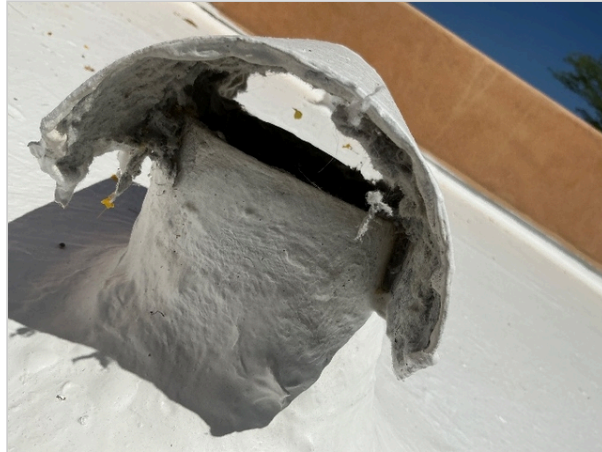
Photo 24

> **Dryer vent to exterior observed to have excess lint at discharge point.** Excessive lint build-up can be conducive to fire. Suggest removal of vent and cleaning of duct by a qualified party.

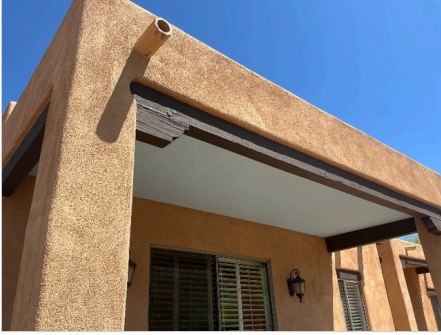
Photo 27

> **Fascia board showing signs of previous moisture intrusion through either splitting, staining, warping or surface degradation.** Suggest evaluation by a qualified party to determine where moisture is/was being introduced. Once the moisture intrusion has been eliminated, the fascia boards should be repaired or replaced as necessary.

Front left

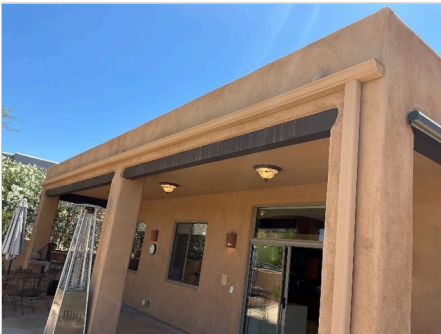
Photo 30

Observed wasp nest on the eaves of the front left patio.

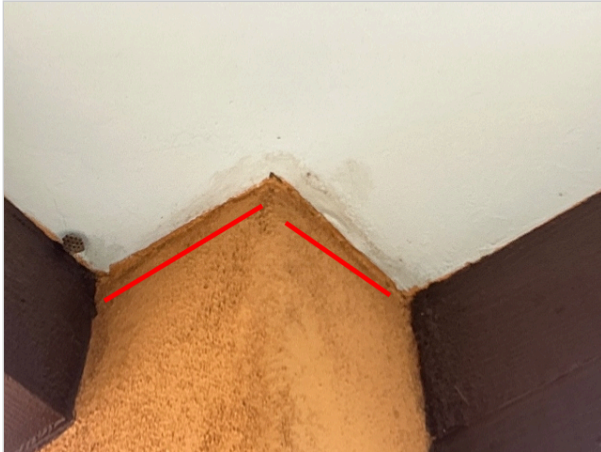
Photo 32

> **A few under-eave area(s) found with evidence of prior moisture intrusion.** Suggest repair by a qualified roofing professional to fix moisture intrusion and assess damage to sheathing.

Front left patio

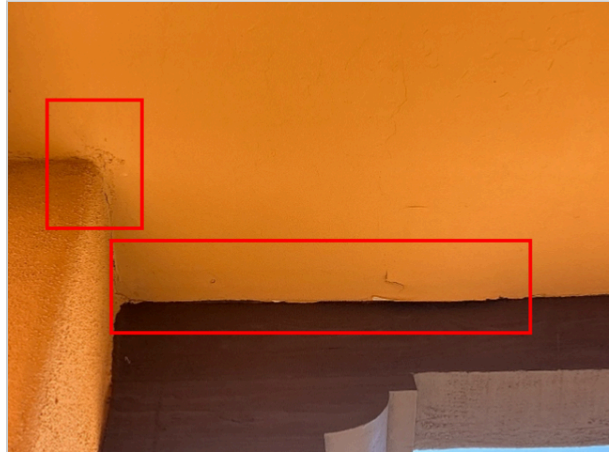
Photo 33

Front entry

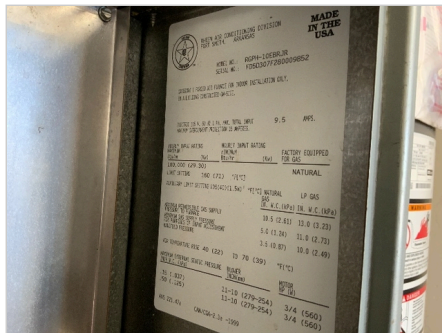
Photo 41

Info badge

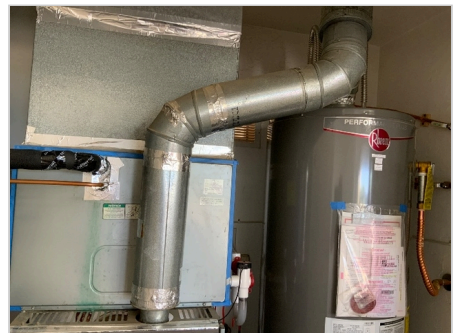
Photo 42

Vent

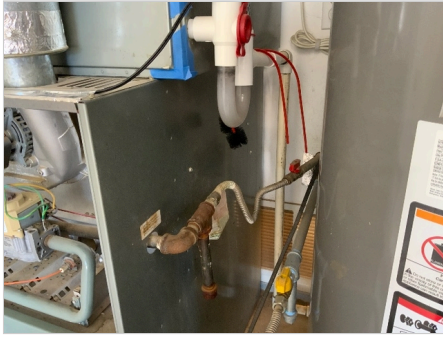
Photo 43

The primary condensate line was trapped. The trap prevents air from moving in or out of the coil box/ air handler during operation. Other issues with either the primary or secondary condensate drain were not observed.

Condensate trap

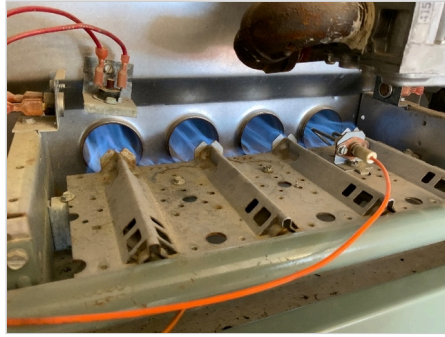
Photo 44

Burners

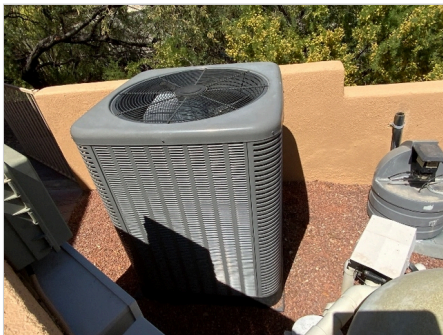
Photo 45

The electric outdoor AC condensing unit was a Ruud, Model Number RA1460CJ1NA and Serial Number W202032935. The unit is located in the back of the structure and appears to be rated at 5 tons and correctly sized for the structure. This unit is approximately 6 year(s) old and has R410A refrigerant. The forced air cooling system was tested and found to be functional. The supply and return air temperature was measured at several locations. At the supply, it was 37 degrees F and, at the return, it was 57 degrees F for a temperature split of 20 degrees F, which is normal.

AC condenser

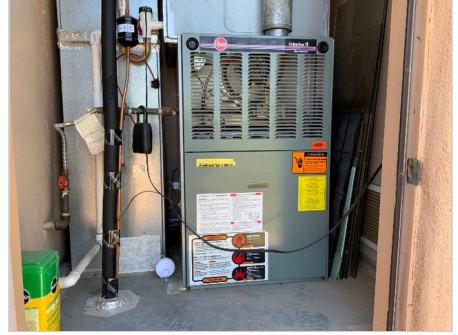
Photo 50

The structure was heated by a Rheem natural gas forced air furnace with Model Number RGPH-10EBRJR and Serial Number FD5D307F280009861 which is approximately 25 year(s) old. The unit was located in the exterior utility closet of the structure. It has an approximate net heating capacity of 100,000 BTUH. The galvanized steel venting system was adequate to exhaust the spent gases to the exterior of the structure and was in good condition. The heating system was functional.

Furnace

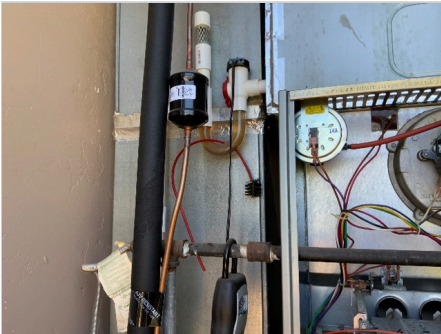
Photo 54

The primary condensate line was trapped. The trap prevents air from moving in or out of the coil box/ air handler during operation. Other issues with either the primary or secondary condensate drain were not observed.

Condensate trap

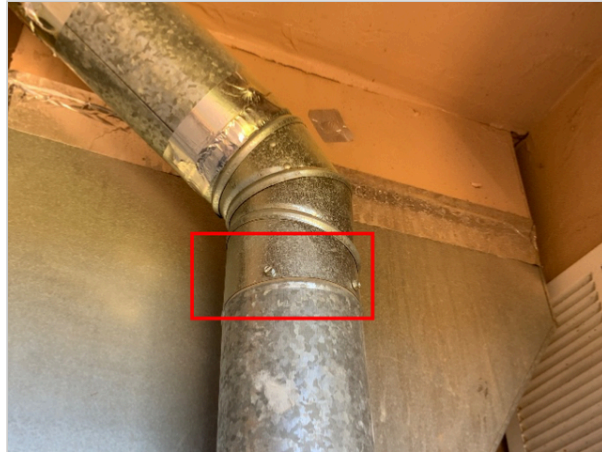
Photo 56

The furnace flue pipe is not sealed where it enters the chimney, possibly leading to exhaust gases entering the structure. In order to ensure proper venting of the flue gases, the chimney should be properly sealed around the flue pipe. Consult with a qualified contractor for repair.

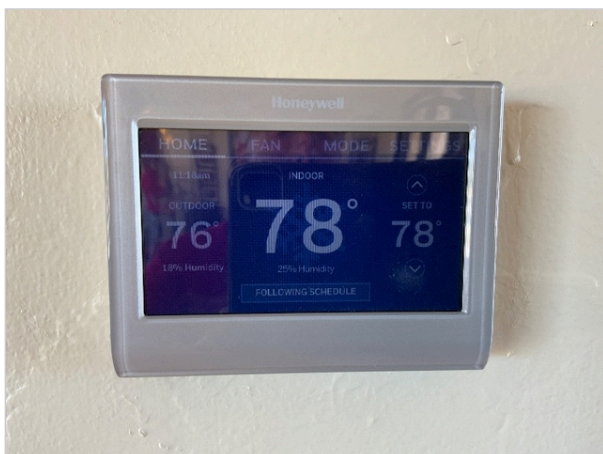
Photo 57

- Thermostat #1 is a digital manufactured by Honeywell. This thermostat is located on the dining room wall of the home and was found to be in working order.
- Thermostat #2 is a digital manufactured by Honeywell. This thermostat is located on the hallway wall of the home and was found to be in working order.

Dining room

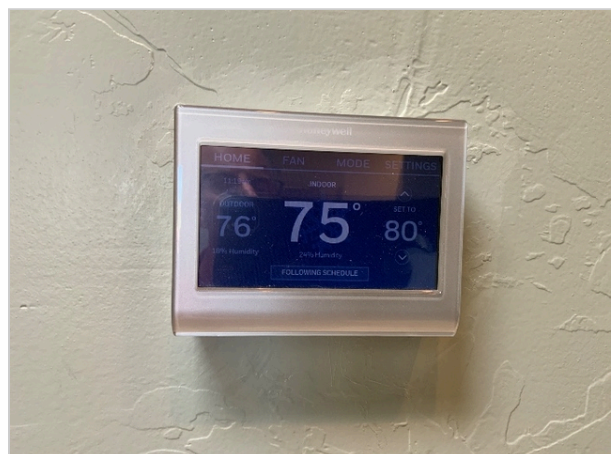
Photo 58

Hall

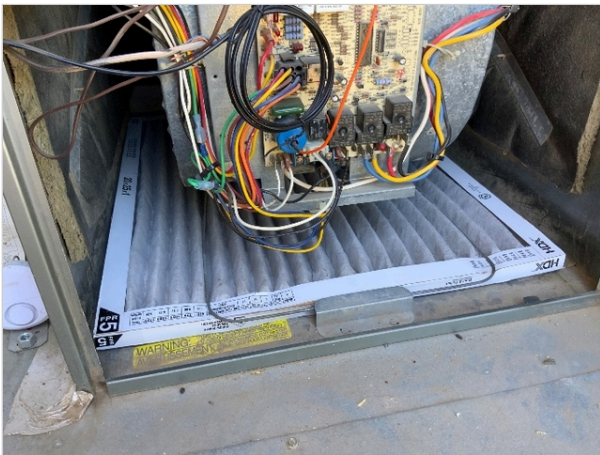
Photo 59

- Filter location #1 is at the bottom of the furnace/air handler. There is one disposable filter(s) found to be in good condition. For disposable filter(s), the size of the replacement filter is 20 x 25 x 1.

Location 1 filter 1

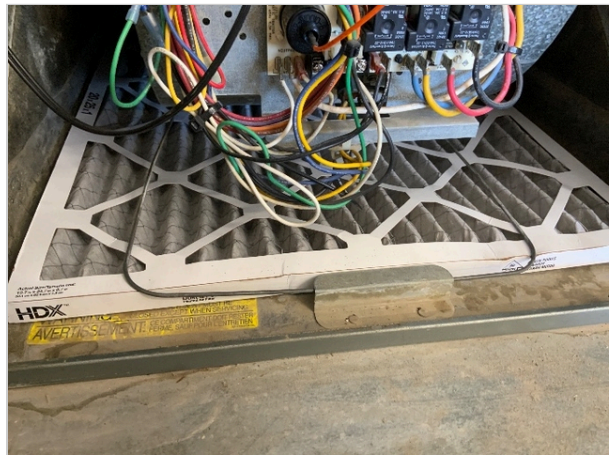
Photo 60

- Filter location #2 is at the bottom of the furnace/air handler. There is one disposable filter(s) found to be in good condition. For disposable filter(s), the size of the replacement filter is 20 x 25 x 1.

Location 2 filter 2

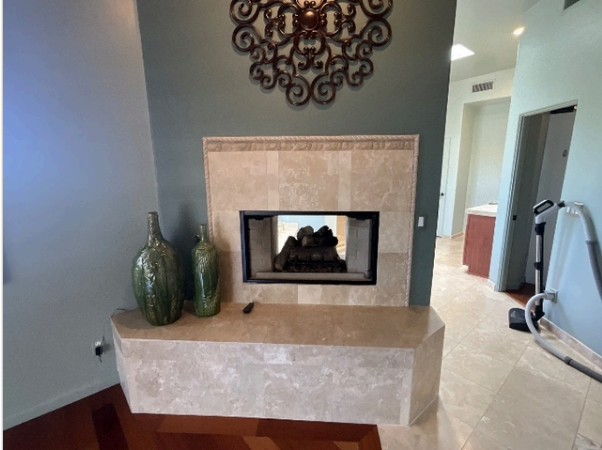
Photo 61

A vented fireplace insert with natural gas fuel supply was located in the master bedroom. The chimney/flue was metal material. The unit was operated and was functional. There were no material defects observed on the gas fireplace.

Primary bedroom fireplace

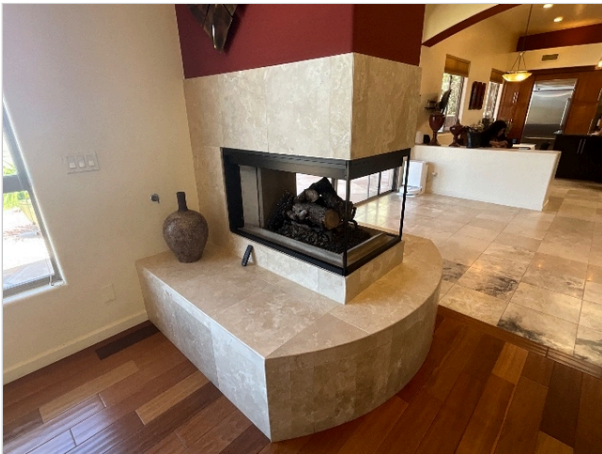
Photo 63

A vented fireplace insert with natural gas fuel supply was located in the living room. The chimney/flue was metal material. The unit was operated and was functional. There were no material defects observed on the gas fireplace.

Living room fireplace

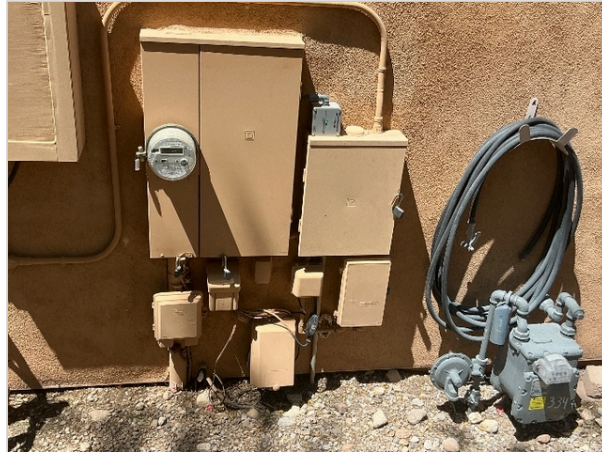
Photo 72

The underground electric service supplied an electric meter on the right exterior wall . There were not any adverse conditions observed with the service drop or service lateral to the main panel. The service conductors were observed to be copper and their condition was good.

Underground service

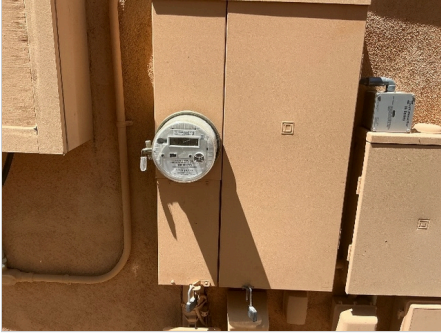
Photo 74

The service wire appeared to be 120/240 volt and 200 amp and entered a Square D service panel, located on the right exterior wall. The main service disconnect was a single 200-amp rated circuit breaker and was located in the main panel.

Main panel

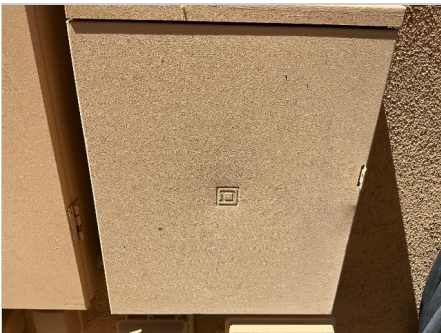
Photo 79

An electric service sub-panel was located Right exterior wall, and was manufactured by Square D. The service wire appeared to be rated for 60 amps. The disconnect switch for this panel was located in the main panel, and was rated at 60 amps. The branch circuits within the panel were copper. These branch circuits and the circuit breaker to which they were attached appeared to be appropriately matched to the circuits..

Sub panel

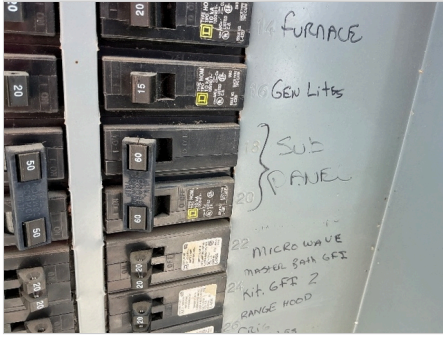
Photo 82

Sub panel disconnect

> **At least one breaker observed to be in "Off" position. Breaker was not marked so inspector unable to determine usage for circuit. Suggest discussion with seller to provide input as to what breaker is powering.**

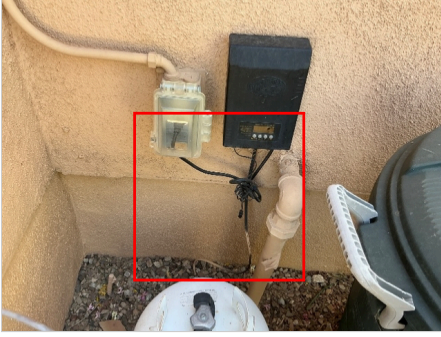
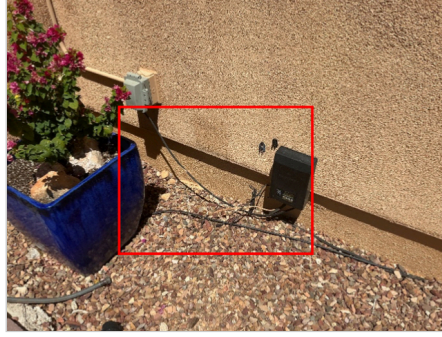
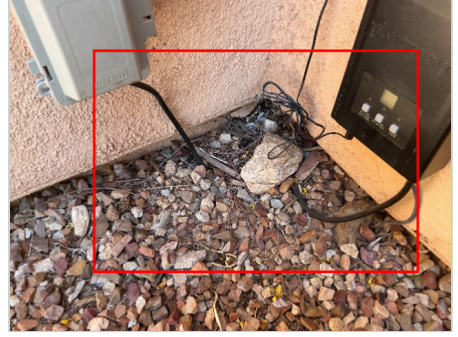
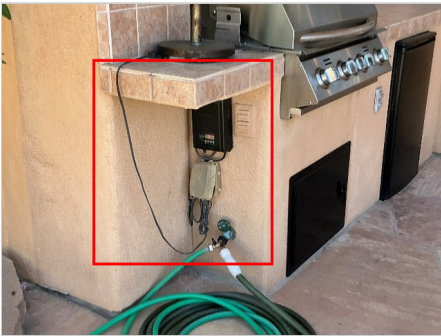
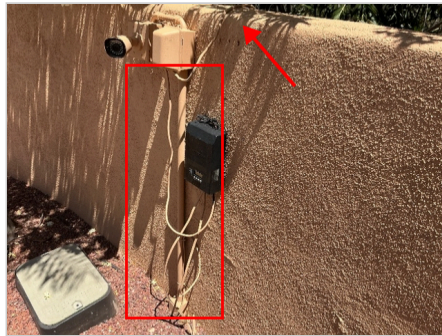
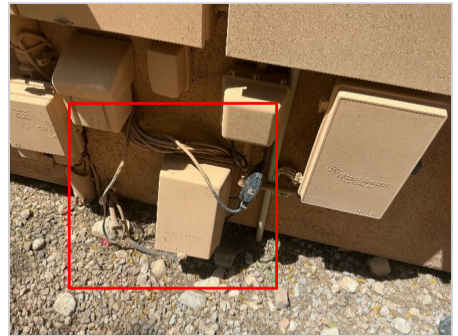
> **Evidence of amateur wiring was observed on exterior of home. This typically takes the form of an extension cord that is being used on a semi-permanent basis. Amateur wiring may not conform to standards methods and could be a safety concern. Consult with a qualified electrician for further evaluation and possible repair**

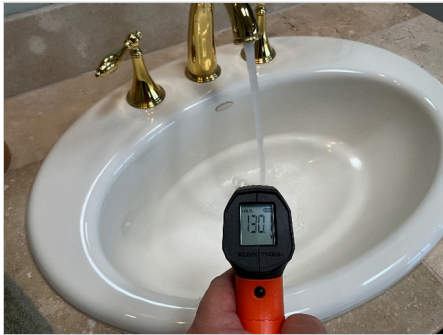
Photo 101

Measured water temperature

Note- The hot water temperature is high and may pose a risk of burning. HomeTeam recommends adjusting the hot water temperature by turning down the water heater thermostat.

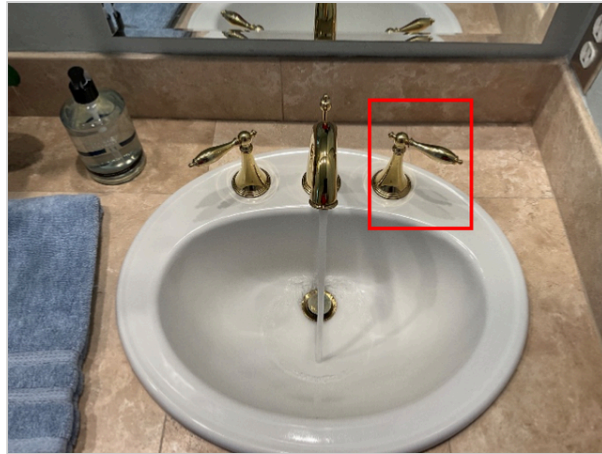
Photo 106

> **Faucet handle requires excessive force to actuate handle.** Suggest repair by a certified plumber to correct.

West tend hallway bathroom right side sink

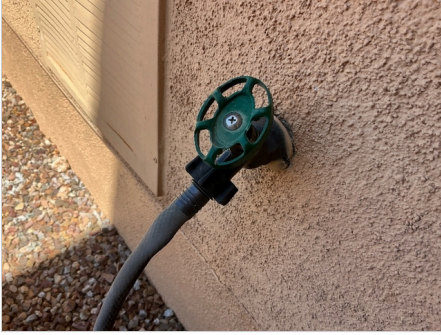
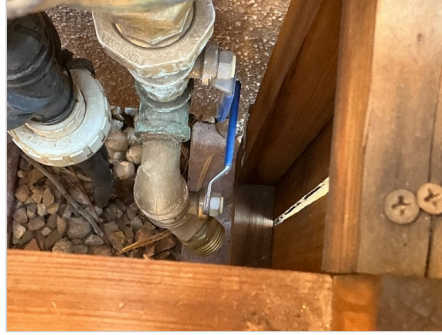
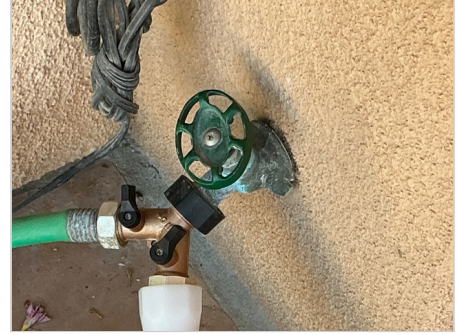
> **Hose bib observed to leak from the bonnet area when valve is actuated.** Suggest repair by a qualified party.

Note: Cross connections observed on at least one hose bib (missing vacuum breaker). Cross connections are a possibility wherever supply plumbing and solid or liquid waste could come together and contaminate potable water with waste to create a serious health issue. Home inspection standards require the inspector to look for and call out any cross connections observed.

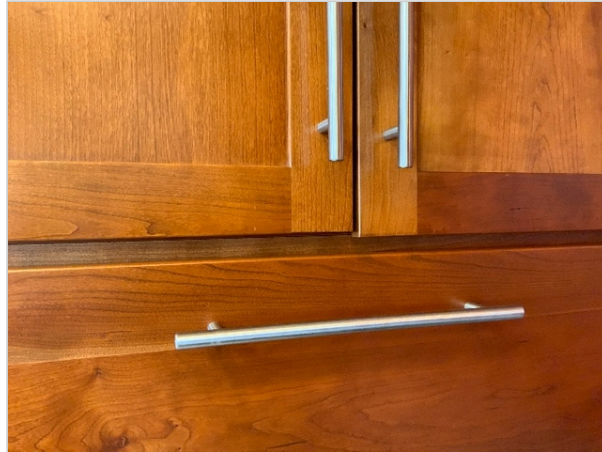
Photo 119

Note- Kitchen cabinet door hinges are in need of adjustment. These adjustments are usually relatively simple and only require the tightening of screws or alignment of a variable adjustment hinge.

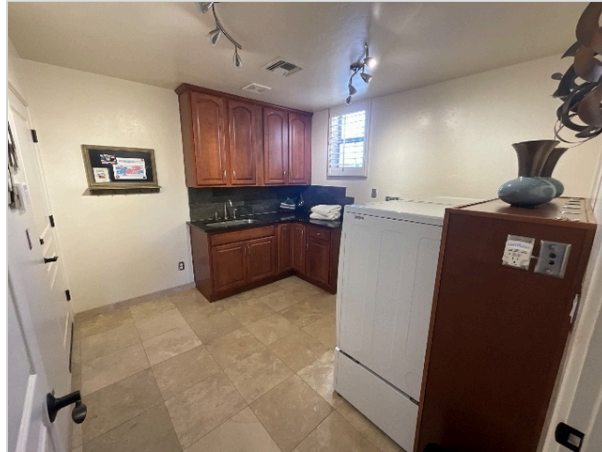
Photo 138

Note- Dryer vent is vertical in at least one place. This is not necessarily a deficiency, but because of this configuration the homeowner should consider having the dryer vent ductwork cleaned at regular intervals to prevent clogs.

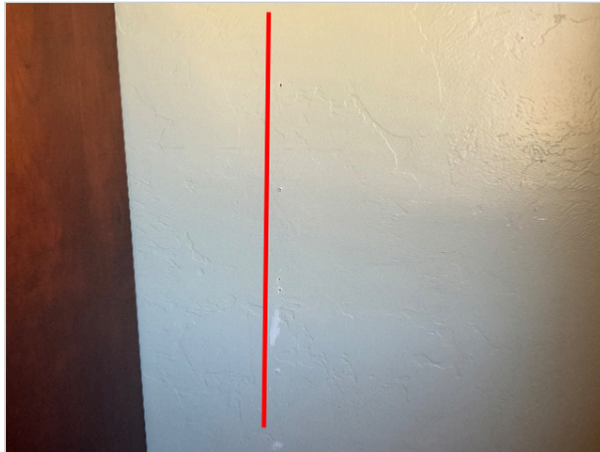
Photo 148

> **Areas observed with evidence of mechanical or pet damage.** Suggest repair of affected areas by a qualified party.

Primary closet

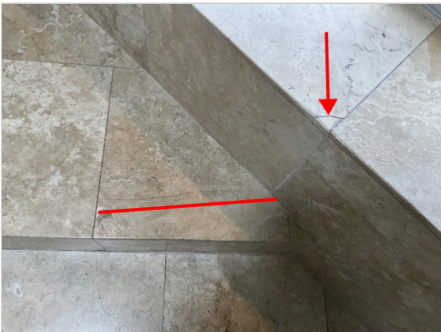
Photo 149

> **Multiple floor tile(s) observed to be cracked.** Tile cracking may indicate a crack in the concrete slab or it may be an isolated issue from the time of tile install. Suggest repair by qualified party assess and to insure debri and moisture are excluded.

Primary bathroom by jetted tub

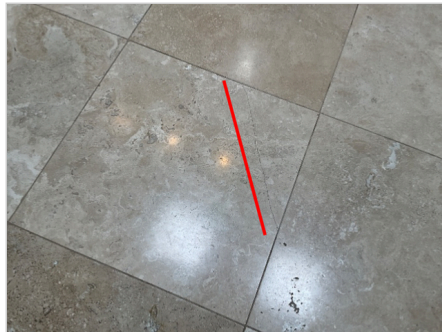
Photo 150

Primary bathroom by shower

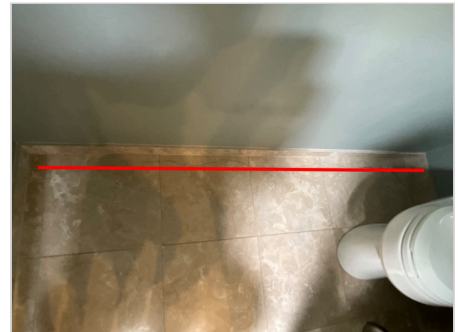
Photo 151

Primary water closet

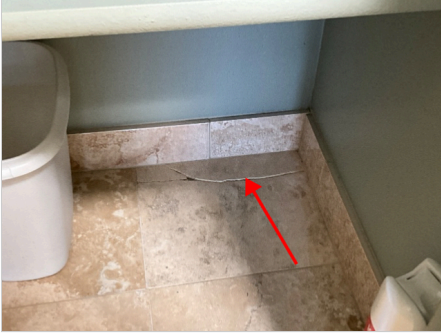
Photo 152

Primary bathroom pantry

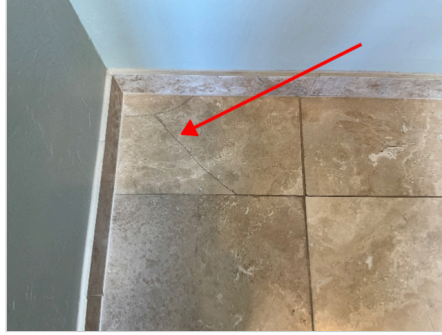
Photo 153

Primary bathroom

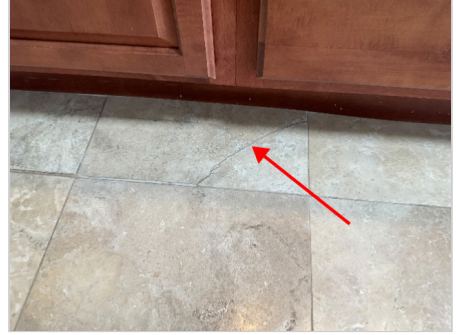
Photo 154

Primary bathroom by sinks

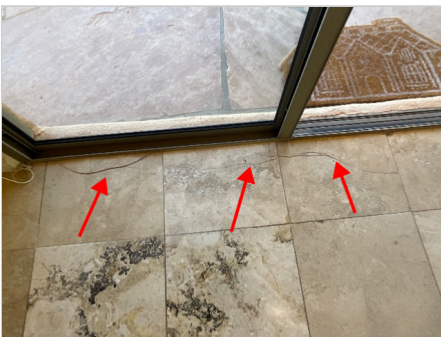
Photo 155

Tiles by rear patio slider door

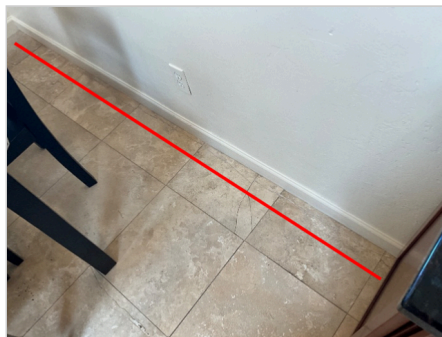
Photo 156

Breakfast nook tiles

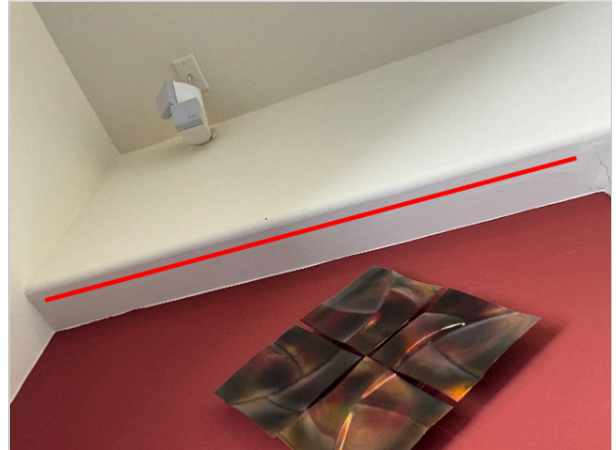
Photo 160

Note- One area(s) observed with settlement cracking in drywall. This type of cracking is typical and can usually be corrected with caulking and paint.

Living room ceiling above fireplace

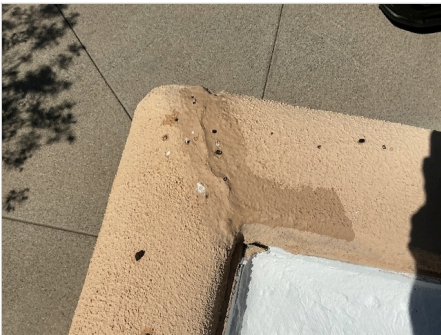
Photo 173

> **Area of previous stucco repair evident on exterior wall.** Suggest that buyer inquire as to why the repair was needed and whether it was completed by a qualified party.

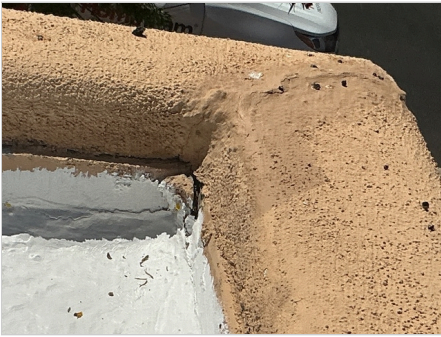
Photo 181

> Holes and damaged siding were noted on the parapet wall of the structure's exterior. This condition does not have any effect on the structural integrity of the building. The areas should be repaired to prevent water or pest intrusion.

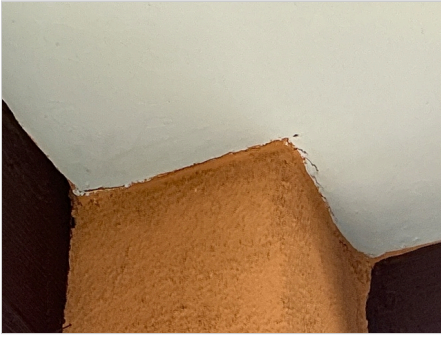
Photo 203

> **Exterior caulking is cracked or missing around the eaves.** This caulking should be repaired or replaced to protect against moisture intrusion.

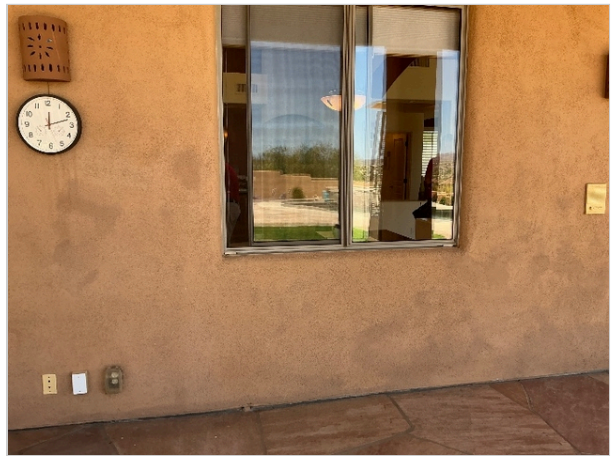
Photo 207

> **Area(s) observed with non-uniform paint.** Suggest correction by a qualified painting professional to protect surface and improve aesthetics.

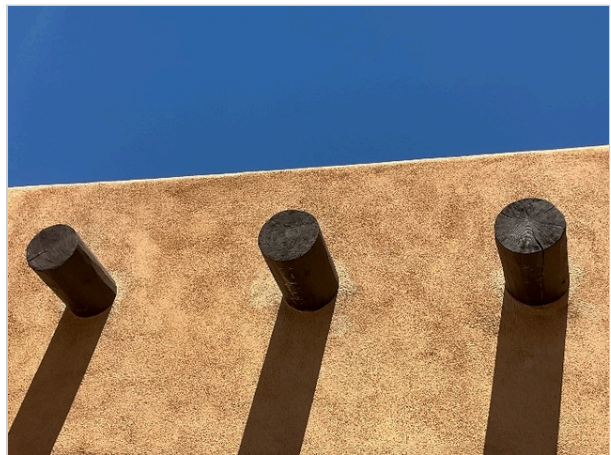
Photo 209

> **Exterior cladding and trim observed with moisture damage.** Suggest area(s) be repaired and sealed to limit further progression of damage.

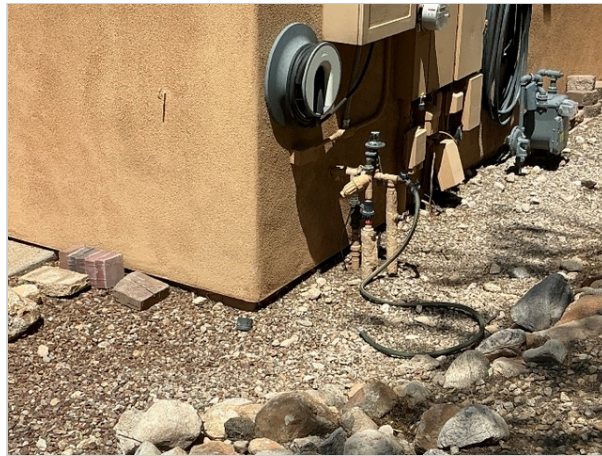
Photo 210

> **Mulch and/or dirt on the front of the structure is in direct contact with wood siding or trim.** This condition can cause water to penetrate into wood and other absorbent materials in the structure, causing wood rot and/ or insect intrusion. The mulch and dirt should be pulled back or the grade adjusted so that there is no earth-to-wood contact.

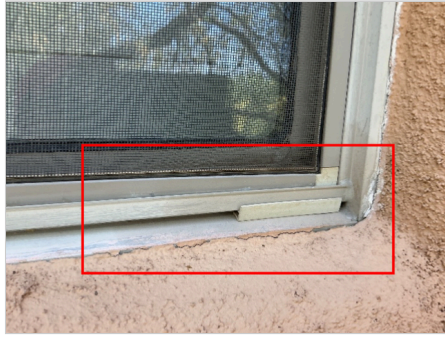
Photo 218

> **Exterior caulking is cracked or missing around the windows.** This caulking should be repaired or replaced to protect against moisture intrusion.

Left

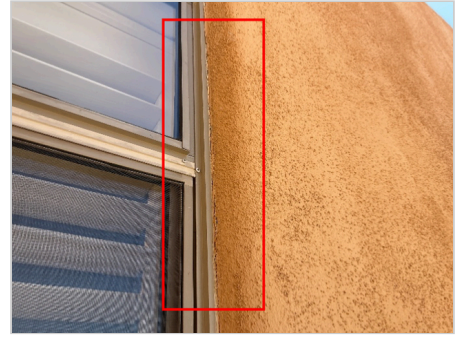
Photo 220

Front left of garage

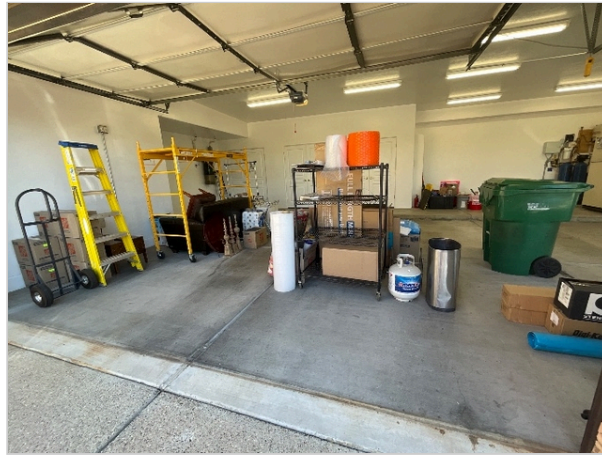
Photo 227

> Weatherstripping at garage door is loose. Suggest repair or replacement to limit intrusion by moisture and pests into garage space.

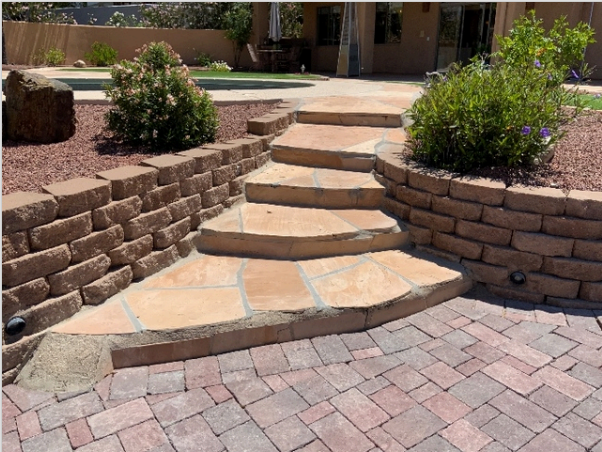
Photo 239

There were no handrails on the steps in the back. Adding a handrail will improve the safety of the stairs.

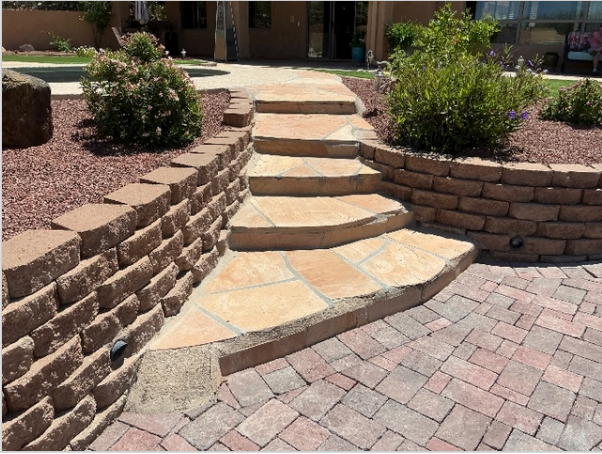
Photo 240

There were no handrails on the steps in the backyard . Adding a handrail will improve the safety of the stairs.

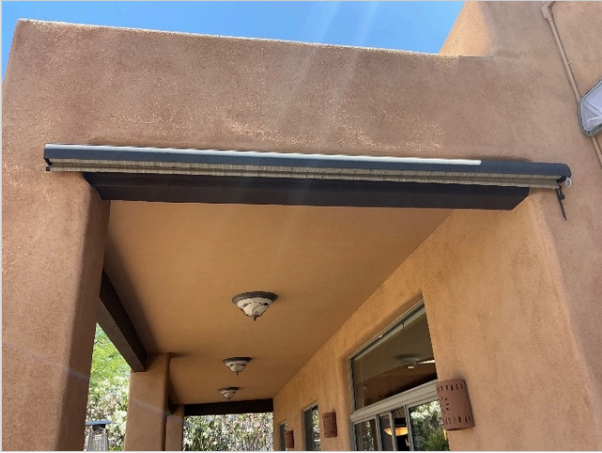
Photo 241

Unable to lower patio awning at time of inspection due to the lowering and raising device was not able to be located.

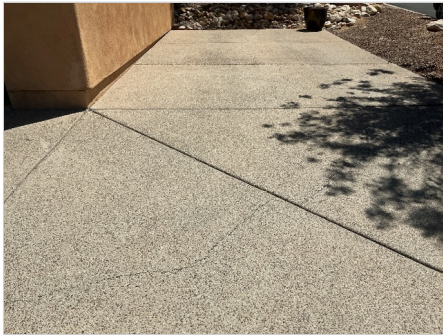
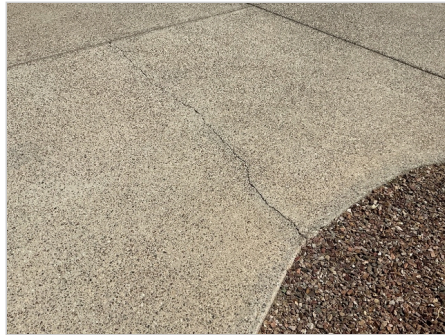
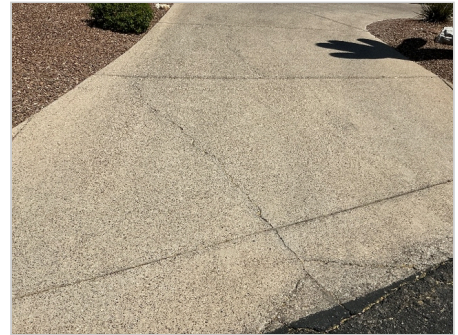
> **Crack(s) observed in concrete garage, driveway, or walkway.** Cracks that have separated and/ or have experienced upheaval at crack itself are of greater concern than those that have not. Suggest filling with epoxy or caulking to limit moisture intrusion and monitoring for further movement.

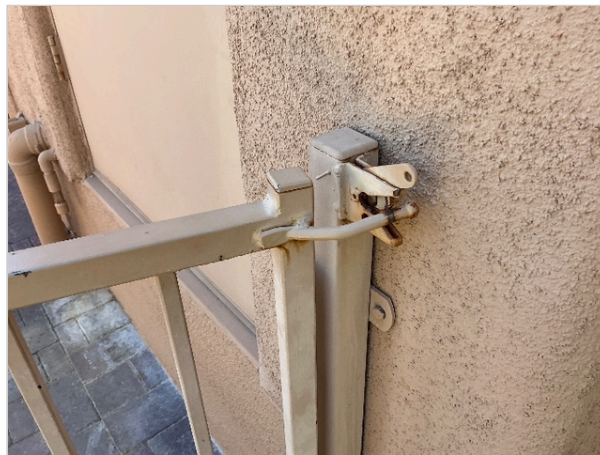
Photo 252

> **The gate on the left side of the home has a locking mechanism that needs repair or adjustment.** Suggest repair or replacement by a qualified party.

Left gate

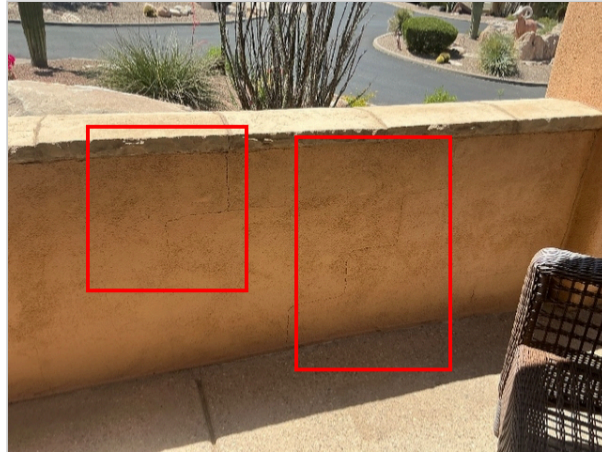
Photo 253

> **Perimeter fencing observed to be damaged in at least one area.** Suggest repair or replacement by a qualified party to enhance aesthetics and security.

Front patio wall

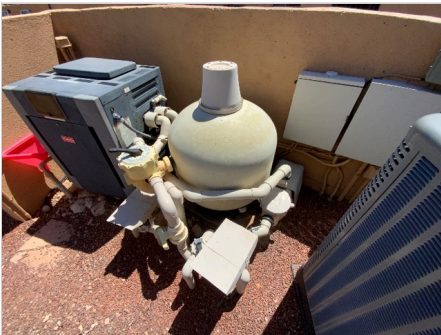
Photo 261

Pool equipment

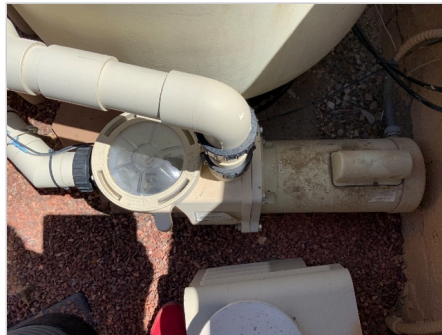
Photo 262

Pump

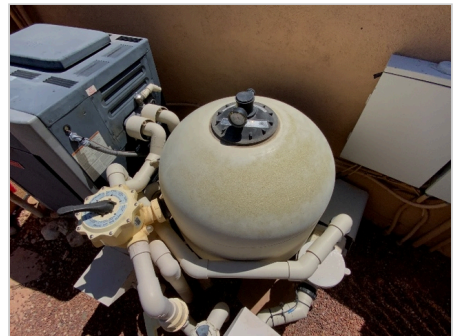
Photo 266

Filter

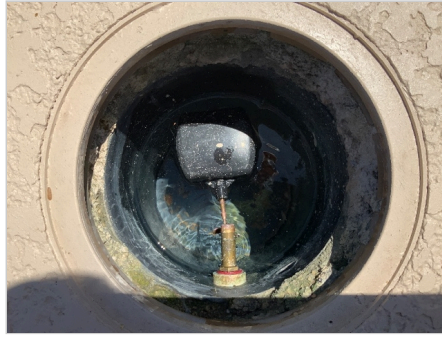
Photo 268

Auto fill

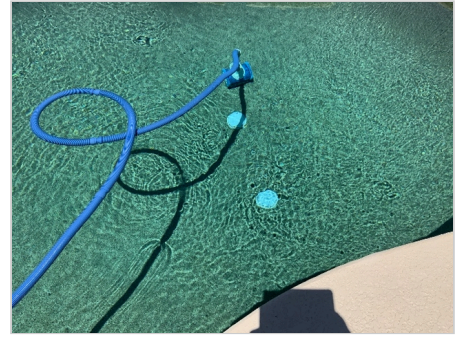
Photo 269

Pool drains

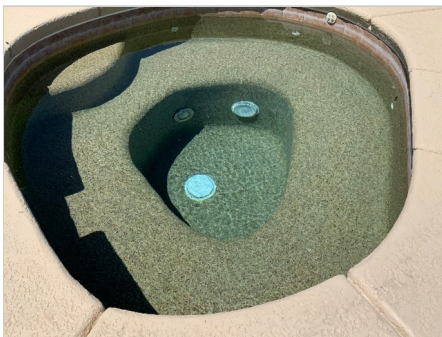
Photo 270

Spa drains

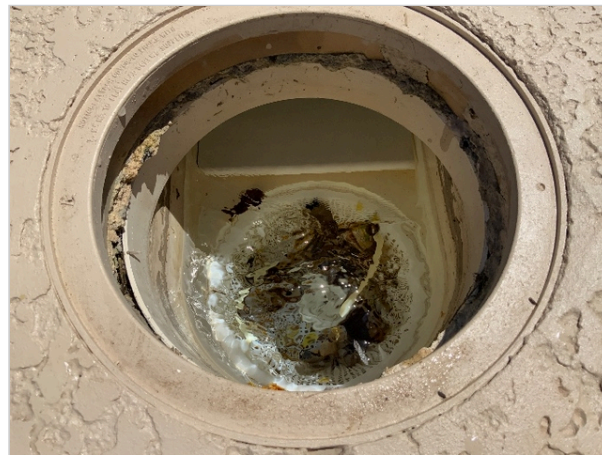
Photo 271

> **Weir valve on skimmer is requires repair.** The weir valve functions to keep debris pulled into skimmer from floating back into pool/ spa. Suggest repair or replacement by an authorized party.

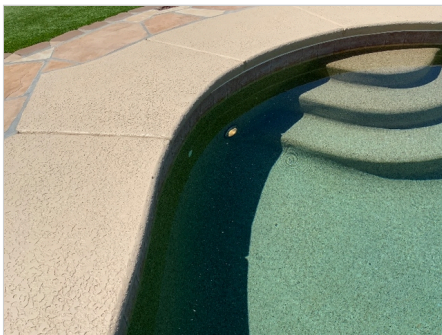
Photo 273

Light

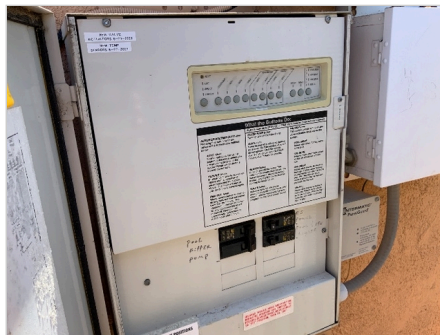
Photo 274

Timer

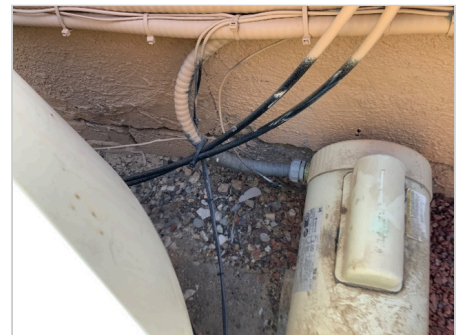
Photo 275

Bond wire

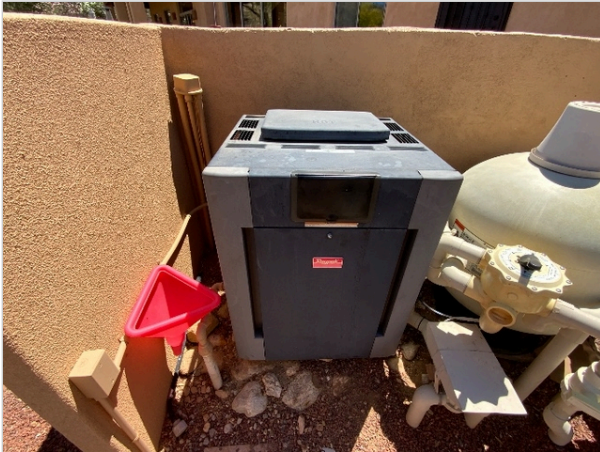
Photo 276

The pool and/or spa uses a Rheem natural gas heater. The unit was inspected and found to be operational with no areas of concern.

Heater

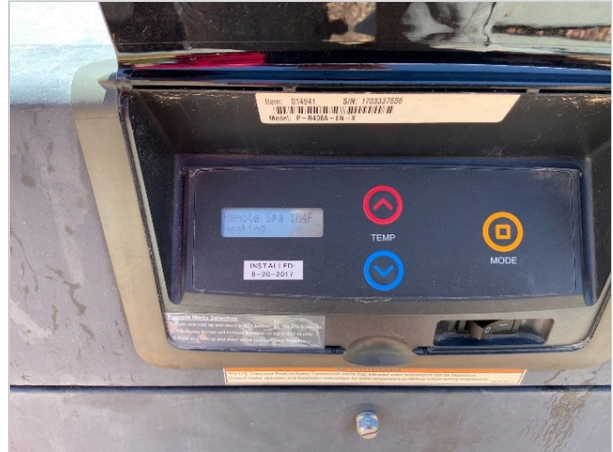
Photo 277

Controls

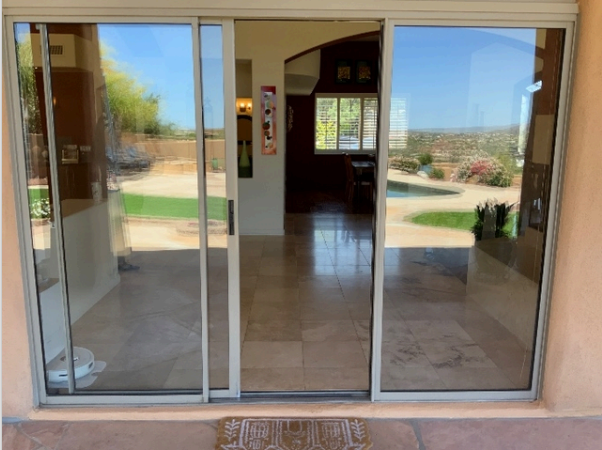
Photo 279

> Doors from house to pool area lack alarms, auto-close, and/ or locking features to prevent or alert access by small children to pool area. HomeTeam suggests that these preventive measures be investigated should small children be in the home for any length of time (supervised or unsupervised).
