# HomeTeam<sup>®</sup>

*HOME INSPECTION REPORT*

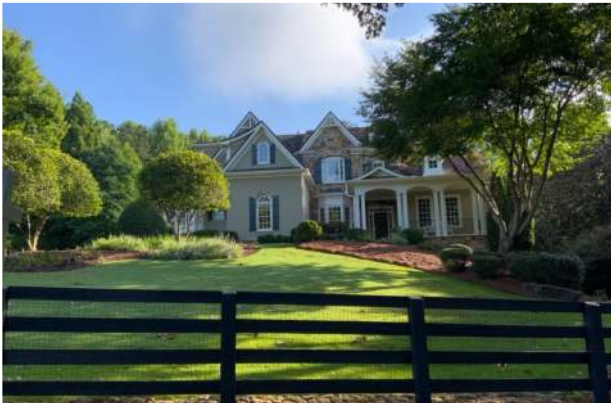
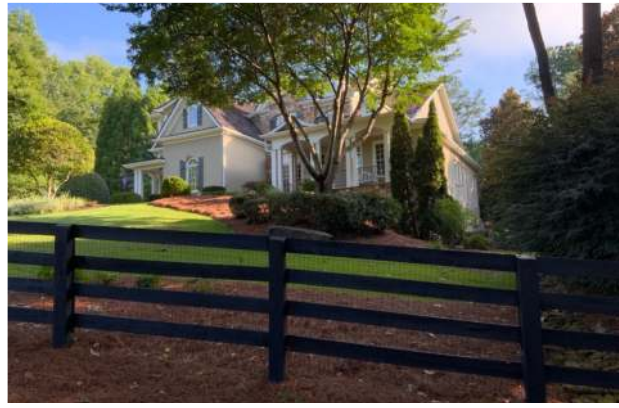
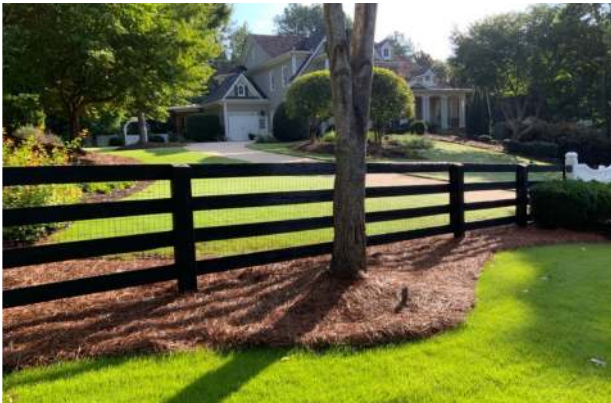
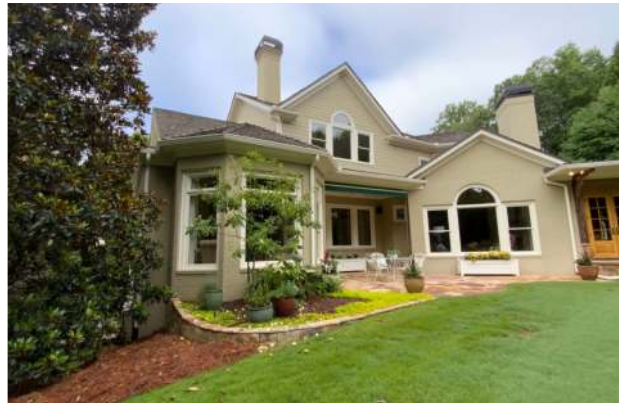
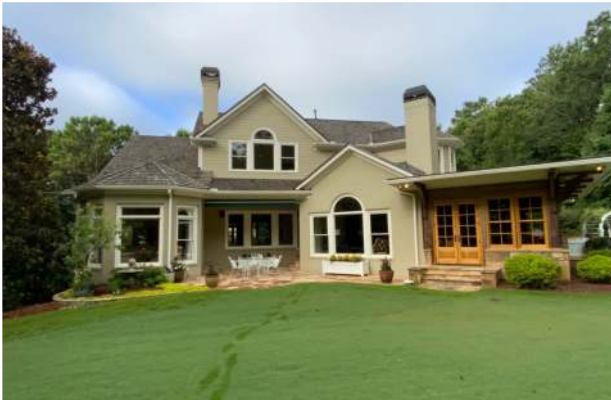
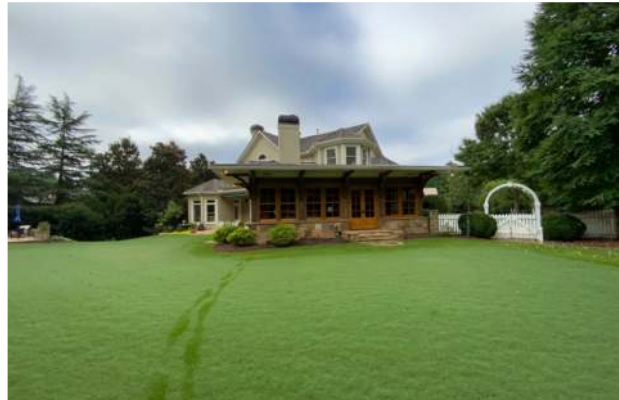
The structure was situated on a hillside lot. The general grade around the structure appeared to be inadequate on the front to direct rain water away from the foundation, assuming normal drainage and downspout, gutter, and other systems are functioning properly.

The grading around the structure appears to be insufficient to carry water away from the foundation. HomeTeam recommends having the soil regraded on the front of the structure and assessed at the time of regrading.

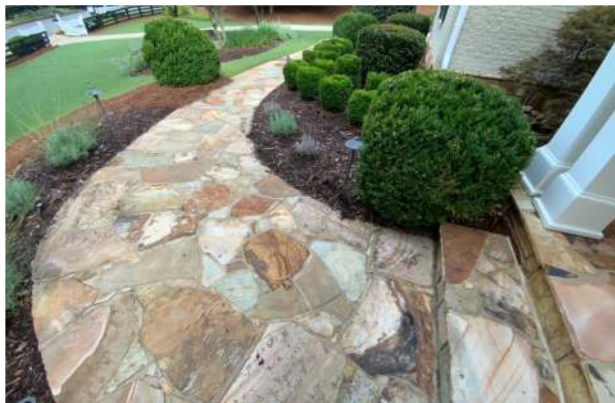
**Photo 12**

There was a stone walkway in the front of the home. Surface defects in walkways develop and progress with age and are considered normal as long as they do not create a safety hazard.

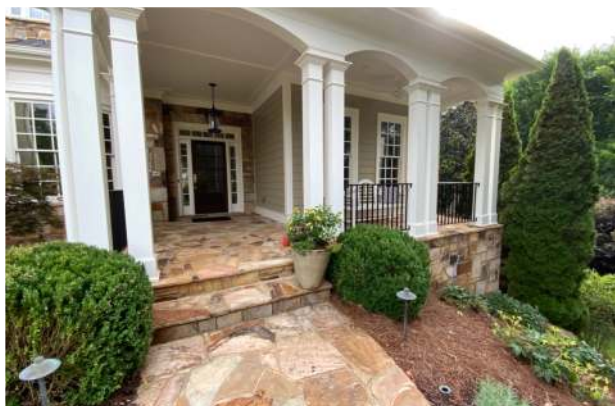
**Photo 13**

The handrail on the porch in the front is loose or otherwise not secure. The handrails should be repaired by a qualified contractor.

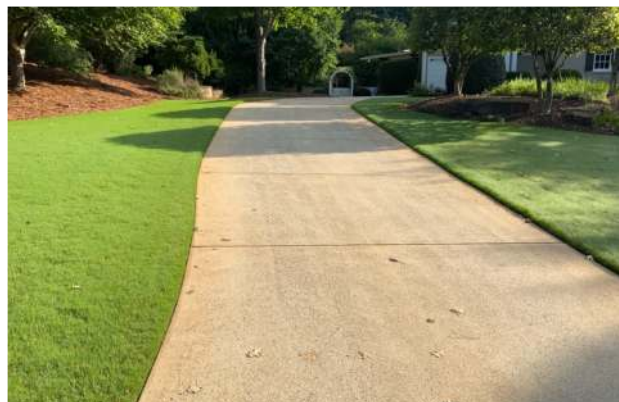
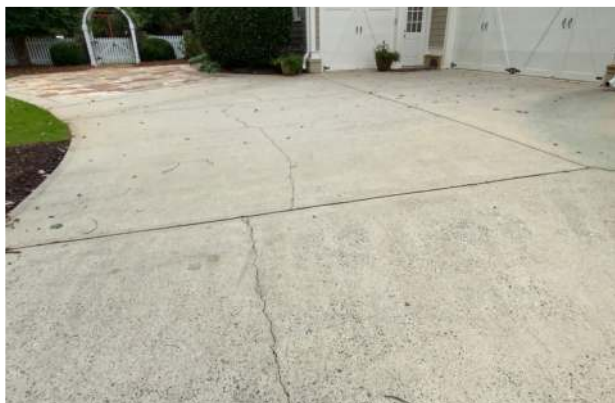
A concrete driveway is present in the front of the structure. Cracks and spalling were observed on the driveway. Surface defects in driveways develop and progress with age and are considered normal as long as they do not create a safety hazard. Sealing defects may help slow the rate of deterioration.

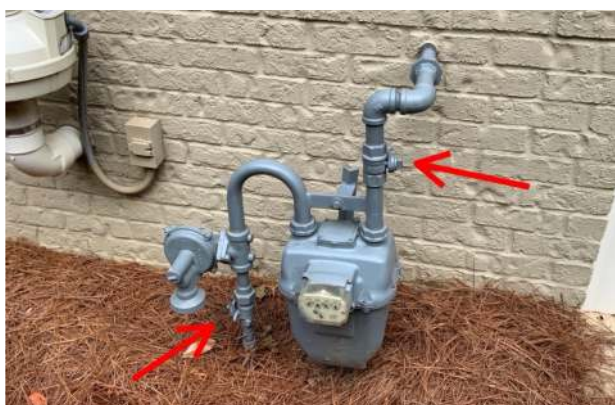
**Photo 26**

The gas meter and main shutoff were located in the right side yard. There was no noticeable odor of gas detected at the time of the inspection. The gas shut off valve will be indicated with arrow in picture below. NOTE: HomeTeam recommends that any structure with natural gas supply lines be protected with CO monitors located in living areas which will most improve the safety of the structure's occupants.

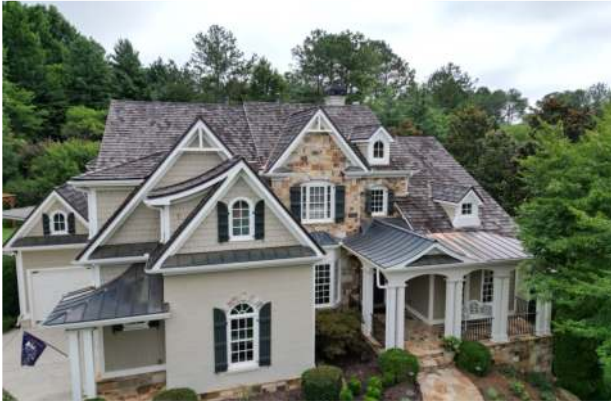
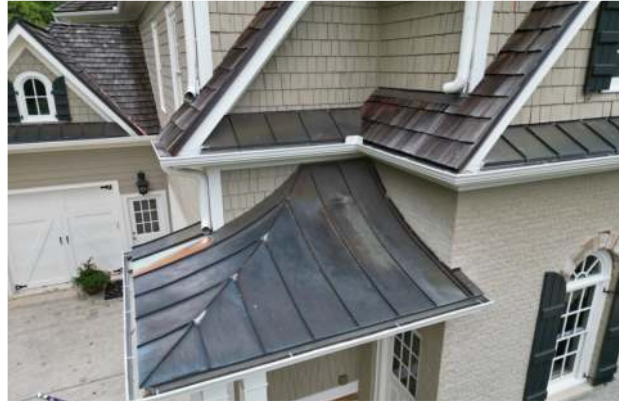
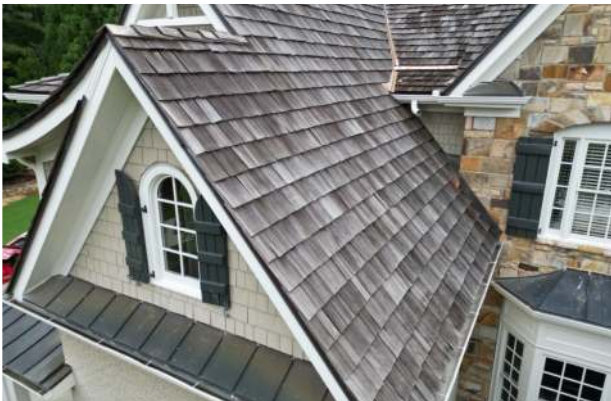
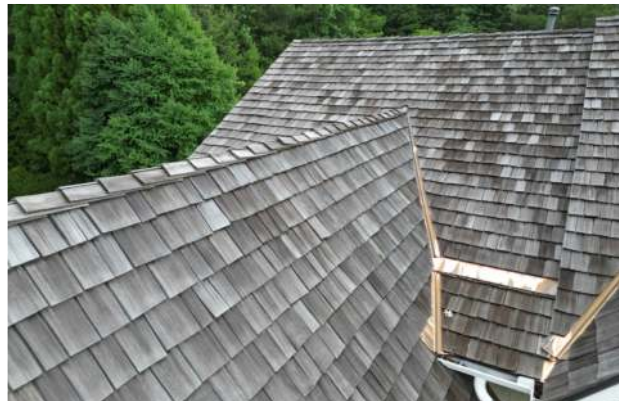
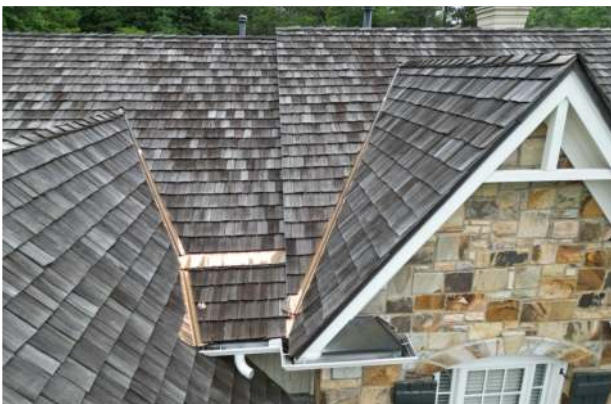
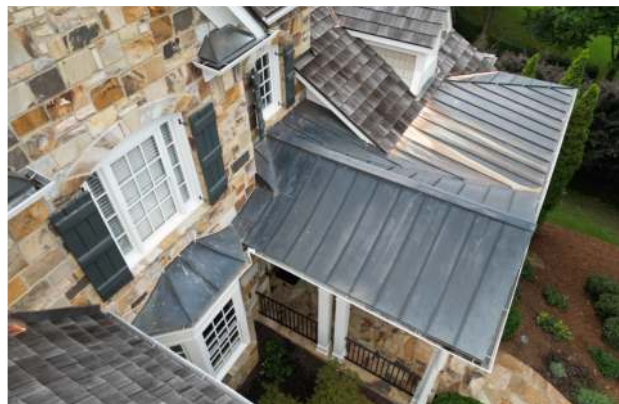
Curled roof shingles have been observed, suggesting that the roof may be nearing the end of its lifespan. It is recommended to have it assessed by a professional roofer.

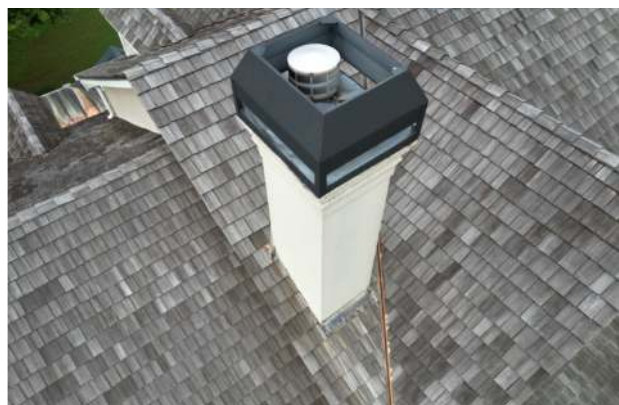
Photo 68

The metal flue chase cap is rusted. Over time, this may lead to water intrusion. No points of visible water intrusion were evident, although our view was limited. As a maintenance item, the rust should be removed and the metal cap painted and sealed to help prolong the life of the cap and reduce the potential for water intrusion.

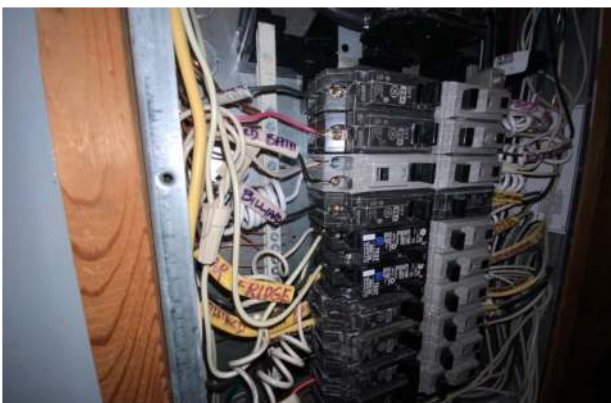
**Photo 137**

**Exposed or un-terminated live wires were observed in the basement.** The wires should either be disconnected at the source or properly terminated in an approved, covered electrical box. Consult with a qualified electrician for repair and assessment.

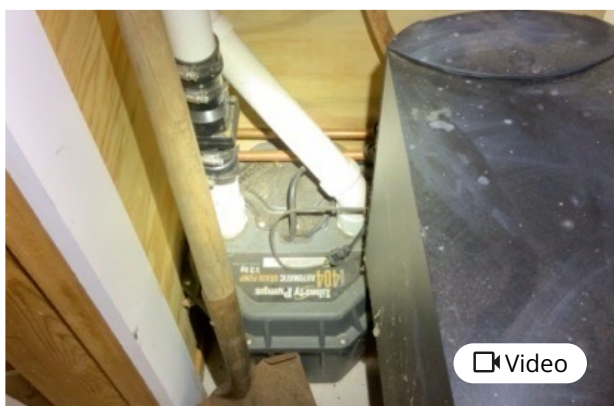
Video 1

An ejector pump was present in the structure. The ejector pump was tested and was functional. There was no ejector pump failure alarm system would offer protection should there be a failure and should be considered as an upgrade.

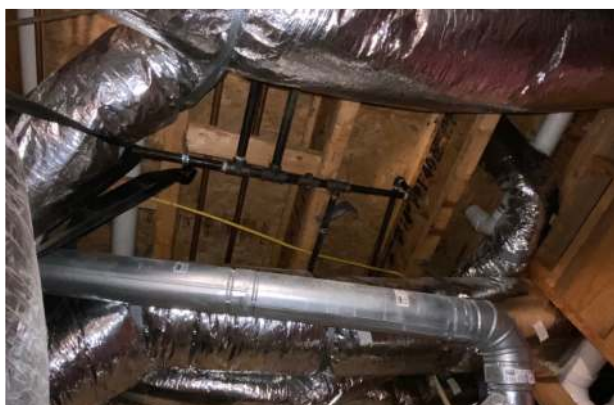
Photo 141

The visible floor structure consisted of an OSB subfloor, supported by two-inch by twelve-inch TJI joists spaced sixteen inches on center.

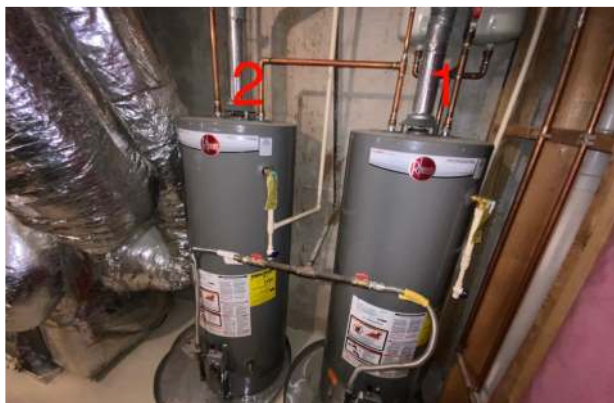
Photo 151

There were two 50 gallon capacity, natural gas water heaters were located in the basement. The water heaters were installed in series. In a series water heater installation, cold water will enter the first tank and get heated and will travel to the second water heater tank. When demand is required, the hot water leaves the second tank and goes to the home. The water heaters will be identified by numbers in the pictures below. Water heater number one (1) was manufactured by Rheem, model number PROG50- 38N RH60 and serial number Q 0362109033 . Information on the water heater indicated that it was manufactured 5 years ago. Water heater number two (2) was manufactured by Rheem, model number PROG50- 38N RH60 and serial number Q 0362109022 . Information on the water heater indicated that it was manufactured 5 years ago. Together they produce hot water temperature of approximately 106 degrees F. Temperature and pressure relief valve (T & P) were present on both water heaters. The overflow legs were present on both water heaters and both terminated properly. Your safety depends on the presence of a T & P valve and proper termination of the overflow leg. Both water heaters appear to be functional. NOTE:

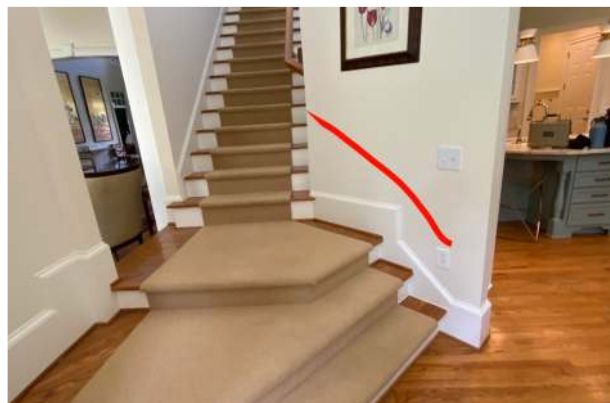
Photo 156

No access for this part of the structure

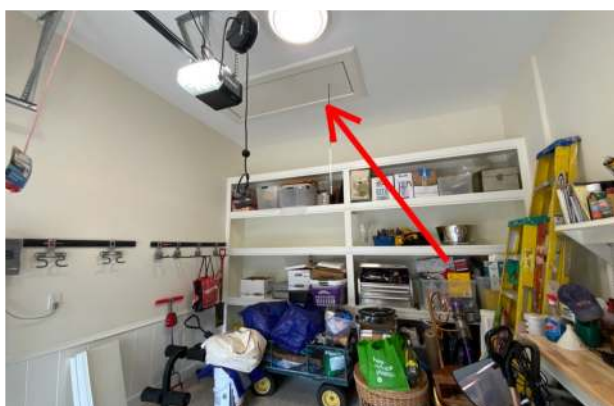
Photo 157

The interior living area and closets were cluttered with many stored items and/or shelves at the time of inspection. The obstructed areas were not able to be visually inspected.

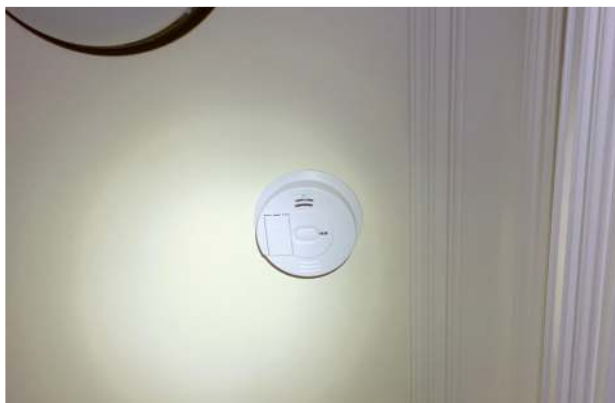
**Photo 158**

**The structure did not have an operable carbon monoxide alarm.** Because of combustible fuel use within the structure, an operable carbon monoxide alarms should be installed in the appropriate places prior to occupancy.

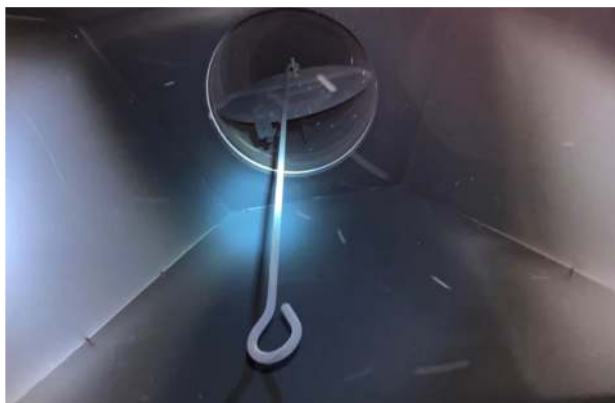
Photo 160

A buildup of soot and/or creosote was evident in the chimney in the living room fireplace. The unit should be cleaned and further assessed by a qualified fireplace service company.

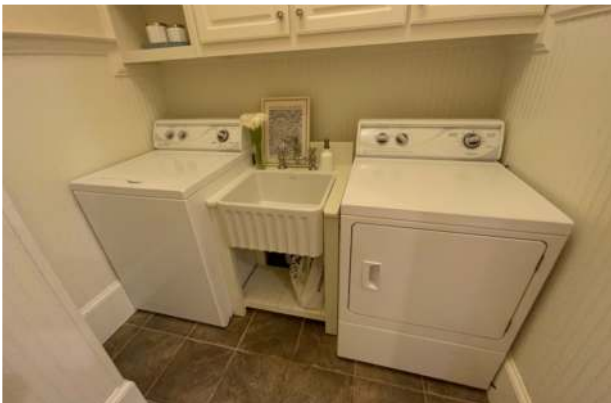
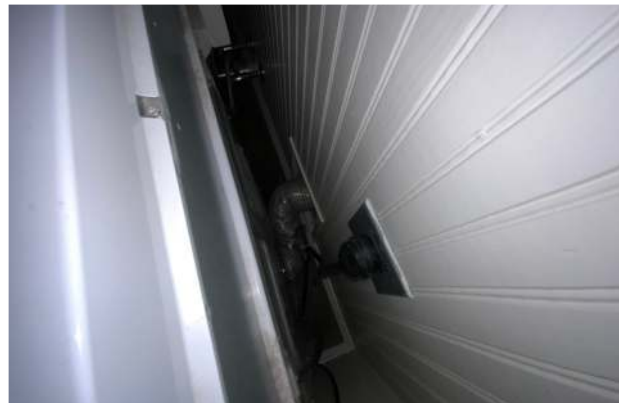
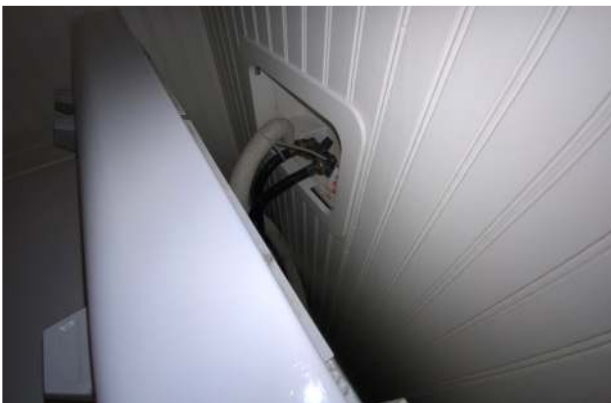
This note is supplied for informational purposes only, as many clients want to know the type of dryer connections available to them. A 240 volt style outlet for an electric clothes dryer connection was installed in the laundry area. For safety reasons, no attempt was made to verify that the electrical outlet is properly wired or that power is present. Consult with a qualified contractor if the desired type of connection is not available. A dryer vent was installed. A drain for a washing machine was present.

The washing machine does not have a pan or floor drain underneath it to catch possible leaks and drain them away safely. As a precaution, HomeTeam recommends placing a moisture detector near the washing machine to monitor for possible leaks. Monitoring for leaks is the best way to prevent possible water damage.

The dryer vent is vertical in at least one place. This is not necessarily a deficiency, but because of this configuration the homeowner should consider having the dryer vent ductwork cleaned at regular intervals to prevent clogs.

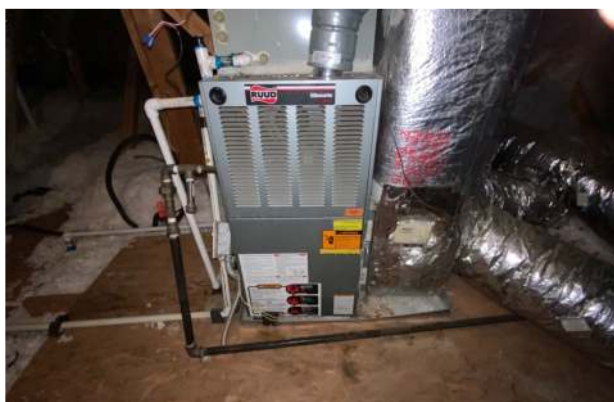
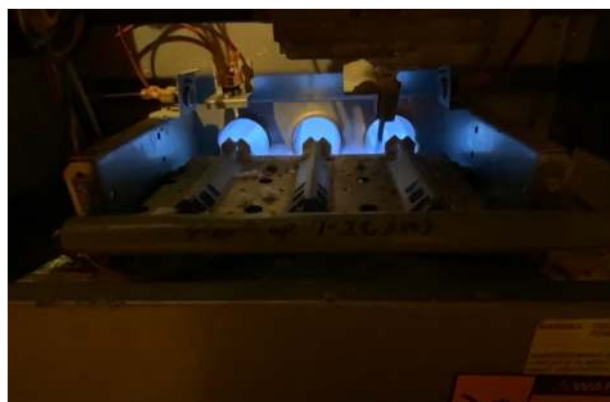
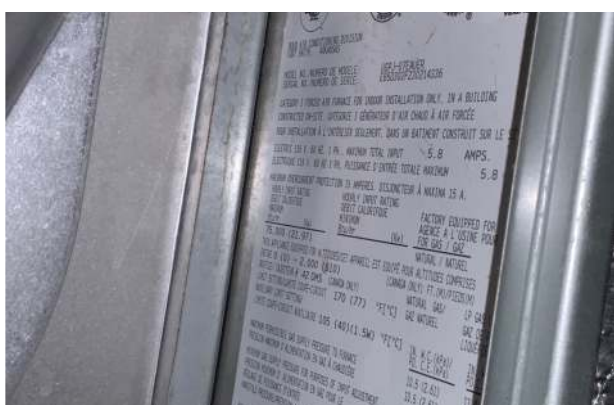
Heat is provided by a Ruud natural gas forced air furnace, Model Number UGPI-OZEAUER , Serial Number EB5D302F230214336 , which is approximately 24 years old. The unit was located in the attic of the structure and provides heating to the second floor area. Termination of HVAC condensate lines was not raised above the floor drain or drain inlet. The condensate lines were not trapped. HVAC condensate lines must be trapped and not in contact with wet drain inlets to prevent the possible migration of bacteria and mold into the air-handling system. The galvanized steel venting system was adequate to exhaust the spent gases to the exterior of the structure and was in good condition. The system was on and the ignition source enabled. The heating system was functional. The unit does not appear to have been recently serviced. It is recommended that the furnace be cleaned and serviced by a qualified contractor upon taking ownership of the property. The furnace should be serviced annually to maintain safe and efficient operation.

The furnace may be past its design life. This is an informational note only to help give an idea of future budgeting considerations. The system was functional at the time of the inspection unless noted otherwise. Please note that since codes change, it is possible the

configuration for the flue and/or condensate lines may need to be altered at the time of a future replacement.

Humidifiers can lead to indoor air quality issues if not properly maintained. It is recommended to have your humidifier evaluated by a qualified HVAC professional.

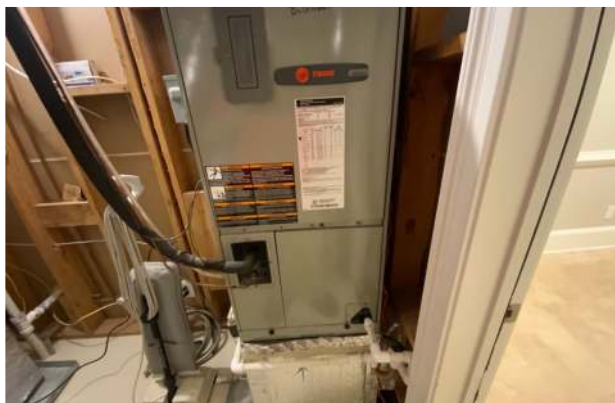
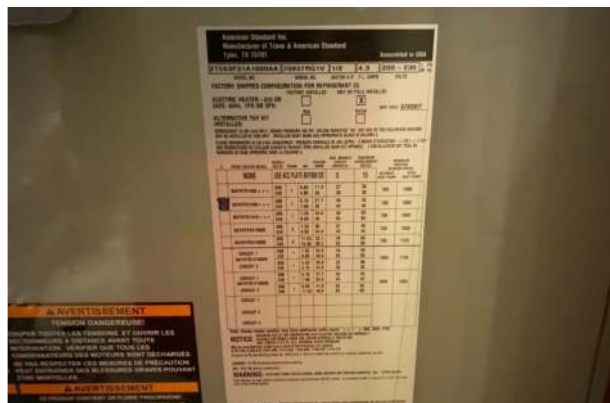
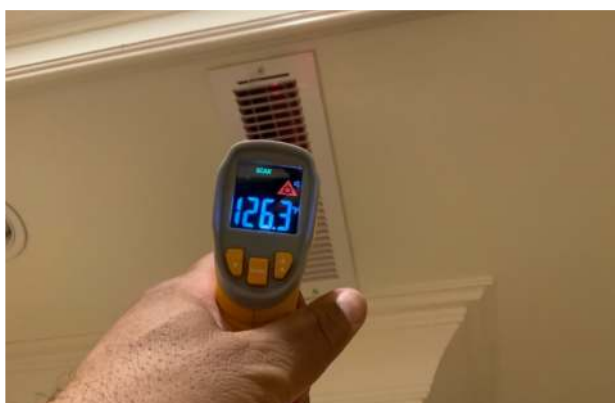
system. The system was on and the ignition source enabled. The heating system was functional. The unit does not appear to have been recently serviced. It is recommended that the furnace be cleaned and serviced by a qualified contractor upon taking ownership of the property. The furnace should be serviced annually to maintain safe and efficient operation.

The furnace may be past its design life. This is an informational note only to help give an idea of future budgeting considerations. The system was functional at the time of the inspection unless noted otherwise. Please note that since codes change, it is possible the configuration for the flue and/or condensate lines may need to be altered at the time of a future replacement.

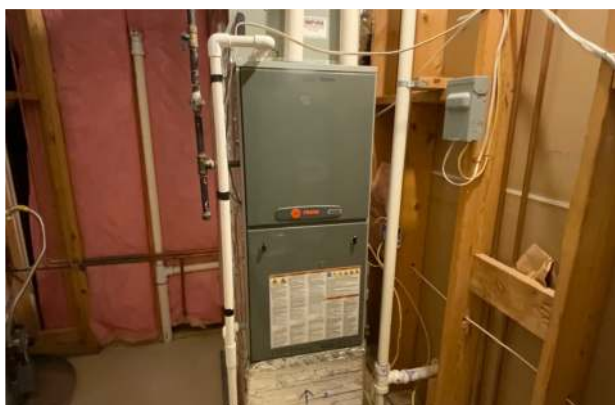
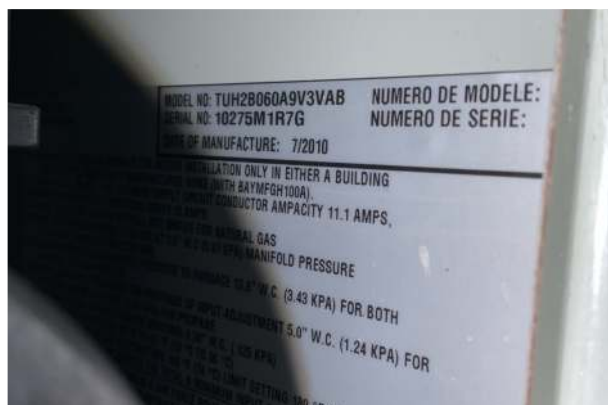
Heat is provided by a Trane natural gas forced air furnace, Model Number TUH2B060A9V3VAB, Serial Number 10275M 1R7G, which is approximately 16 years old. The unit was located in the basement of the structure and provides heating to the Sun room area. Termination of HVAC condensate lines was raised above the floor drain or drain inlet. The condensate lines were not trapped. HVAC condensate lines must be

trapped and not in contact with wet drain inlets to prevent the possible migration of bacteria and mold into the air-handling system. The PVC venting system was adequate to exhaust the spent gases to the exterior of the structure and was in good condition. The system was on and the ignition source enabled. The heating system was functional. The unit does not appear to have been recently serviced. It is recommended that the furnace be cleaned and serviced by a qualified contractor upon taking ownership of the property. The furnace should be serviced annually to maintain safe and efficient operation. Note: The inspection does not include a heat-loss analysis, heating design or adequacy evaluation, energy efficiency assessment, installation compliance check, chimney flue inspection, draft test or buried fuel tank inspection.

The furnace may be past its design life. This is an informational note only to help give an idea of future budgeting considerations. The system was functional at the time of the inspection unless noted otherwise. Please note that since codes change, it is possible the configuration for the flue and/or condensate lines may need to be altered at the time of a future replacement.

Rust noted in heating system should be evaluated by qualified HVAC contractor

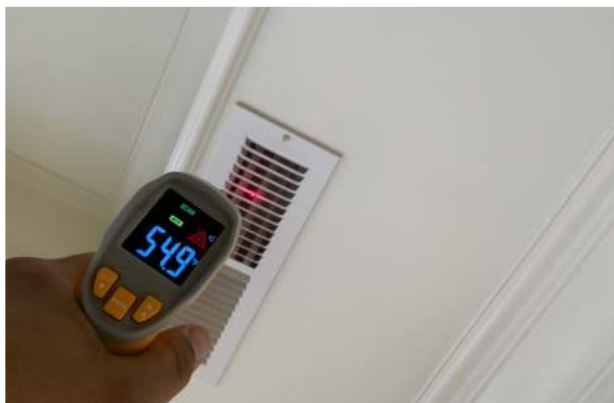
Photo 220

The air conditioner may be past its design life.<sup>f</sup> , Unless noted otherwise, the system was functional at the time of the inspection. As with a light bulb that functions normally one day but the next may not turn on, a system's age is a helpful factor that assists in budgeting for eventual replacement.

The insulation on the air conditioning line set is damaged **in and around multiple areas of the property**. This could affect the efficiency of the system and should be replaced.

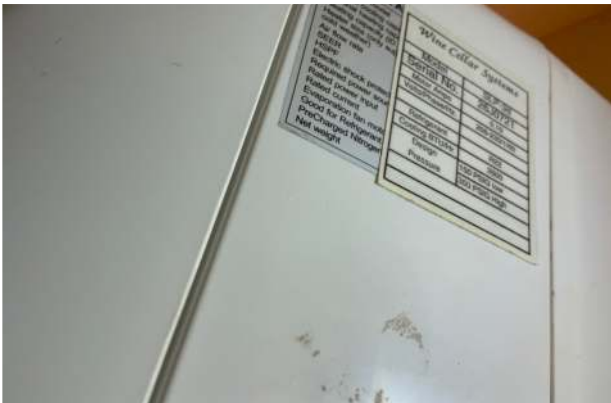
Photo 236

AC condenser was not operational during inspection. Have qualified HVAC technician troubleshoot.

Thermostat inoperable
