**HomeTeam**<sup>®</sup>  
INSPECTION SERVICE

RE: 123 Sample Drive, Fort Myers, FL 33908

# SUMMARY

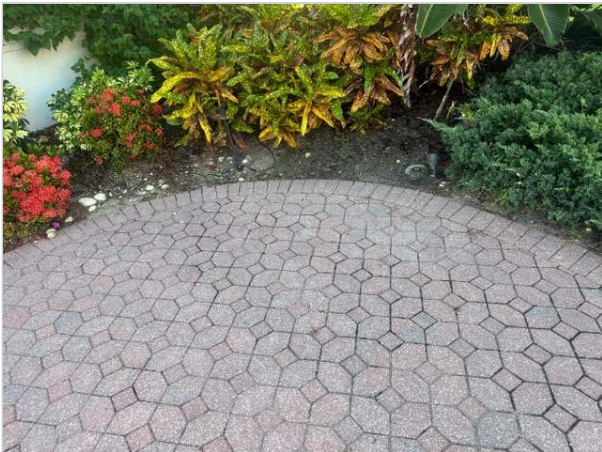
The brick pavers were settling/lifting in a few areas. This condition should be further assessed and corrected as needed to prevent trip hazards.

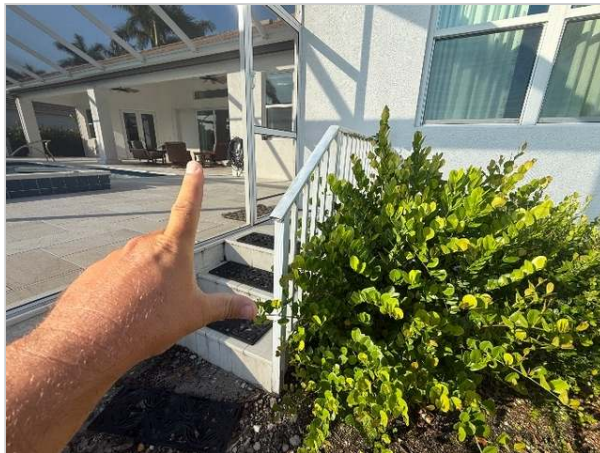
At the lanai exterior, the left hand rail was loose and in need of repair for safety purposes.

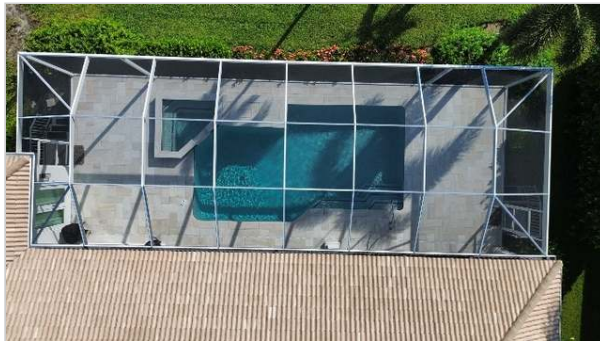
The brick pavers were settling on the lanai. This condition should be further assessed and corrected as needed to prevent trip hazards.

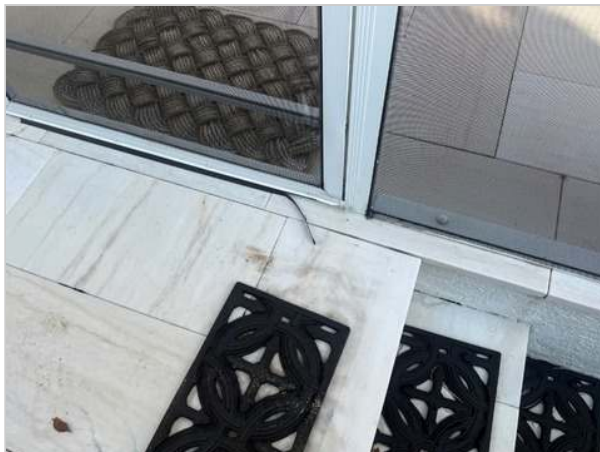
On the lanai, the weather stripping at the right screen door was damaged and in need of replacement.

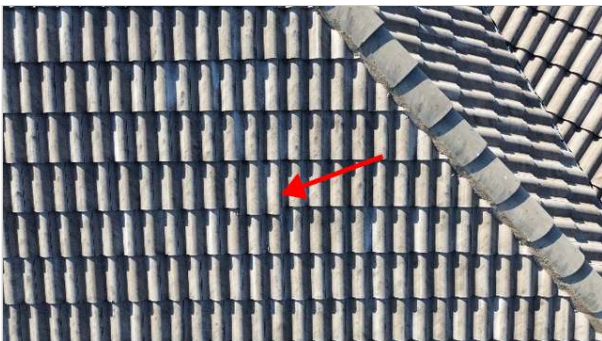
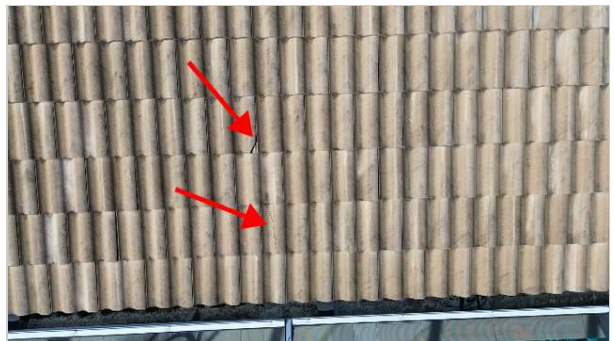
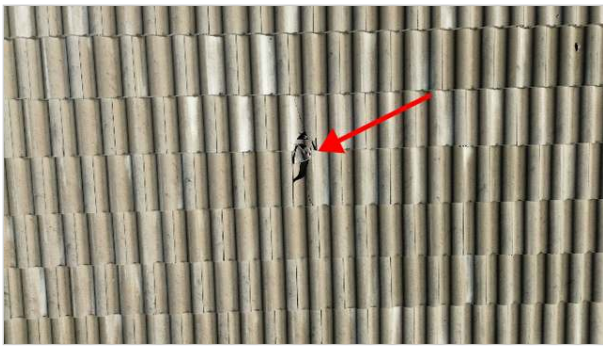
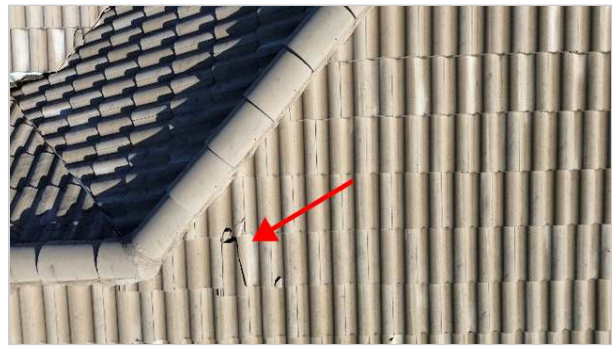
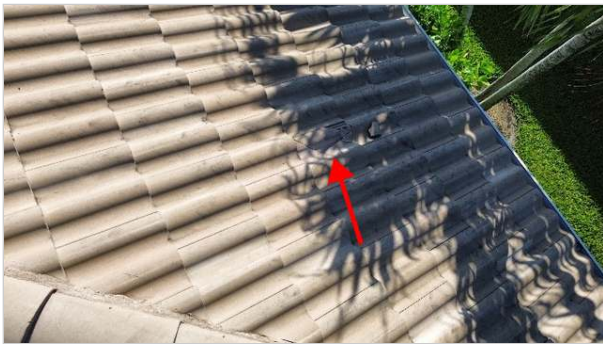
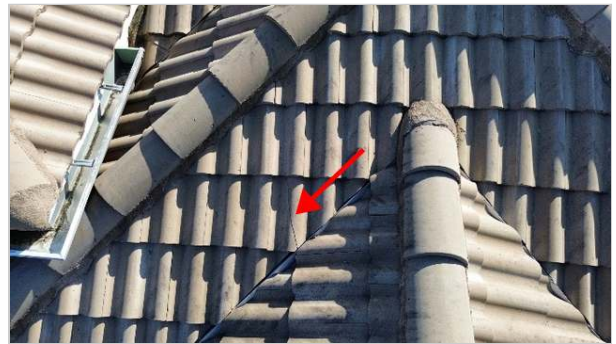
There were broken, damaged, and/or chipped tiles in several areas, and several of the tiles were sliding out of place. These conditions, and the condition of the roof overall, should be further assessed and corrected as needed by a licensed roofing contractor.

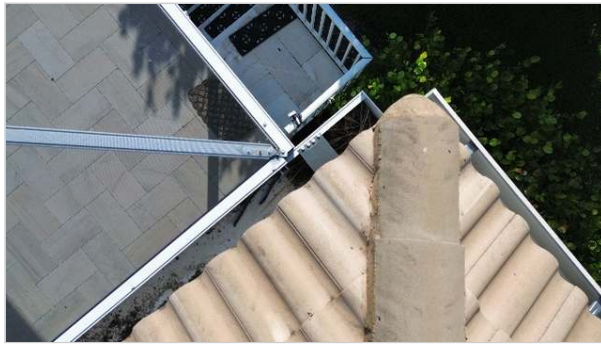
At the rear of the home, there was debris in the super gutter in need of cleaning.

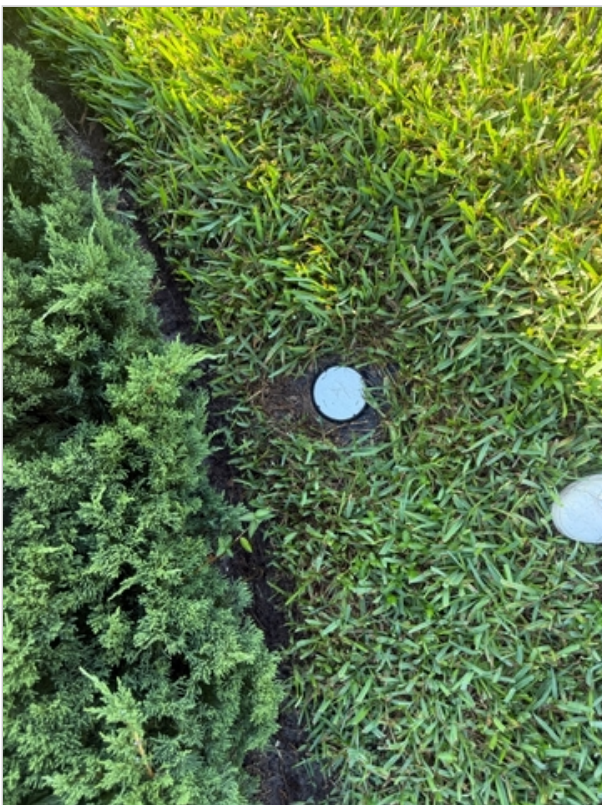
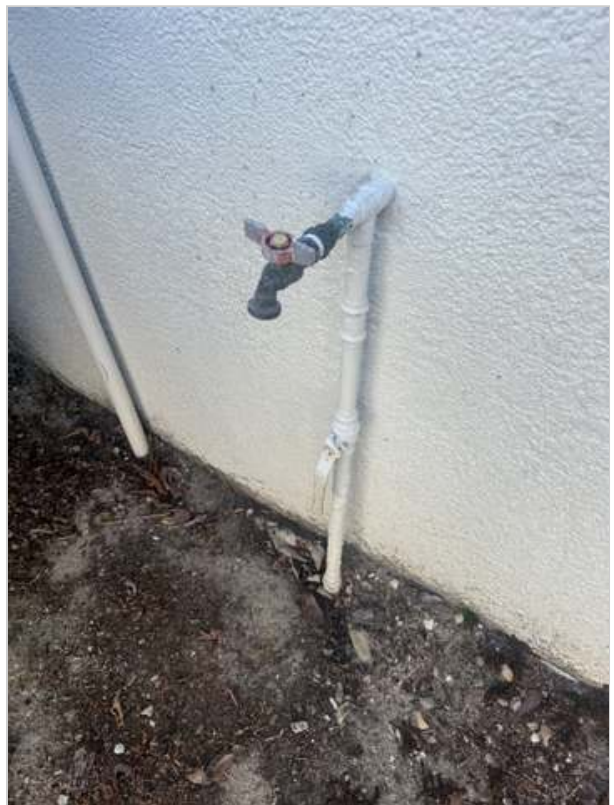
The water meter was located in the front yard. The main water shutoff valve for the home was located adjacent to the water service entry point at the exterior wall.

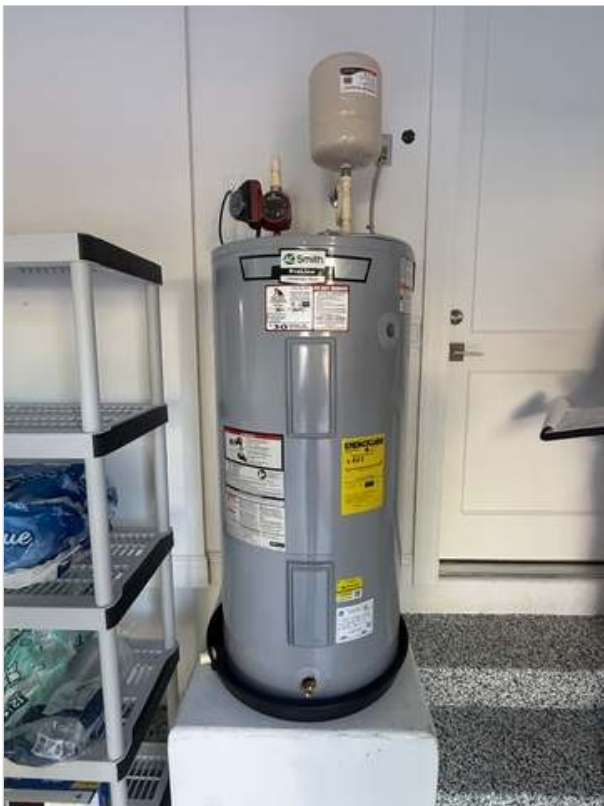
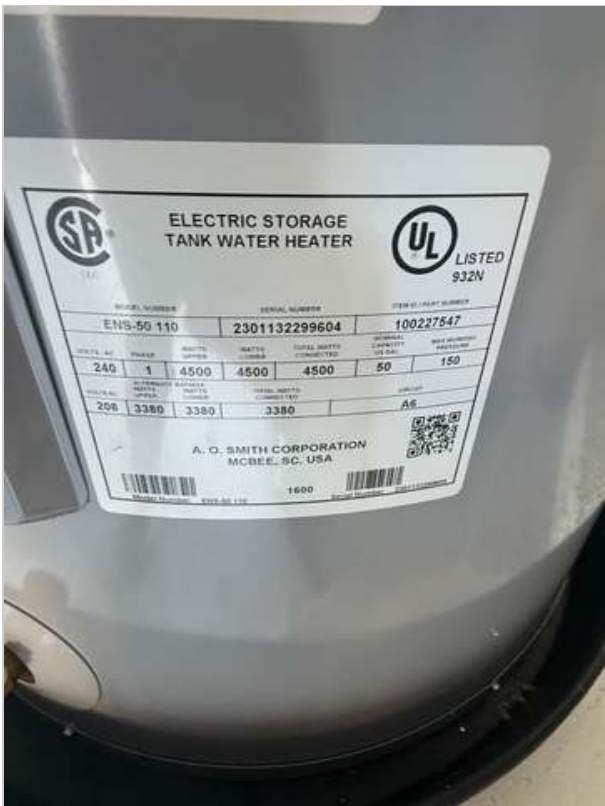
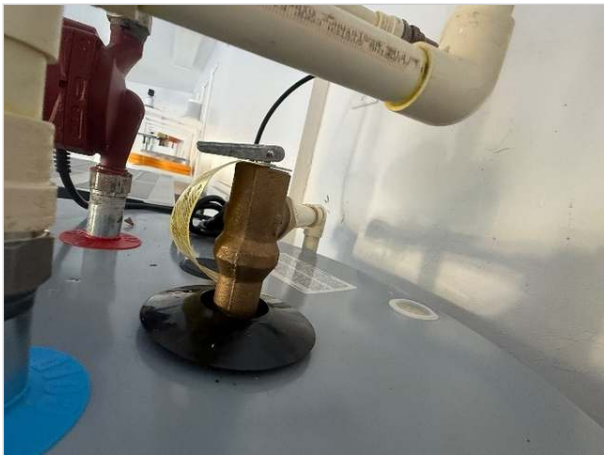
There was a fifty gallon capacity, electric water heater located in the garage. The water heater was manufactured by A.

O. Smith; model number ENS-50 110 and serial number 2301132299604. Information on the water heater indicated that it was manufactured three years ago. The water heater was functional.

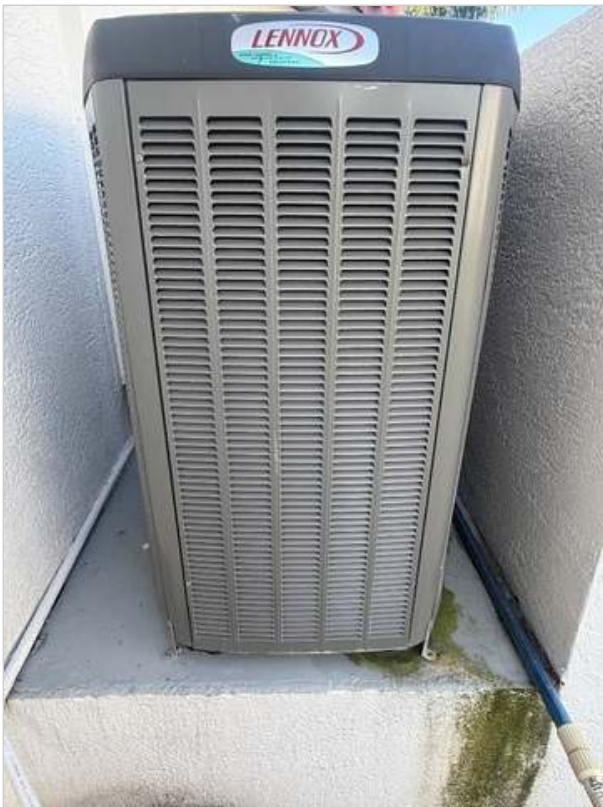
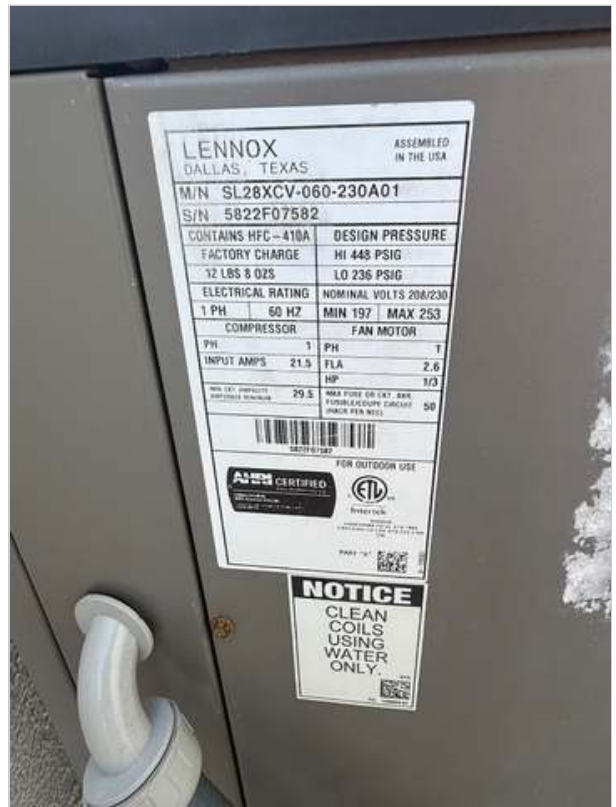
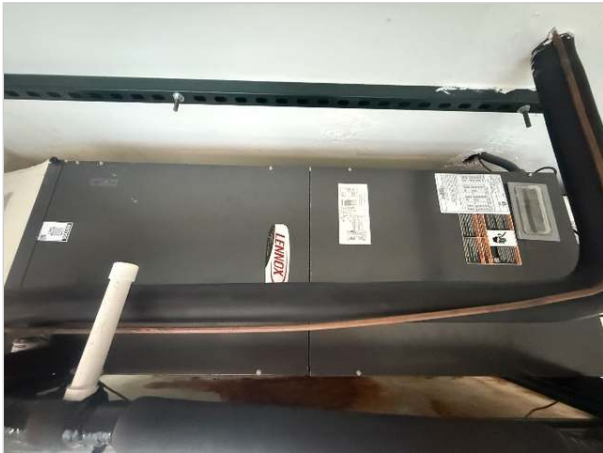
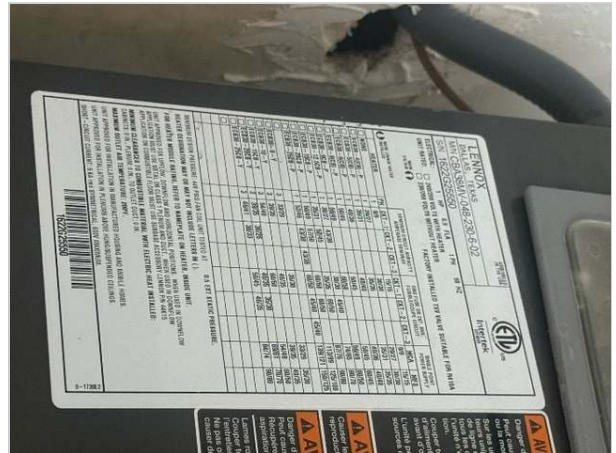
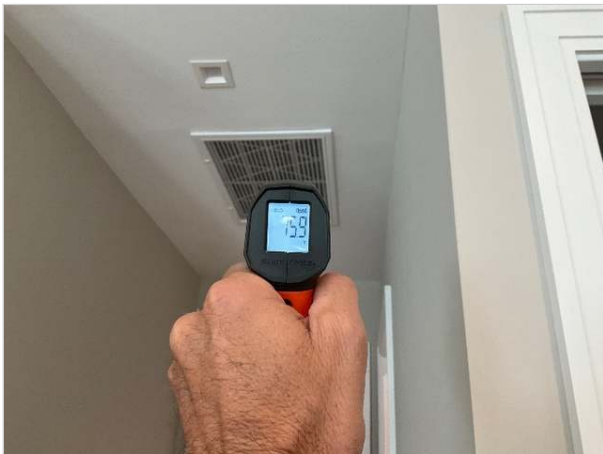
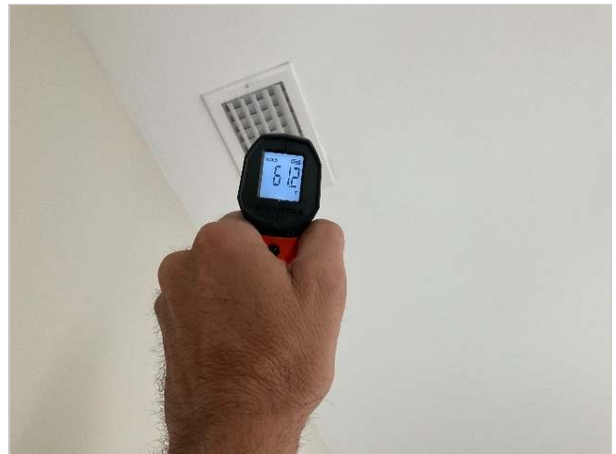
There was a Lennox five ton, four year old air conditioning condenser, and a Lennox, four ton, four year old air handler. The system was working within industry standards at the time of our inspection. The temperature differential (supply temperature to return temperature) was fifteen degrees (industry standard is fourteen to twenty two degrees). The equipment was found to be in good condition at the time of the inspection.

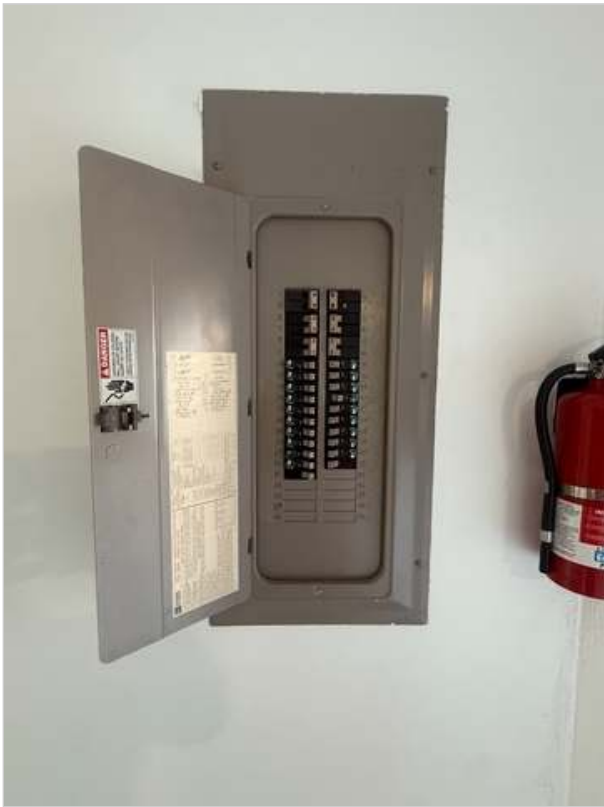
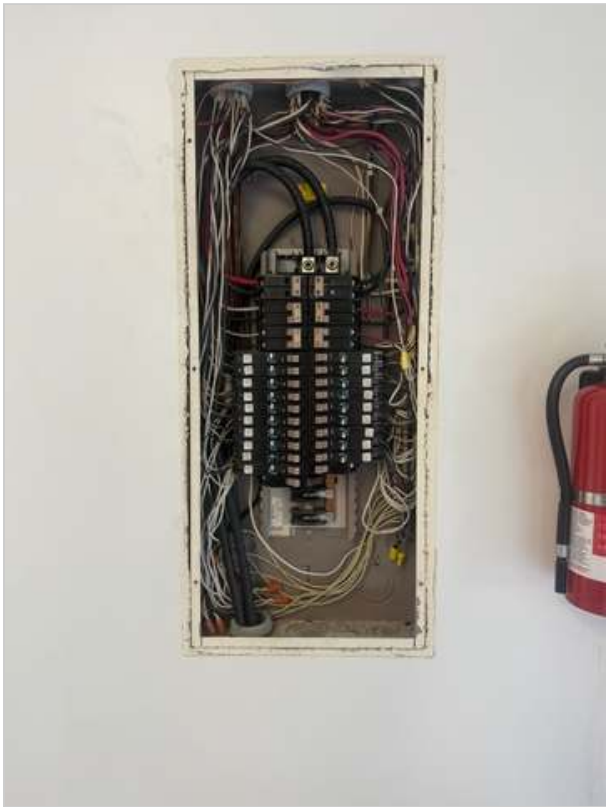
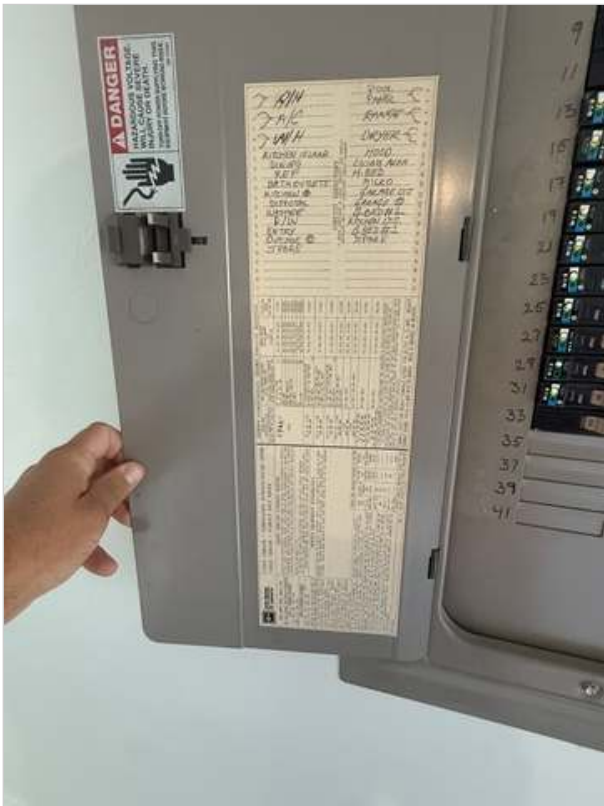
The service wire entered an Eaton service panel, located on the garage wall with two hundred amps and 120/240 volt rated capacity. The branch circuits within the panel were copper. These branch circuits and the circuit breakers to which they were attached appeared to be appropriately matched.

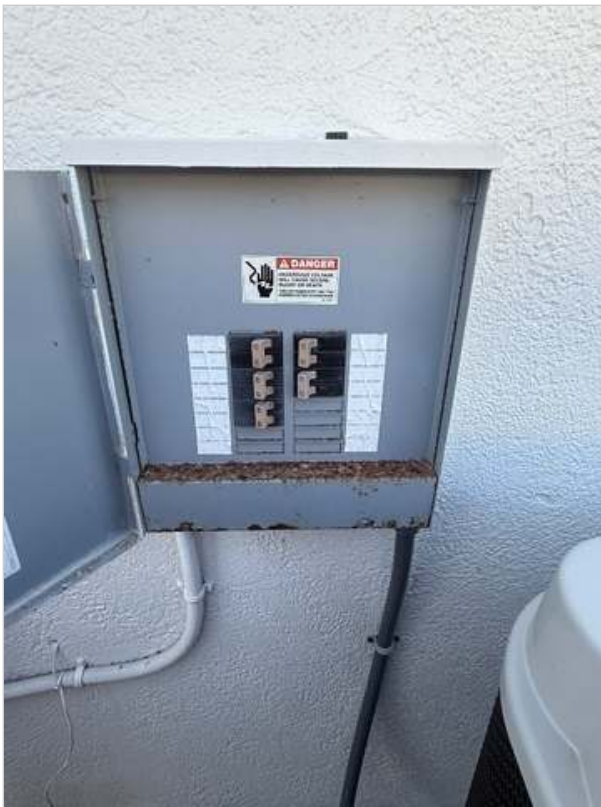
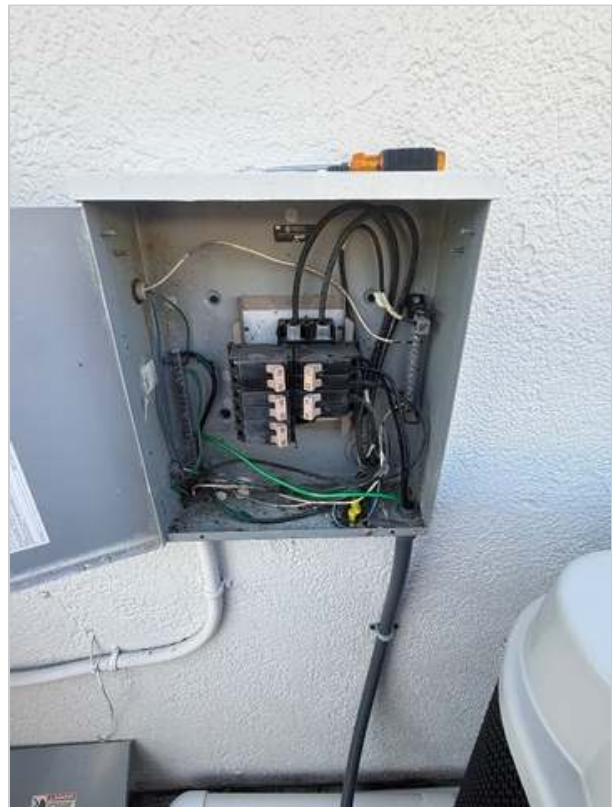
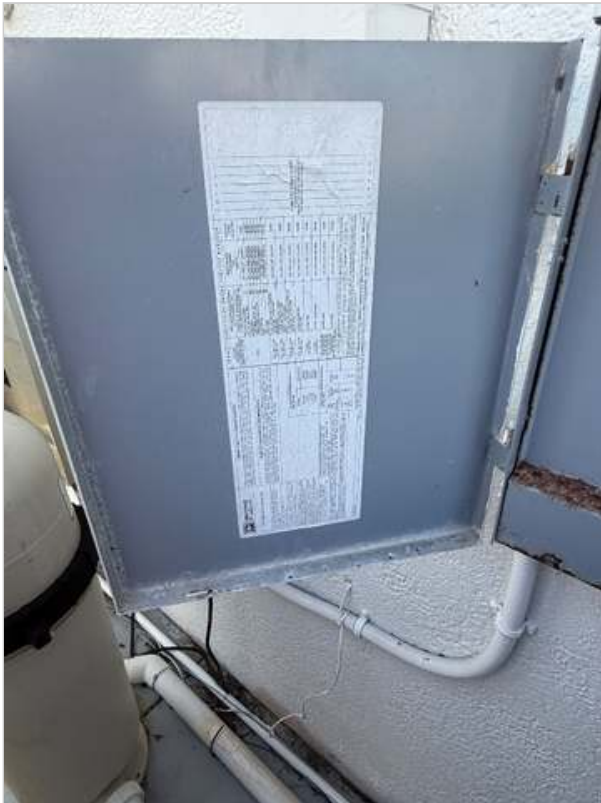
There was also an Eaton sub panel located at the pool equipment, with one hundred amps and 120/240 volt rated capacity.

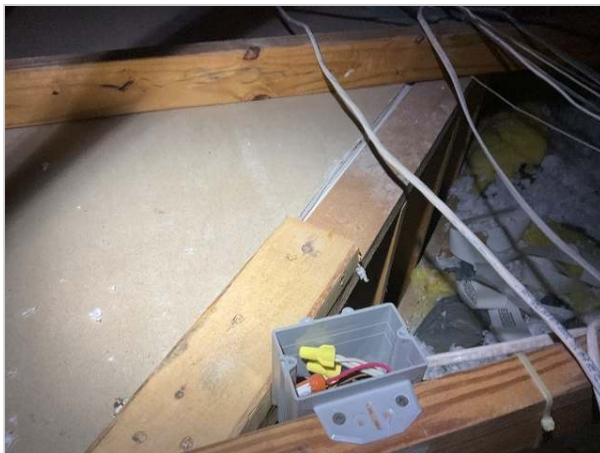
There were open splices in the attic by the master bedroom access.

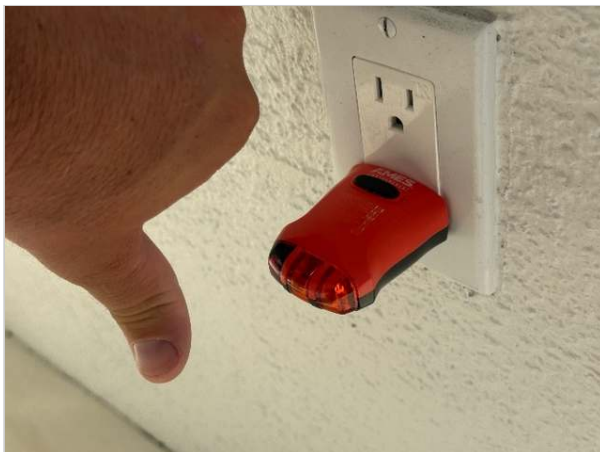
The outlets on the lanai were not GFCI protected, as recommended.

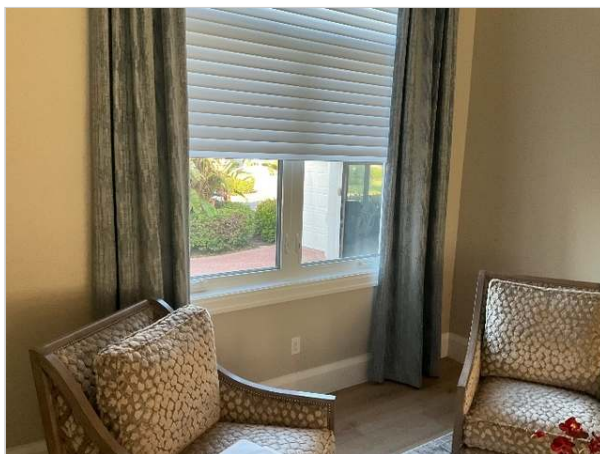
The front dining room windows would not release and were in need of a service call.

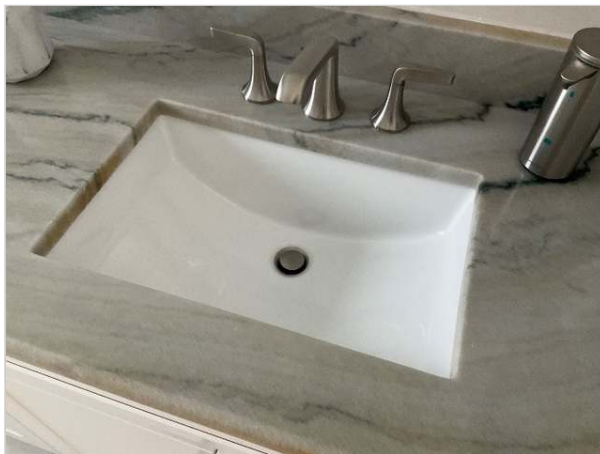
In the guest bathroom, the drain stopper for the right sink was in need of adjustment or repair in order to function properly.

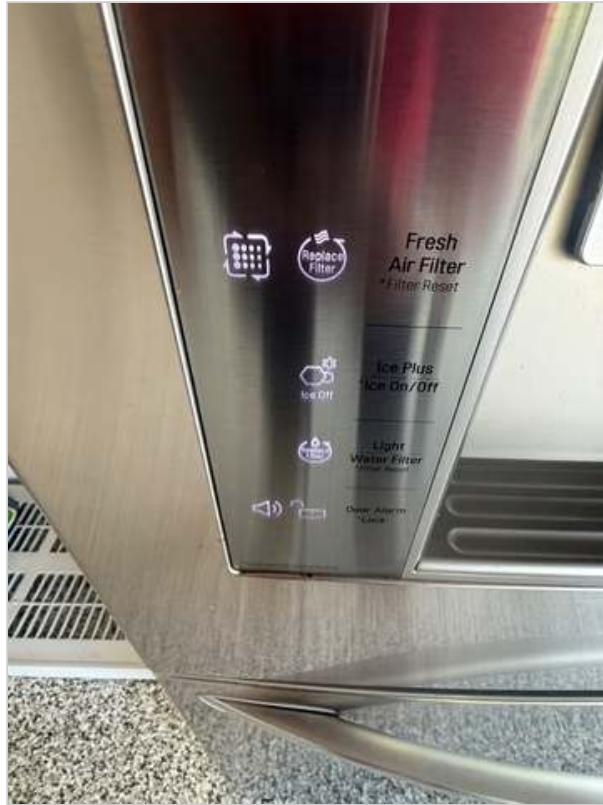
The icemaker was turned off prior to the inspection. Time did not allow the icemaker to begin operation. Therefore, the icemaker was not assessed as a part of this inspection. It is recommended that the unit be checked after twenty-four hours of continuous operation.

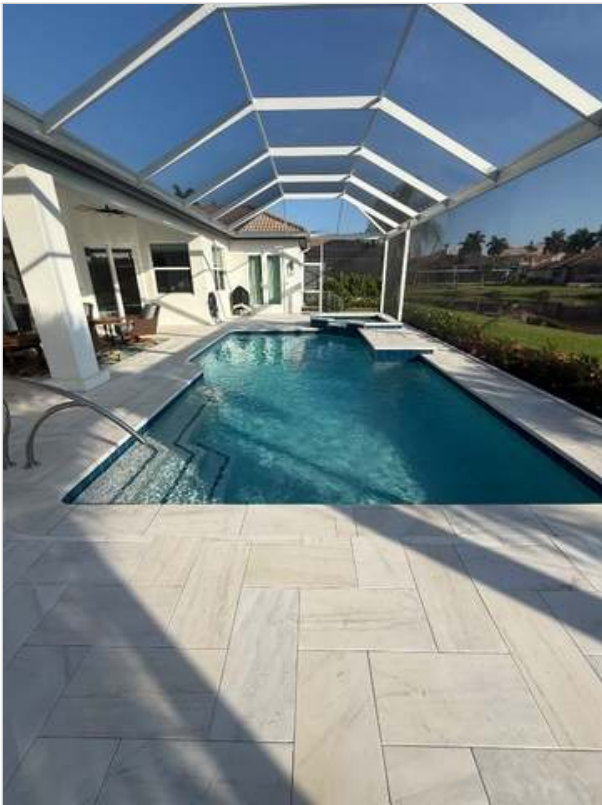
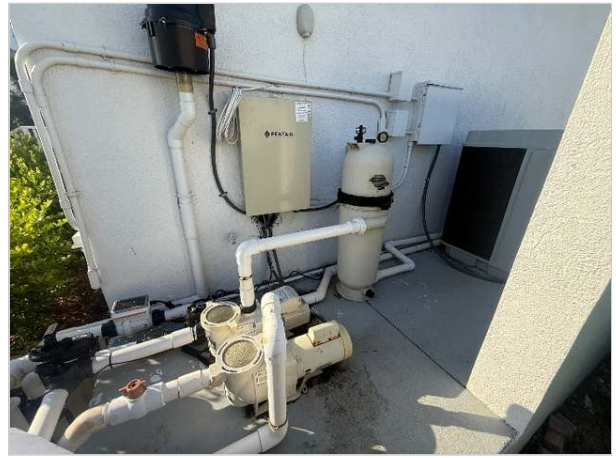
The spa blower was nonfunctional and in need of repair or replacement. This condition should be further assessed and corrected as needed by a qualified pool technician.
