**HomeTeam**<sup>®</sup>  
INSPECTION SERVICE

**123 Sample Drive  
Chattanooga , TN 37409**

## SUMMARY:

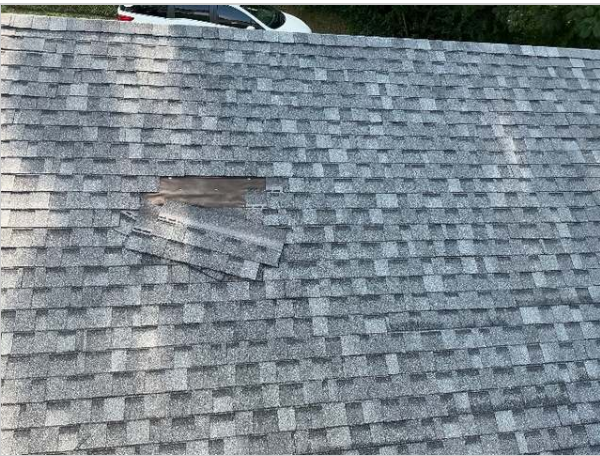
1. There were loose shingles on the carport roof. Recommend that the shingles be properly secured by a qualified roofing professional.

There were loose shingles on the carport roof. Recommend that the shingles be properly secured by a qualified roofing professional.

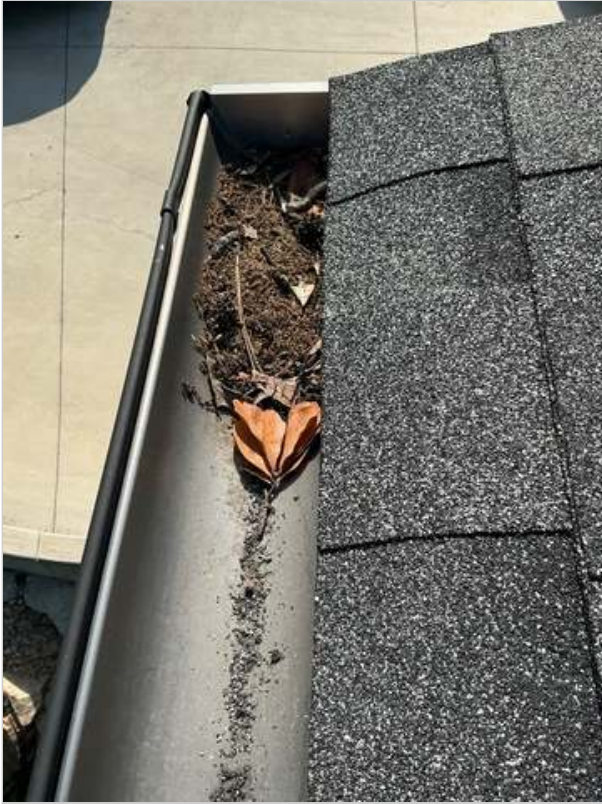
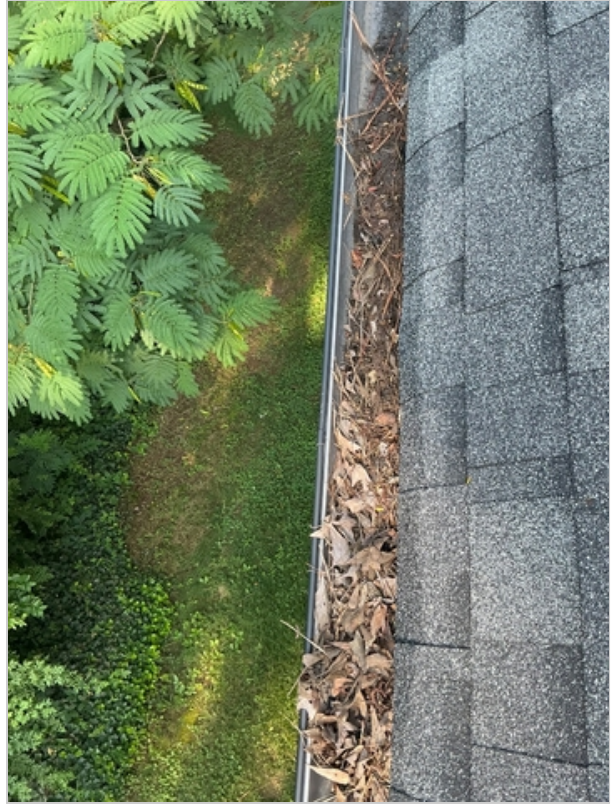
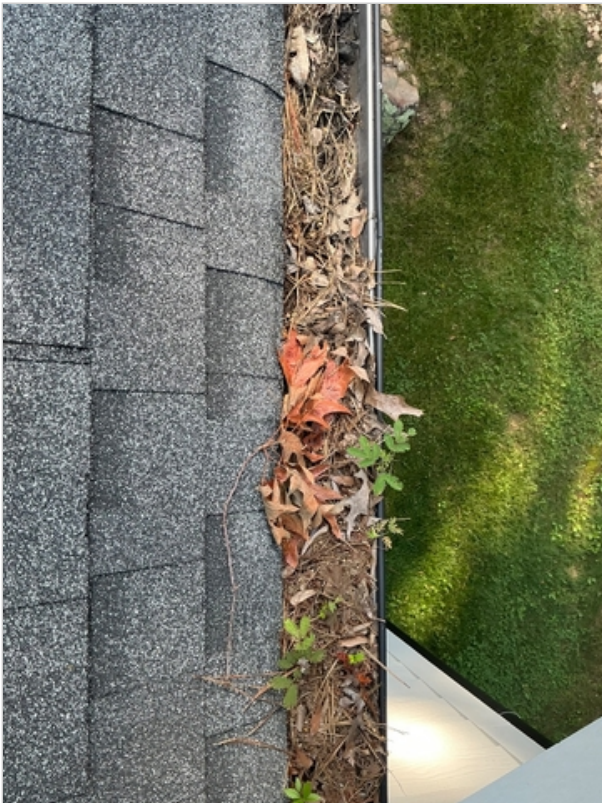
1. **The gutters were stopped up and full of debris and will need to be cleaned out to function properly.**
2. **The toilet in the first level bathroom was loose at the floor connection. The toilet needs to be secured to the floor to prevent possible water leakage. It is recommended that a professional plumbing company be consulted for the repairs.**

The gutters were stopped up and full of debris and will need to be cleaned out to function properly.

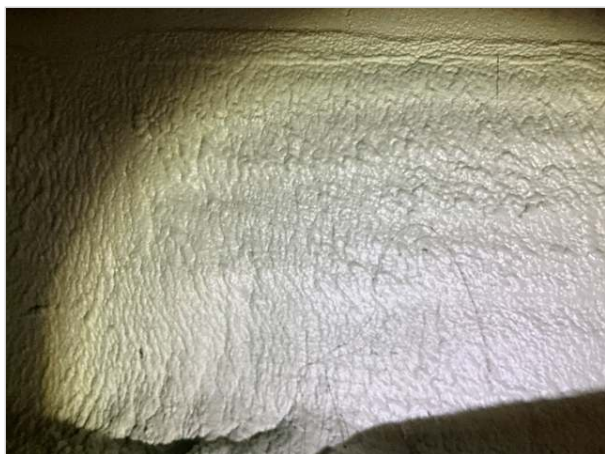
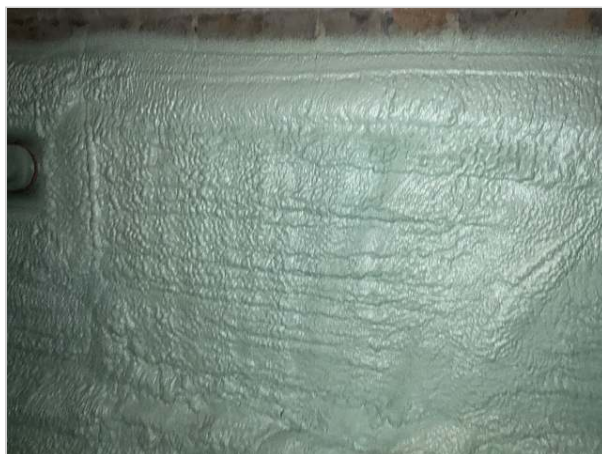
- **NOTE:** *In the crawlspace, the concrete foundation was fully sealed and covered the concrete block foundation, therefore it is not possible to view the concrete block foundation for any cracks due to the settling or structural issues.*

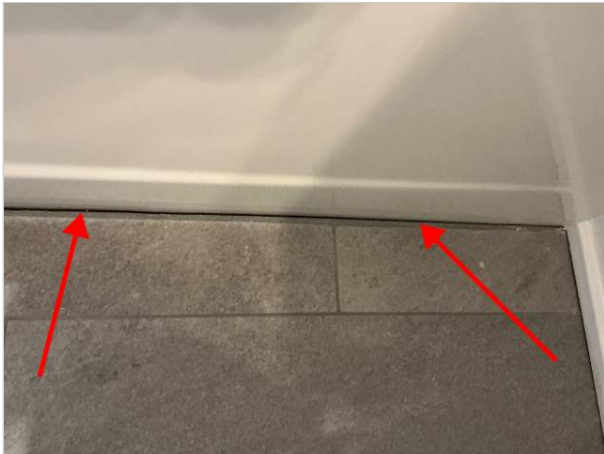
Recommend that the area where the floor and tub meet in the first level bathroom and the second level hall bathroom be sealed to prevent any water intrusion.

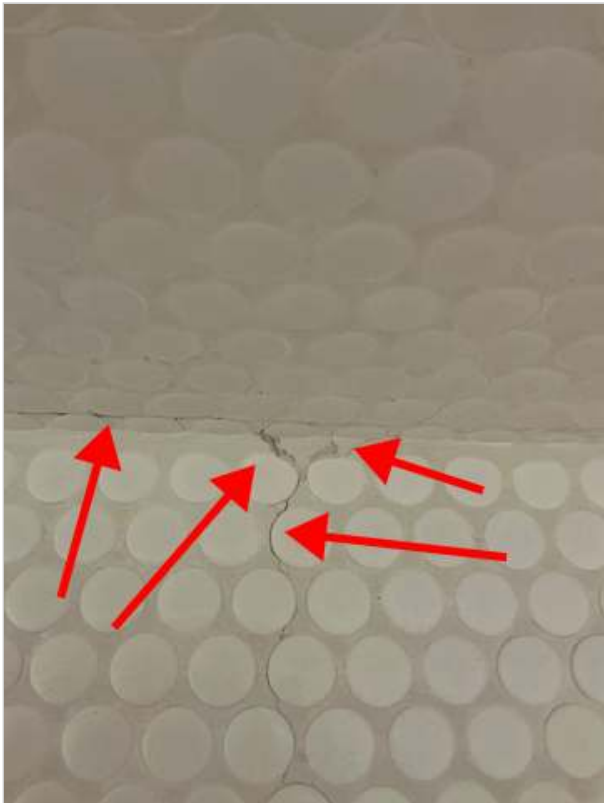
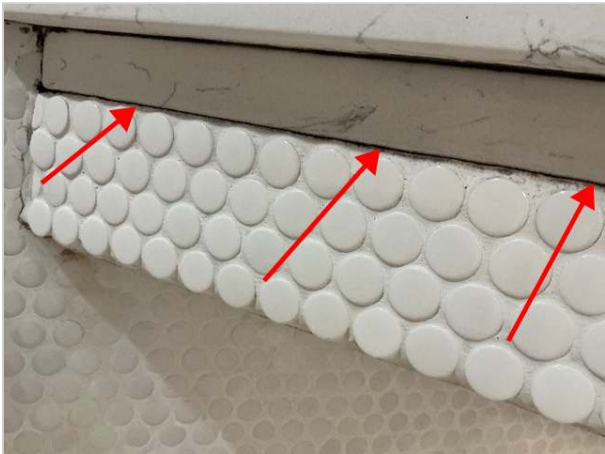
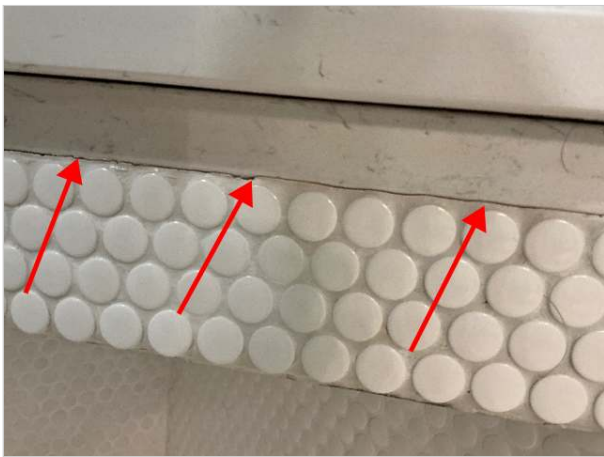
There is one area on the left floor of the master bathroom shower and an area at the triangle seat that should be sealed to prevent any water intrusion.

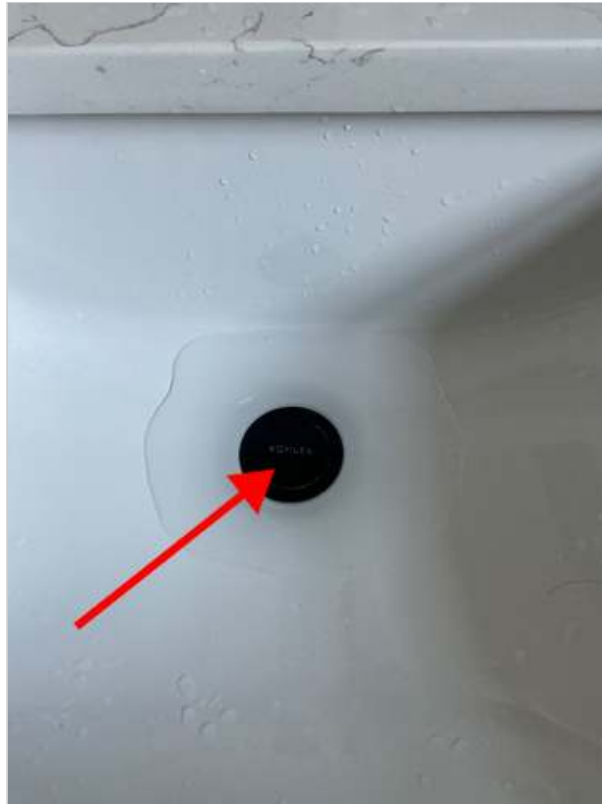
The second level hall bathroom sink stopper does not hold water.

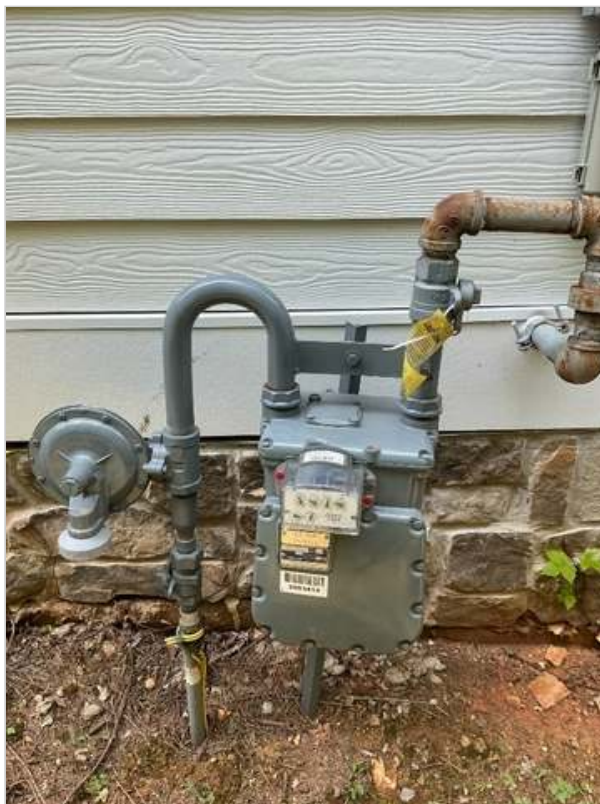
The gas meter was located on the left rear exterior wall. Although no actual testing was performed to detect the presence of gas fumes, there was no noticeable odor of gas detected at the time of the inspection.

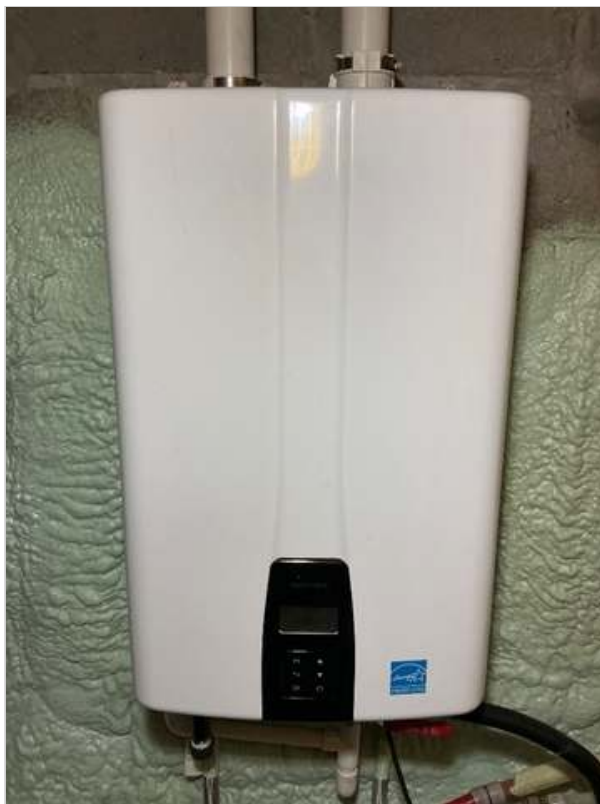
There was an on demand 237 gallons per hour capacity, natural gas water heater located in the crawlspace. The water heater was manufactured by Navien, Model Number NPE-240A2, Serial Number 2087Y2142726619. Information on the water heater indicated that it was manufactured 6 years ago. A temperature and pressure relief valve (T & P) was present. Because of the lime build-up typical of T & P valves, we do not test them. An overflow drip leg pipe was present.

The on demand type water heater was functional.

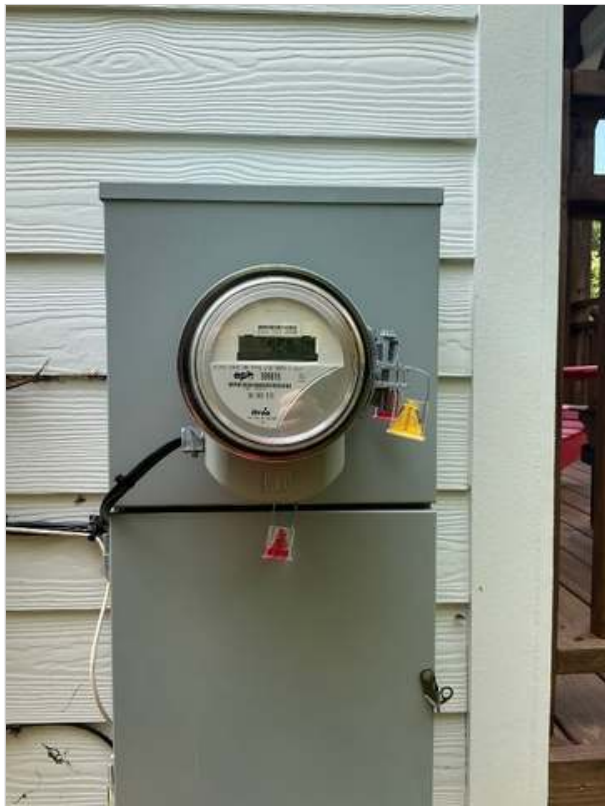
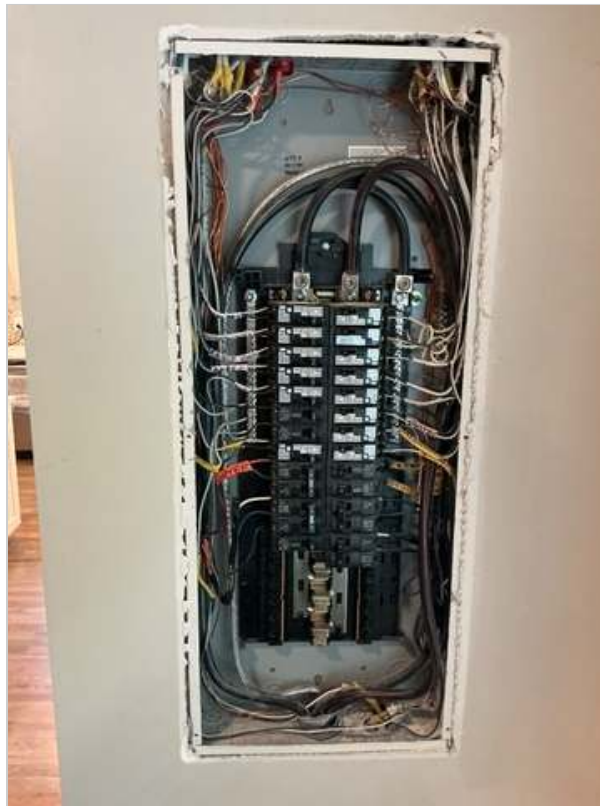
The underground electric service wire entered the home on the exterior wall. The electric meter was located on the left side wall. The service wire entered a Siemens service panel, located on the living room wall with a 200 amp and a 120/240 volt rated capacity. The branch circuits within the panel that was checked were installed on circuit breakers. These branch circuits and the circuit breakers to which they were attached appeared to be appropriately matched to the correct wire size.

The visible house wiring consisted primarily of the Romex type and appeared to be in good condition.

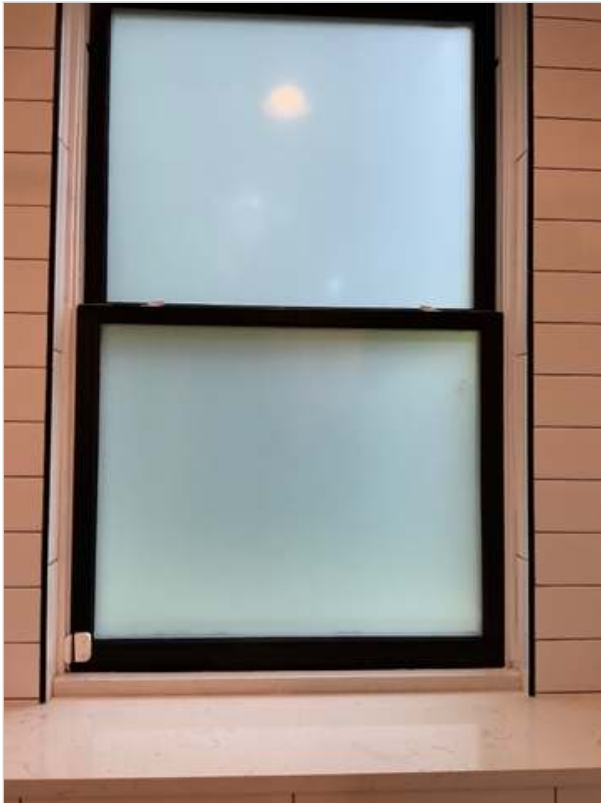
First floor bathroom.

The following windows would not open at the time of inspection:

- The window in the first floor bathroom.
- The window in the first floor bedroom.
- The far left window in the second floor rear bedroom.
- The far right window in the second floor rear bedroom.

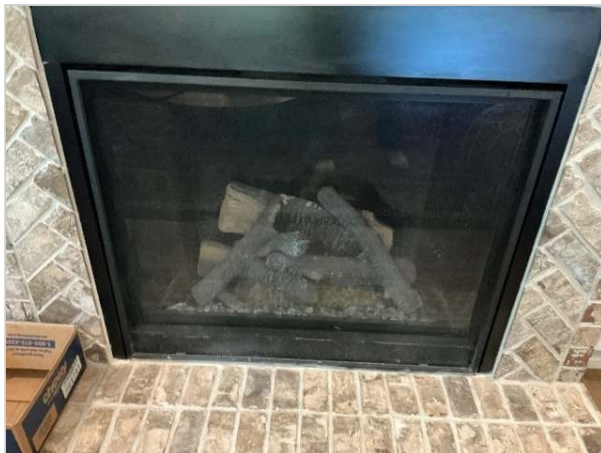
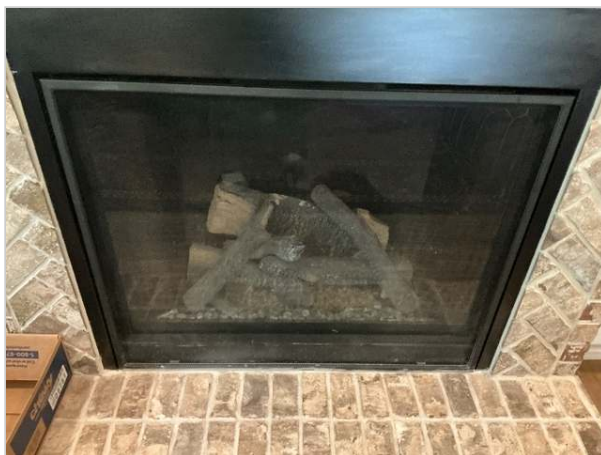
A ventless natural gas-log fireplace was located in the living room. The fireplace was not operated, did appear to be functional.

The fireplace remote was not functional at the time of inspection. Therefore, the fireplace was not tested. Recommend that the fireplace be tested prior to closing

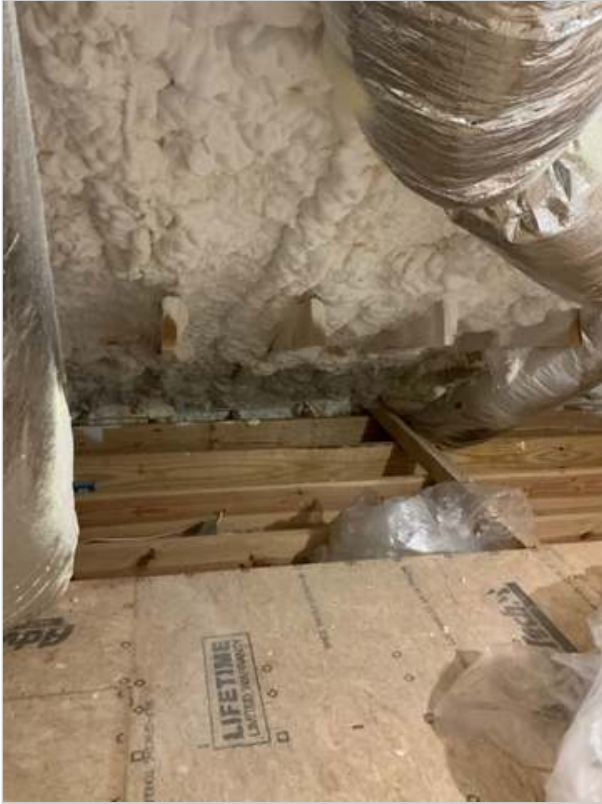
In the attic area it was noticed that the sheathing/decking and rafters was covered with sprayed type insulated material, which restricts the view of the sheathing/decking and rafters. As a result, we were not able to see the entire roof structure during the inspection. Determining the presence of any concealed defects is beyond the scope of the inspection.

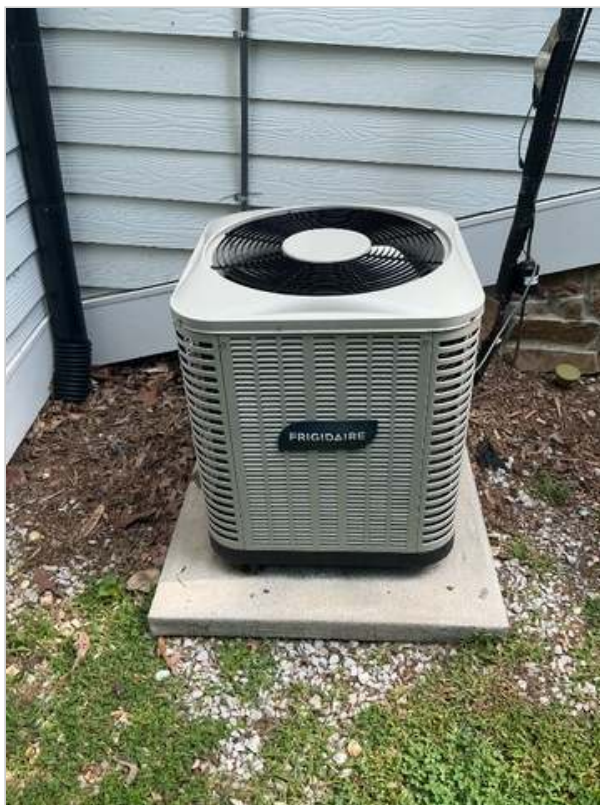
The electric outdoor Central Air Conditioner condensing unit for the upstairs was a Frigidaire, Model Number FSA1BE4M1SN18K, Serial Number FSG2008050602. The unit is located in the exterior of the home. This unit is approximately 6 years old. Periodic preventive maintenance is recommended to keep this unit in good working condition.

The upstairs cooling system was found to be functional.

- **INFORMATIONAL NOTE:** The air conditioning overall temperature differential is 15 degrees: Supply air 48 degrees; Return air 63 degrees.

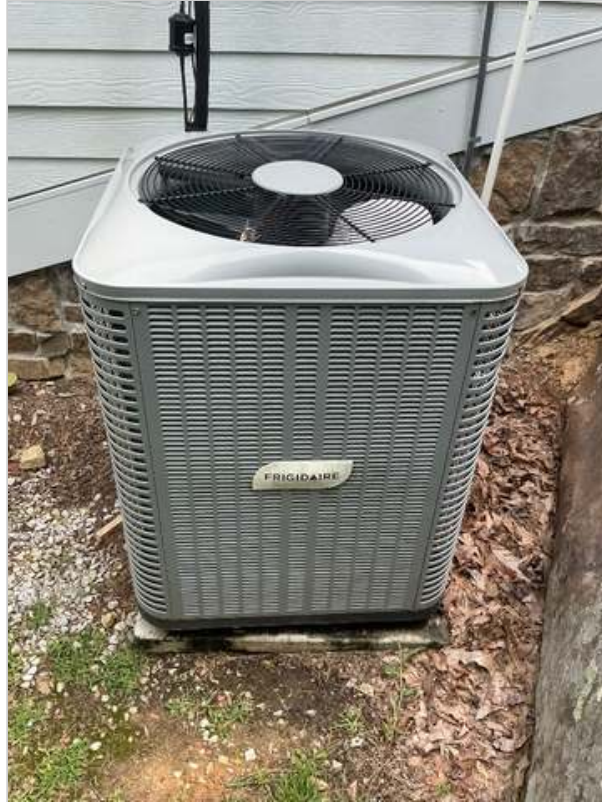
The electric outdoor Central Air Conditioner condensing unit for the downstairs was a Frigidaire, Model Number FSH1BE4M1SP30KP, Serial Number FSG2106039734. The unit is located in the exterior of the home. This unit is approximately 5 years old. Periodic preventive maintenance is recommended to keep this unit in good working condition.

The downstairs cooling system was found to be functional.

- **INFORMATIONAL NOTE:** The air conditioning overall temperature differential is 17 degrees: Supply air 53 degrees; Return air 70 degrees.
