# HomeTeam<sup>®</sup>

### *HOME INSPECTION REPORT*

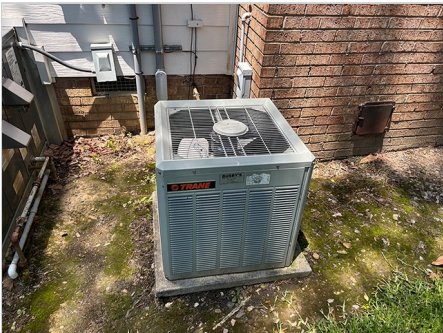
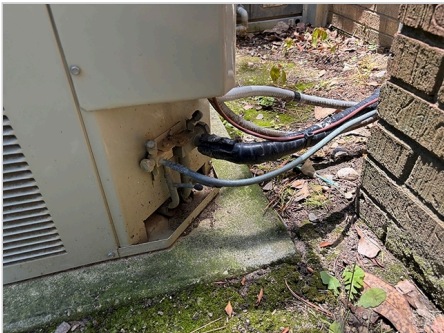
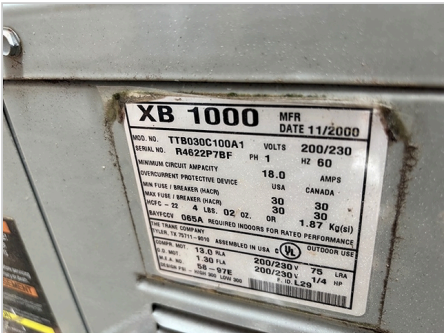
AIR CONDITIONER

The electric outdoor air conditioner condensing unit was a Trane, Model Number TTB030C100A1 and Serial Number R4622P7BF. The unit is located on the right side of the structure. This unit is approximately 26 years old. Periodic preventive maintenance is recommended to keep this unit in good working condition, and HomeTeam strongly recommends partnering with a reputable HVAC company for routine maintenance for the heating and cooling systems in the fall and spring. The air conditioning system was tested and found to be functional. As a reminder, this is functionality test and visual inspection only; we do not check suction pressures, contactor amps, or refrigerant levels. If a more detailed inspection is required, please consult with an HVAC company.

The air conditioner may be past its design life. Unless noted otherwise, the system was functional at the time of the inspection. As with a light bulb that functions normally one day but the next may not turn on, a system's age is a helpful factor that assists in budgeting for eventual replacement.

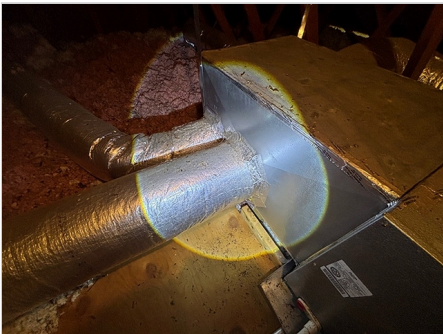
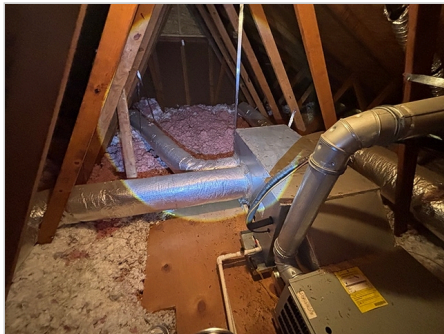
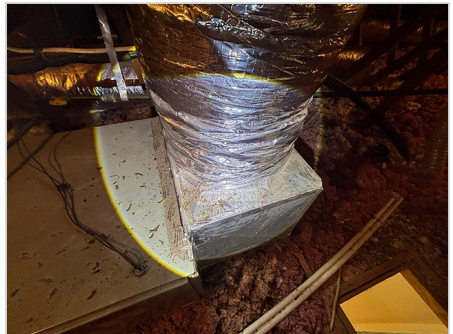
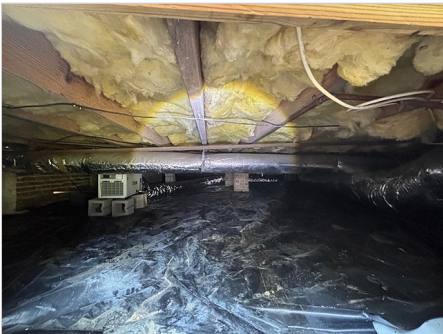
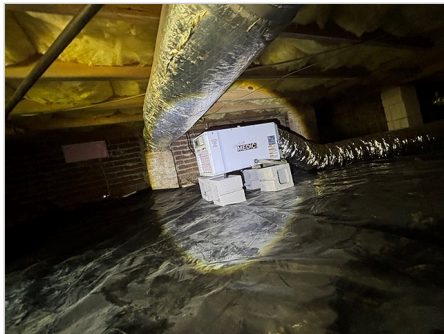
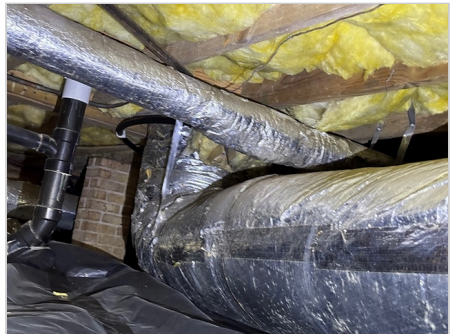
**Some of the insulation, sealant tape, and/or mastic on the ductwork is missing or damaged.** All ductwork should be completely sealed and insulated for maximum efficiency. **\*\*MAINTENANCE ITEM\*\***

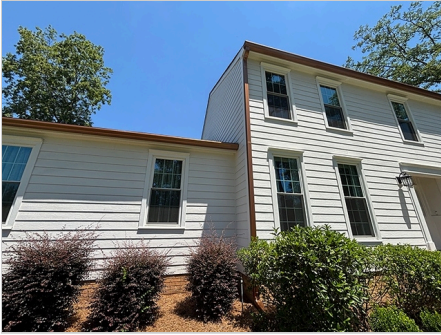
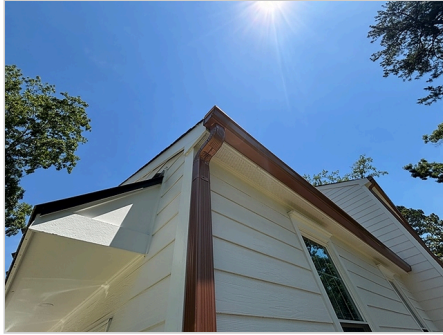
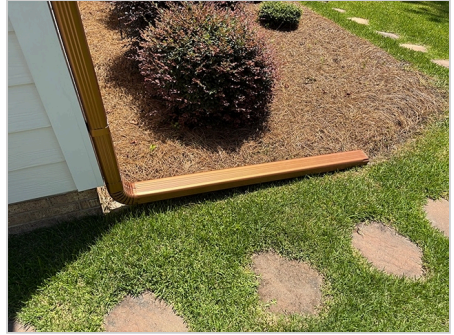
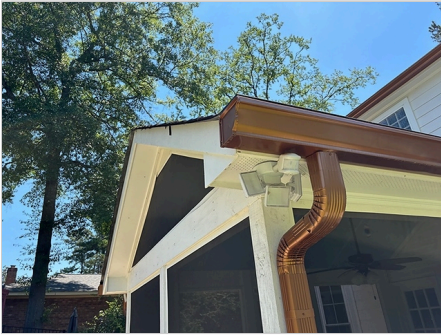
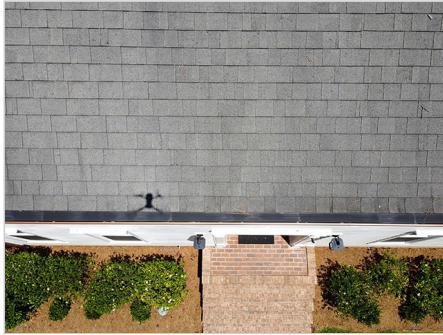
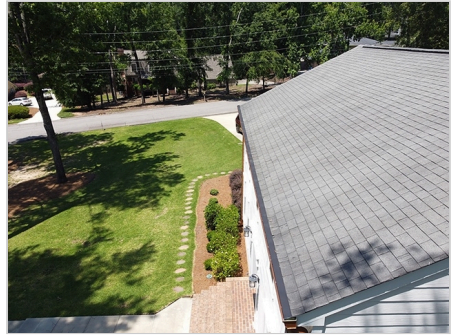
The roof drainage system consisted of aluminum gutters and downspouts which appeared to be functional at the time of the inspection. Gutters and downspouts should receive routine maintenance to prevent premature failure and drainage problems that may lead to water intrusion. Observation of fascia behind the gutters is obscured by the gutters. Keeping the gutters clean will help reduce the likelihood of overflows and resulting damage to fascia. Homeowners should be aware that gutters that have been dirty or clogged for an extended time may have led to unobservable damage to fascia or roofing components.

Water flow from downspout extensions or splash blocks should be carried several feet from the foundation towards a down-slope to ensure water drains well away from the foundation. These measures will help ensure excessive water is not deposited in close proximity to the foundation, which can lead to interior water intrusion, particularly during periods of heavy rain or water-saturated soil. A properly-functioning drainage system is one of the most important items for extending the life expectancy of a house and its components.

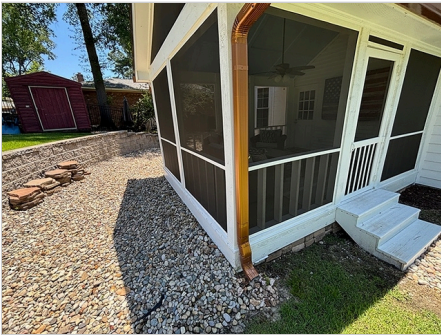
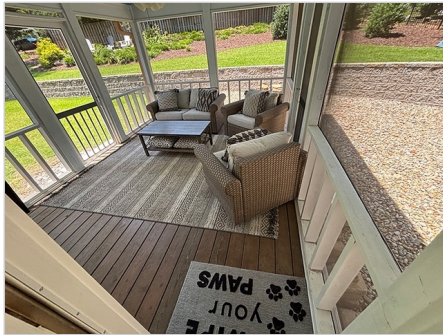
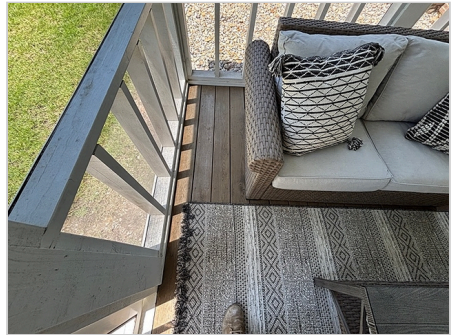
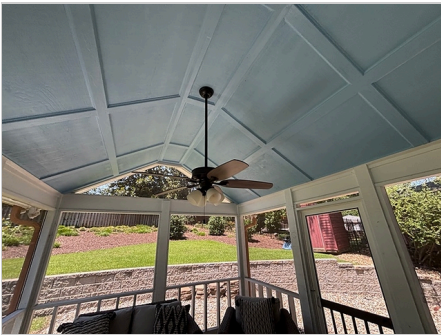
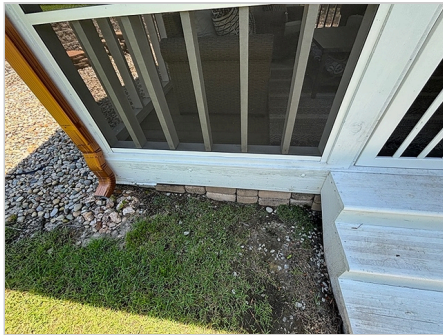
A wood deck was located in the back of the structure. There did not appear to be any deterioration of the deck surface. The handrails on the deck are missing secure. A wood deck should be cleaned and sealed regularly to prevent deterioration.

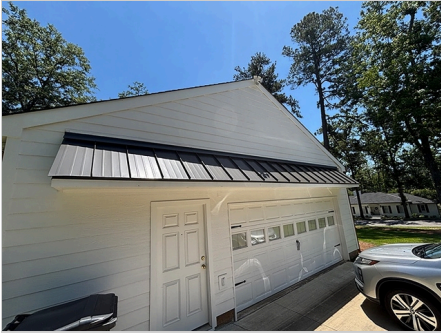
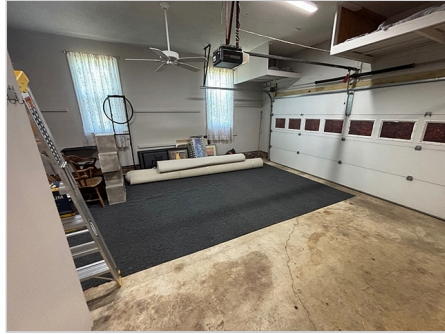
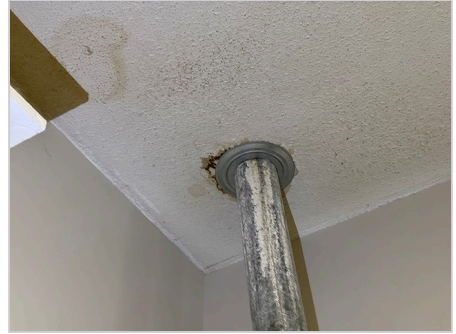
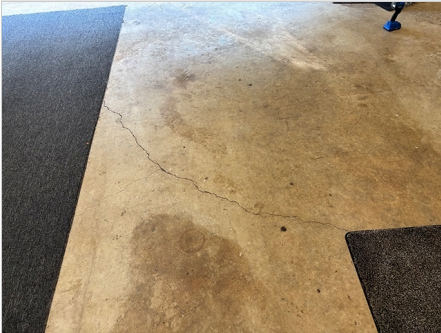
**Evidence of moisture intrusion was present in areas of the garage.** The areas were not dry at the time of the inspection. Many water intrusion problems can be controlled by improving the drainage on the exterior of the structure. It is important that all roof drainage and surface water (ie, from driveway) is directed away from the foundation. Monitor for future water intrusion and repair as necessary.

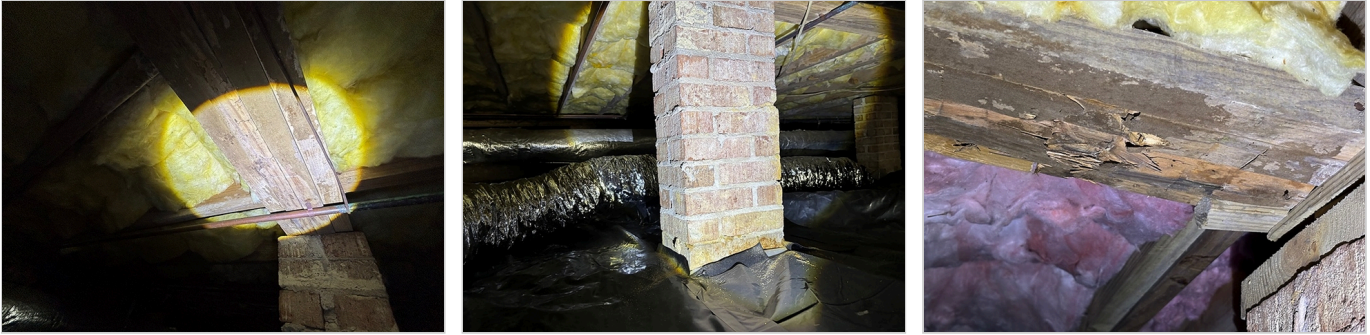
**Microbial growth was found in the crawlspace.** Due to moist conditions that may be present in the crawlspace, this is common but should be evaluated if growth is excessive.

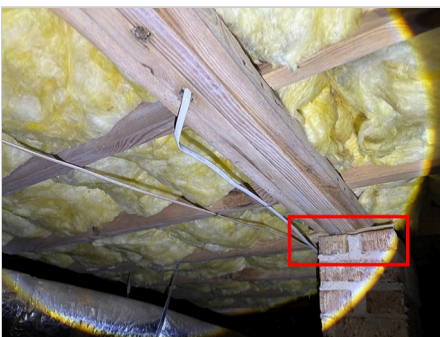
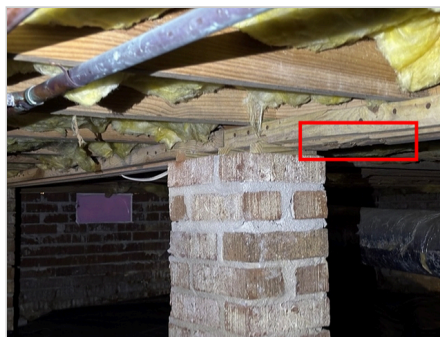
**Some floor joists are cut or damaged and require repair or re-support.** The joists should be repaired and the areas further assessed for any additional required repairs.

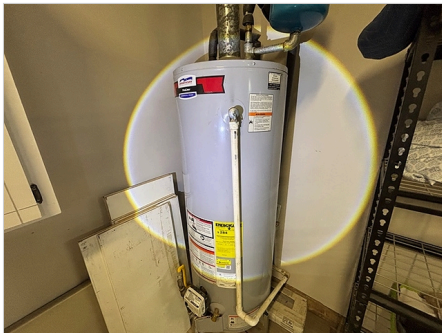
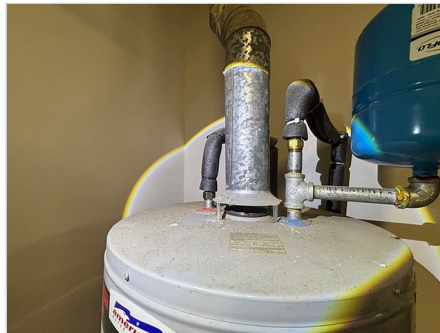
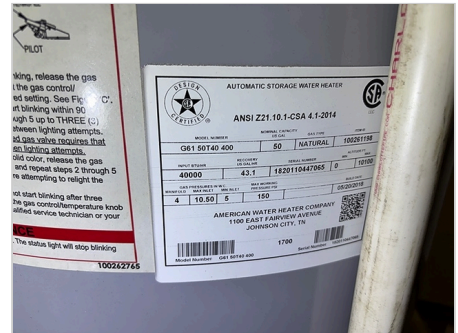
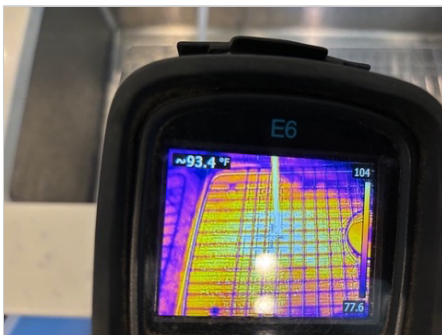
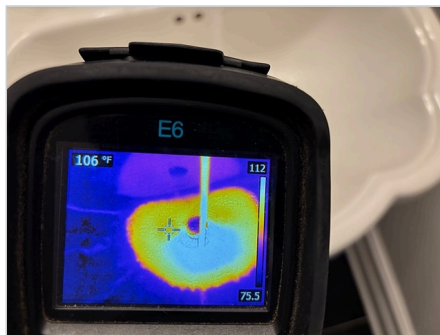
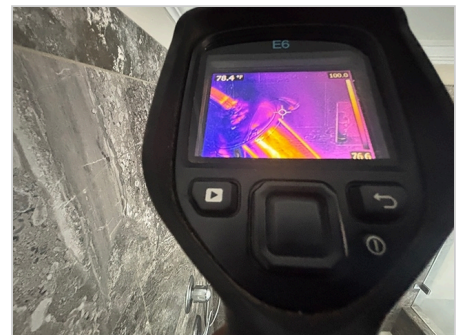
**The water heater in the garage lacks proper protection from vehicle impact. A crash guard or other measure should be added to allow for safer operation.**

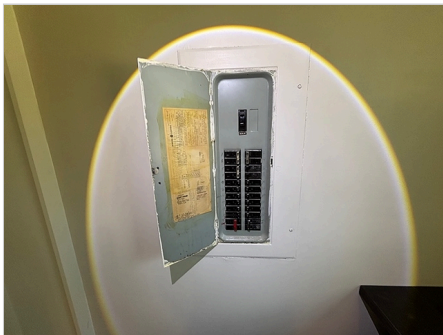
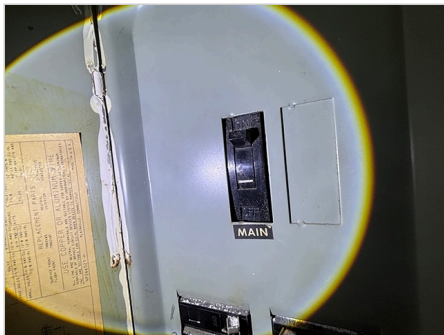
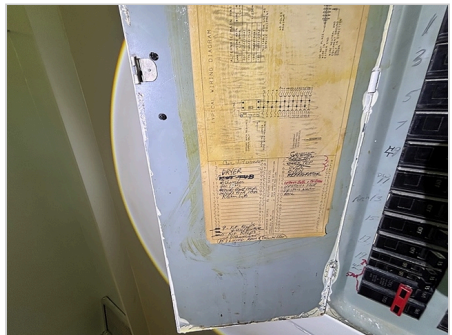
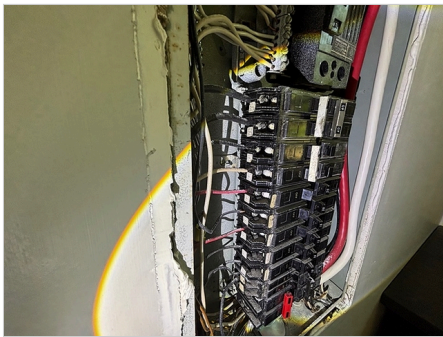
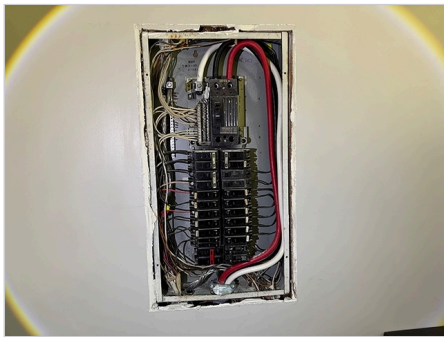
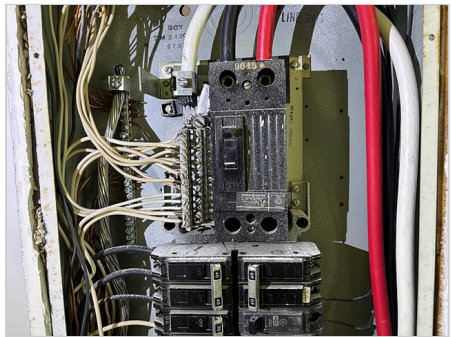
**The screws securing the cover to the electrical panel are pointed and can lead to inadvertent nicking of electrical wires, resulting in a safety hazard.** They should be replaced with blunt screws.

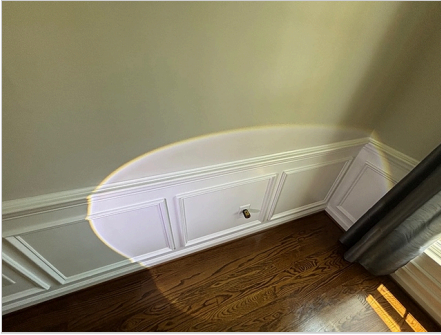
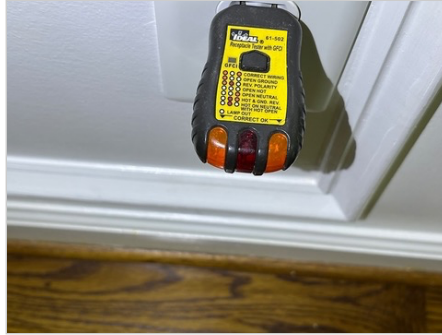
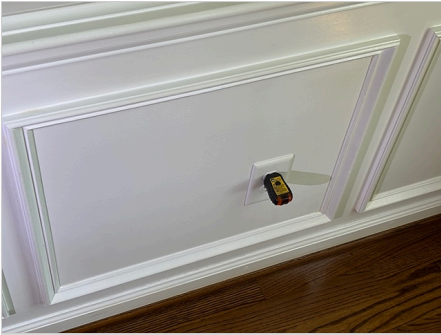
**Outlet(s) in the home were not functional.** Consult with a qualified electrician for repair and further assessment of outlets.

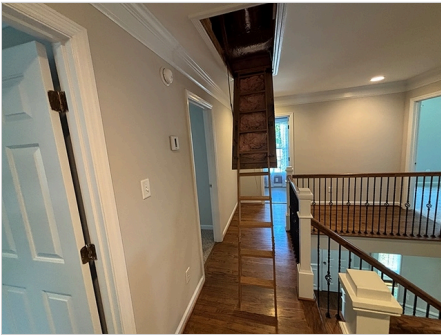
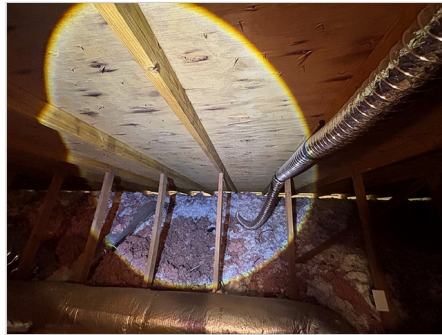
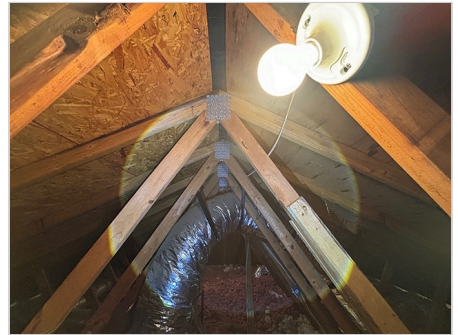
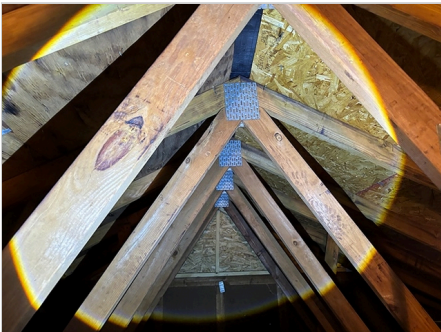
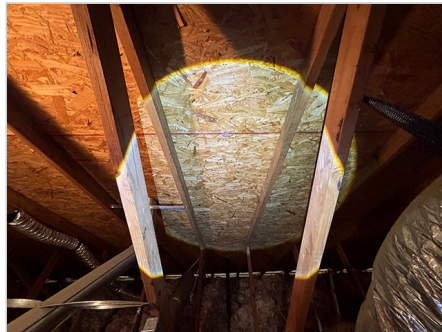
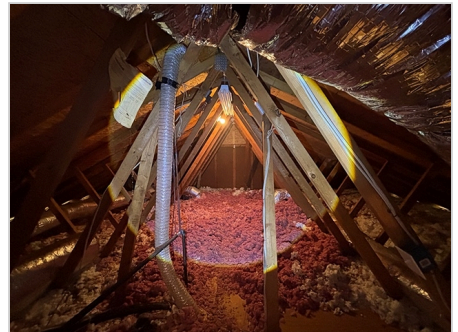
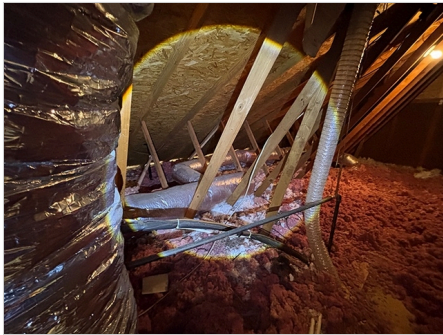
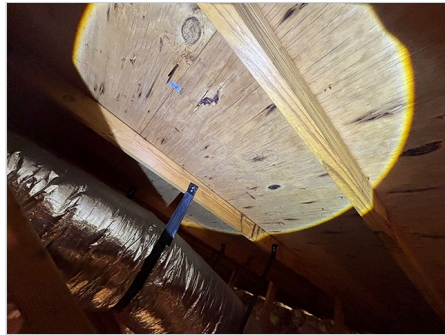
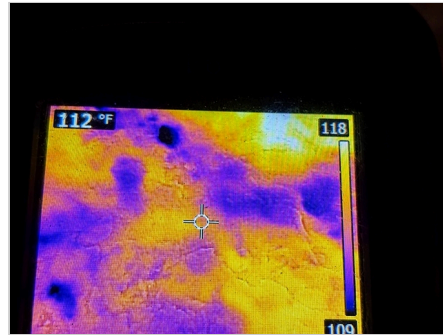
**The attic shows evidence of pest intrusion.** No live pests were visible at the time of the inspection. The client should ensure all openings have been sealed once it is determined the area is completely free of live insects and/or animals.

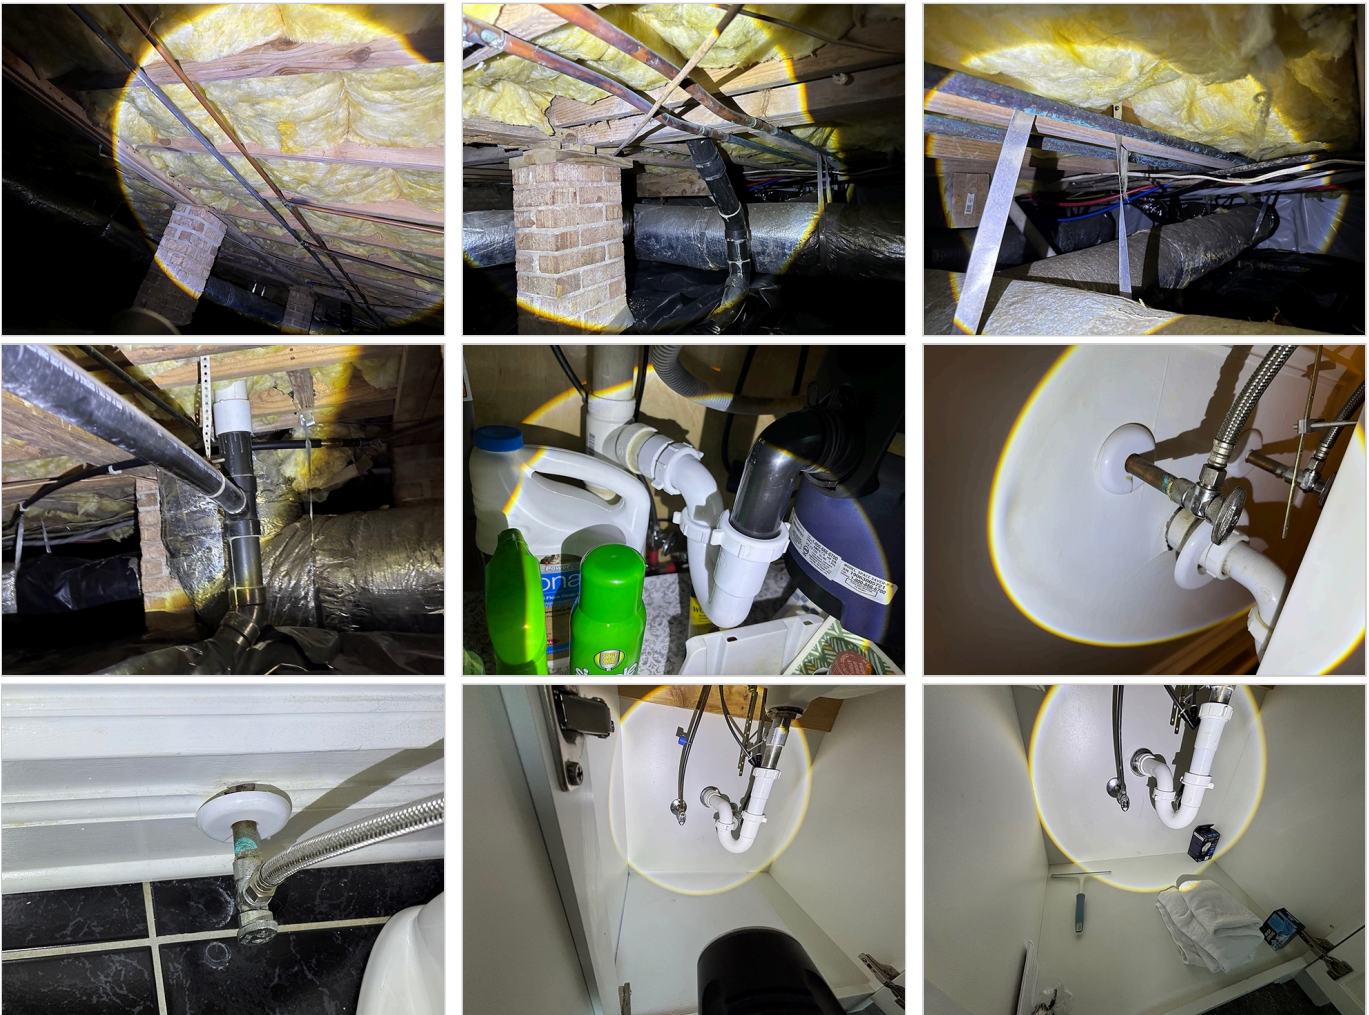
**Some of the hardware/fixtures in wet areas are loose and should be repaired and sealed to prevent water intrusion.**

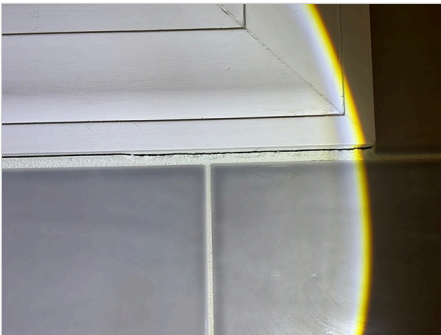
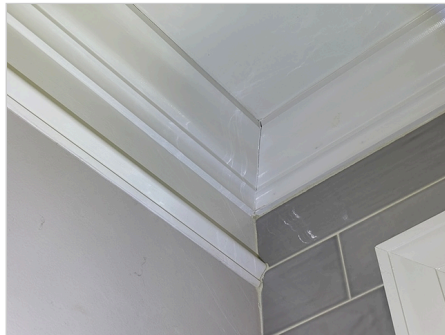
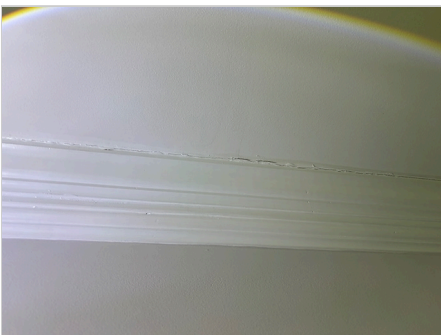
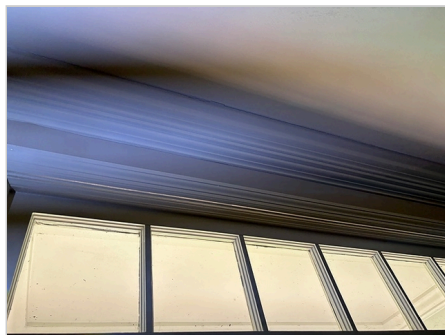
**Some of the caulk/grout was missing from around areas of the interior.** These areas should be sealed to prevent moisture penetration. Failure to keep walls sealed can cause deterioration and extensive moisture damage including microbial growth in the interior walls, which is not always visible at the time of the inspection. **\*\*MAINTENANCE ITEM\*\***

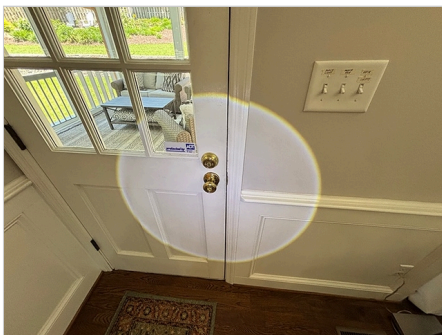
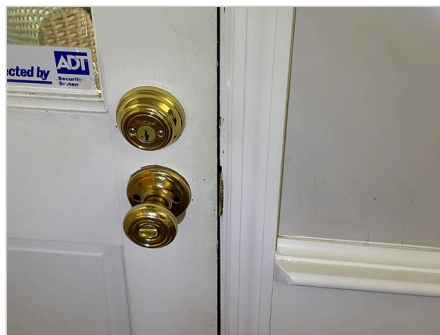
**Exterior doors on the structure have a deadbolt that requires a key to unlock them from the interior of the structure, which may be a safety issue in case of fire.** For safety during emergency egress, all exterior doors should be operable without a key from the interior. The affected locks should be repaired or replaced to allow for manual, keyless operation from the interior.
