### *HOME INSPECTION REPORT*

Address of Inspection: **123 Sample Drive**

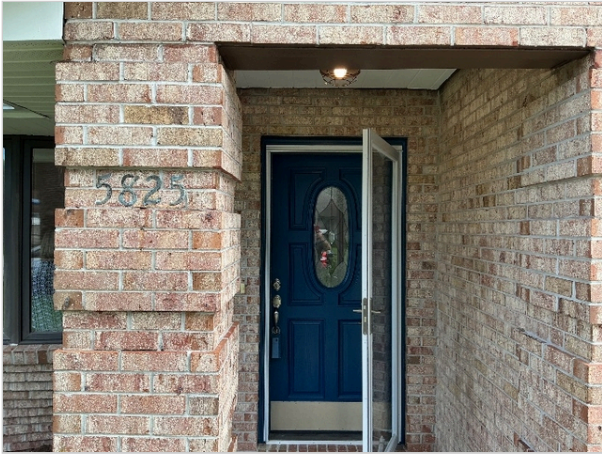
Hairline cracking

Small hairline cracking was observed in the mortar joints of the brick veneer, along with evidence of previous mortar repairs in localized areas. The observed cracking appears minor and is consistent with normal settlement and thermal movement commonly associated with masonry veneer. No significant displacement or other indications of structural concern were observed at the time of the inspection. Recommend monitoring the repaired and cracked areas for signs of continued movement and consulting a qualified masonry contractor if the cracks widen, additional cracking develops, or repairs begin to fail.

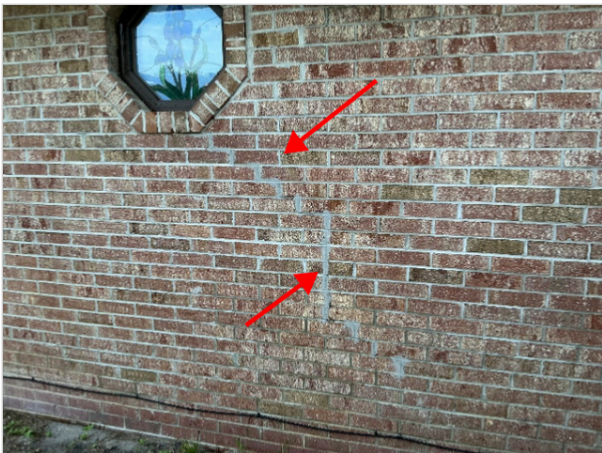
Previous repairs

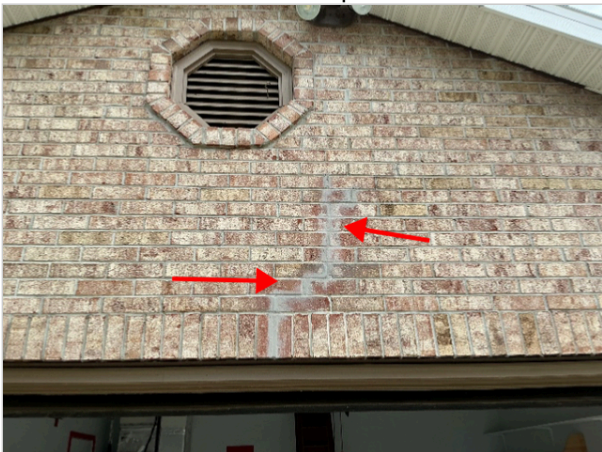
Previous repairs

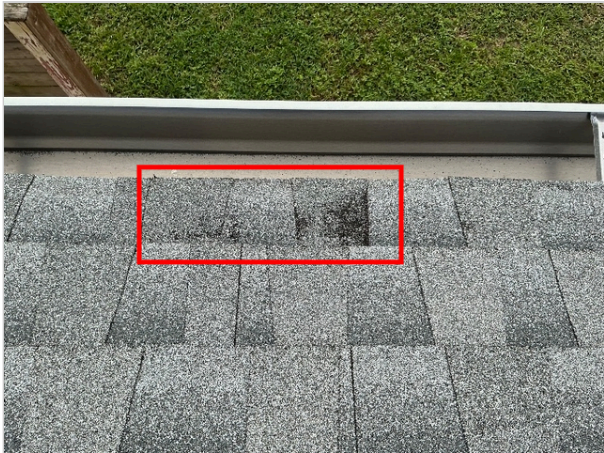
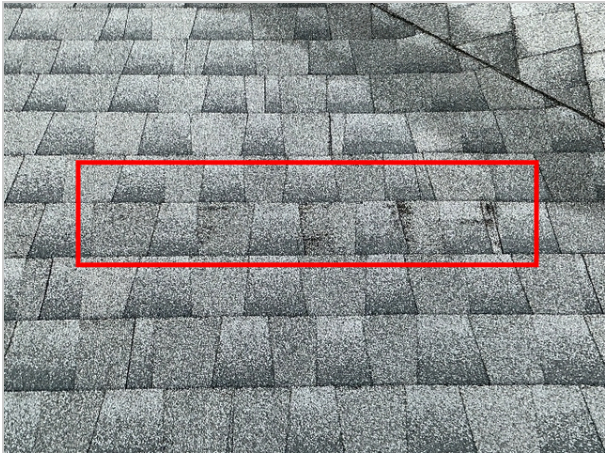
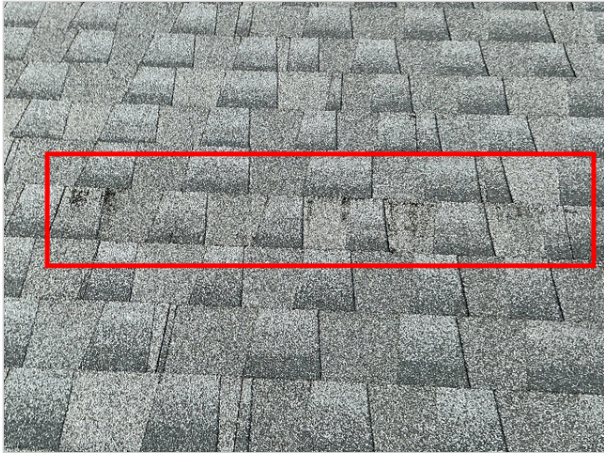
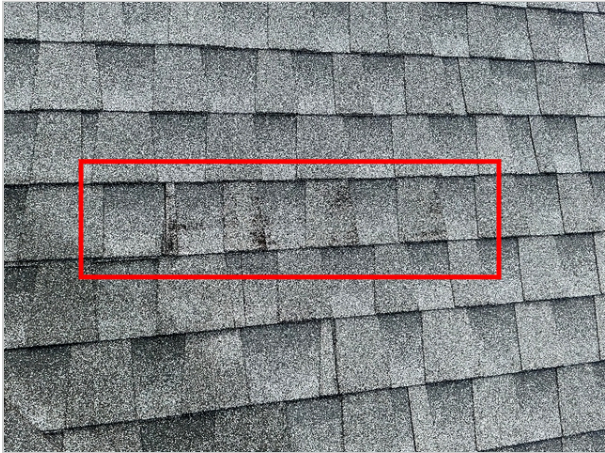
Localized granule loss was observed on several asphalt shingles. This condition is most likely the result of normal weathering and aging, although localized mechanical wear or foot traffic may also have contributed. Granule loss reduces the shingles' protective surface and may accelerate deterioration over time. Recommend monitoring the affected areas and having a qualified roofing contractor evaluate the roof to determine if maintenance or localized repairs are warranted.

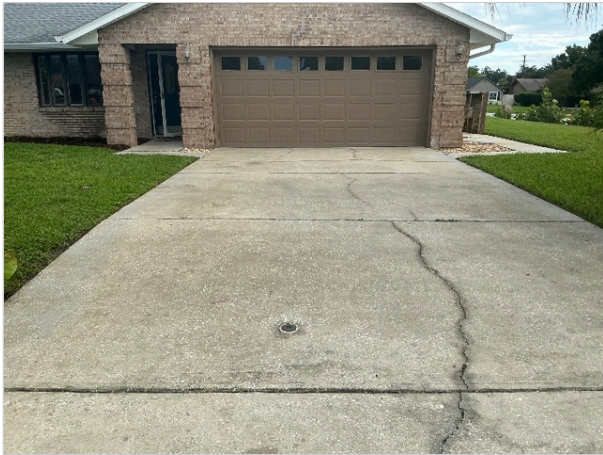
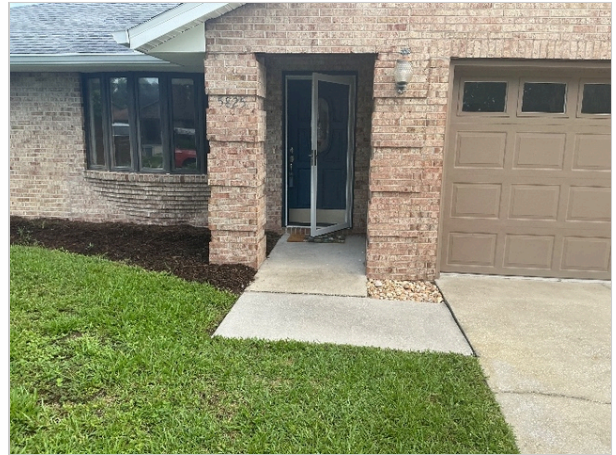
A concrete driveway is present in the front of the structure. Cracks and spalling were observed on the driveway. Surface defects in driveways develop and progress with age and are considered normal as long as they do not create a safety hazard. Sealing defects may help slow the rate of deterioration.

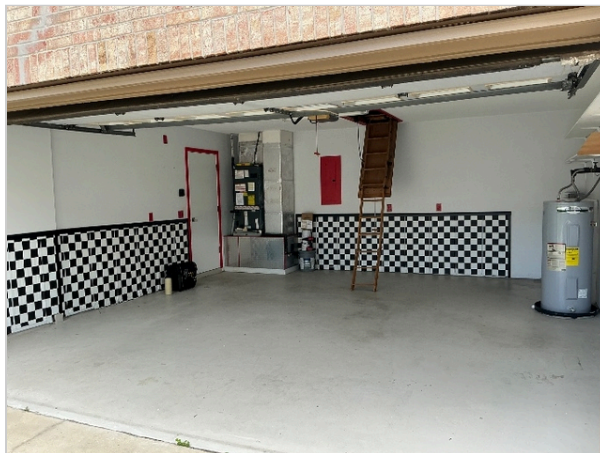
The automatic garage door opener did not reverse direction when the door encountered an obstruction during testing. This is a safety hazard that increases the risk of injury or property damage. Recommend discontinuing use of the automatic opener until it has been evaluated, adjusted, or repaired by a qualified garage door service contractor. After repairs, the opener should be tested to verify proper operation of all required safety features.

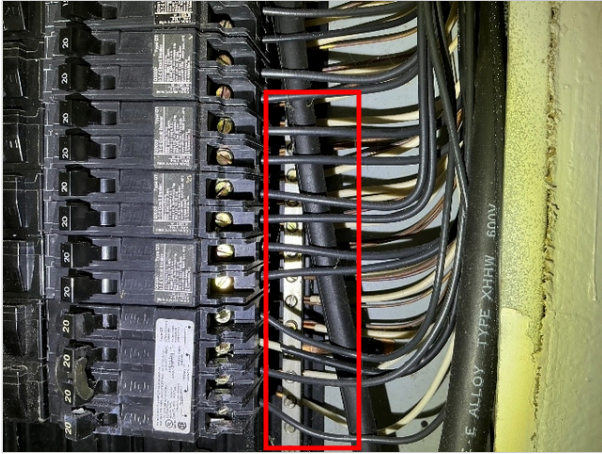
DT - Neutral Bar

**The neutral bar in the electric panel had two attached circuits (wires).** Each circuit should have its own dedicated breaker to prevent nuisance tripping and ensure good terminal contact, which may help prevent overheating. This situation is commonly referred to as a "double-tap". An electrician should repair this condition and further assess the panel for any additional required repairs.

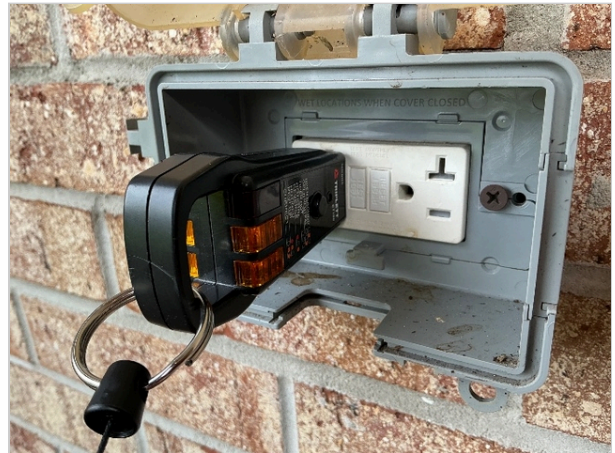
Dead - Front

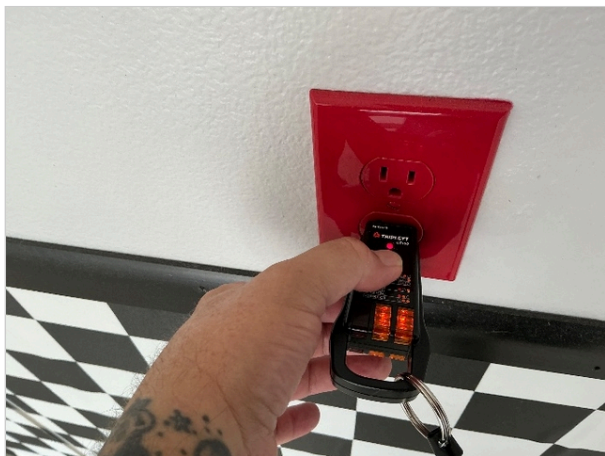
-GFCI - Garage

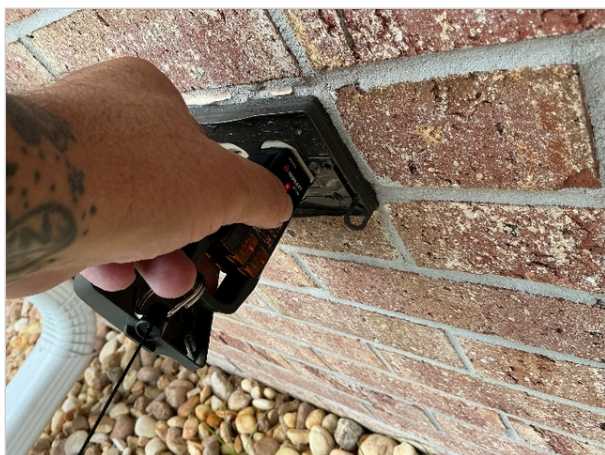
-GFCI - Laundry

**The home lacks multiple GFCI protection.**

**One outlet was not functional.** Consult with a qualified electrician for repair and further assessment of outlets.

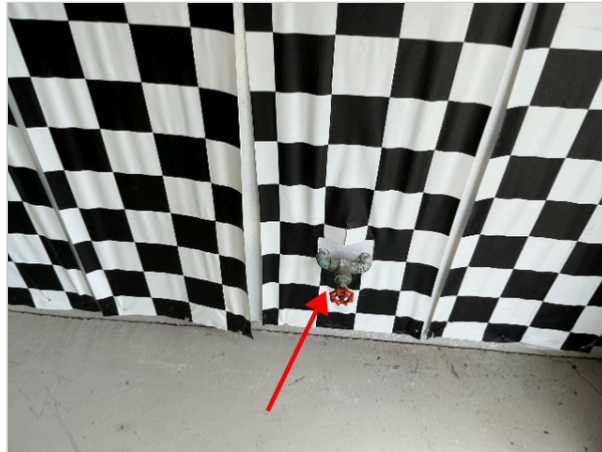
Shutoff

The water meter was located not observed. The main water shutoff valve for the structure was located adjacent to the water service entry point was not observed. Water shutoff valves are visually inspected only. No attempt is made to operate the main or any other water supply shutoff valves during the inspection. These valves are infrequently used and could leak after being operated. The only exception to this policy is made when the main water supply valve is off upon arrival at the inspection. Since it is the buyers right to have all utilities operable for the home inspection, we will attempt to turn the main water valve on for the inspection. The HomeTeam is not responsible for leaks caused by operating the valve.

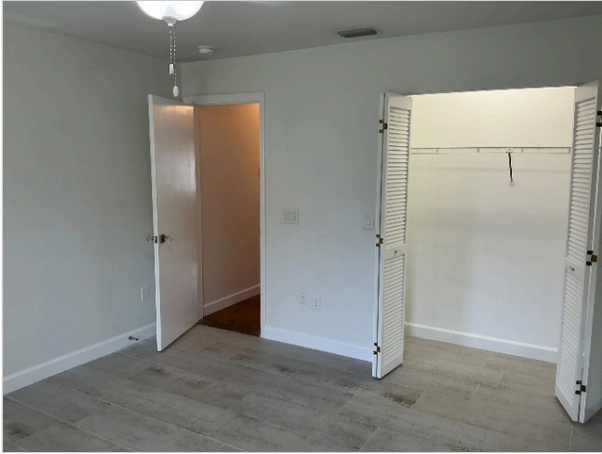
Wood-look ceramic tile flooring exhibited localized chips and surface damage in several tiles. The observed damage is primarily cosmetic but may create rough edges and can allow additional deterioration if left unaddressed. Recommend replacing the damaged tiles or performing appropriate repairs as needed to maintain the flooring's appearance and serviceability.

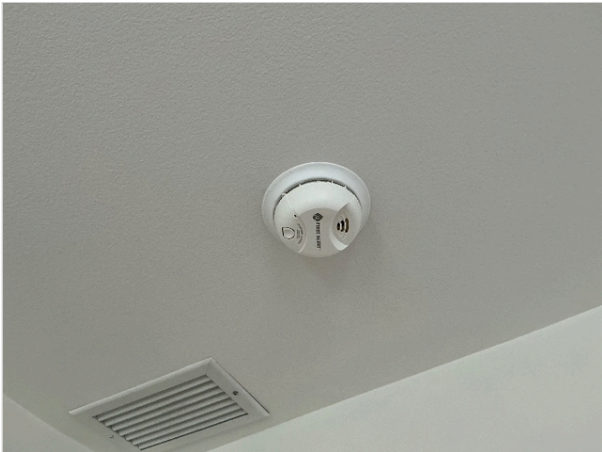
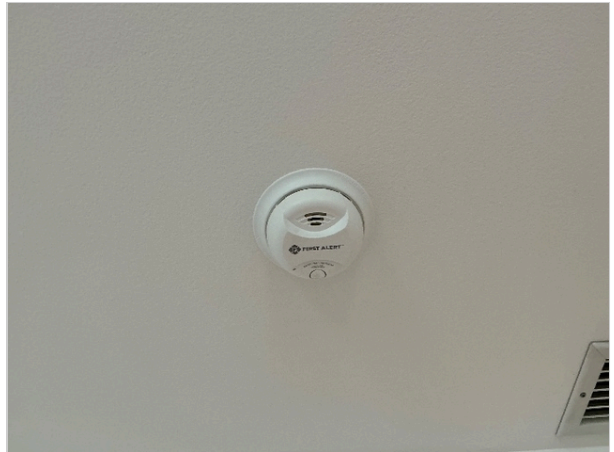
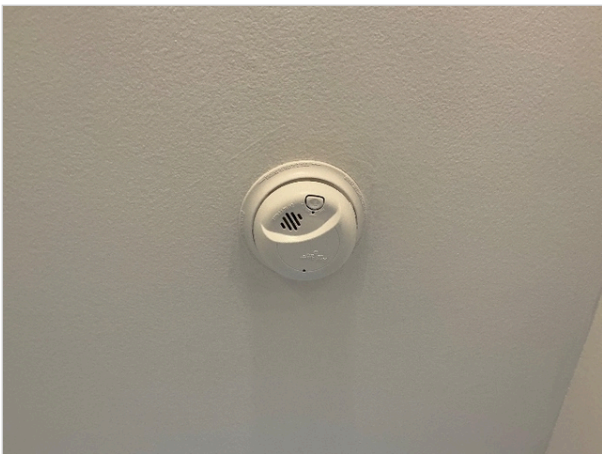
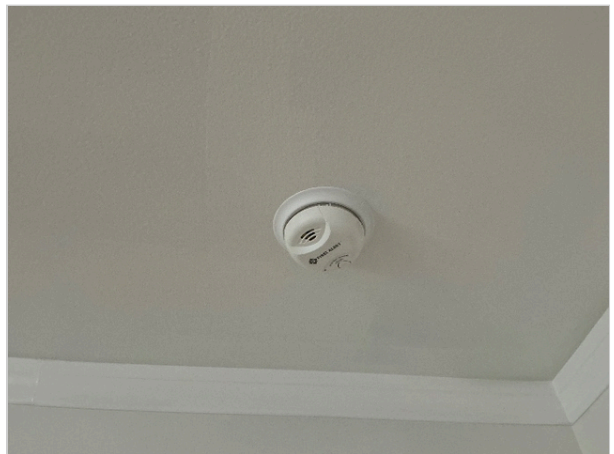
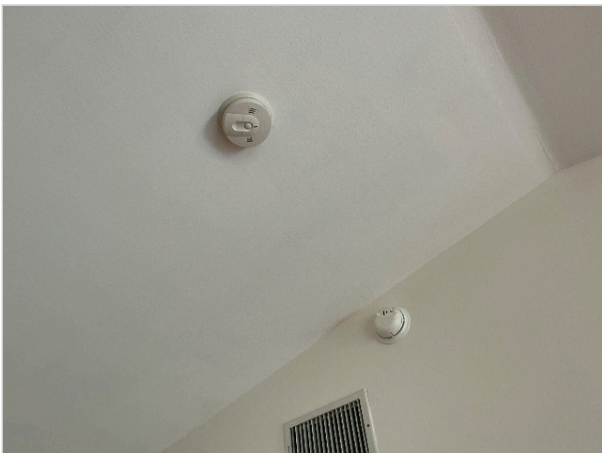
Carbon monoxide detectors were not present in the house.

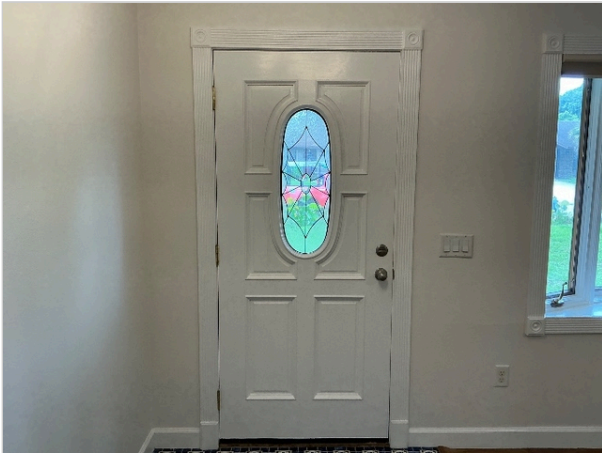
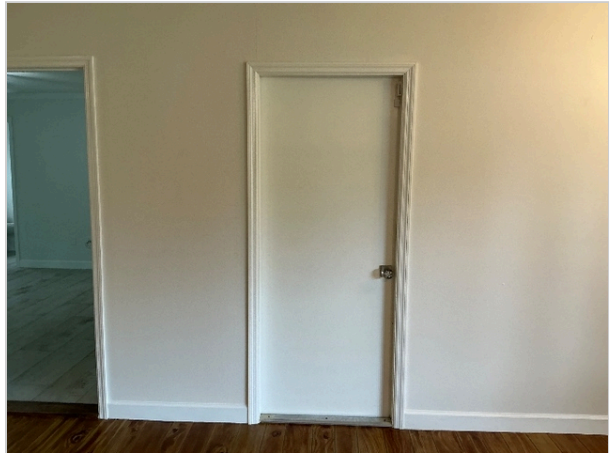
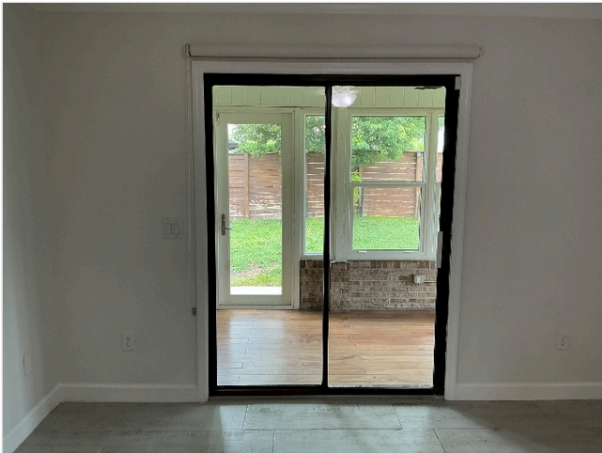
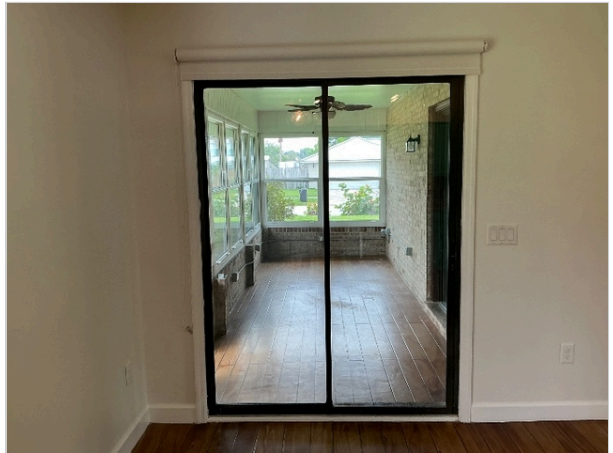
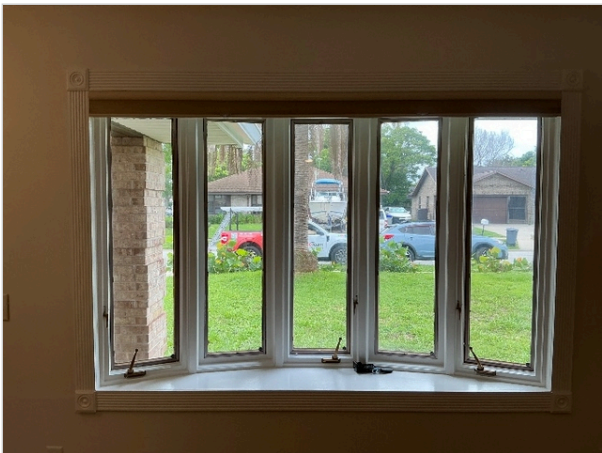
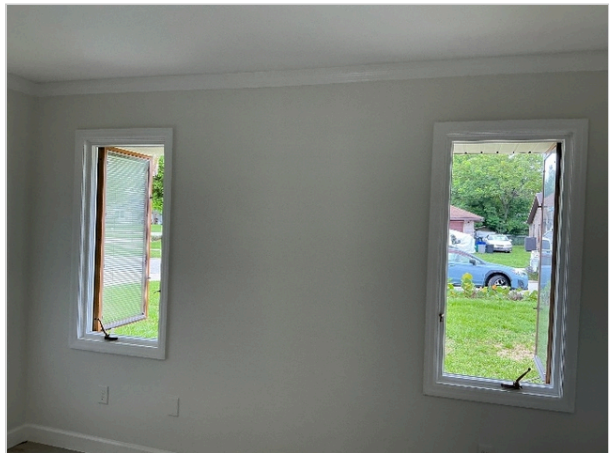
A representative number of accessible windows and doors were operated and found to be functional. The primary windows were aluminum, single hung style, with double pane glass. All exterior doors were operated and found to be functional. The exterior door locks should be changed or rekeyed upon occupancy. Possible problem areas may not be identified if the windows or doors have been recently painted.

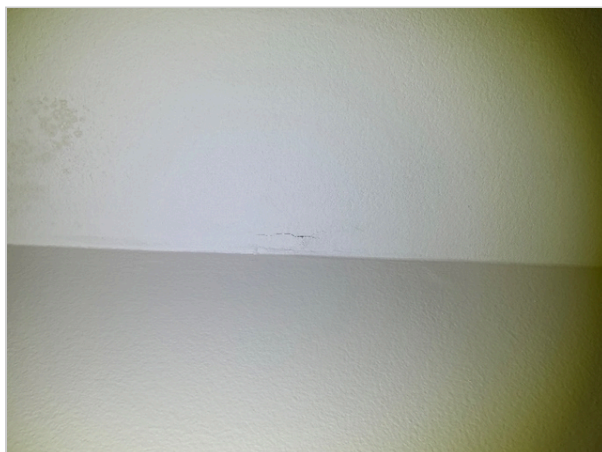
Multiple hairline drywall cracks were observed at interior wall and wall-to-ceiling joints. The cracks appear minor and consistent with typical cosmetic movement and/or normal settling. No elevated moisture levels were detected at the time of the inspection (approximately 14.7% using a non-invasive moisture meter), and no visible evidence of active moisture intrusion was observed. Monitor these areas for changes such as widening, displacement, or recurring repairs, and patch and repaint as needed. If significant movement or additional signs of structural distress develop, further evaluation by a qualified contractor is recommended.

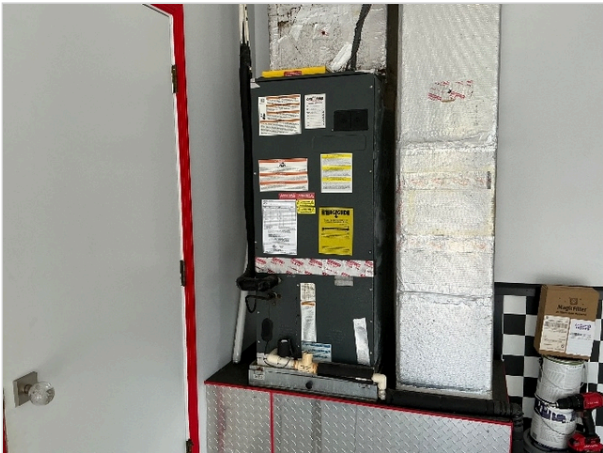
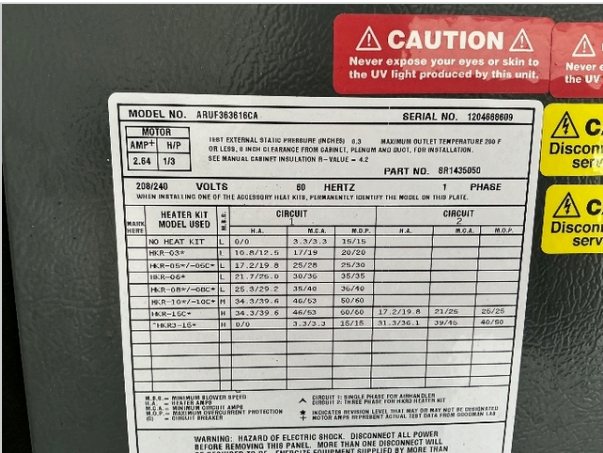
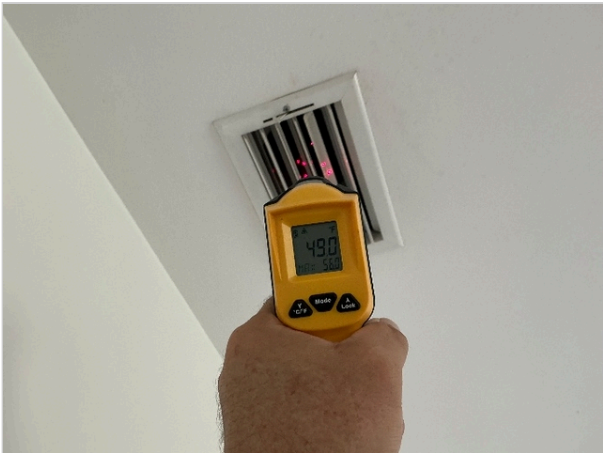
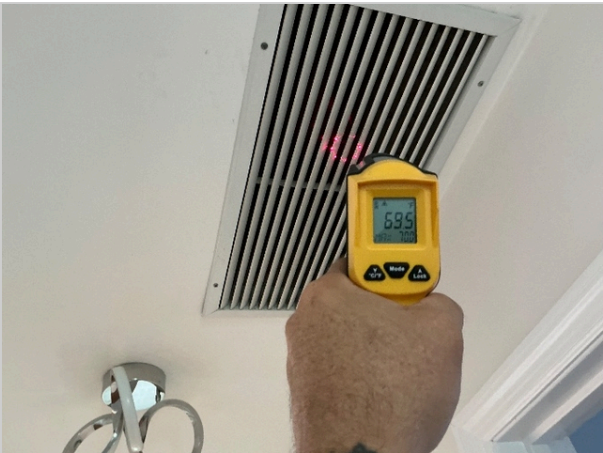
The HVAC condensate line was raised above the floor drain or drain inlet. The condensate line was trapped. The HVAC condensate line must be trapped and not in contact with wet drain inlets to prevent the possible migration of bacteria and mold into the air-handling system. The heating system was found to be functional.

The temperature was measured at several locations. At the supply it was 49 degrees F, and at the return it was 70 for a average of 60 degrees F, which is normal.
