### *HOME INSPECTION REPORT*

On Monday, August 24, 2026 The HomeTeam Inspection Service made a visual inspection of 123 Sample Drive, Pigeon Forge, TN 37863. Enclosed please find a written, narrative report of our findings in accordance with the terms of our Inspection Agreement.

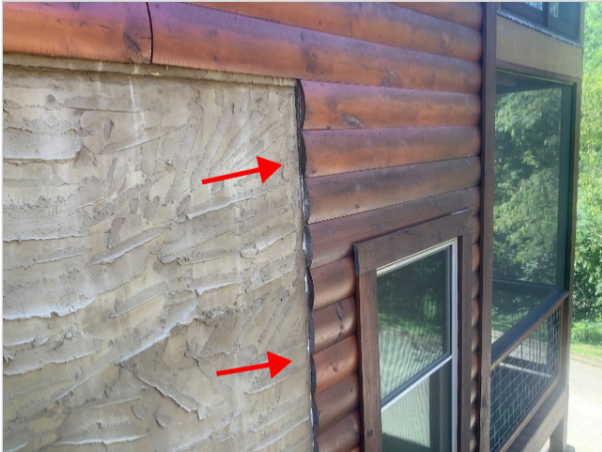
**Photo 6**

Evidence of carpenter bees noted.

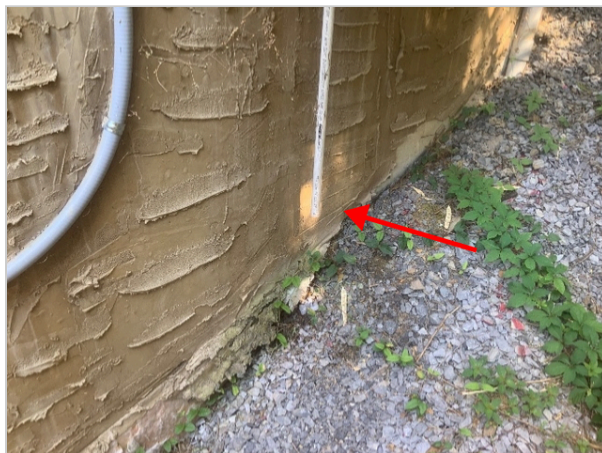
Photo 9

The siding and sill plate are positioned at or below grade level in certain areas of the structure. This configuration poses a heightened risk for moisture intrusion, wood decay, and pest infestation due to direct soil contact. To mitigate these risks, it is recommended to regrade the soil to establish a proper slope away from the foundation and maintain a minimum clearance of 6 inches between the siding/sill plate and the soil. Additionally, inspecting the affected areas for existing damage is advised. Consultation with a licensed contractor is strongly recommended to implement corrective measures and ensure long-term protection of the structure

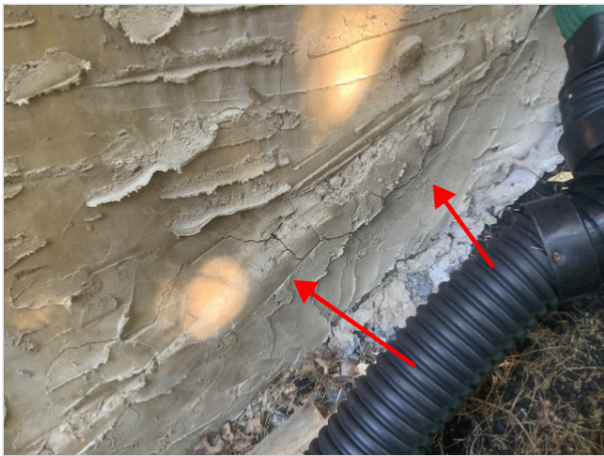
Photo 12

Cement parging was missing and damaged on the left side of the structure. This can lead to potential moisture intrusion into the foundation. This area should be monitored for further moisture.

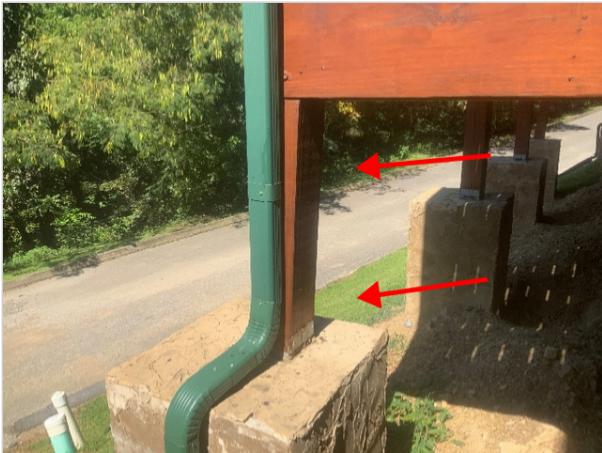
Photo 14

**Some of the structural supports under the balcony should be re-secured** to ensure deck safety.

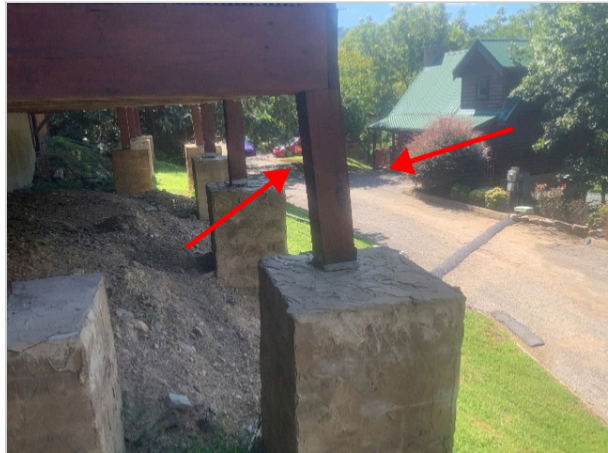
Photo 15

Joists hangers improperly attached. Recommend repair by qualified contractor.

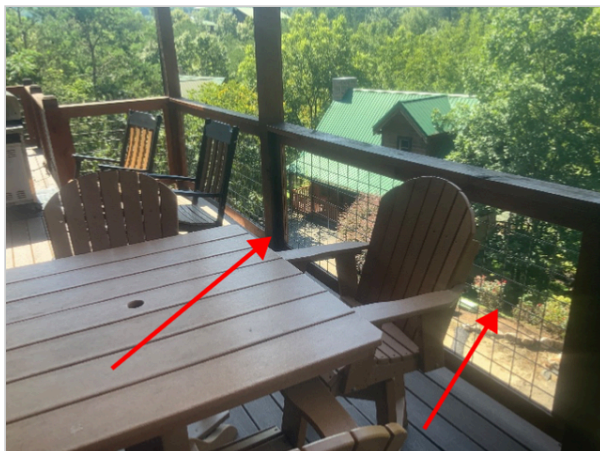
**Photo 18**

The railing balusters were constructed in a climbable form. This can be a safety concern for young children as they could climb this and fall.

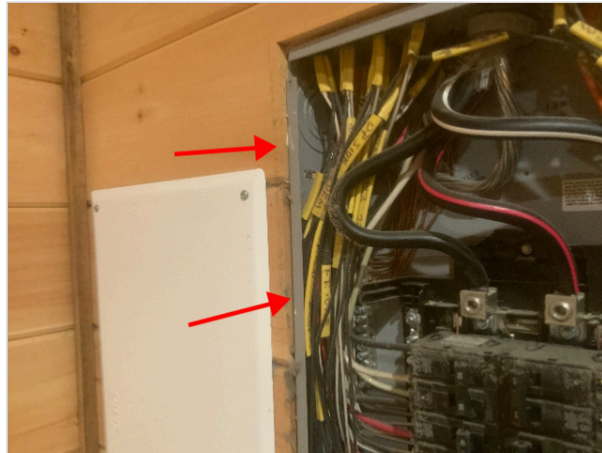
**Photo 20**

There is a gap between the dead front cover and the panel box, which prevents the cover from securely sealing the enclosure. The dead front cover is designed to protect against accidental contact with live parts and to contain any potential arcing that may occur within the panel. This gap increases the risk of sparks reaching nearby combustible surfaces, posing a fire hazard. It is recommended that a licensed electrician evaluate and correct this condition.

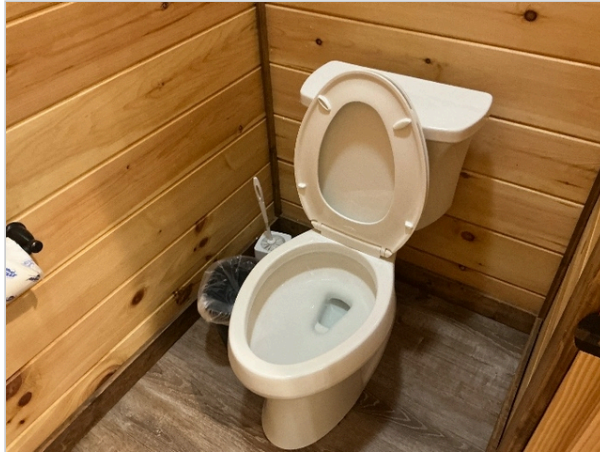
**Photo 37**

**The toilet in the basement bath is loose.** Failure to secure the toilet may lead to leakage around the wax ring. The toilet should be secured.

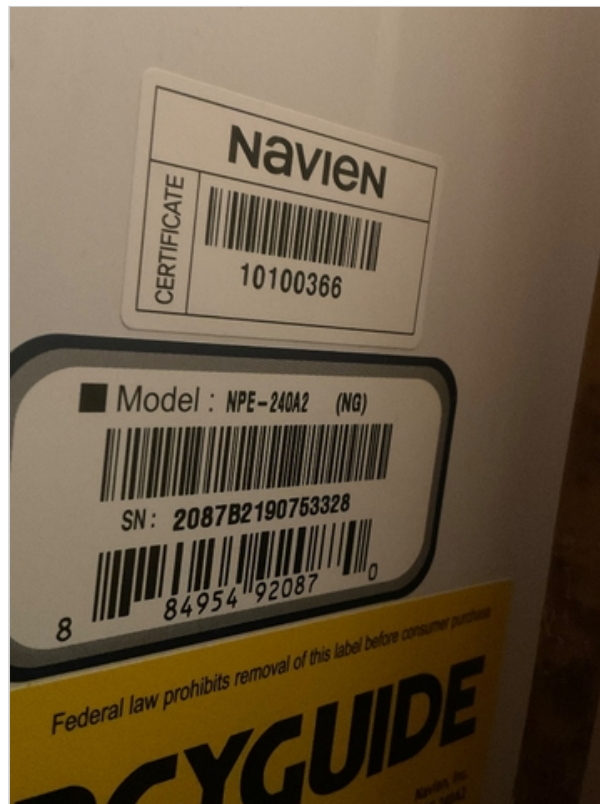
Photo 49

**The water heater overflow leg does not terminate properly.** The overflow leg should be repaired/replaced with one that terminates properly.

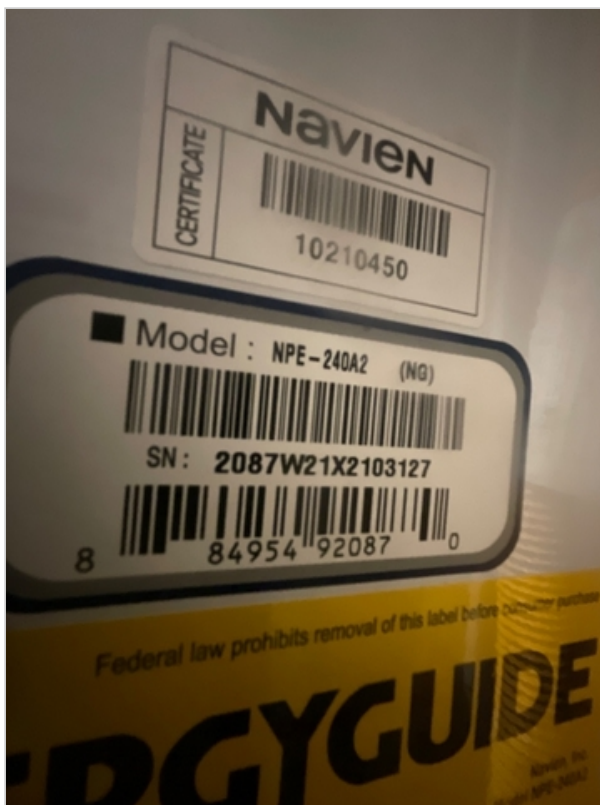
**Photo 51**

**The water heater overflow leg does not terminate properly.** The overflow leg should be repaired/replaced with one that terminates properly.

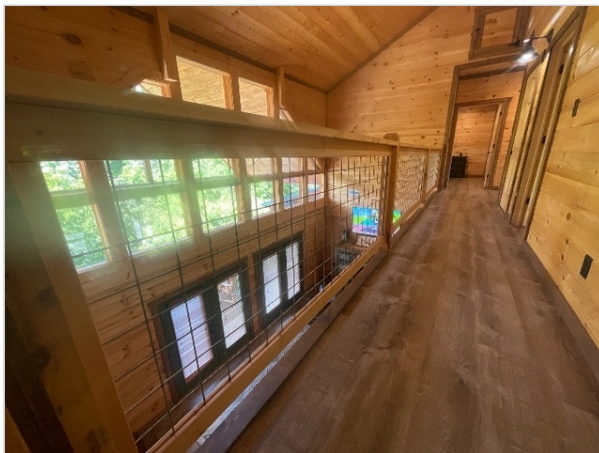
**Photo 53**

The railing balusters were constructed in ladder form. This can be a safety concern for young children as they could climb this and fall.

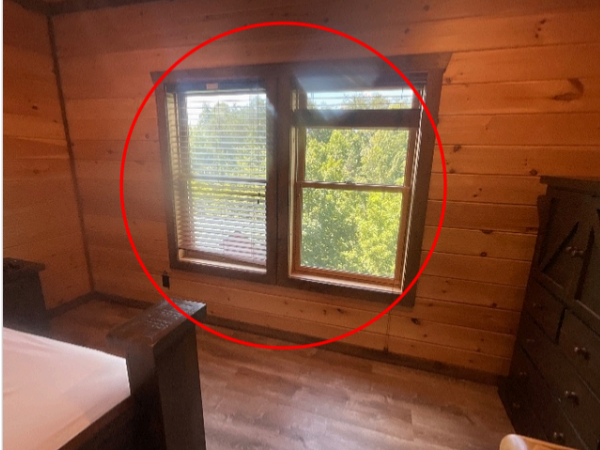
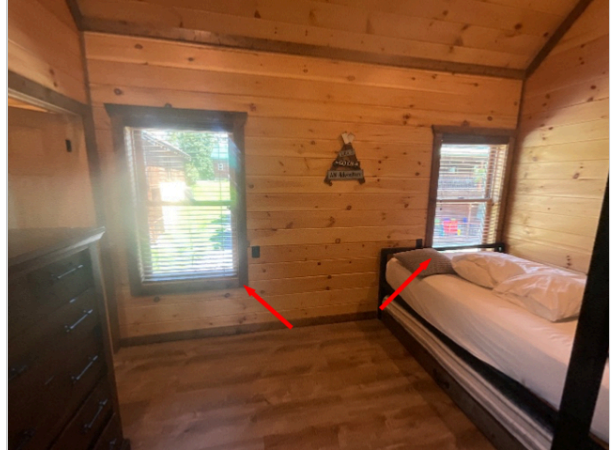
- The window is operable.
- The top of the sill height is located less than 24 inches above the finished floor.
- The top of the sill height is located more than 72 inches above the finished grade below on the exterior side.

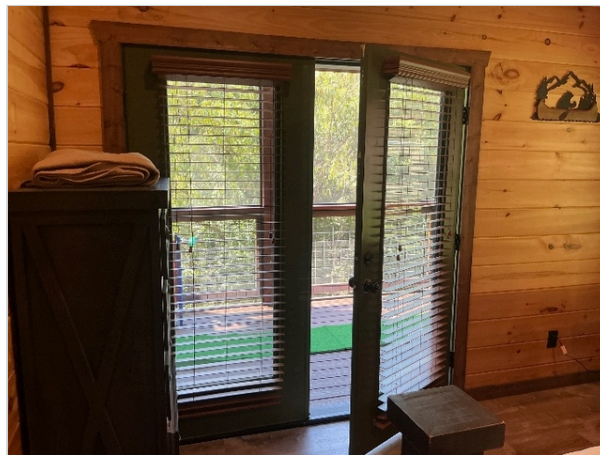
**Photo 59**

The exterior door sticks. The door is out of alignment and needs adjusting.

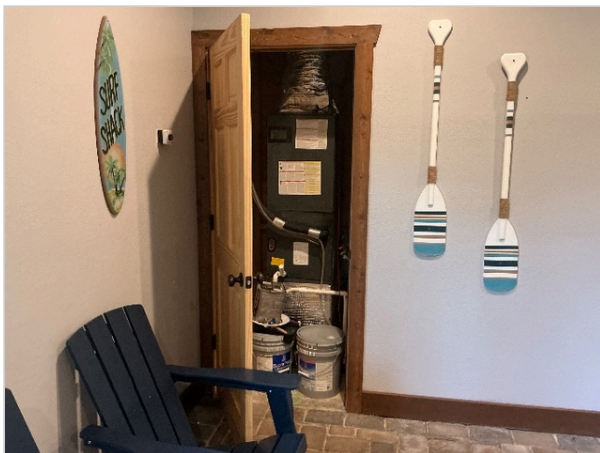
Photo 60

The door to the lower level utility closet does not latch. The door, frame, and/or latching mechanism should be adjusted to allow for proper operation of the door.

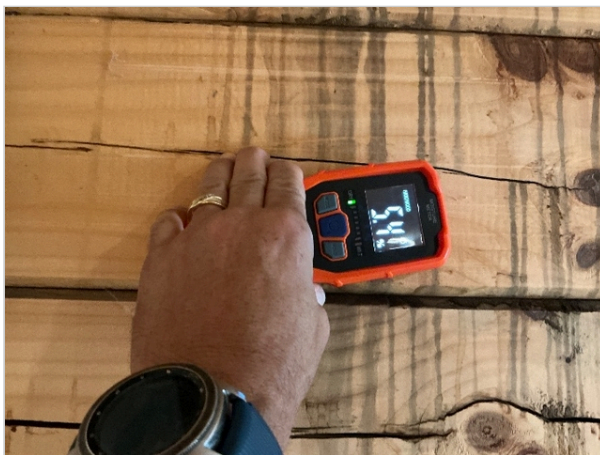
Photo 61

**Water stains were present on the wall of the structure.** The stains appeared to be dry at the time of the inspection and should be monitored for any future moisture.

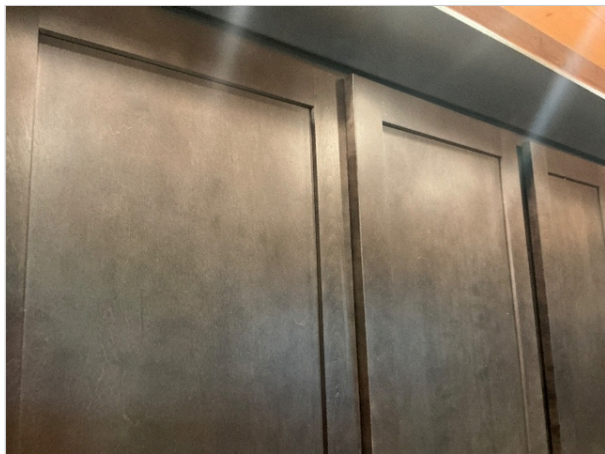
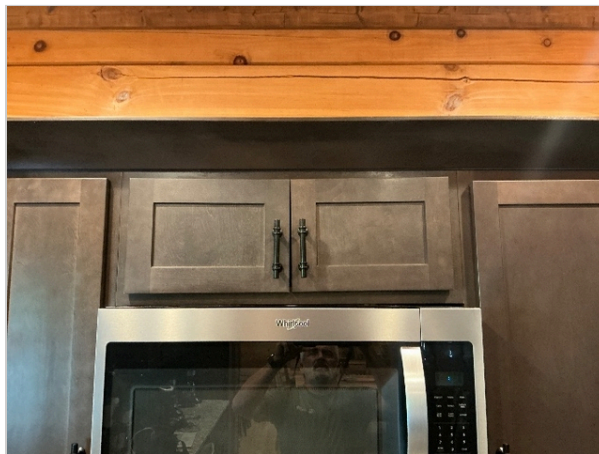
Kitchen cabinet door hinges are in need of adjustment. These adjustments are usually relatively simple and only require the tightening of screws or alignment of a variable adjustment hinge.

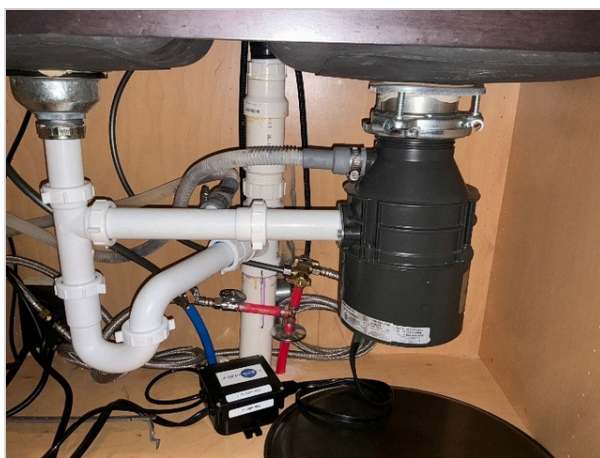
Photo 65

When operated the disposal is very noisy.

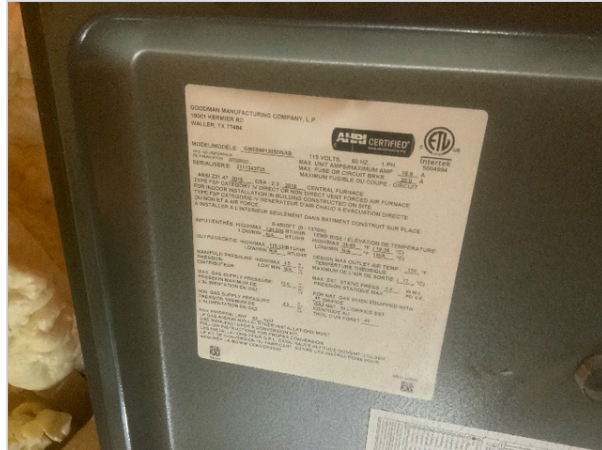
**Photo 67**

The HVAC condensate line was raised above the floor drain or drain inlet. The condensate line was trapped. The HVAC condensate line must be trapped and not in contact with wet drain inlets to prevent the possible migration of bacteria and mold into the air-handling system. The heating system was found to be functional but in need of service and cleaning.

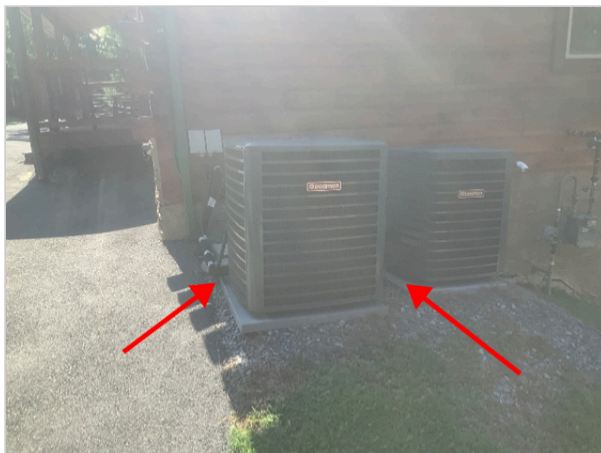
**Photo 73**

The outdoor compressor unit is not level. The unit should be leveled to ensure proper lubrication of the moving parts.

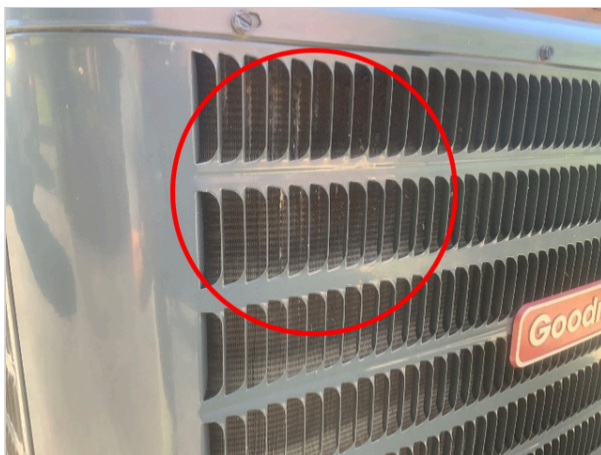
**Photo 74**

**The fins on the outdoor compressor unit are bent.** Combing or straightening the fins may improve the efficiency of the unit by aiding heat transfer.

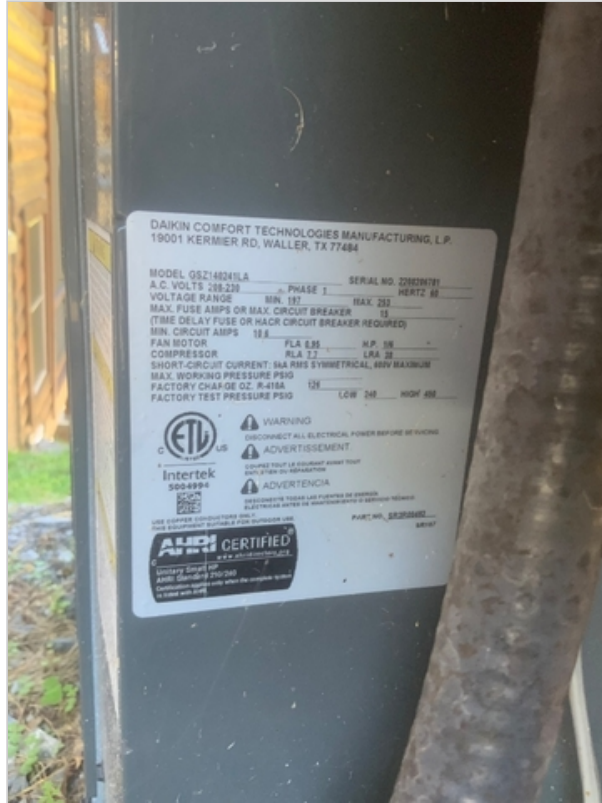
**Photo 75**

**The fins on the outdoor compressor unit are bent.** Combing or straightening the fins may improve the efficiency of the unit by aiding heat transfer.

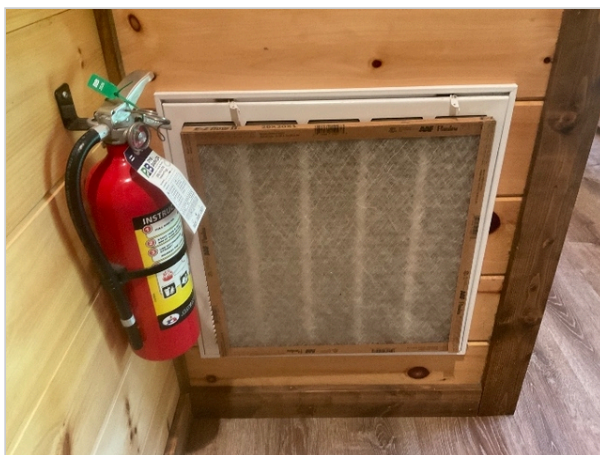
**Photo 78**

**The air filter is extremely dirty** and should be replaced. Prolonged operation of an HVAC system with a dirty filter can cause internal damage to the compressor valves that may not be observable during the inspection; operating with a dirty filter may also damage the air handler. HomeTeam recommends having the HVAC system cleaned and serviced for this reason.

Third floor hall

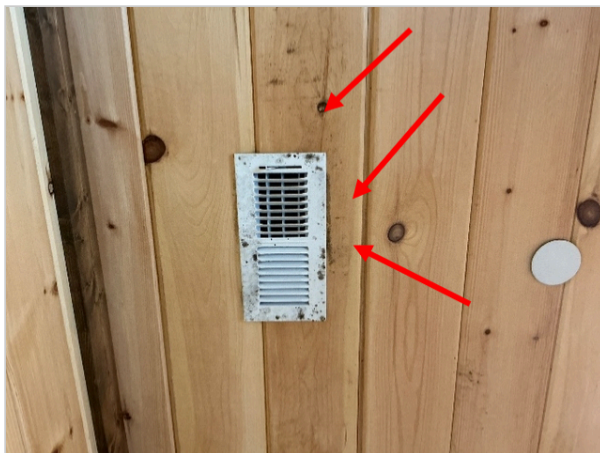
**Photo 79**

Condensation was observed at an HVAC supply register. Condensation at supply registers can occur when cold conditioned air causes the register or surrounding surfaces to fall below the dew point and may be associated with elevated indoor humidity, inadequate duct insulation, air leakage around the register/duct connection, or other HVAC conditions. Continued condensation may result in staining or moisture-related damage. Recommend evaluation and correction by a qualified HVAC contractor.

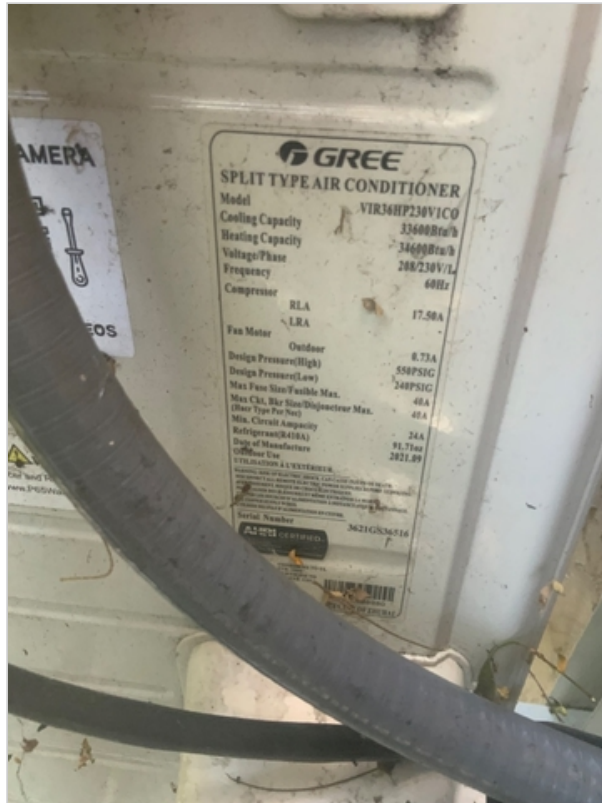
Photo 81

Upon inspection of the HVAC system, it was determined that the **secondary condensate drain** is blocked, which could lead to moisture backup and potential water damage if left unresolved. The secondary drain serves as a backup system in the event that the primary drain becomes clogged or malfunctioning, and its blockage is a significant concern that could compromise the efficiency of the HVAC system and the integrity of the surrounding structure.
