# HomeTeam<sup>®</sup>

## INSPECTION SERVICE

### *HOME INSPECTION REPORT*

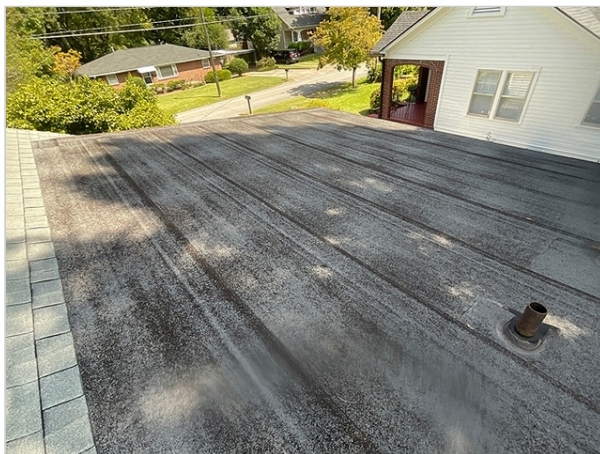
**Photo 21**

**The roof requires routine maintenance to prolong its life.** At the time of the maintenance, the roof should be further assessed for any additional repairs.

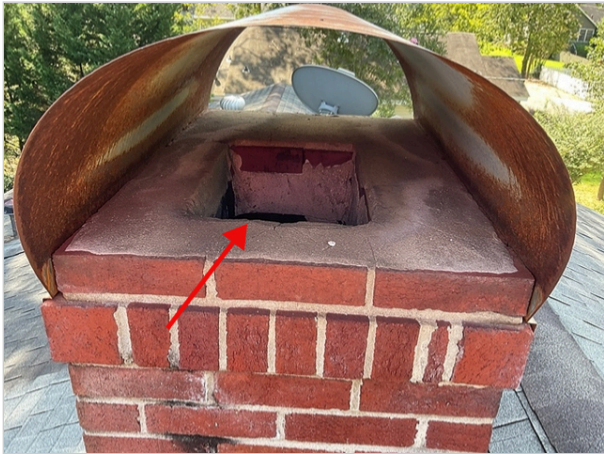
**Photo 27**

Open chimney. Cover to prevent animal intrusion

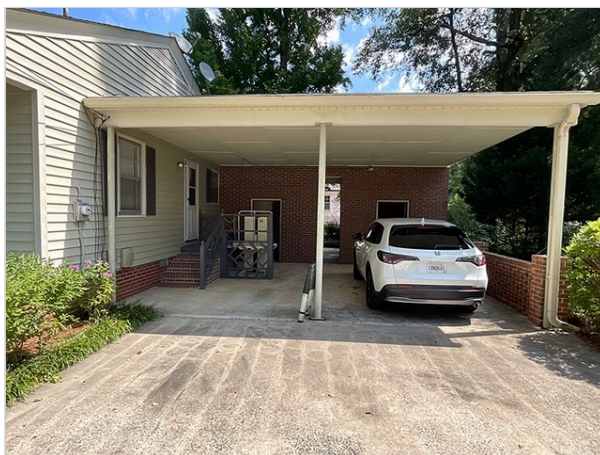
**Photo 30**

**Evidence of moisture intrusion was present on rear wall of the storage room behind the carport.** The area was dry at the time of the inspection. Many water intrusion problems can be controlled by improving the drainage on the exterior of the structure. It is important that all roof drainage and surface water (ie, from driveway) is directed away from the foundation. Monitor for future water intrusion and repair as necessary.

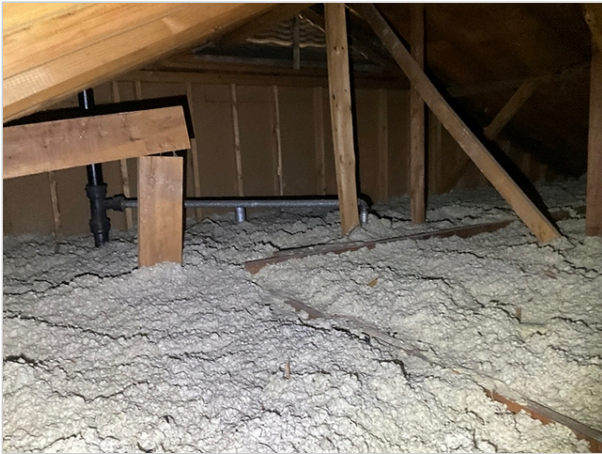
**Photo 40**

**Areas of the attic were not properly insulated.** This can lead to excessive energy bills and undesirable temperature variations within the structure. Insulation should be added to the affected areas.

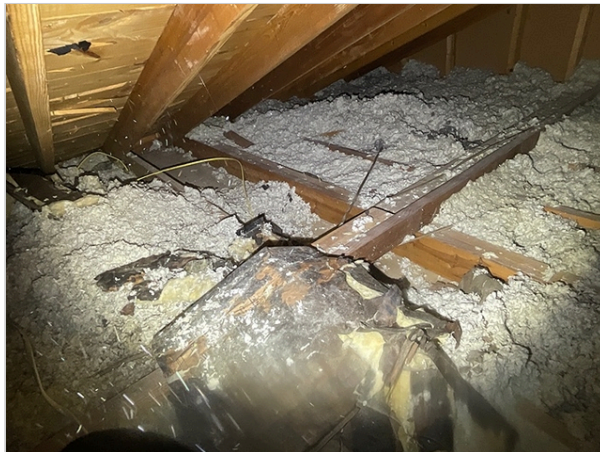
**Photo 41**

**Parts of the attic show signs of previous water intrusion.** The areas were dry at the time of the inspection. The buyer should maintain vigilance in monitoring the areas for any recurrence of the previous issue and should rectify any

issues immediately upon observing them.

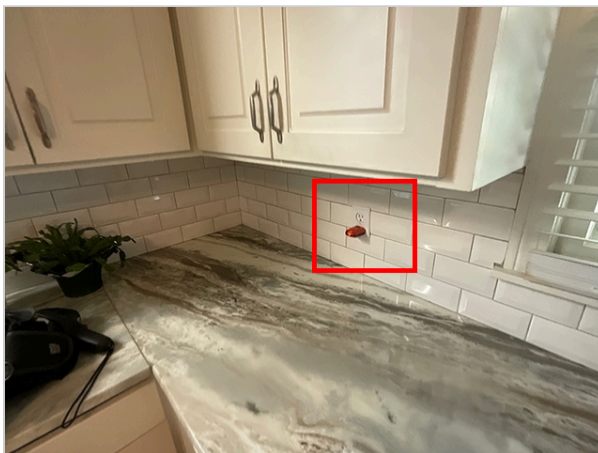
**Photo 48**

Kitchen lacks GFCI protection

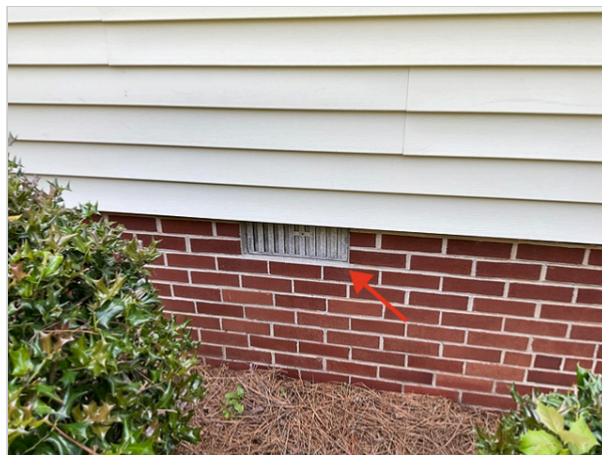
**Photo 62**

**The crawlspace vents were all closed at the time of the inspection.** The crawlspace vents should be open unless the outside temperature is below freezing to allow for the proper ventilation into the crawlspace.

Vents are closed at time of inspection

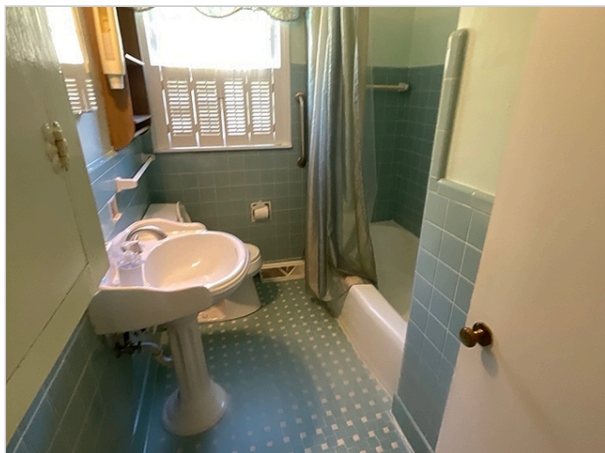
**Photo 67**

**The toilet in the master bath is loose.** Failure to secure the toilet may lead to leakage around the wax ring. The toilet should be secured.

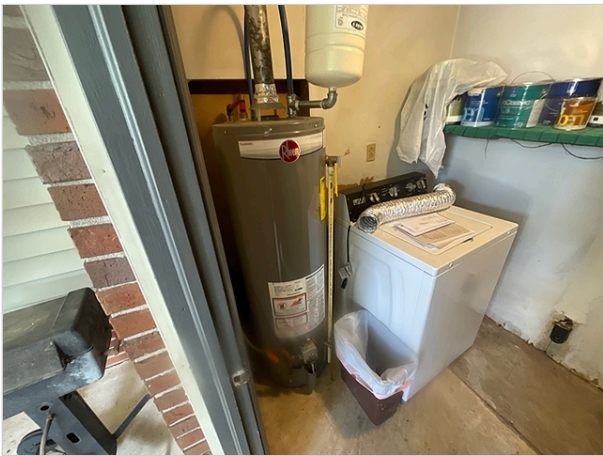
**Photo 70**

A 40 gallon capacity, natural gas water heater was located in the utility room. The water heater was manufactured by Rheem, model number PROG40 - 38N1 RIH59 and serial number Q461424013. Information on the water heater indicated that it was manufactured 11 years ago. Hot water temperature was approximately 118 degrees F.

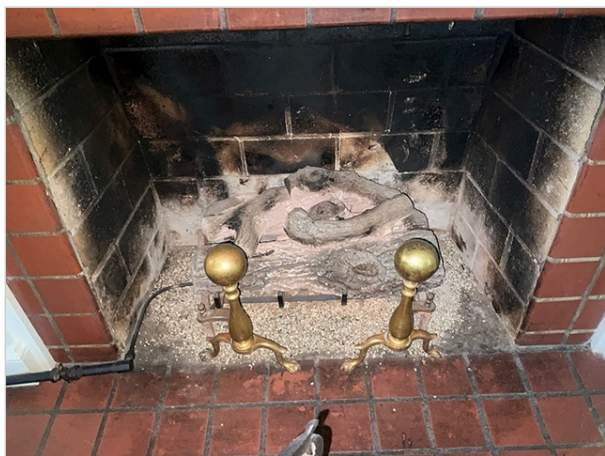
**Photo 84**

A masonry fireplace was located in the family room. A natural gas supply line was present and was not operated. The damper did appear to be functional. The chimney flue was masonry. There was no visual evidence of creosote buildup in the firebox and/or chimney.

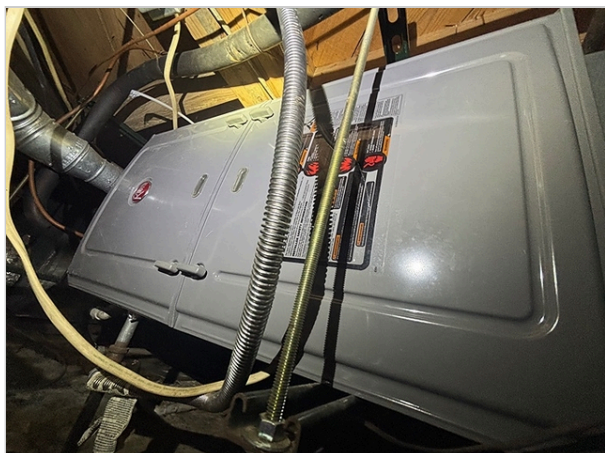
**Photo 89**

The structure was heated by a Rheem natural gas forced air furnace, Model Number R801SA075417MSA and Serial Number W061715935, which is 8 years old. The unit was located in the crawl space of the structure. It has an approximate net heating capacity of 75,000 BTUH. The automatic safety controls on the unit were tested and found to be functional at the time of the inspection.

The HVAC condensate line was raised above the floor drain or drain inlet. The condensate line was trapped. The HVAC condensate line must be trapped and not in contact with wet drain inlets to prevent the possible migration of bacteria and mold into the air-handling system. The heating system was found to be functional.

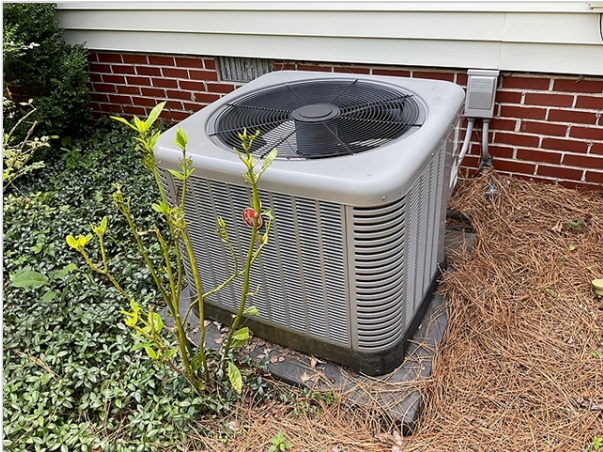
**Photo 92**

The electric outdoor air conditioner condensing unit was a Rheem, Model Number RA1436AJ1NA and Serial Number W391619026. The unit is located on the left side of the structure. This unit is approximately 9 years old. Periodic preventive maintenance is recommended to keep this unit in good working condition. The cooling system was functional.

The temperature was measured at several locations. At the supply it was 59 degrees F, and at the return it was 72 for a average of 13 degrees F, which is normal.

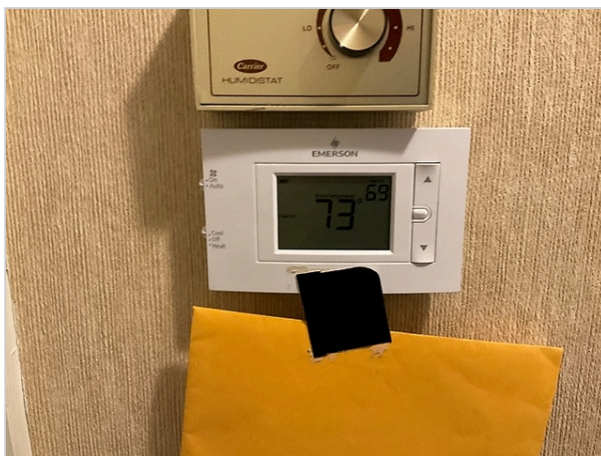
**Photo 95**

The control for the heating and air conditioning system was a 24 volt digital thermostat located on the hallway wall of the home. The thermostat was manufactured by Emerson and was found to be in working order.
