# HomeTeam<sup>®</sup>

### *HOME INSPECTION REPORT*

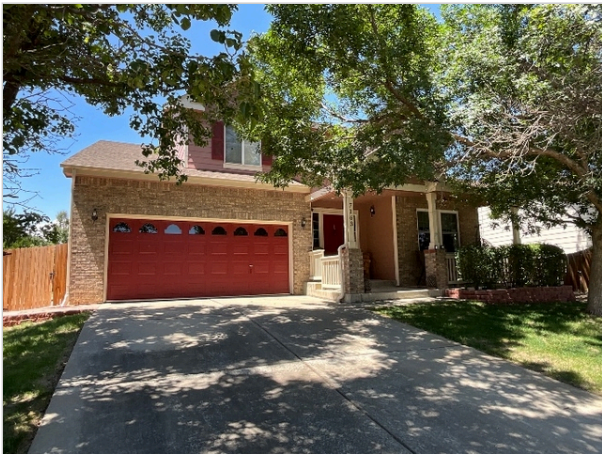
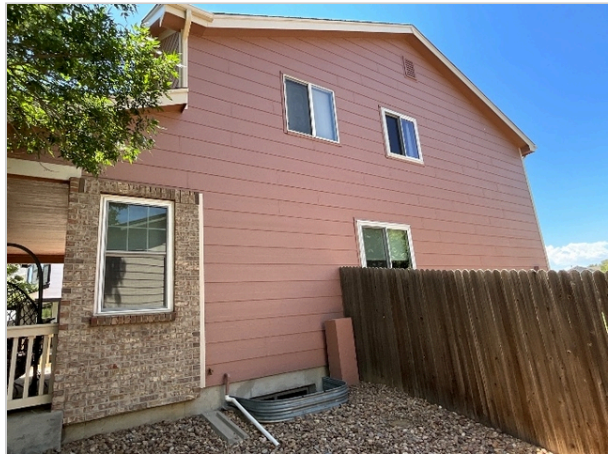
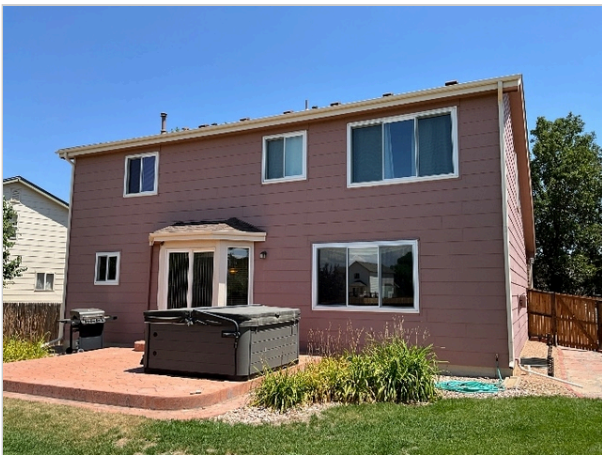
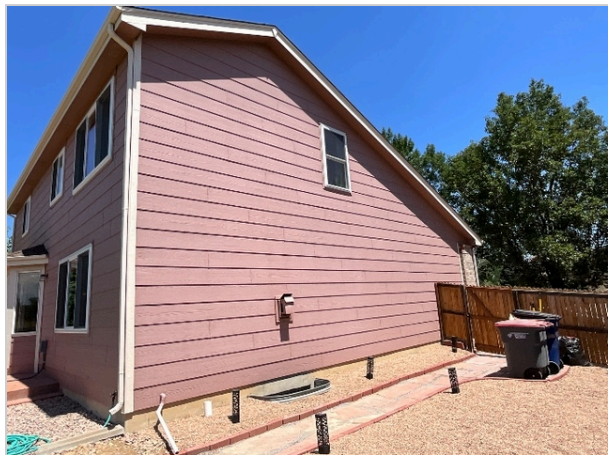
**One or more areas of window trim showed signs of water damage**, including discoloration, swelling, and/or deterioration of the material. This condition may be caused by prolonged moisture exposure due to leaks, condensation, or failed sealing. We recommend further evaluation and appropriate repair or replacement by a qualified contractor. It is also advised to identify and correct the source of moisture to prevent recurrence.

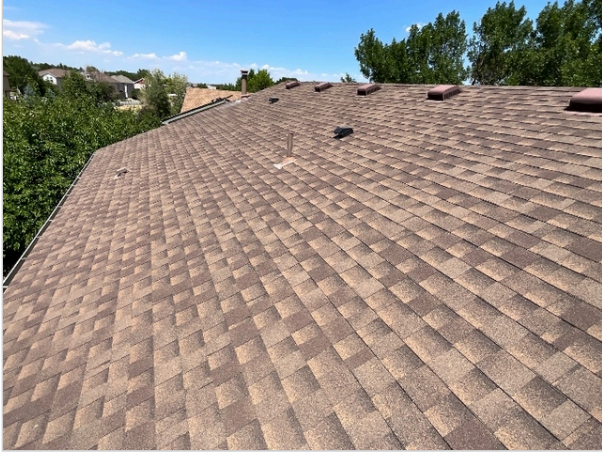
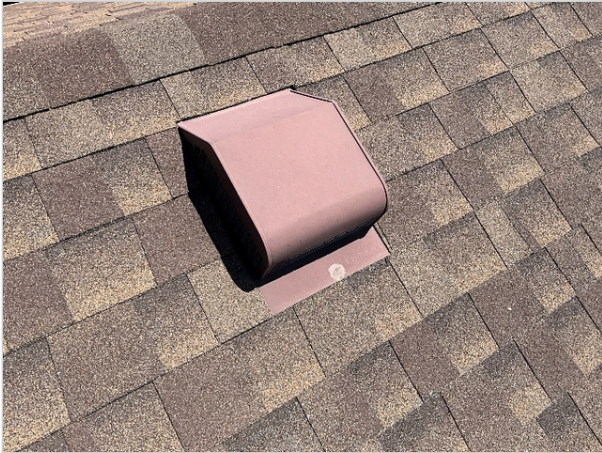
**One or more popped nails were noted on the roof** at the time of the inspection. A popped nail can be identified by a lifted corner on a shingle. The heating and cooling of the roof will often cause roofing nails to lift under the shingles, causing the corner to lift. While it is not likely that the condition is causing a leak, the nails should be reset and sealed to prevent wind from getting under the shingle and possibly lifting the shingle off the roof. Consult with a qualified roofer for repair.

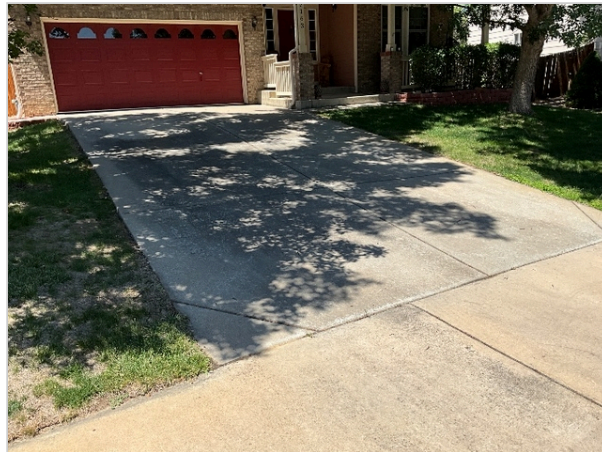
A concrete driveway is present in the front of the structure. Cracks and spalling were observed on the driveway. Surface defects in driveways develop and progress with age and are considered normal as long as they do not create a safety hazard. Sealing defects may help slow the rate of deterioration.

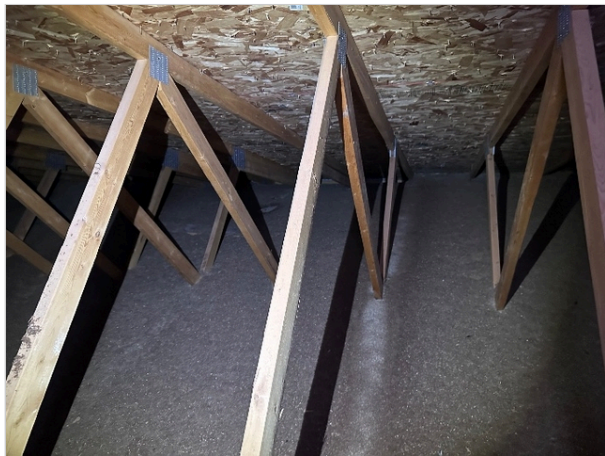
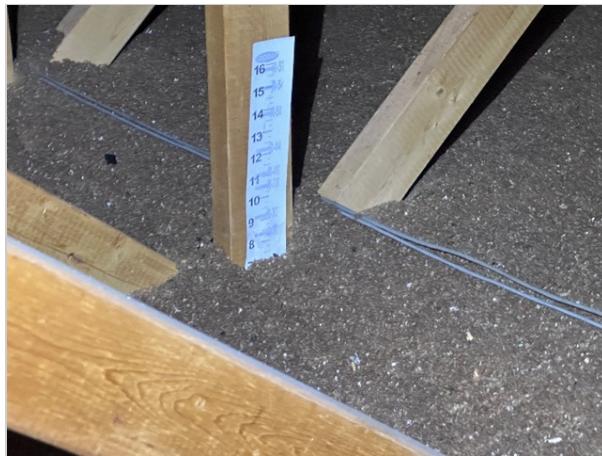
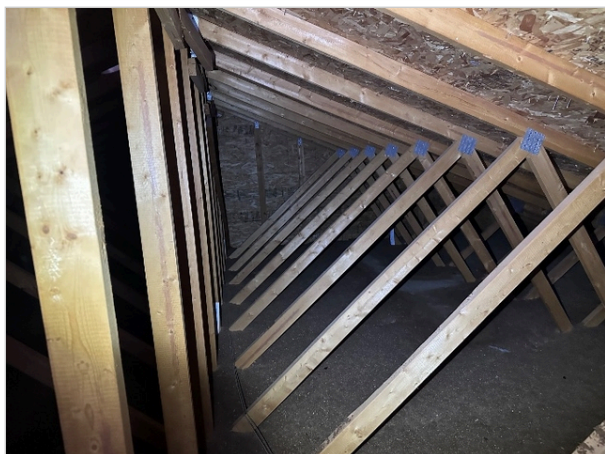
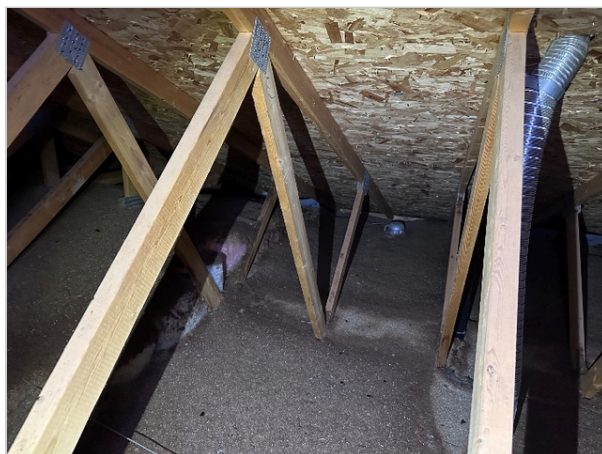
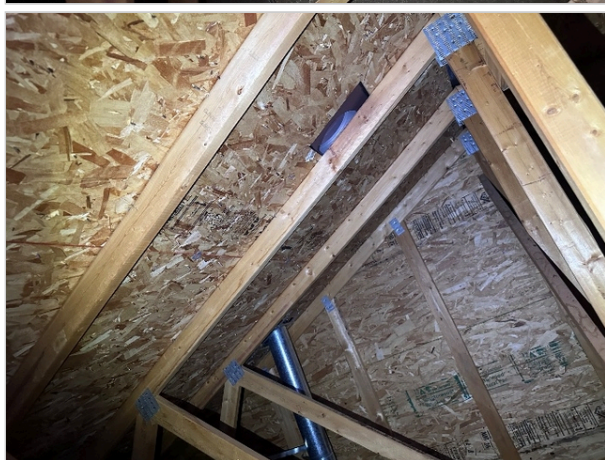
**Rust was observed on roofing nails in the attic, and the upper layer of attic insulation exhibited signs consistent with elevated humidity.** The source of the excess moisture could not be determined at the time of the inspection. Bathroom or laundry exhaust fans discharging into the attic are common causes, although no definitive source was identified. Attic ventilation appeared generally adequate but may benefit from improvement. **HomeTeam Recommends:** Have a qualified contractor evaluate the attic to identify and correct the source of the elevated humidity. Verify that all bathroom and laundry exhaust fans discharge to the exterior of the home rather than into the attic, and improve attic ventilation as needed to help reduce the potential for future moisture-related damage.

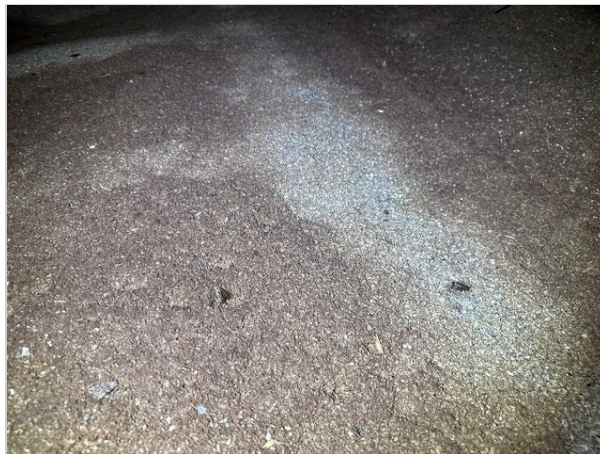
**Humidity affected insulation**

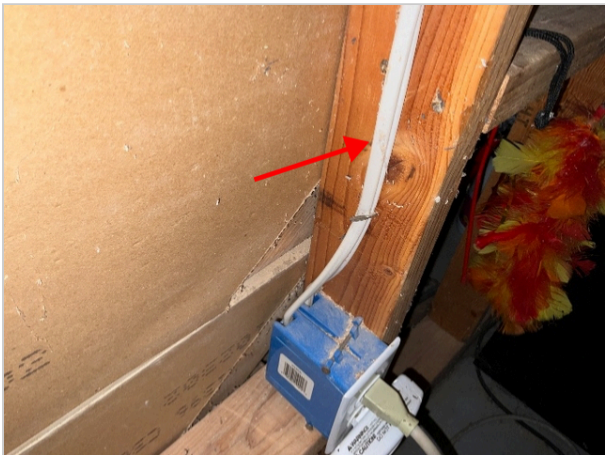
The visible house wiring consisted primarily of the Romex type and appeared to be in good condition. An electric service grounding system was installed. Service grounding requirements have changed many times over the years. The grounding system for a 30-year-old electric service is different from that of a 10-year-old service. The inspection does not attempt to verify that the grounding system or any other part of the electric service complies with current codes.

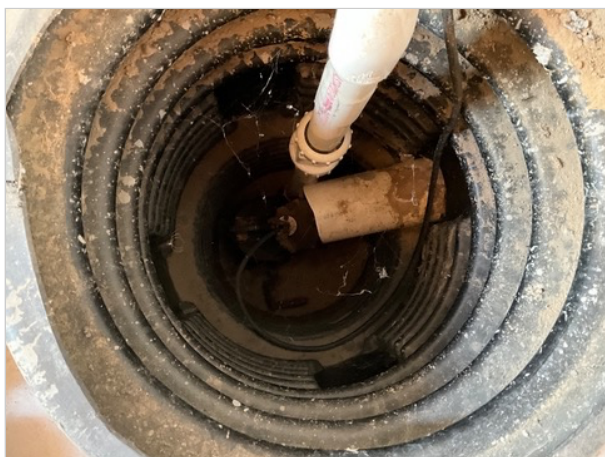
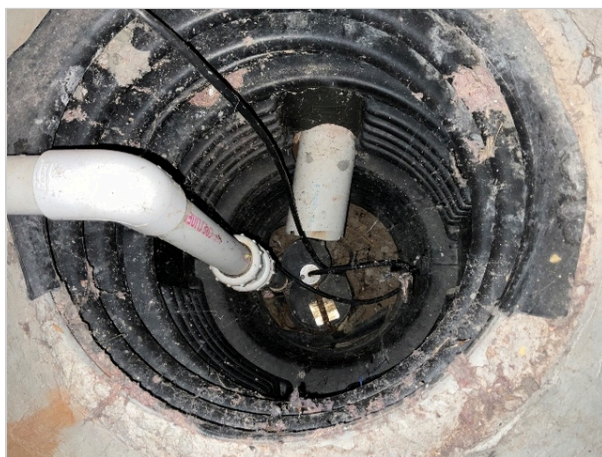
There were 2 sump pumps located in the basement. The sump pump was not tested because the sump was dry at the time of the inspection.. HomeTeam recommends all sump pumps be tested regularly. Backup pumps (battery and hydro) provide an added measure of protection and should be considered as an upgrade.

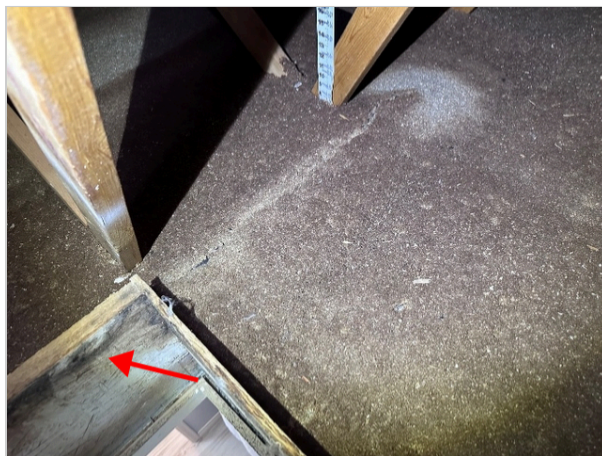
**The primary bathroom does not have an exhaust fan, and a mold-like substance was observed around the attic access scuttle in the adjoining closet, which may be related to elevated moisture levels. HomeTeam recommends having the mold-like substance evaluated and cleaned as needed, and installing a properly vented bathroom exhaust fan to help reduce moisture accumulation and improve ventilation.**

Black Substance

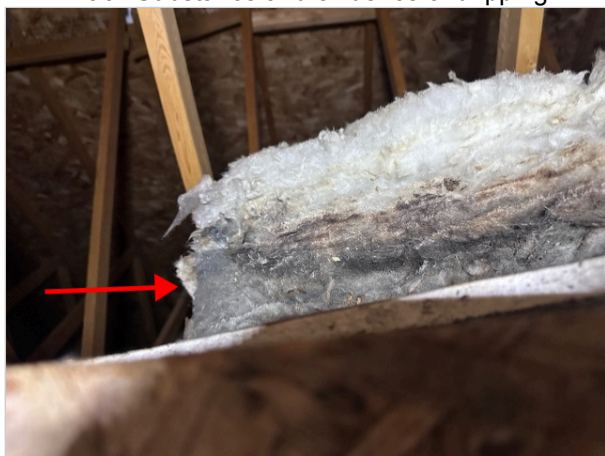
Black Substance in Attic Scuttle Insulation

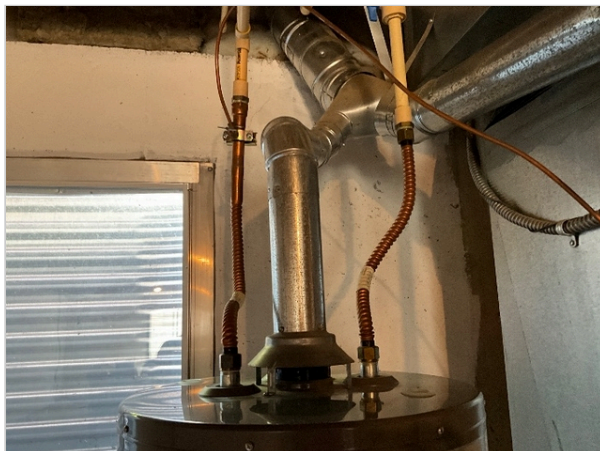
**Water heater does not have an expansion tank** or overpressure valve. Water heaters are recommended to have a way to absorb water expansion through heating without triggering the T & P Valve. Water expansion can cause damage to the plumbing and water heaters. HomeTeam recommends evaluation by a qualified Plumber.

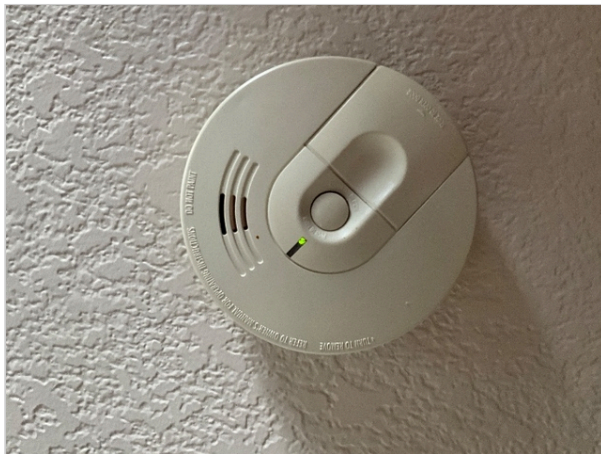
**Smoke alarms appeared to be older and may have exceeded their recommended service life.** Most smoke alarms should be replaced every 10 years, regardless of whether they appear to function properly. **HomeTeam Recommends:** Replacing all older smoke alarms with new units to help ensure reliable operation and improved occupant safety.

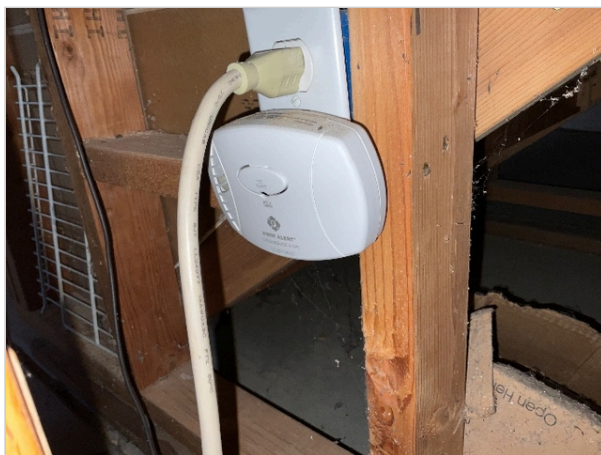
**Carbon monoxide alarms were not located within 15 feet of all sleeping areas**, which may delay occupant notification in the event of elevated carbon monoxide levels. **HomeTeam recommends** installing carbon monoxide alarms in the appropriate locations in accordance with current safety standards and the manufacturer's instructions.

1 carbon monoxide alarm in basement only

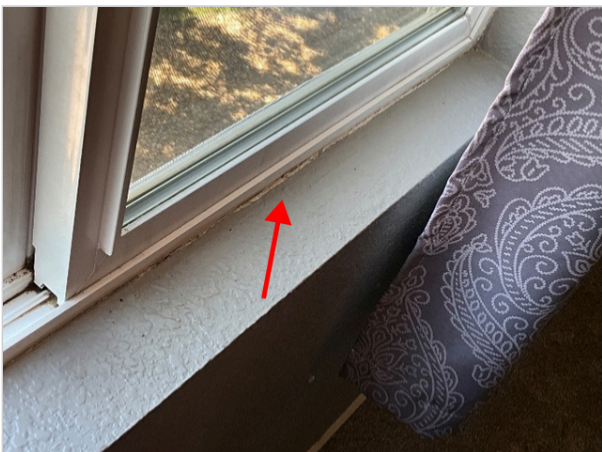
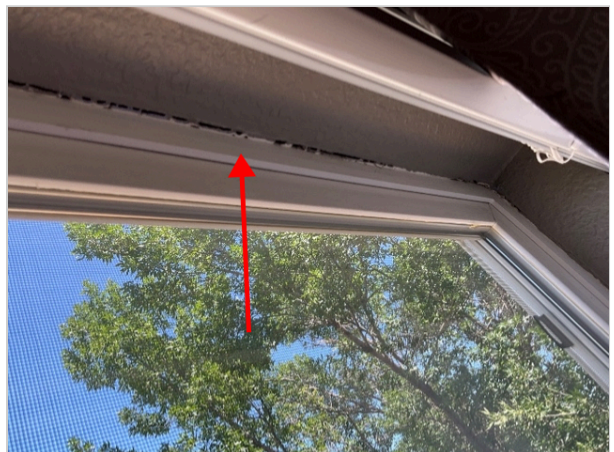
**Large gaps were observed between the drywall and the frame of the right front second-floor window**, indicating the recently installed window has not been properly finished. **HomeTeam recommends** having the installation completed by sealing and finishing the gaps to improve appearance and help prevent air leakage.

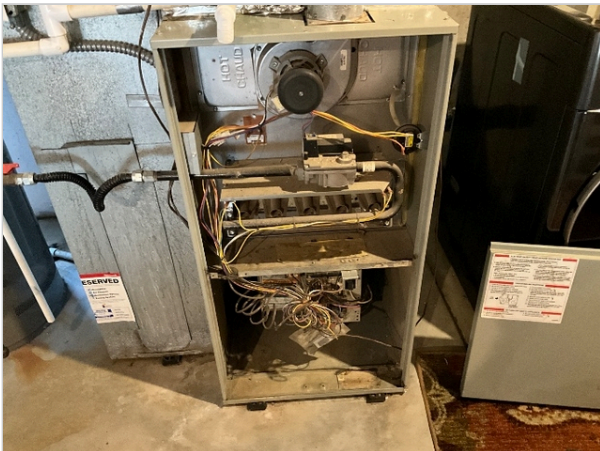
The HVAC condensate line was not raised above the floor drain or drain inlet. The condensate line did not appear to be trapped. The HVAC condensate line must be trapped and not in contact with wet drain inlets to prevent the possible migration of bacteria and mold into the air-handling system. The heating system was found to be functional.

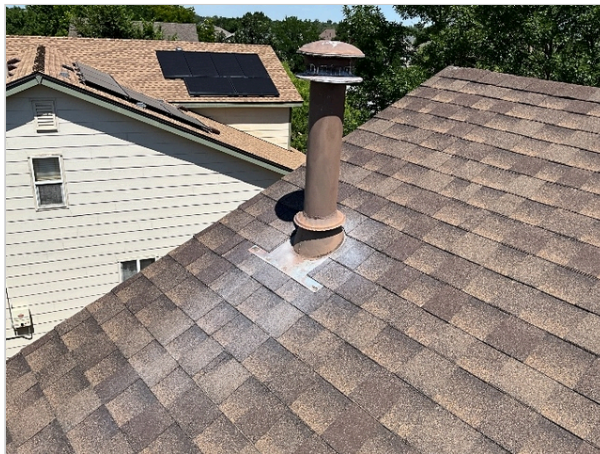
**White residue was observed on the roof surface beneath the HVAC flue.** This is commonly caused by condensation and minerals from normal furnace or water heater operation; however, it can also be related to improper combustion or venting issues. HomeTeam recommends evaluation by a qualified HVAC contractor to confirm proper combustion and venting and to address any contributing conditions.
