### *HOME INSPECTION REPORT*

On Wednesday, August 5, 2026 The HomeTeam Inspection Service made a visual inspection of 123 Sample Drive, Brambleton, VA 20148. Enclosed please find a written, narrative report of our findings in accordance with the terms of our Inspection Agreement.

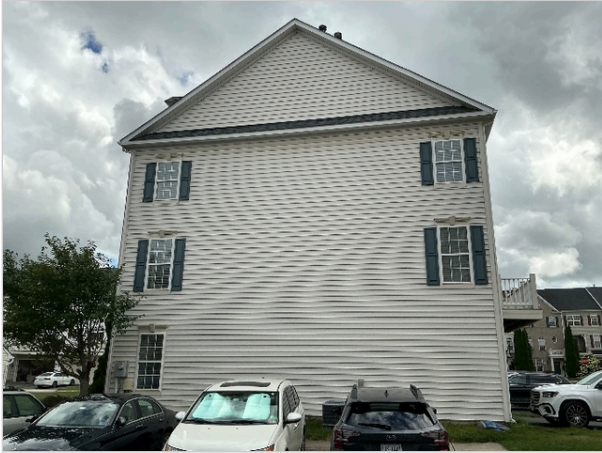
**Photo 4**

Vinyl Cladding on Side and Back of Home

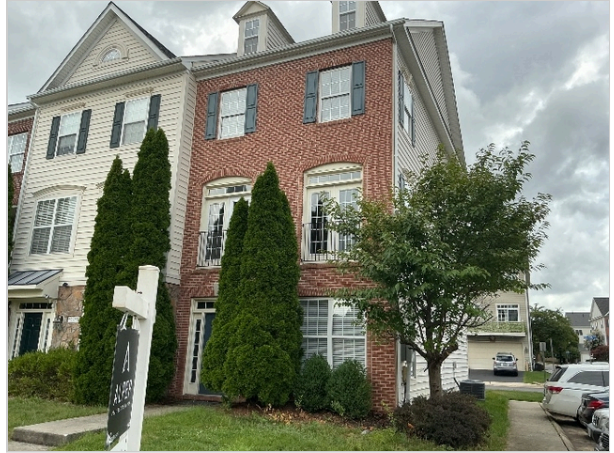
**Photo 5**

Brick Cladding on Front of Home

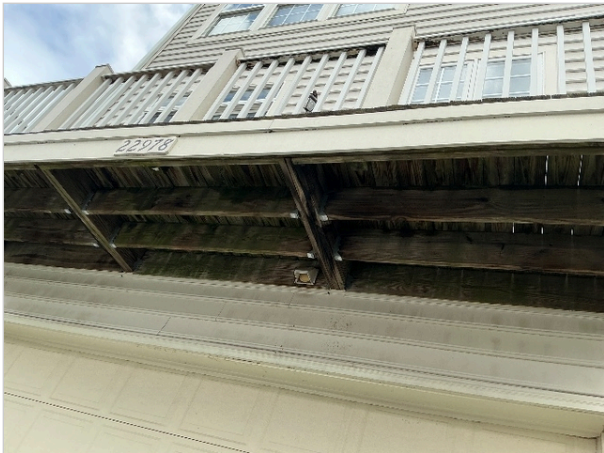
Photo 9

A wood and composite deck was located above the garage of the structure. There appeared to have some deterioration of the deck surface. The handrails on the deck appeared to be secure. A wood deck should be cleaned and sealed regularly to prevent deterioration.

Deck / Balcony Framing

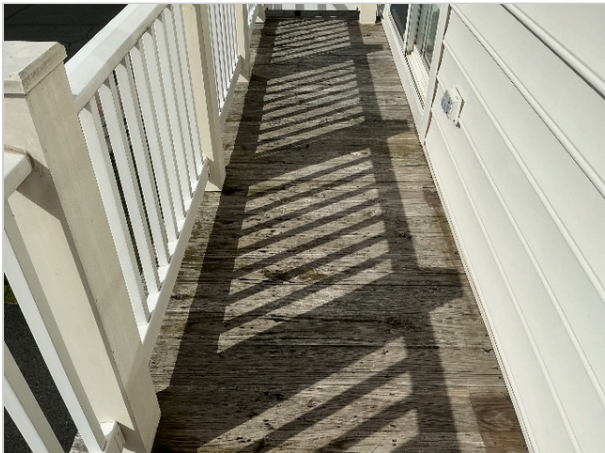
Photo 10

Deck / Balcony Surface

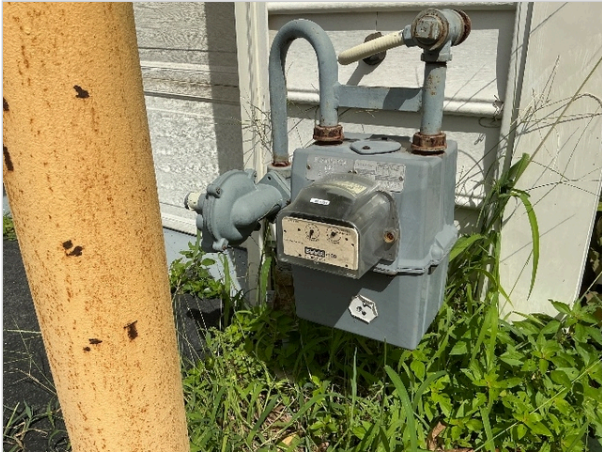
Photo 14

Gas Meter on left side of home

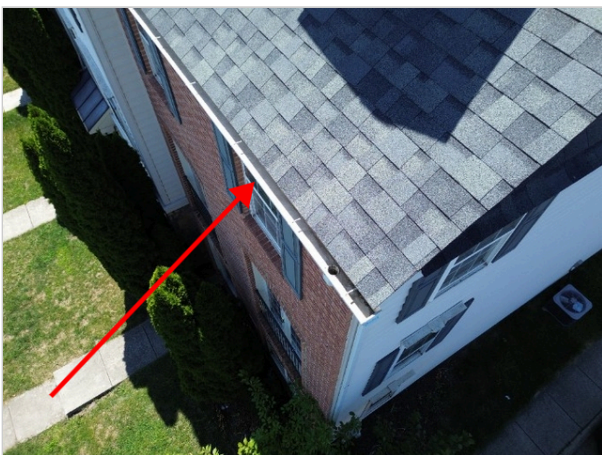
Photo 16

Gutters appear clear and functional

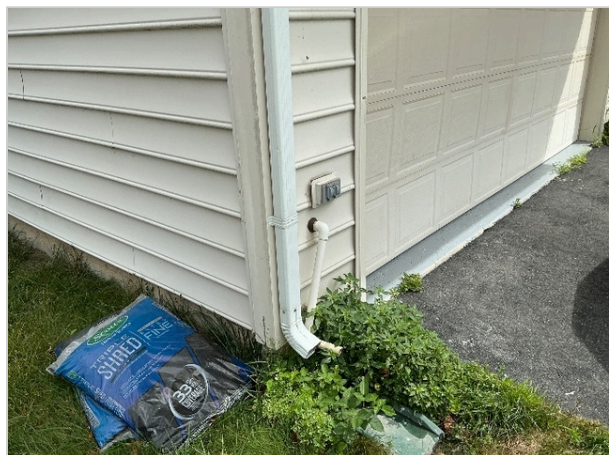
Photo 17

Downspout at back of home.

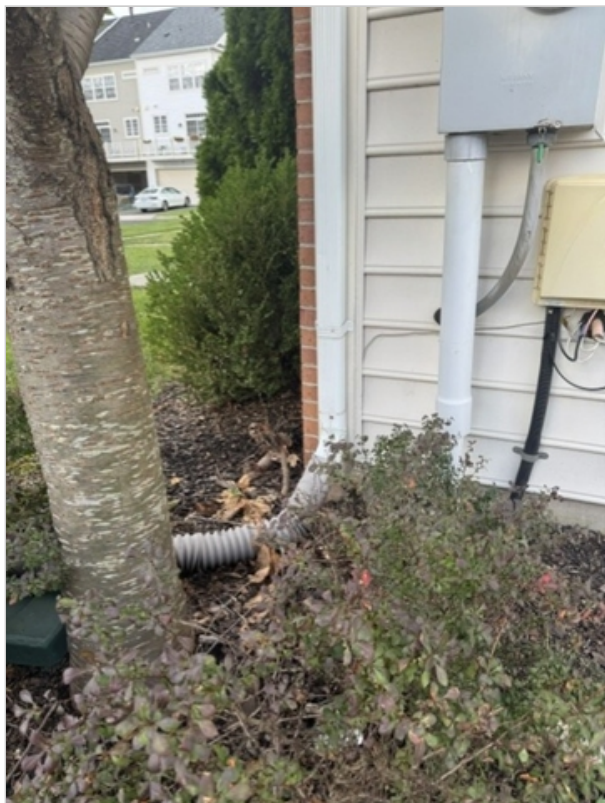
**Photo 18**

Downspout with extension

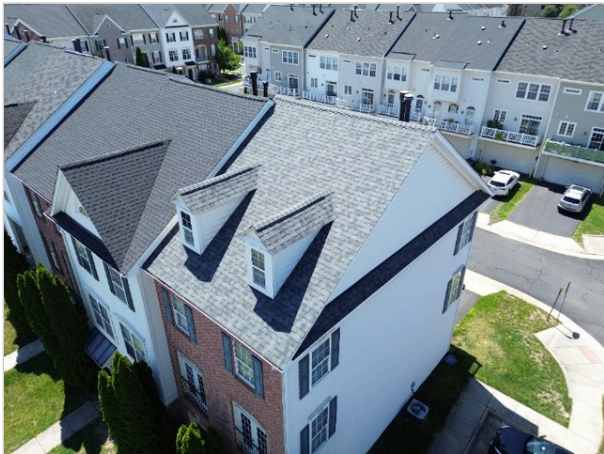
Photo 19

The roof shingles exhibited light curling and moderate surface wear. Nail pops were not observed. Evidence of a hail event was not observed.

Front Side of Roof with Dormers

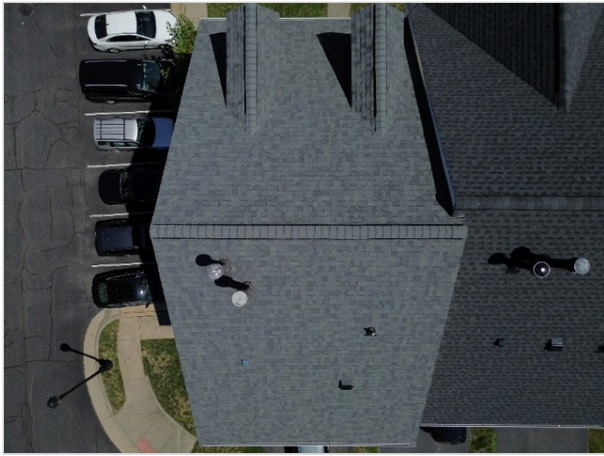
Photo 21

Overview of Roof

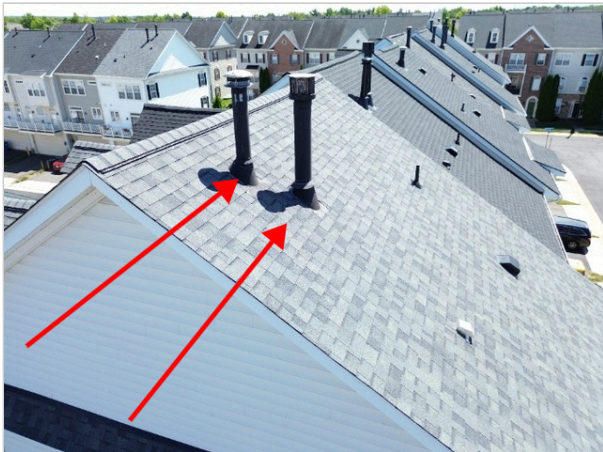
Photo 23

Gas Burning B Vents

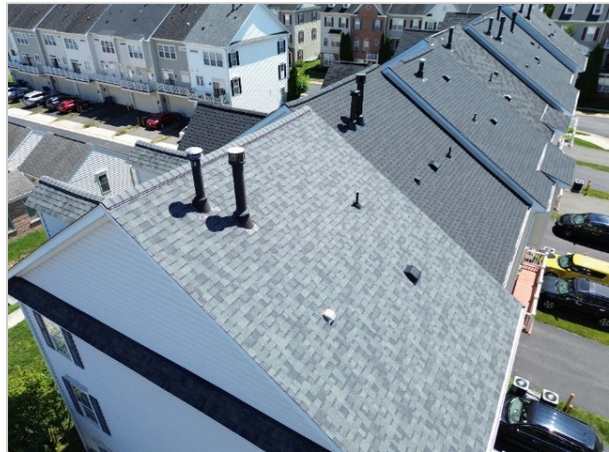
Photo 24

Back side of Roof with Vent Penetrations

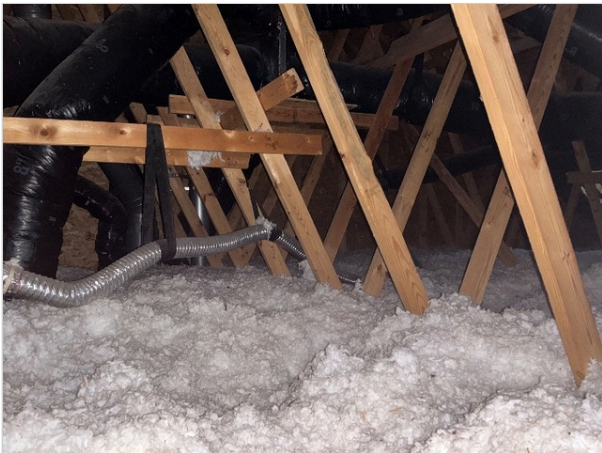
**Photo 31**

Insulation and Truss Structure

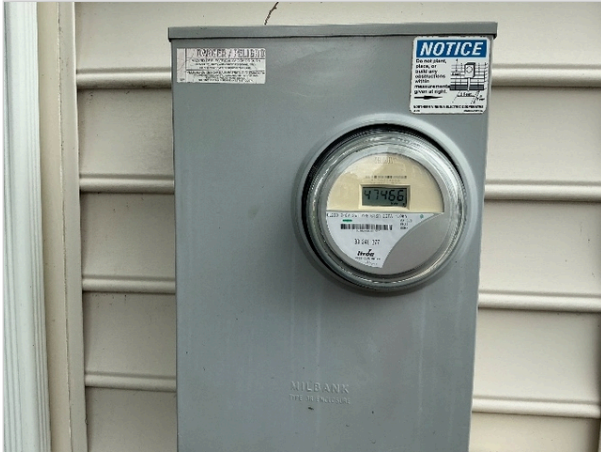
**Photo 36**

Electric Meter on Left side of Home

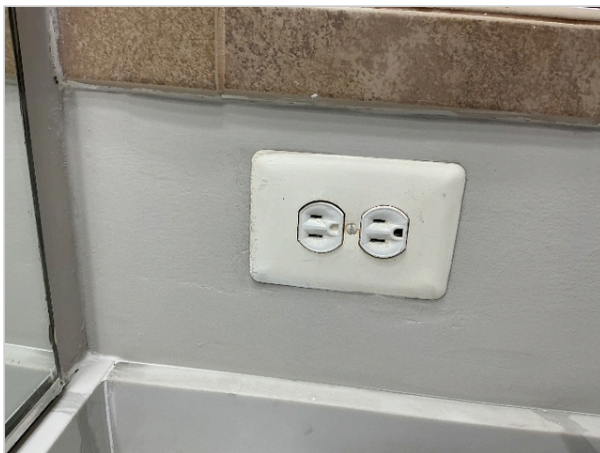
**Photo 42**

Grounding prong appears to have been painted or plastered over in bathroom of third floor third bedroom

**Bathroom Electric Receptacle**

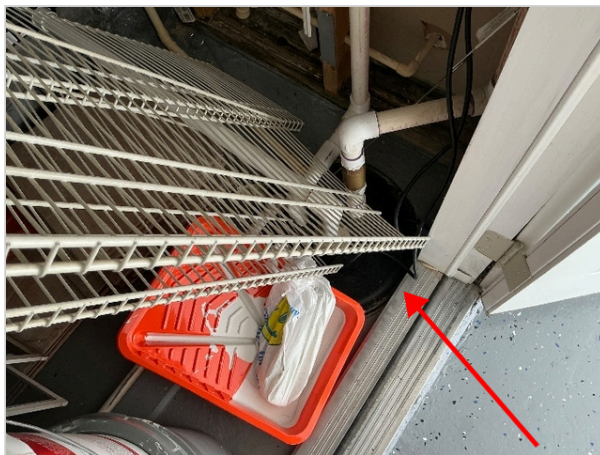
**Photo 45**

There was a sump pump located in the garage. The sump pump was functional. HomeTeam recommends all sump pumps be tested regularly. Backup pumps (battery and hydro) provide an added measure of protection and should be considered as an upgrade.

Sump Pump in Utility Closet in Garage

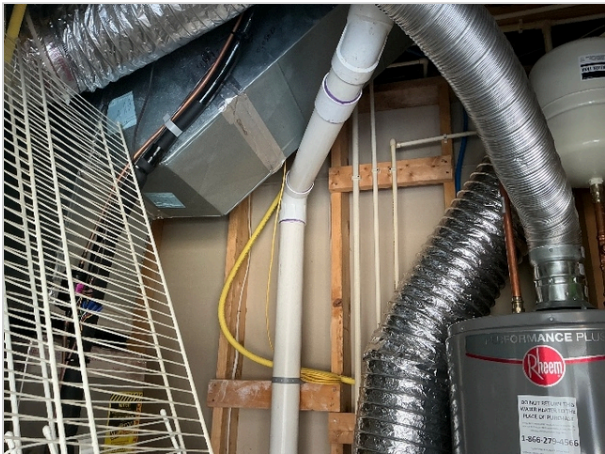
Photo 49

Water Heater Exhaust Duct

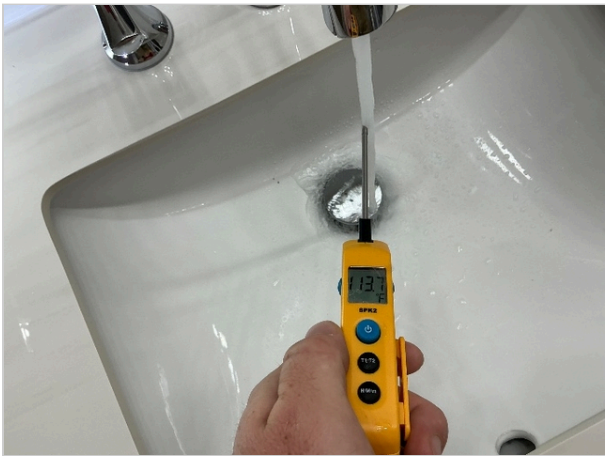
Photo 51

Hot Water Temp

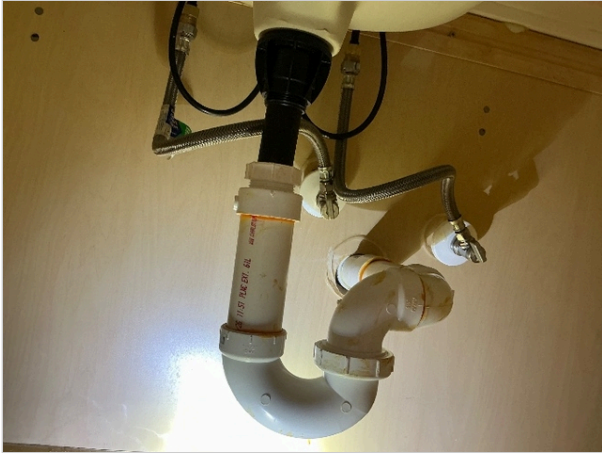
**Photo 53**

Beneath the sink of third floor hallway bathroom

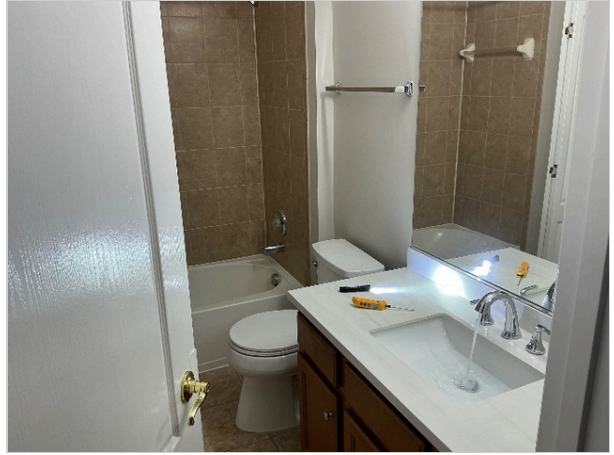
**Photo 54**

Third floor hallway bathroom

Drain plug in third floor hallway bathroom appears to be broken. Tub still drains properly, but requires the plug to be removed.

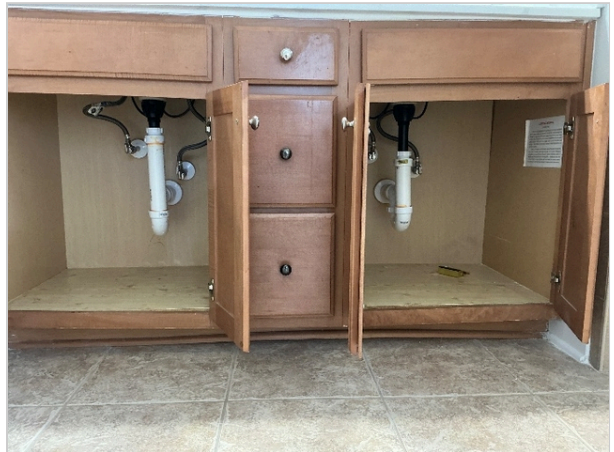
**Photo 56**

Beneath the sinks in bathroom of third bedroom

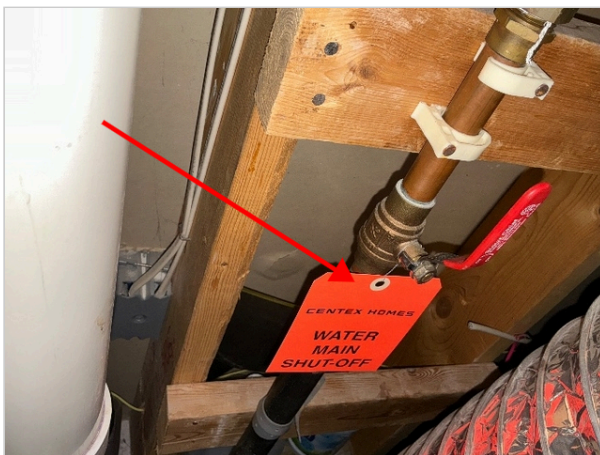
**Photo 65**

Water Main Shut off

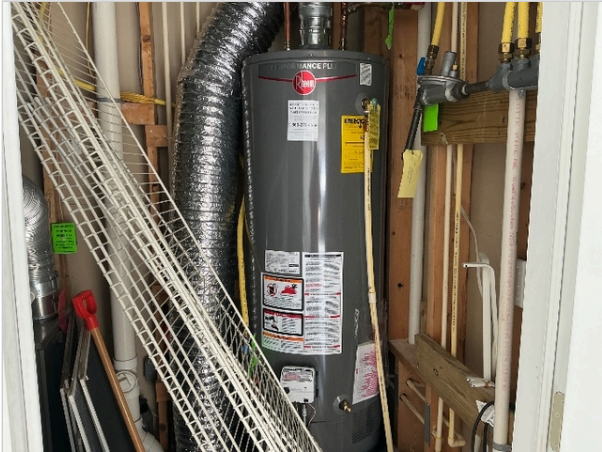
Photo 66

Water Heater in Utility Closet

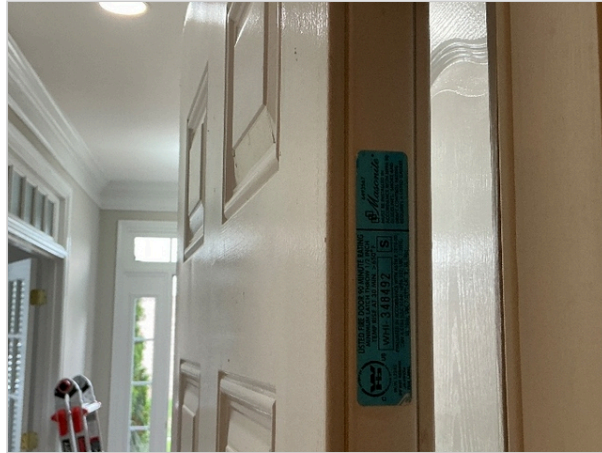
Photo 78

Fire rated door at garage entrance

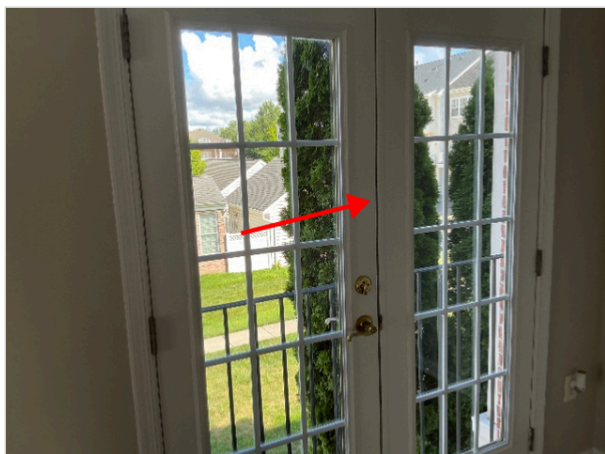
Photo 86

Unable to unlock the exterior door in living room

Living room exterior door

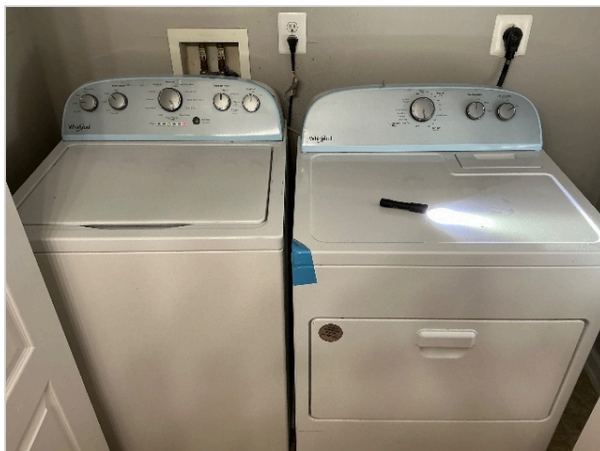
**Photo 102**

Washer and dryer located in the third floor bathroom

Dryer vent is not properly connected. That should be properly connected to properly vent out of house.

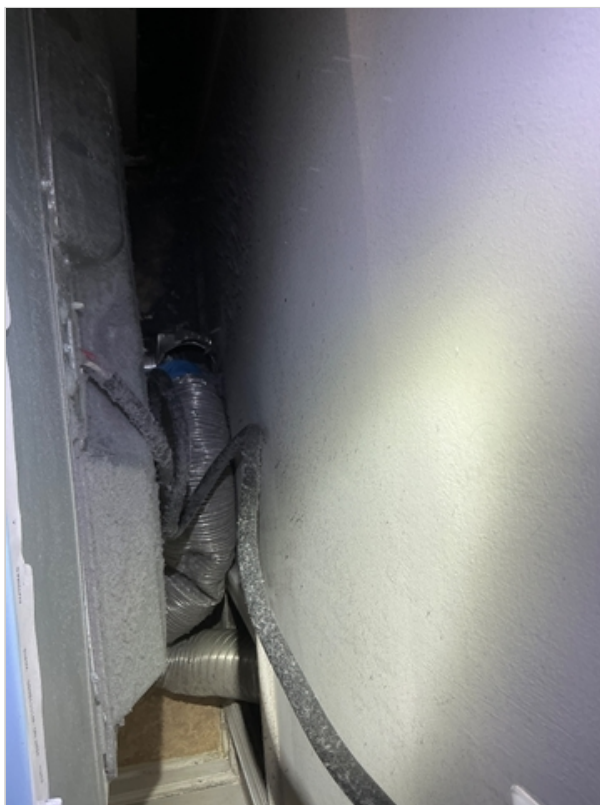
**Photo 103**

Third floor bathroom

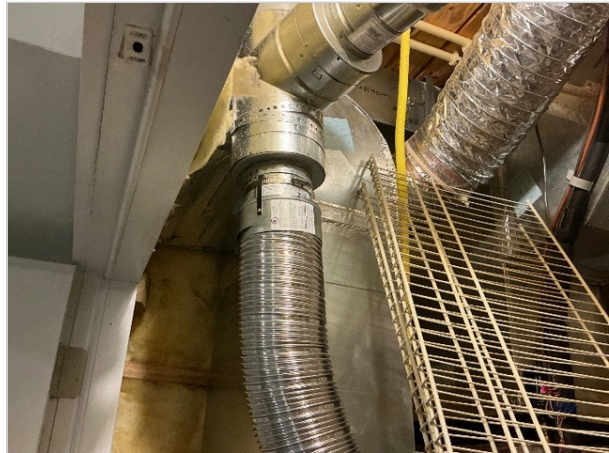
**Photo 105**

Furnace Duct Work

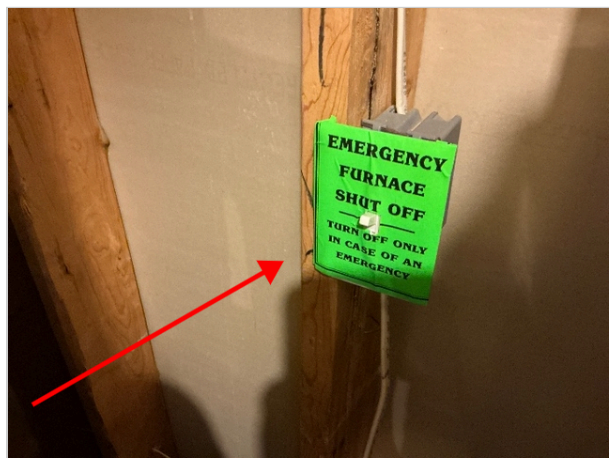
**Photo 107**

Furnace Shut off

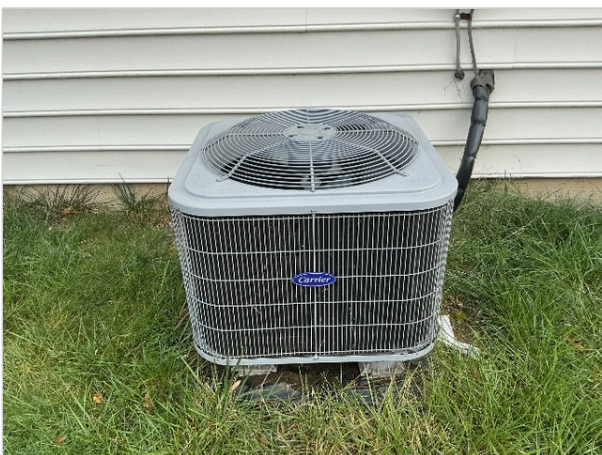
**Photo 110**

Outside condensing unit

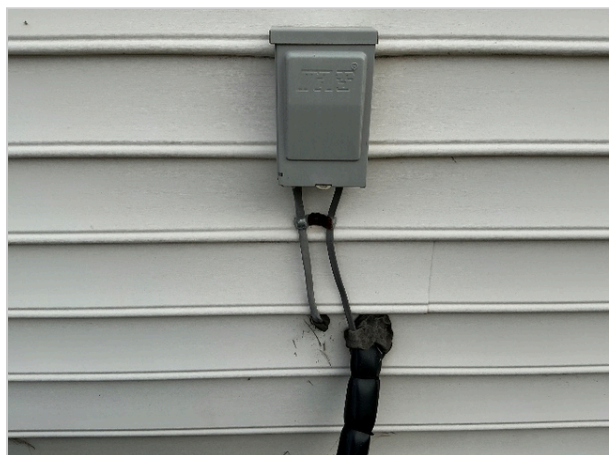
**Photo 111**

AC shut off box

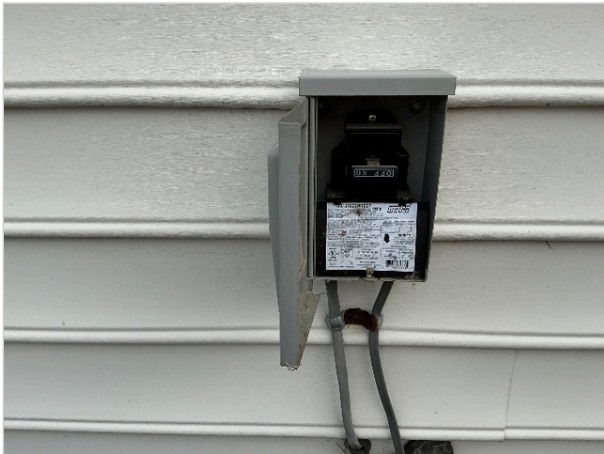
Photo 112

AC shut off switch

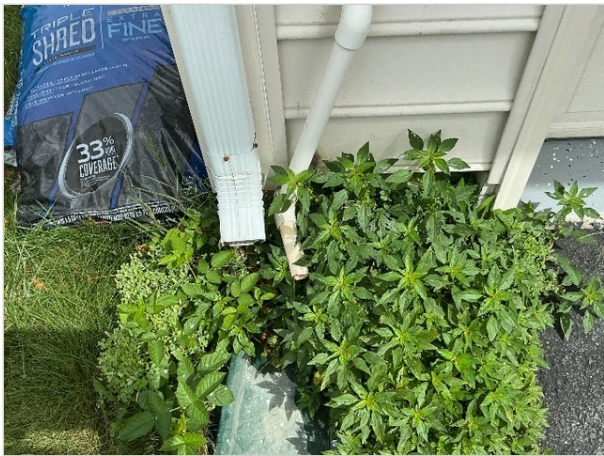
Photo 114

Downspout near Garage

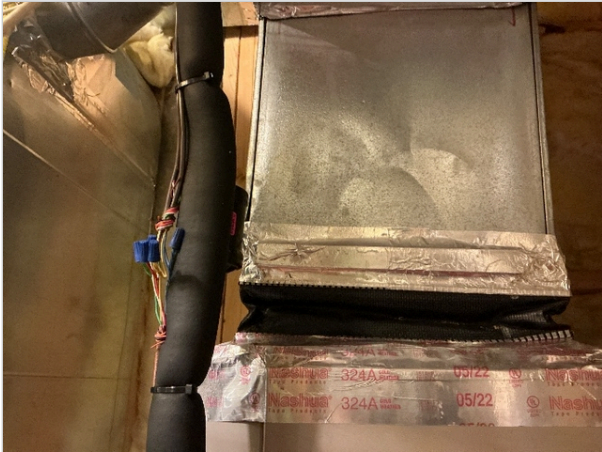
**Photo 115**

Furnace Duct Work
