### *HOME INSPECTION REPORT*

Monday, July 13, 2026

**John Smith**  
**123 Sample Drive,**  
**Savannah, GA 31410**

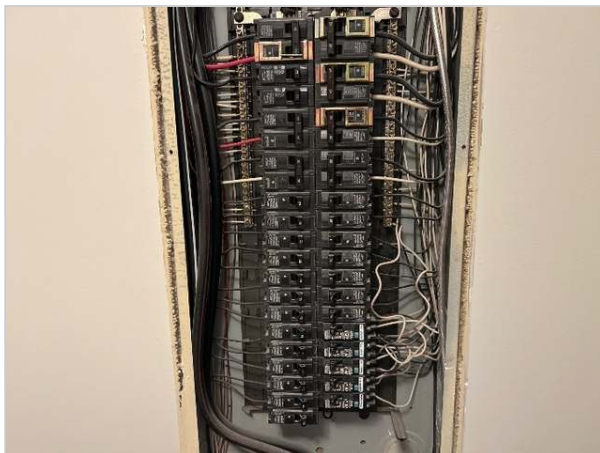
The service wire entered a Siemens service panel, located on the laundry room wall with a 200 amp and 120/240 volt rated capacity. The main service disconnect switch was located on the exterior wall. The branch circuits within the panel were copper. These branch circuits and the circuit breakers to which they were attached appeared to be appropriately matched. The internal components of the service panel, i.e. main lugs, bus bars, etc were in good condition.

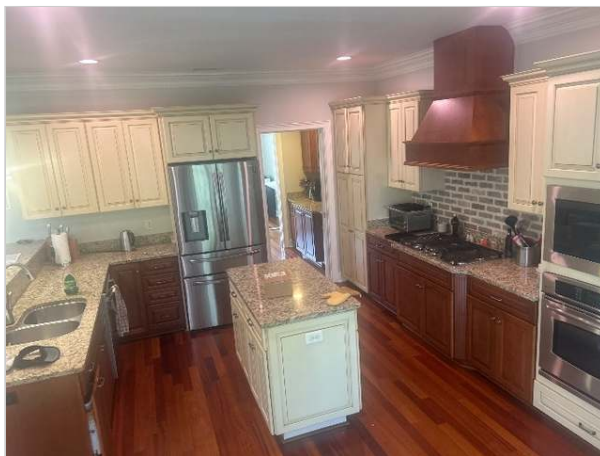
The General Electric electric built-in oven was inspected and did appear to be functional. The accuracy of the clock, timers and settings on ovens are not within the scope of this inspection.

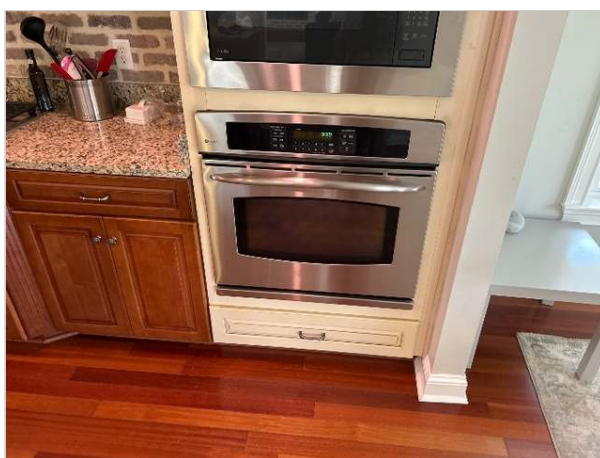
The General Electric built in microwave was inspected and did appear to be functional. The exhaust capacity is not within the scope of this inspection. Cleaning the fan and filter may increase the exhaust capability.

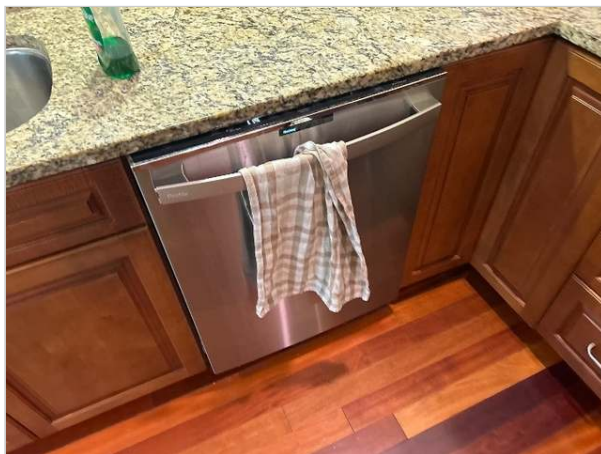
A piece of the trim on the dishwasher is loose.

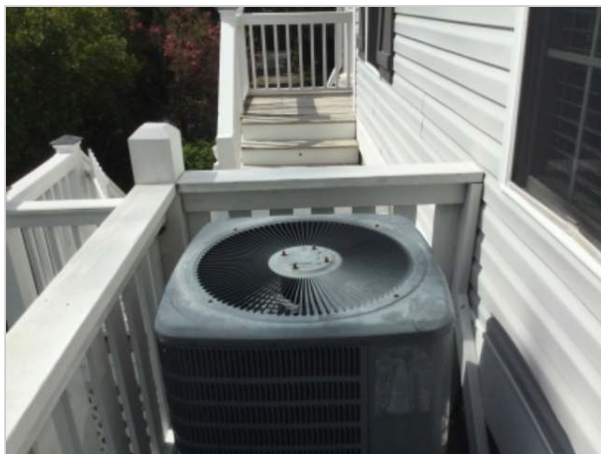
The 1st level was heated and cooled by a Goodman electric heat pump, Serial Number 1703009475 Model Number GSZ140301KD which is 9 years old. The unit was located on the right side of the home. The heat pump system was found to be functional.

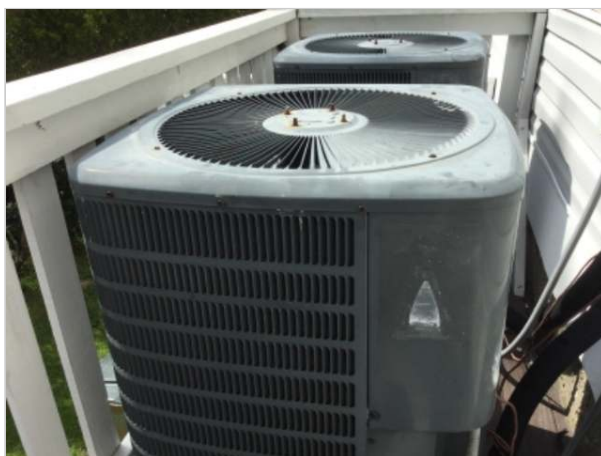
The 2nd level was heated and cooled by a Goodman electric heat pump, Serial Number 1703009476 Model Number GSZ140301KD which is 9 years old. The unit was located on the right side of the home. The heat pump system was found to be functional.

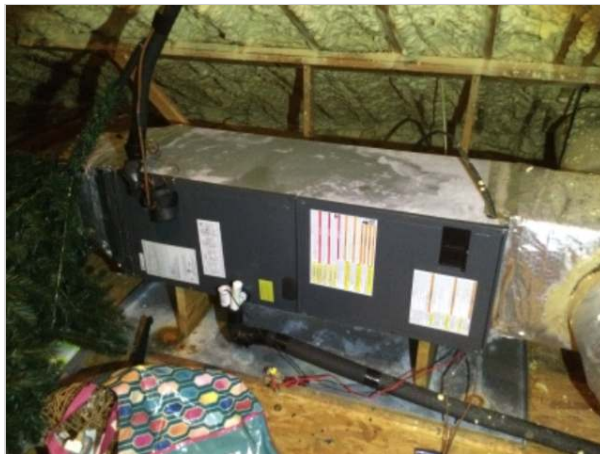
The 1st level electric air handler was a Goodman model number ARUF31B14AA and serial number 1702097730. The unit is located attic of the home. This unit is approximately 9 years old. Periodic preventive maintenance is recommended to keep this unit in good working condition. Termination of HVAC condensate lines was raised above the floor drain or drain inlet. The condensate lines were trapped. HVAC condensate lines must be trapped and not in contact with wet drain inlets to prevent the possible migration of bacteria and mold into the air-handling system. The air handler system was found to be functional.

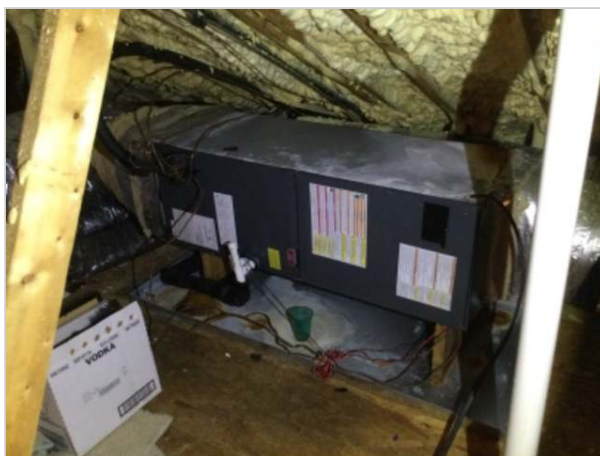
The 2nd level electric air handler was a Goodman model number ARUF31B14AA and serial number 1702097732. The unit is located attic of the home. This unit is approximately 9 years old. Periodic preventive maintenance is recommended to keep this unit in good working condition. Termination of HVAC condensate lines was raised above the floor drain or drain inlet. The condensate lines were trapped. HVAC condensate lines must be trapped and not in contact with wet drain inlets to prevent the possible migration of bacteria and mold into the air-handling system. The air handler system was found to be functional.
