### *HOME INSPECTION REPORT*

On Sunday, May 3, 2026, HomeTeam Inspection Service of Northeast Orlando made a visual inspection of 123 Sample Drive, Saint Cloud, FL 34771. Enclosed is a written, narrative report of our findings in accordance with the terms of our Inspection Agreement. Although maintenance items may have been addressed verbally at the time of the inspection, they may not be included in this report.

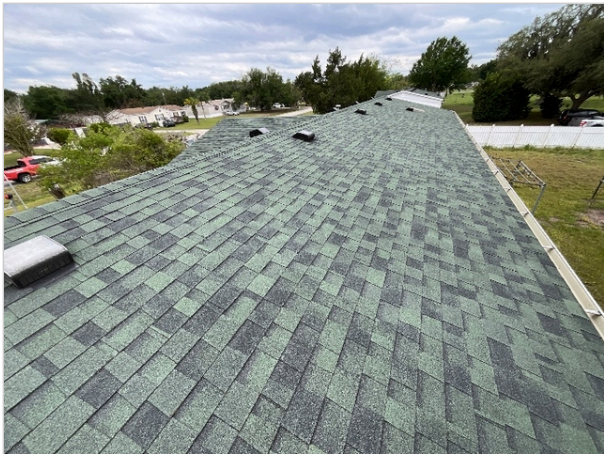
One or more exposed nail heads were observed on the roof. HomeTeam recommends a qualified individual seal the exposed nail heads to prevent water intrusion.

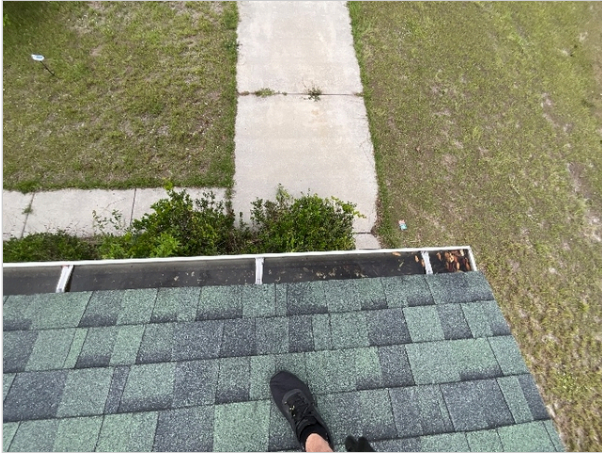
**Standing water was present in the front gutter.** This condition could cause the gutter to overflow in the affected area during periods of heavy or extended rain. This condition can lead to the gutters gradually pulling away from the fascia and possible water damage to fascia that may not be apparent. The gutters should be cleaned and adjusted for proper flow as appropriate, and the underlying fascia assessed and repaired as necessary.

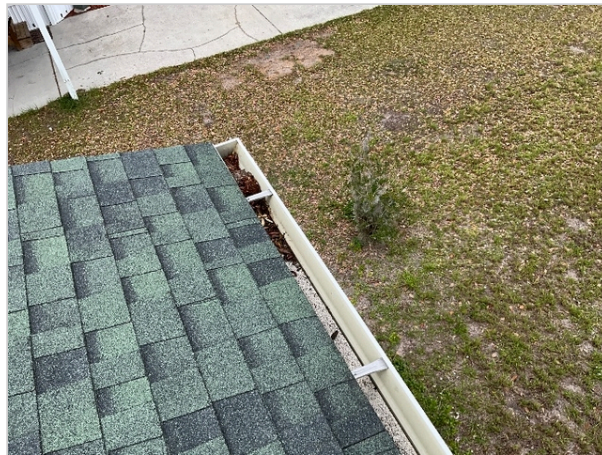
Gutters were in need of cleaning. Clogged gutters can cause unpredictable roof drainage, affecting the foundation or exterior surfaces. Overflow from gutters can cause damage to the fascia that is not visible or apparent at the time of the inspection. HomeTeam recommends cleaning the gutters.

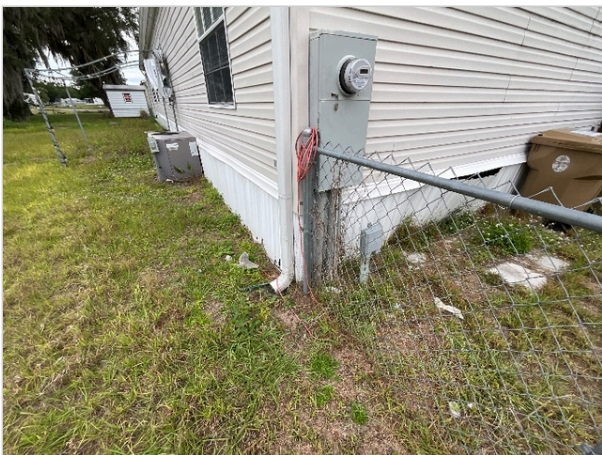
Downspout drainage was at or too close to the foundation. To prevent moisture issues, HomeTeam recommends redirecting roof drainage at least six feet away from the foundation.

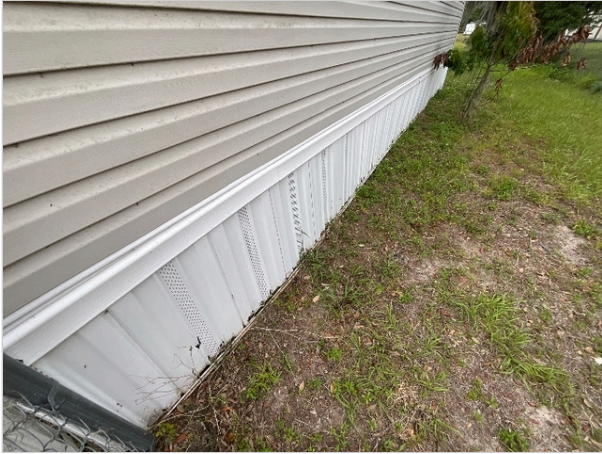
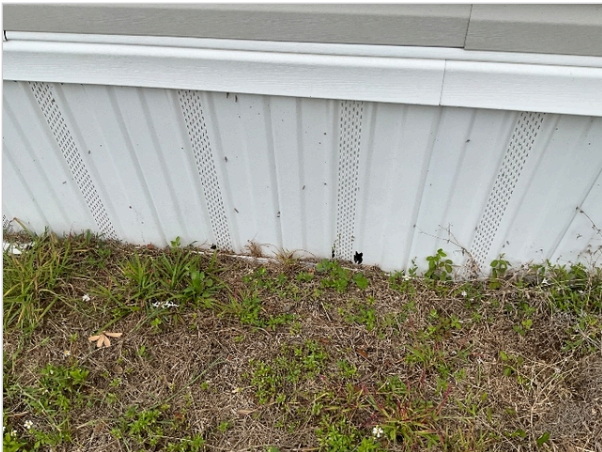
The vinyl skirting was damaged in several areas. This can allow pests into the crawl space area. HomeTeam recommends a qualified individual replace the damaged skirting.

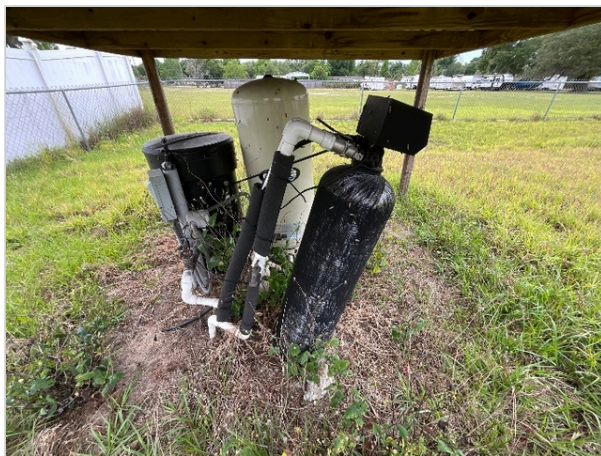
The water softener was leaning to the front. HomeTeam recommends a qualified individual ensure the water softener is properly seated and secured.

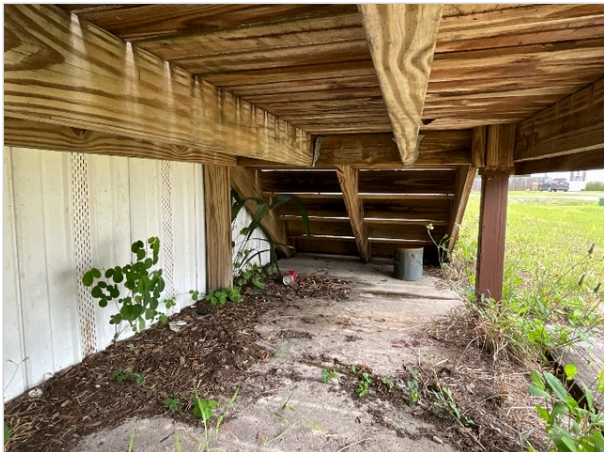
The deck stairs were beginning to deteriorate. HomeTeam recommends replacing the stair wood as needed.

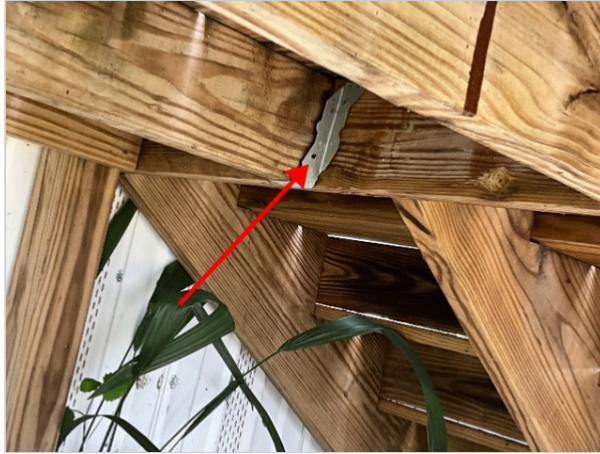
A joist hanger was missing a fastener. HomeTeam recommends a qualified individual install fasteners as needed.

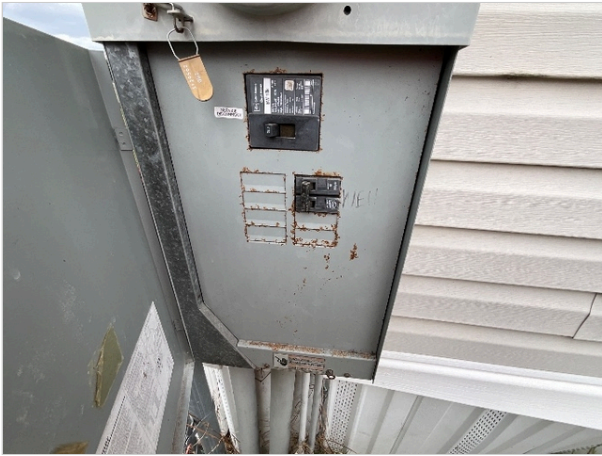
A circuit breaker in the electric panel had two attached circuits (wires). Each circuit should have its own dedicated breaker to prevent nuisance tripping and ensure good terminal contact, which may help prevent overheating. This situation is commonly referred to as a "double-tap". An electrician should repair this condition and further assess the panel for any additional required repairs.

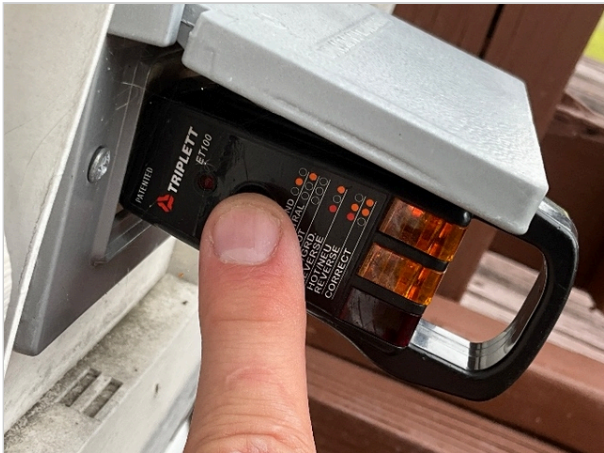
Exterior by side door

One or more GFCI receptacles were faulty. HomeTeam recommends consulting a qualified individual to assess the affected components for repair or replacement.

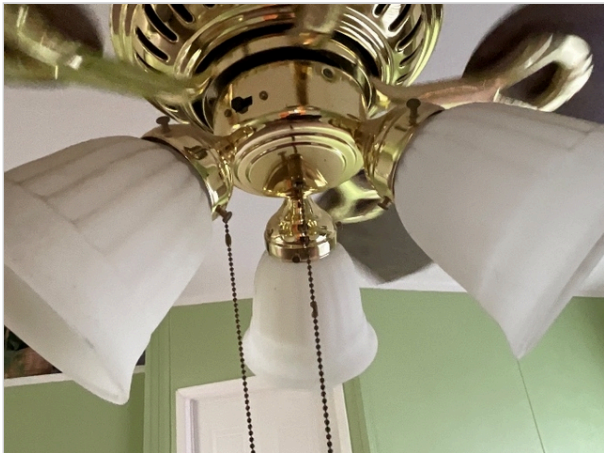
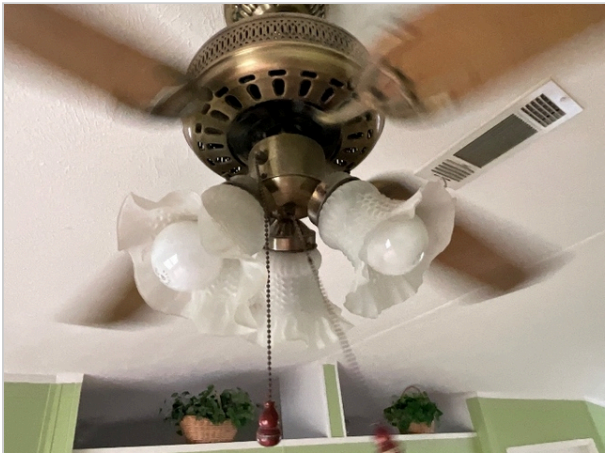
Multiple fan lights were not functioning. HomeTeam recommends replacing the bulbs.

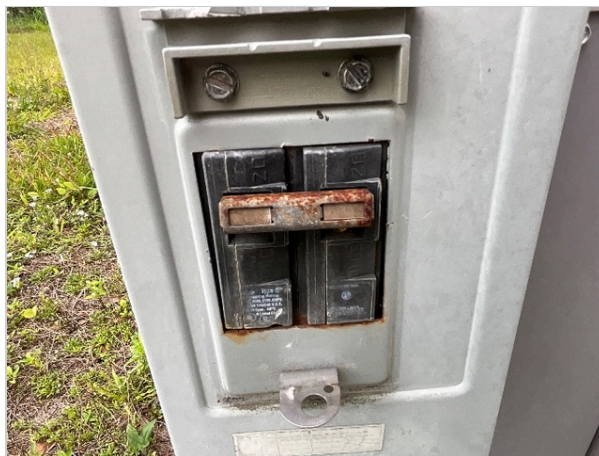
The air conditioner is nearing the end of its design life. The system was not functional at the time of the inspection.

The hvac disconnect switch cover was broken. HomeTeam recommends replacing the cover.

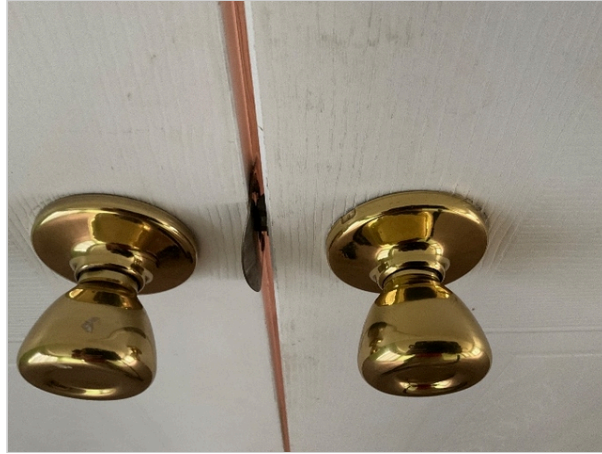
The master bedroom door would not latch. HomeTeam recommends a qualified individual adjust the door.

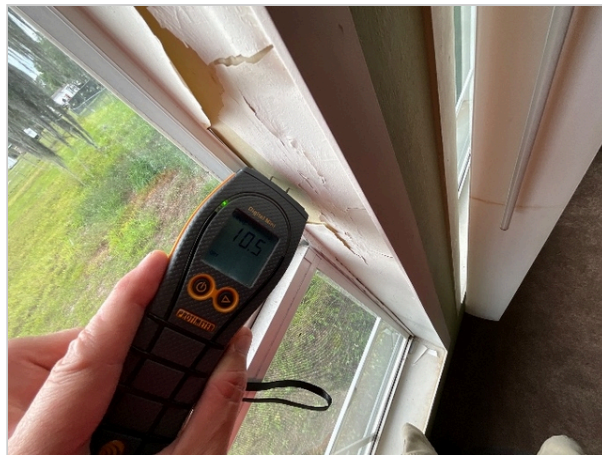
There was peeling paint around the window frame. The area was dry at the time of inspection. HomeTeam recommends monitoring the area.

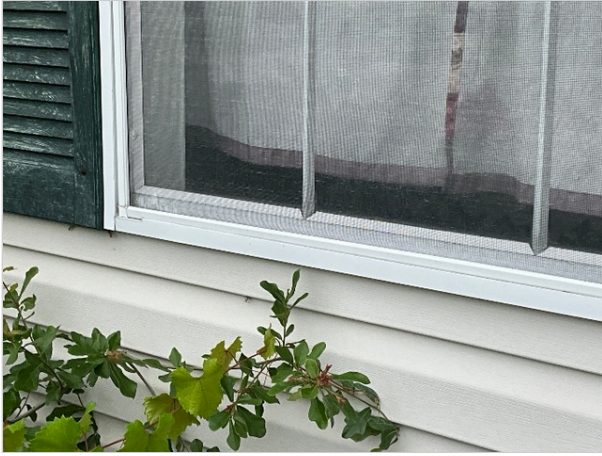
There were multiple holes in the screens throughout the home which can allow pests in the home. HomeTeam recommends a qualified individual replace the screen.

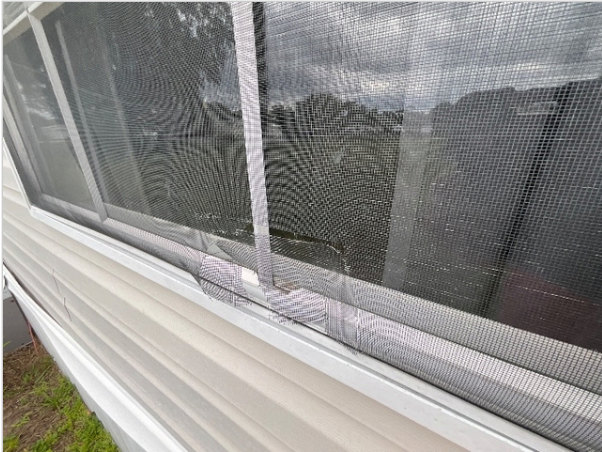
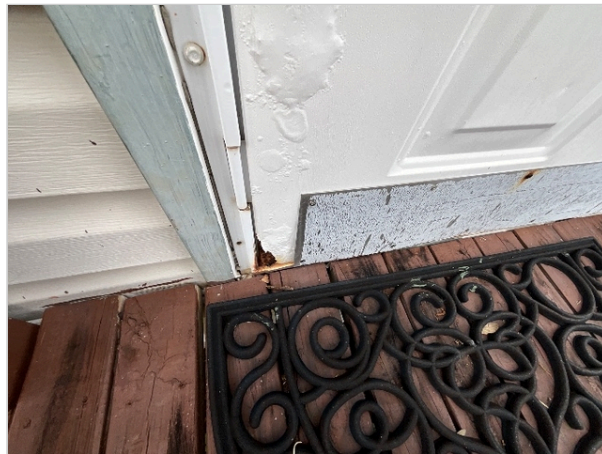
The left door was rusted at the bottom. HomeTeam recommends cleaning the area, and repainting or replacing the door.

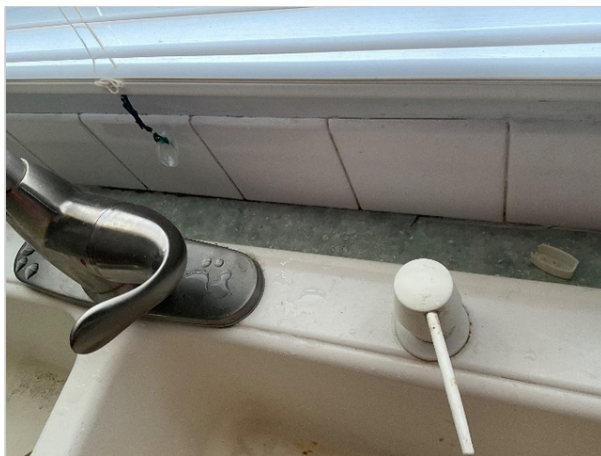
The caulking in the kitchen is inadequate and in need of repair. Failure to keep walls sealed can cause deterioration and extensive moisture damage including mold growth to the interior walls, which is not always visible at the time of the inspection. HomeTeam recommends having a qualified individual replace the caulking as needed.

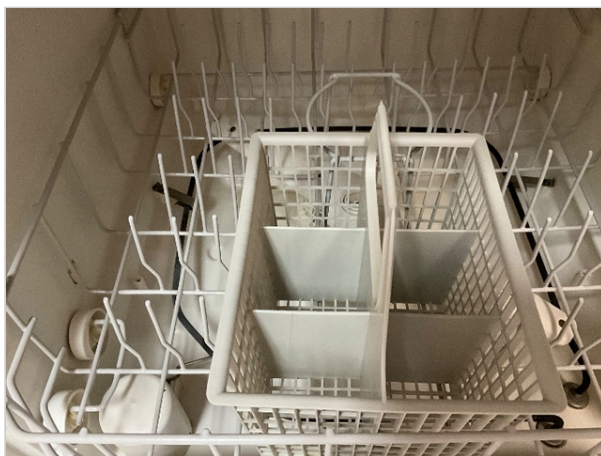
The dishwasher was inspected and actuated but water would not come into the system. HomeTeam recommends a qualified individual connect the dishwasher to the required services and test the appliance for functionality.

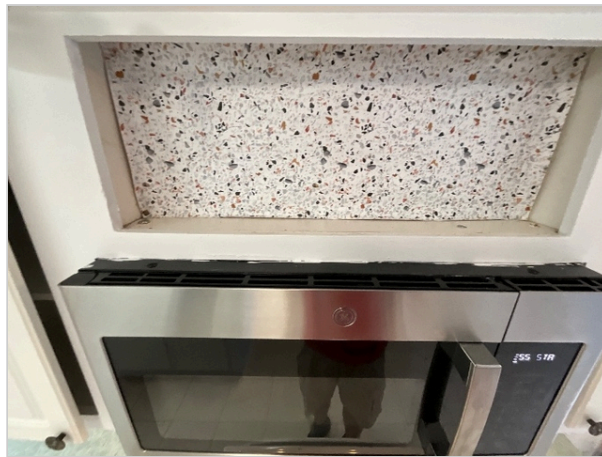
The vent was making a screeching sound when actuated. HomeTeam recommends a qualified individual evaluate and repair the vent.

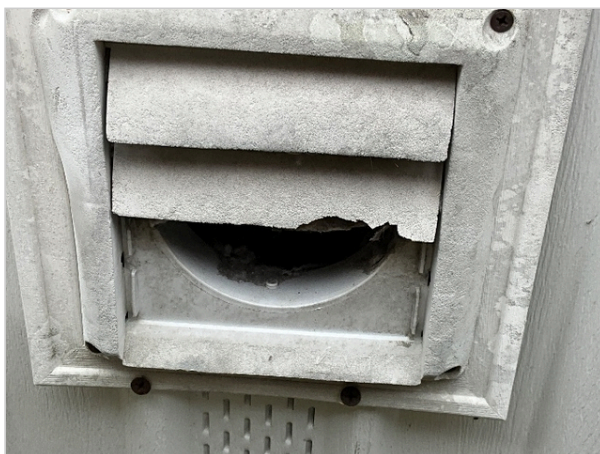
The dryer vent flaps were damaged. HomeTeam recommends a qualified individual replace the cover.

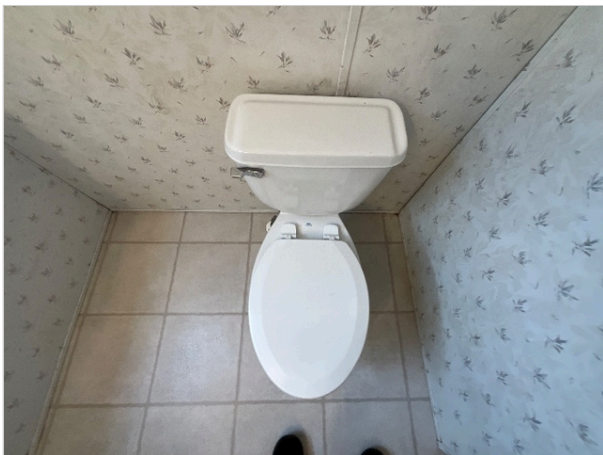
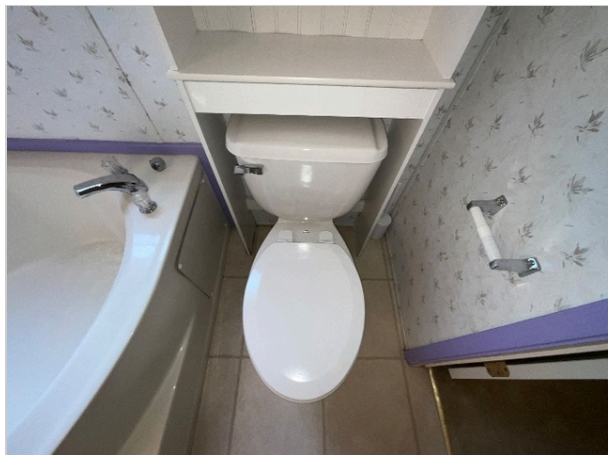
The toilets were not secured properly to the floor. This could compromise the seal of the wax ring and increase the risk of leaks. HomeTeam recommends a qualified individual tighten the toilets to ensure proper stability and prevent potential water damage.

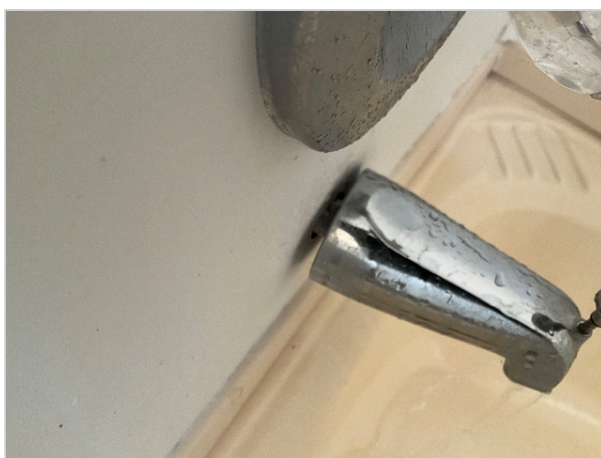
The hallway tub faucet was slightly pulled out from the wall. This can allow water behind the wall. HomeTeam recommends a qualified individual secure the faucet to the wall.

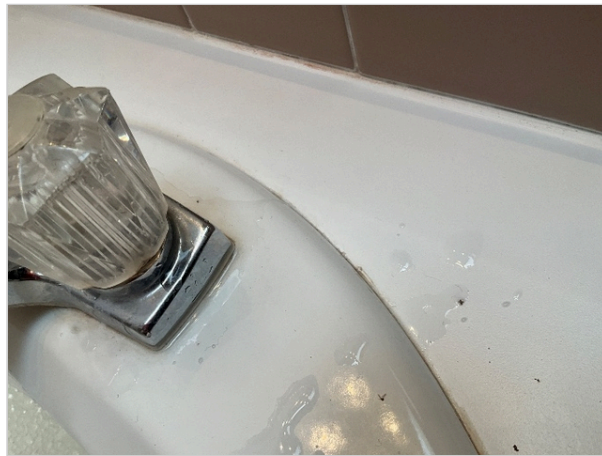
The hallway bathroom sink was leaking from the cold knob when it was actuated. HomeTeam recommends a qualified individual seal the knob.

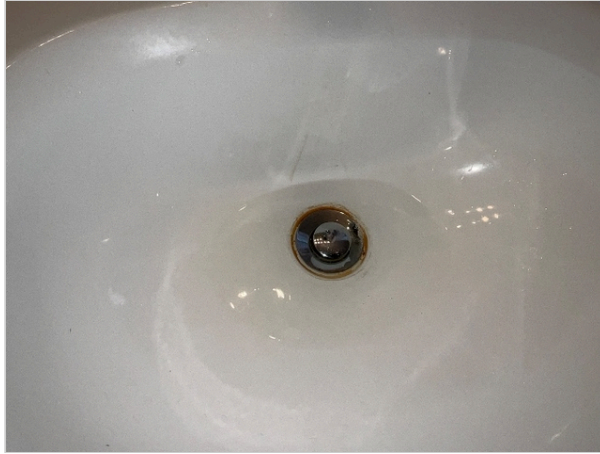
Hallway bathroom sink

Slow drainage was observed in one or more drains. HomeTeam recommends a qualified individual assess the affected components for repair or replacement.

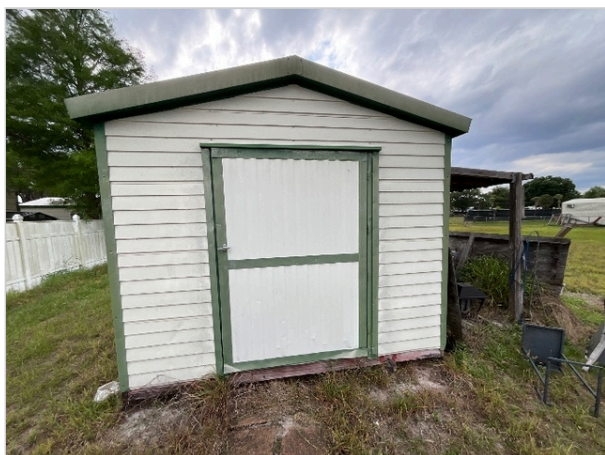
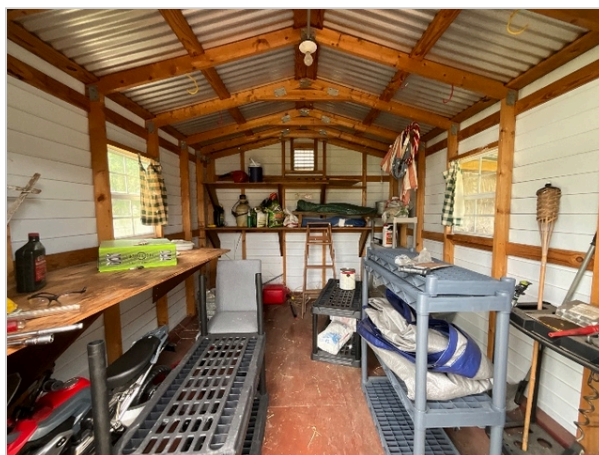
One or more outbuildings were present on the property. Outbuilding are noted but was not inspected because outbuildings are not dwelling structures. Outbuildings are not within the scope of the inspection.
