*HOME INSPECTION REPORT*

On 06-22-2026 14:00:00 The HomeTeam Inspection Service made a visual inspection of 123 Sample Drive, Painesville OH 44077. Enclosed please find a written, narrative report of our findings in accordance with the terms of our Inspection Agreement.

## HOUSE- BASEMENT- ATTACHED GARAGE

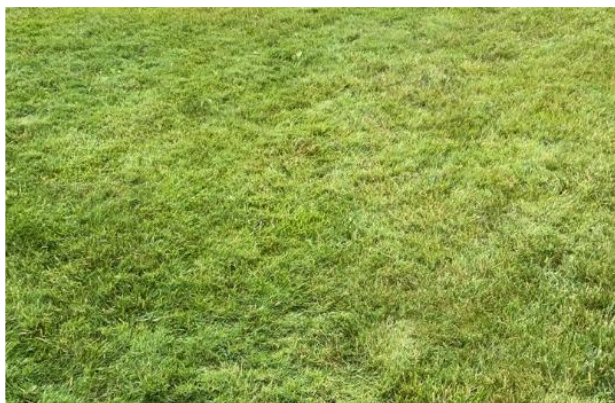
**Photo 1: Backyard has a gentle slope away from the house**

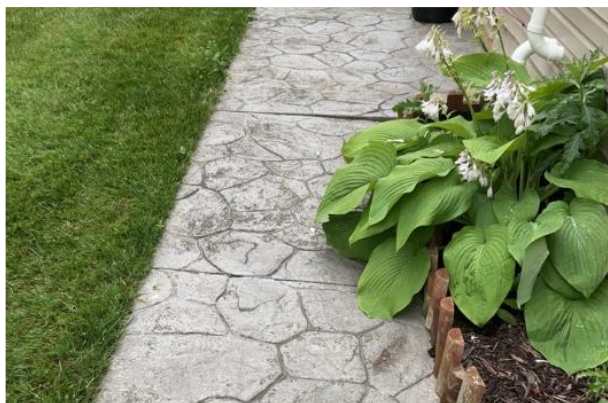
**Photo 2: Side yard has a gentle slope away from the house**

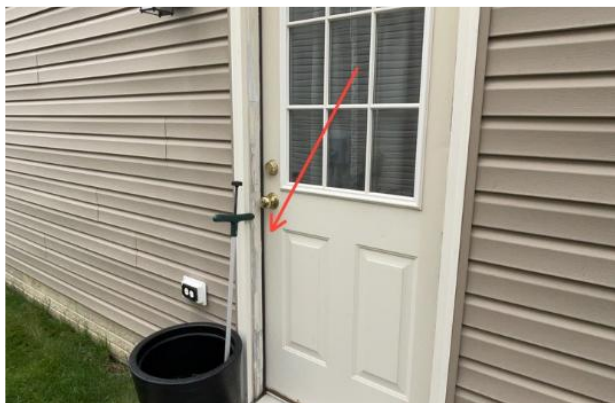
**Peeling paint was present on the exterior of the home.** In order to preserve the life of the exterior surfaces and materials, all areas should be scraped, sealed, and painted after any damaged wood is repaired. This is a routine maintenance item.

**Photo 13: Peeling paint around man door**

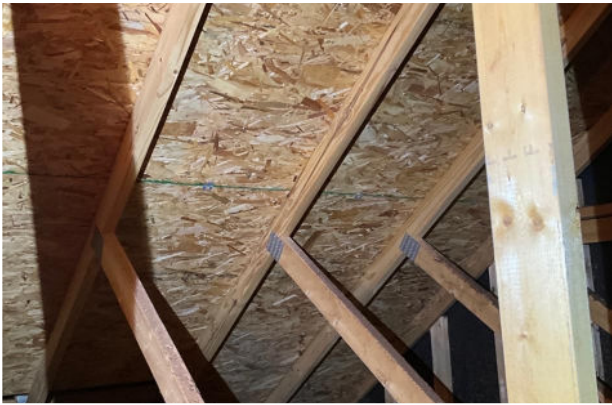
Photo 42: Attic over bedroom to the right of the stairs

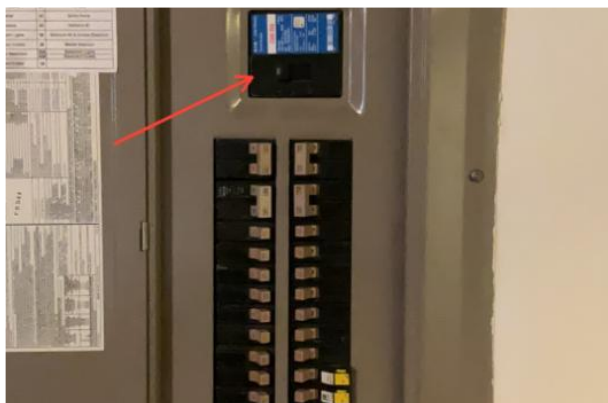
**Photo 60: Main service disconnect**

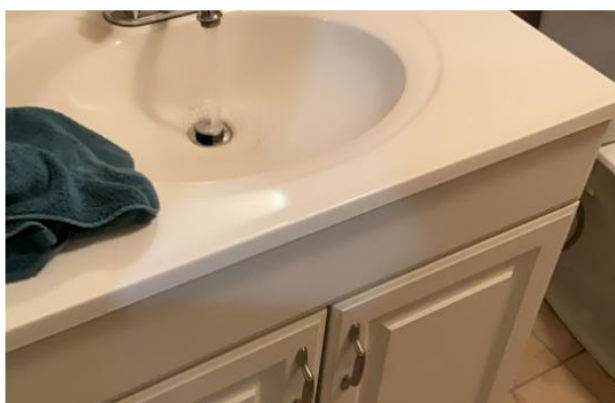
**Photo 76: Functioning downstairs, bath-room sink and toilet**

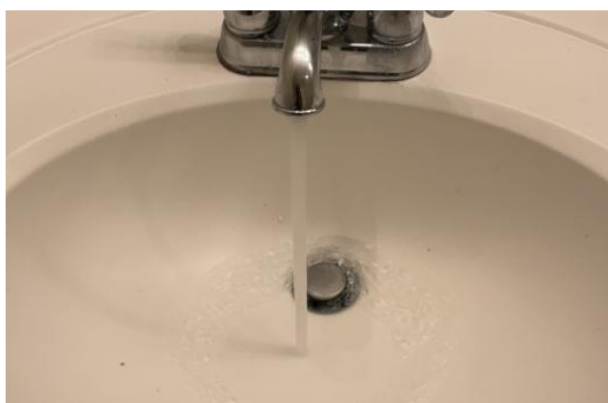
**Photo 77: Functional sink upstairs bath-room**

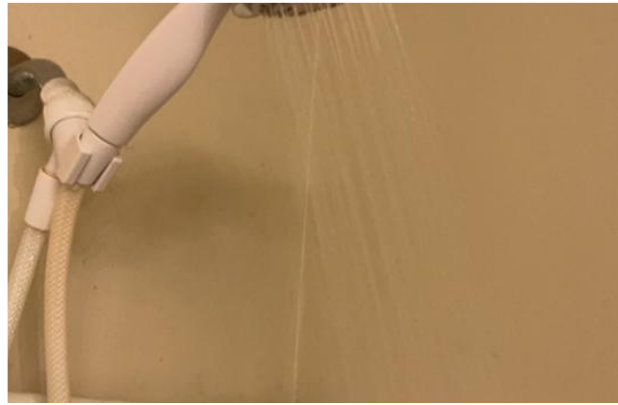
**Photo 79: Functional upstairs shower**

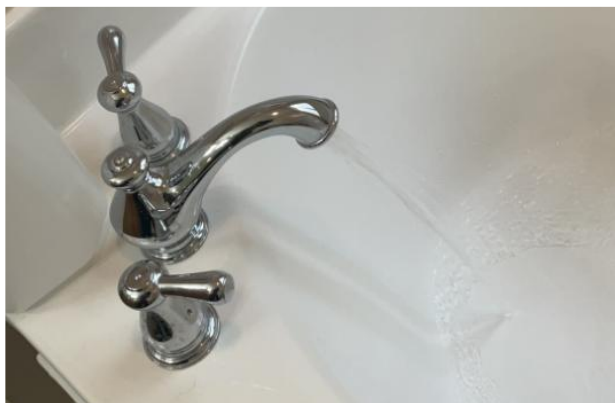
**Photo 84: Functional tub faucet in master bath**

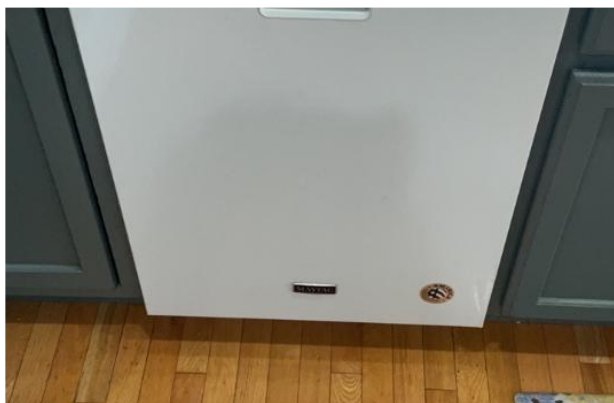
Photo 112: Dishwasher is functional

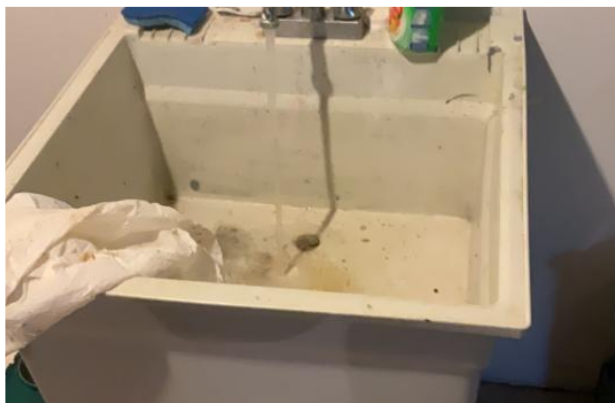
**Photo 114: Functioning laundry sink**

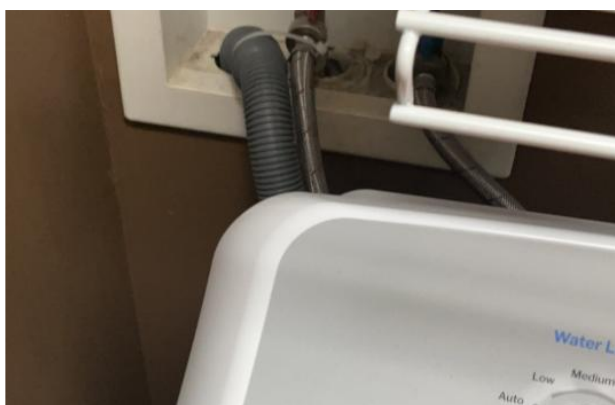
**Photo 116: Water supply and drain**

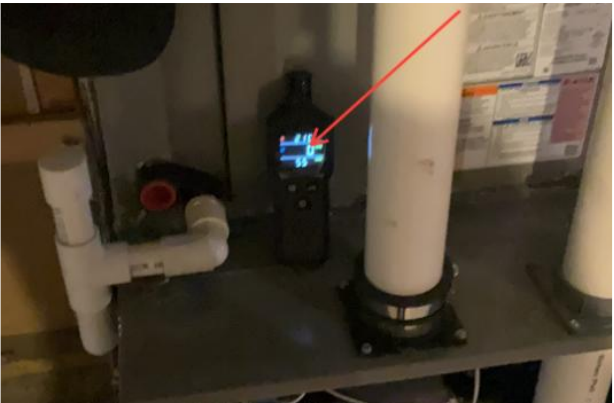
Photo 125: No CO gases were detected at inspection

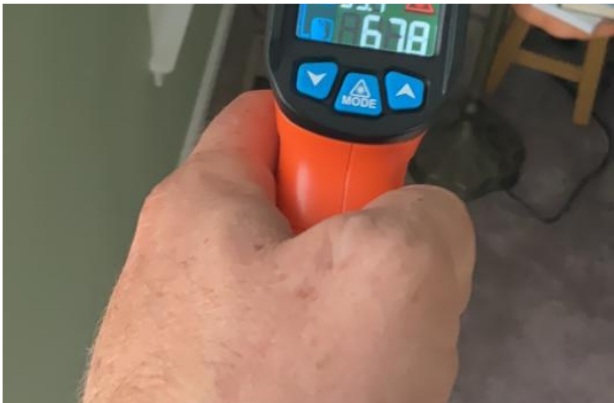
Photo 133: Functioning air conditioner
