### *HOME INSPECTION REPORT*

On Sunday, November 9, 2025 The HomeTeam Inspection Service made a visual inspection of 1234 Anywhere Rd., Anytown, USA 12345. Enclosed please find a written, narrative report of our findings in accordance with the terms of our Inspection Agreement.

Michael Burton  
HomeTeam Inspection Service of Central Panhandle  
Florida Home Inspector # HI12530

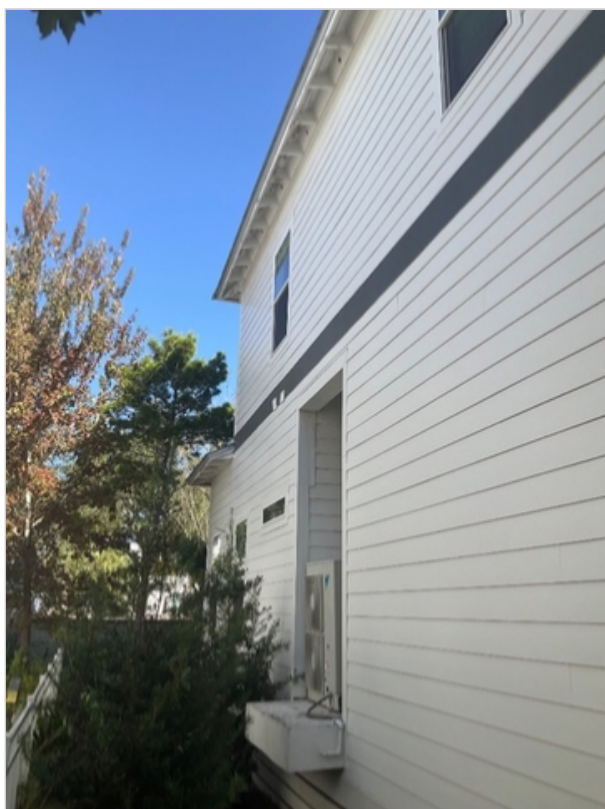
**Photo 1**

Left side

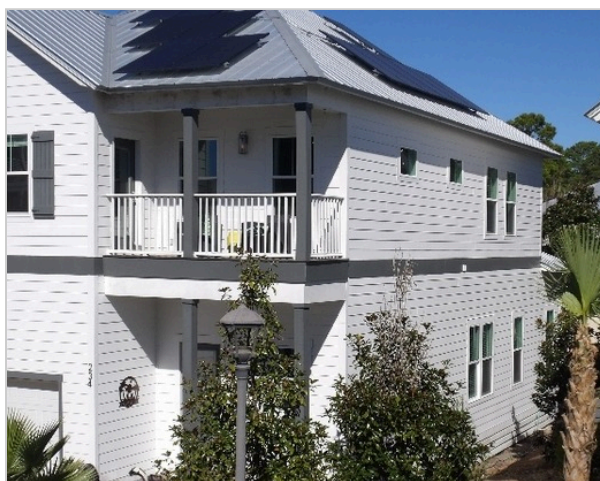
**Photo 2**

Right side

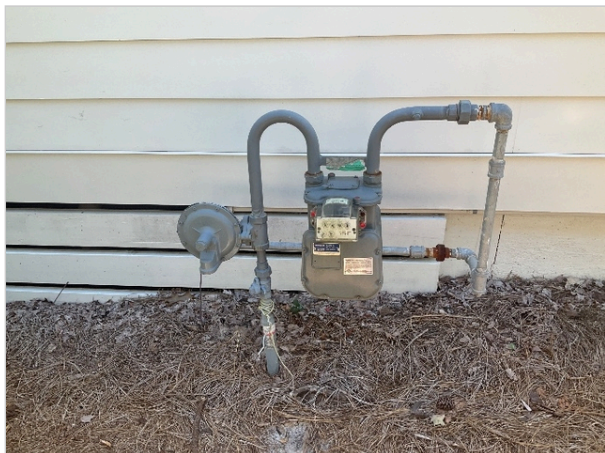
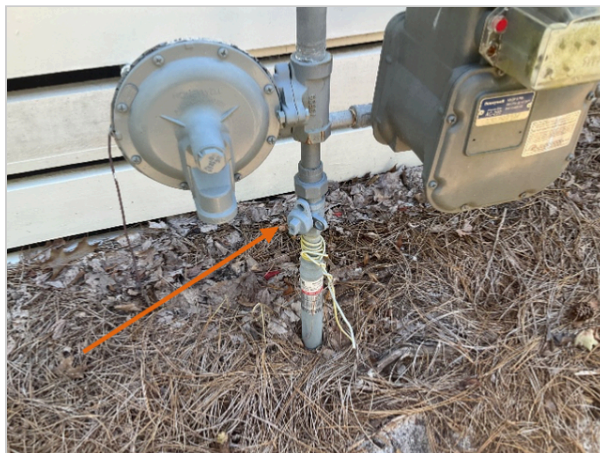
**Photo 41**

The gas meter and main shutoff were located in the left side yard. There was no noticeable odor of gas detected at the time of the inspection.

Shutoff valve

NOTE: HomeTeam recommends that all stuctures with natural gas supply lines be protected with CO monitors located in areas which will most improve the safety of the structure's occupants.

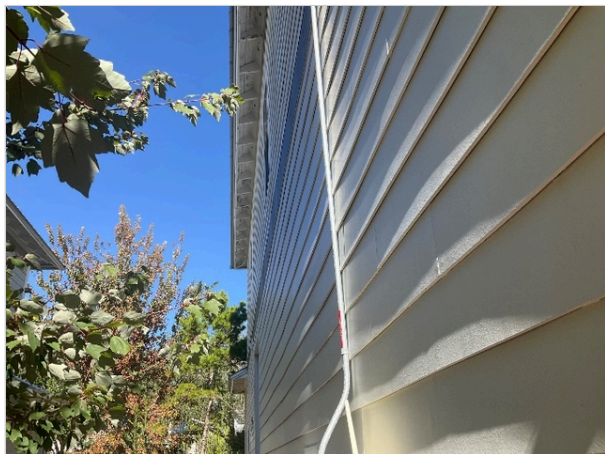
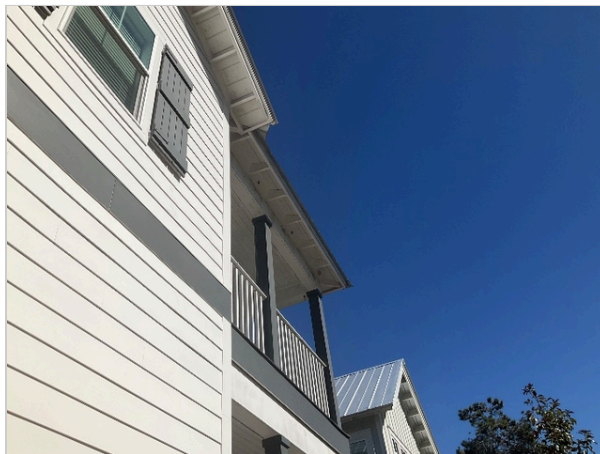
**Photo 43**

A properly-functioning drainage system is one of the most important items for extending the life expectancy of a house and its components.

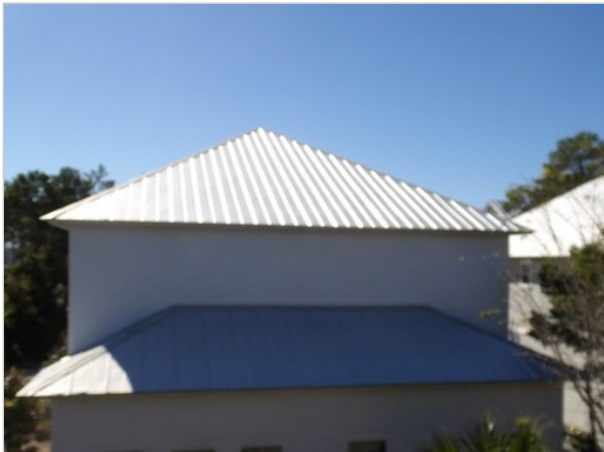
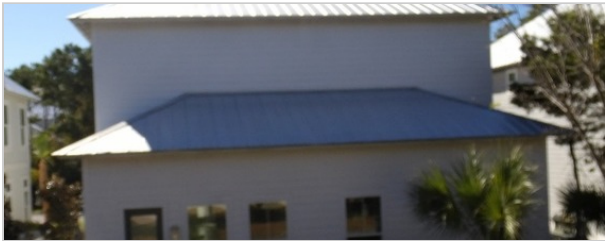
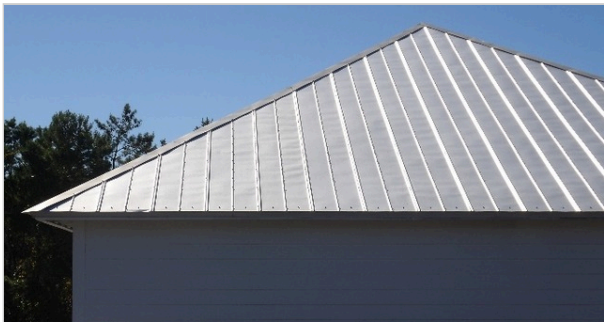
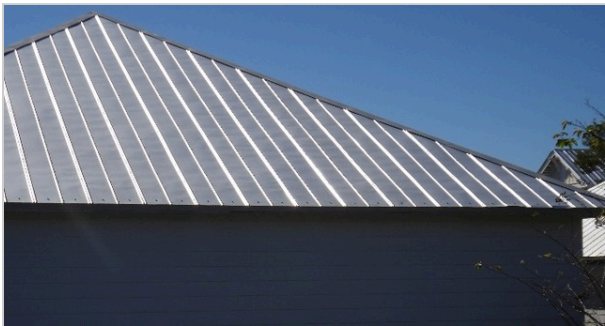
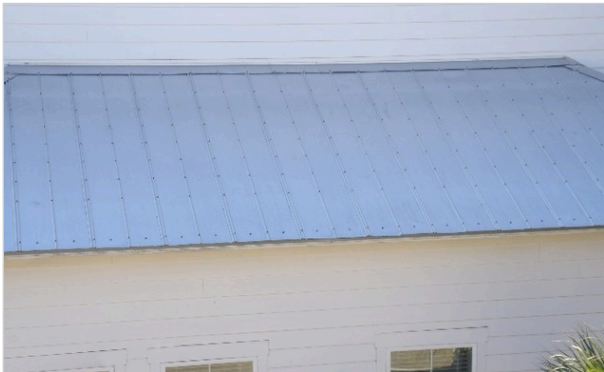
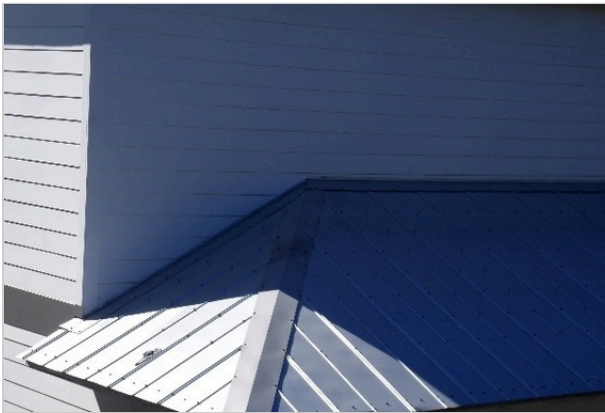
**Photo 45**

The structure had a metal roof. The metal roof was observed using a remote controlled camera mounted on a long extension pole.

The panel seams appeared to be adequate. The observed washers/sealant for the fastener holes appeared to be adequate.

Metal roofs, if properly maintained, can last a long time. The roof should be inspected annually to ensure these areas, including any sealant or washers, are in good order. Any deterioration of these items should be addressed promptly to avoid water intrusion and further deterioration.

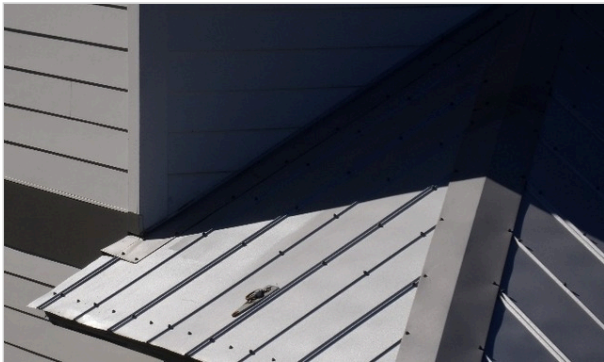
**Photo 51**

Flip flop present

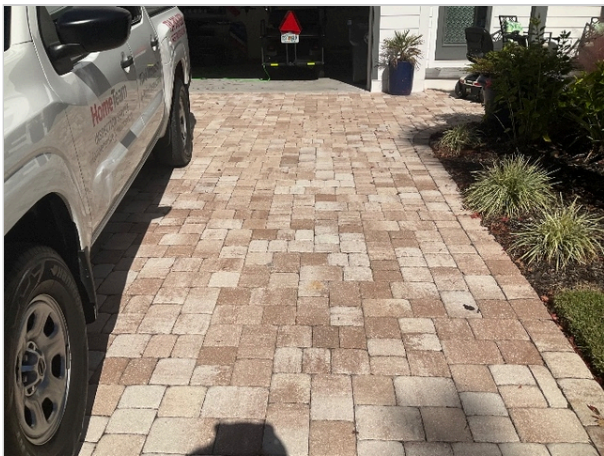
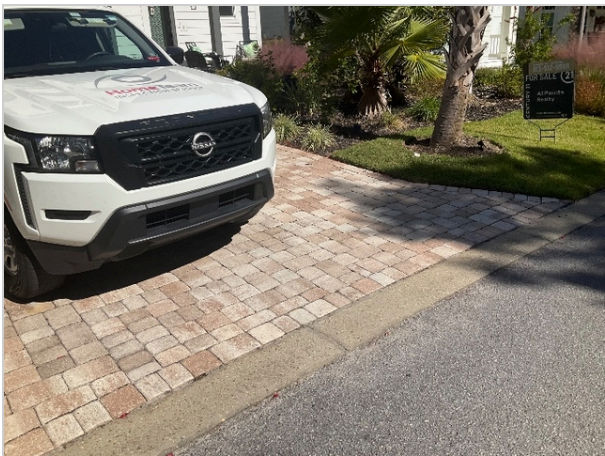
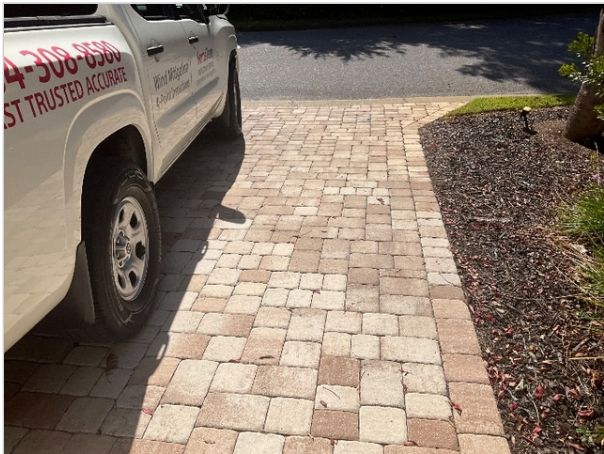
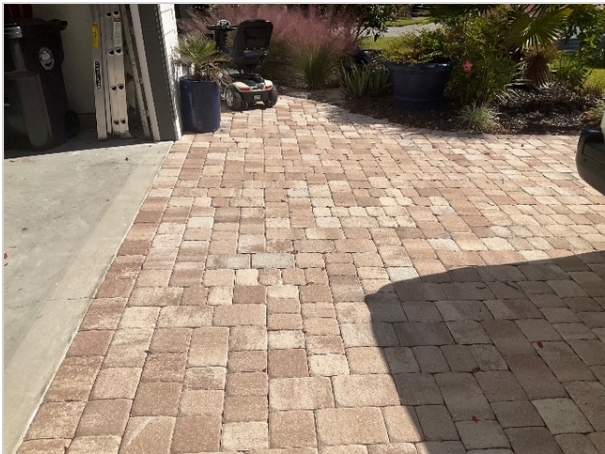
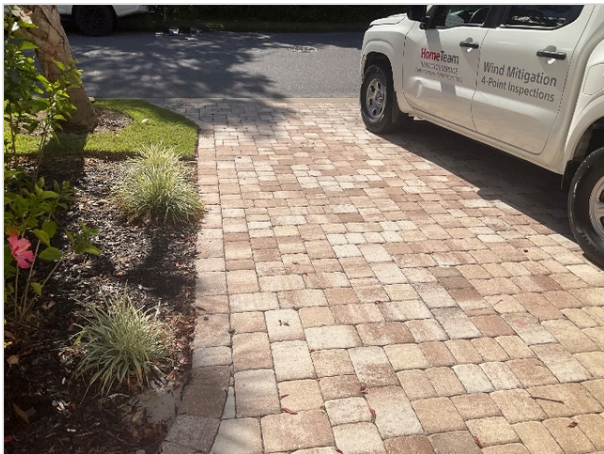
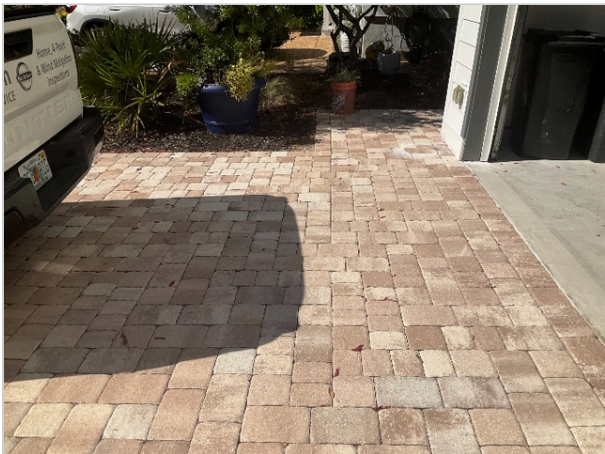
**Photo 66**

A paver driveway is present in the front of the structure. Cracks and spalling were not observed on the driveway. Surface defects in driveways develop and progress with age and are considered normal as long as they do not create a safety hazard. Sealing defects may help slow the rate of deterioration.

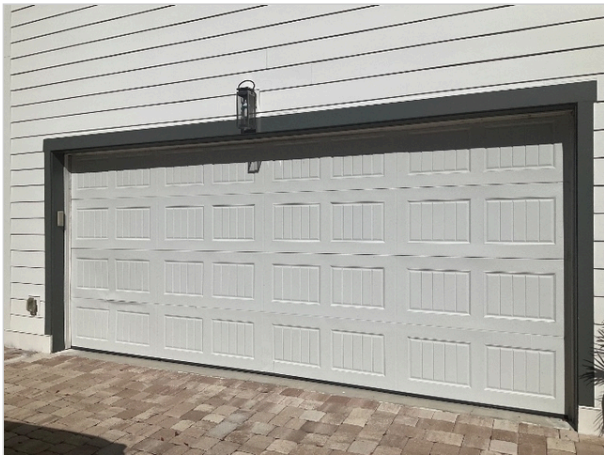
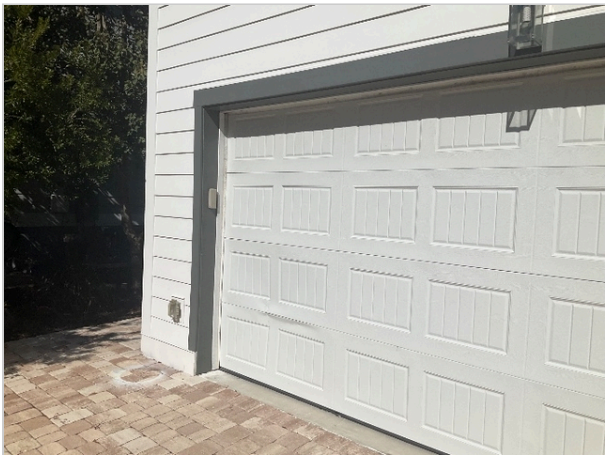
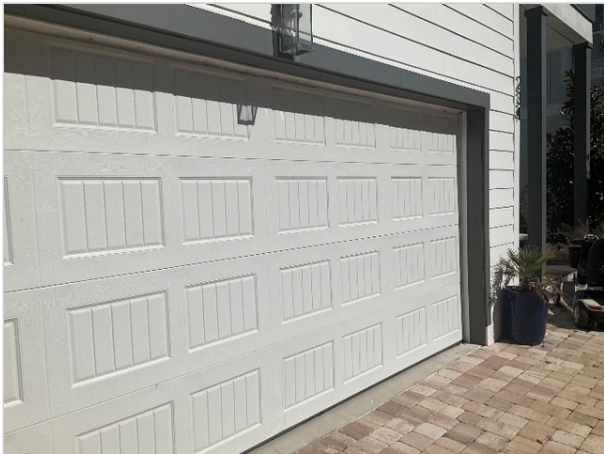
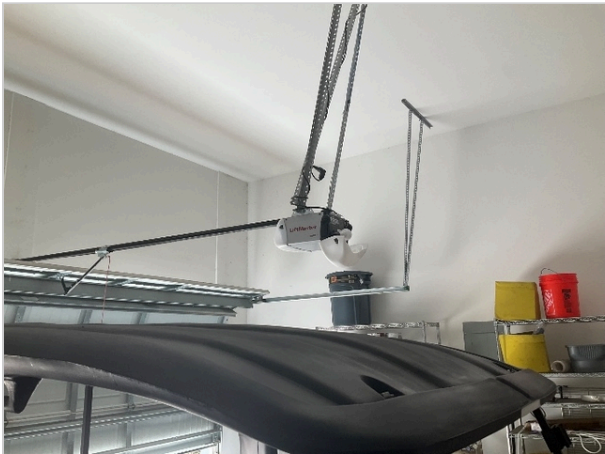
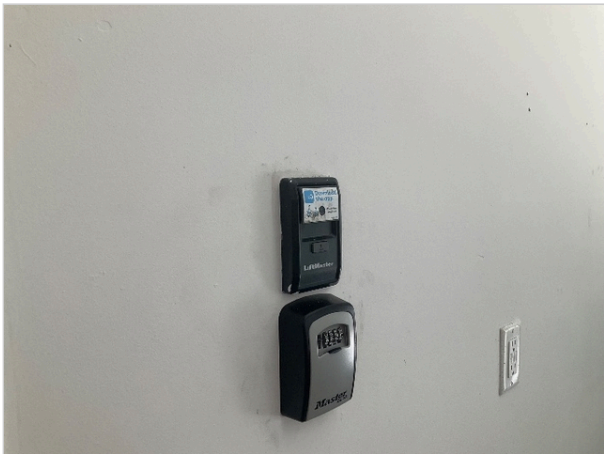
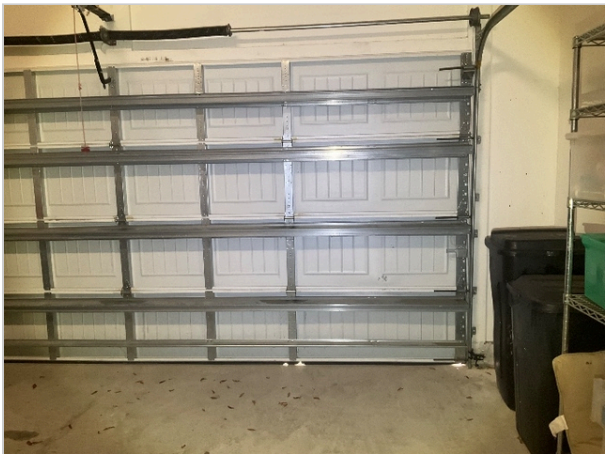
**Photo 72**

The attached garage was designed for two cars with access provided by one overhead-style door. A functional electric garage door opener was present. The electric eye and resistance sensors both functioned. The garage floor was in good condition but cracks were present.

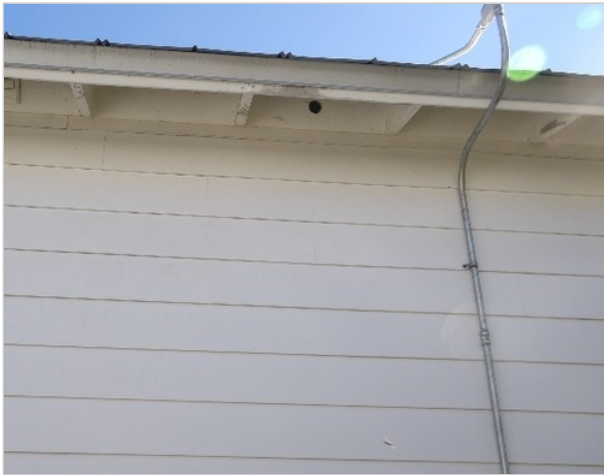
**Photo 118**

Two soffit vent covers were missing on the left side, one on the right front, and 1 or 2 on the front.

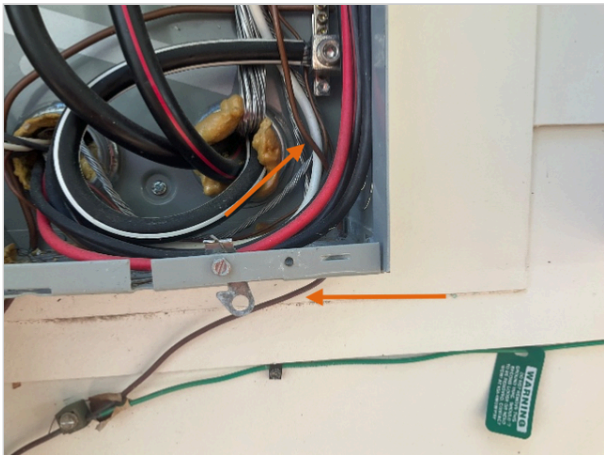
**Photo 129**

**Ground wire**

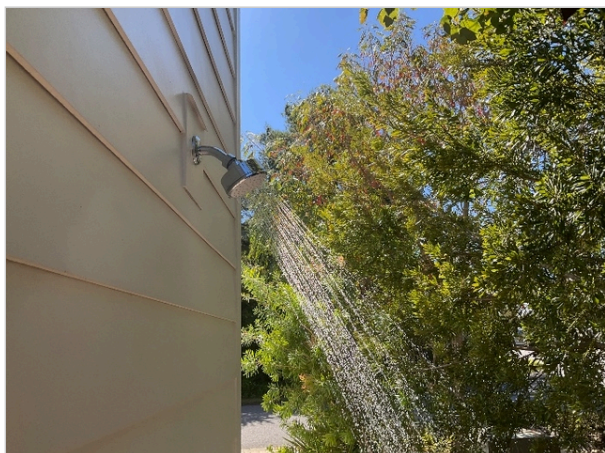
**Photo 154**

Outside shower:

Functional

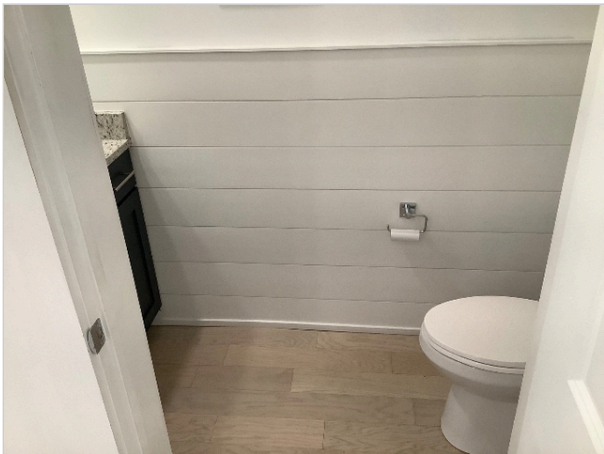
**Photo 176**

1st floor half bath

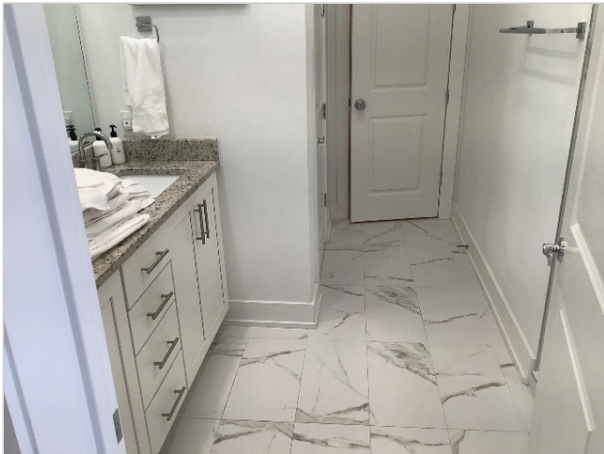
**Photo 180**

1st floor primary bathroom

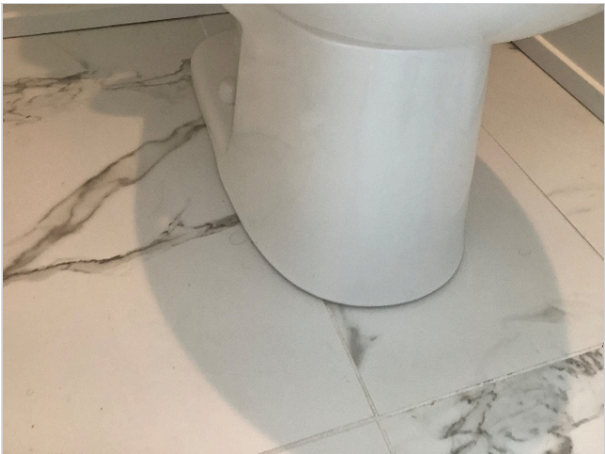
**Photo 190**

**The toilet in the 2nd floor front bathroom is loose.** Failure to secure the toilet may lead to leakage around the wax ring. The toilet should be secured.

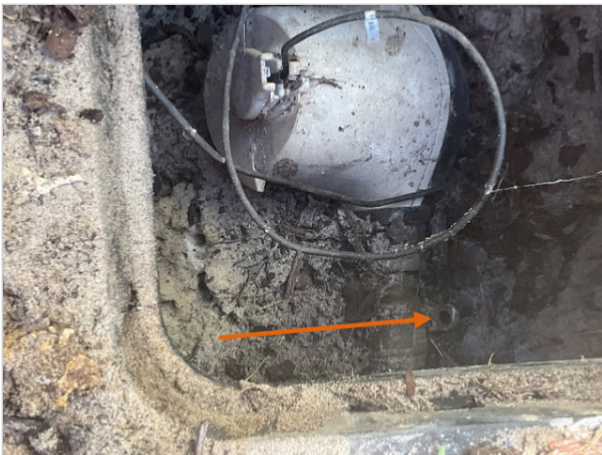
**Photo 193**

Shutoff valve

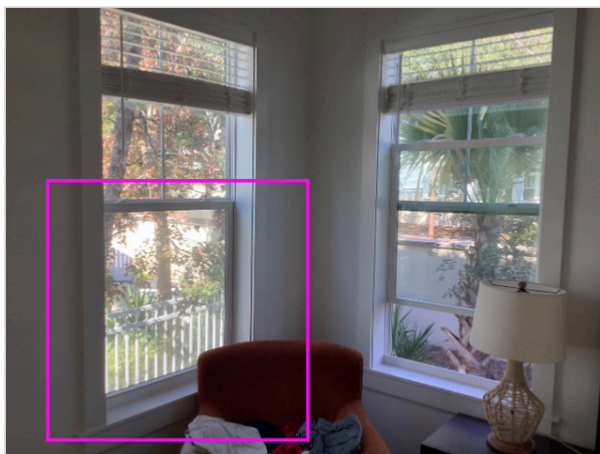
**Photo 224**

**A broken window tensioner is present on one of the 1st floor bedroom windows.** This condition is usually caused by a defective balancer (or tensioner) mechanism and prevents a window from staying in the open position without support. The affected windows should be repaired, or some other safe method implemented to raise, lower, and hold position for affected windows.

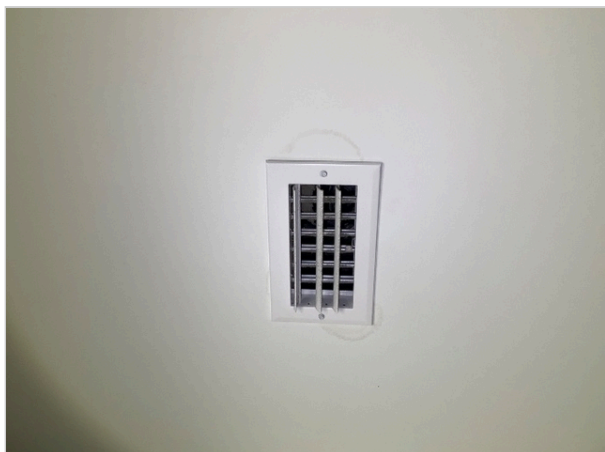
**Photo 227**

**Moisture stains were present around the HVAC outlets in the 2nd floor rear right and middle bedrooms and around the exhaust fan in the 1st floor primary bathroom.** The thermal camera did not show any moisture present at the time of the inspection and should be monitored for any future moisture.

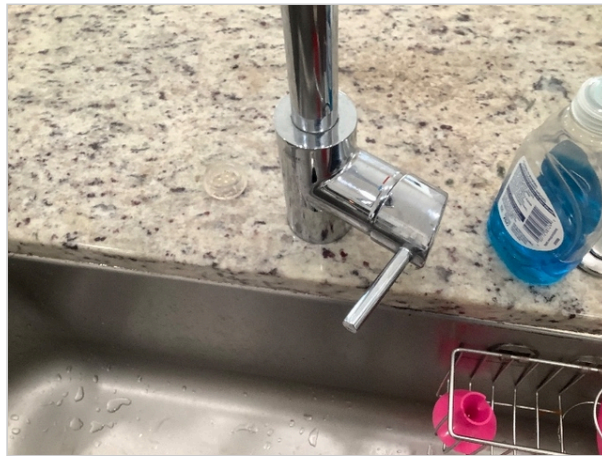
**Photo 235**

The kitchen sink faucet is loose from the counter.

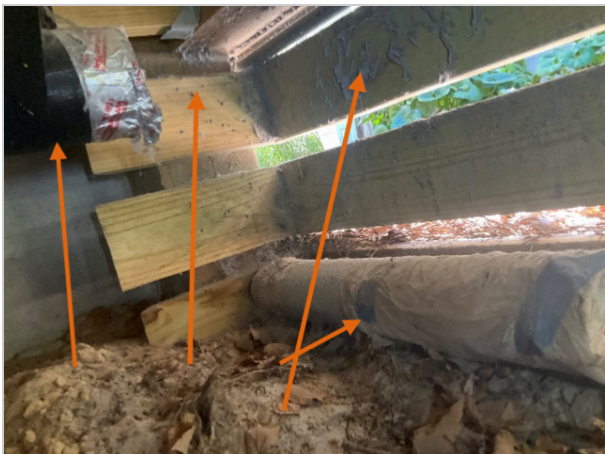
**Photo 257**

Lint

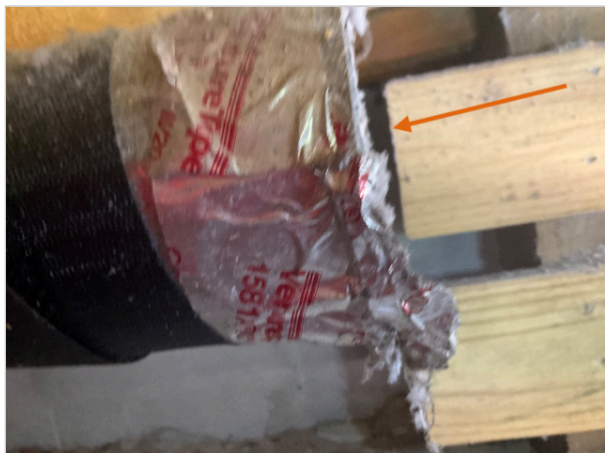
**Photo 258**

Open

The dryer vent pipe ends inside the crawlspace, about 1 - 2 ft from the edge of the house/Crawlspace ventilated closeout boards on the left.

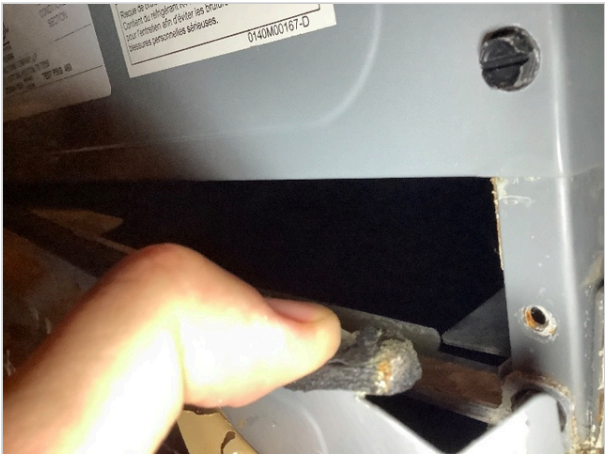
**Photo 282**

The 2nd floor HVAC system had no filter installed.
