# PROPERTY INSPECTION REPORT

**Prepared For:** John Doe  
(Name of Client)

**Concerning:** 1234 Anywhere St, Anytown, TX, 12345  
(Address or Other Identification of Inspected Property)

**By:** Jerimy Schiewe (# 21015) Dale Lockamy (# 22446) Bobby McDonald (# 8094) 01-01-2026  
(Name and License Number of Inspector) (Date)

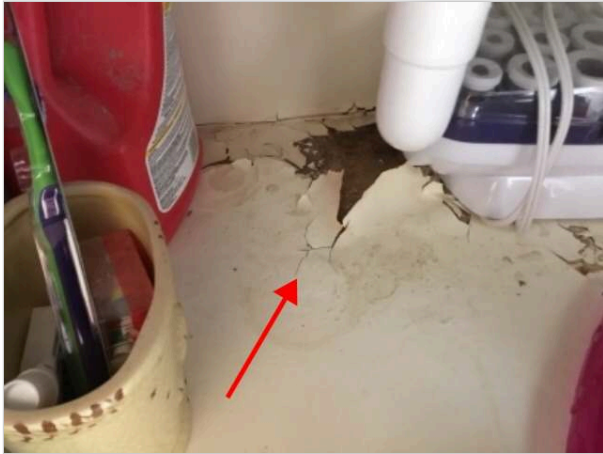
1B

Sheetrock crack(s) were observed on interior wall surfaces at rear right in rear living room (PIC 1A) and front right at door entry in upstairs rear left bedroom (PIC 1B).

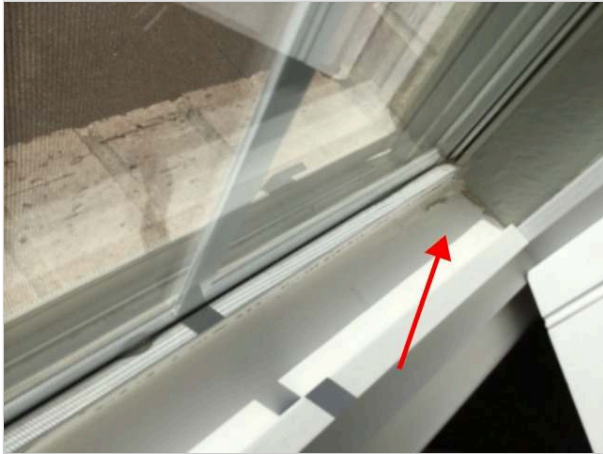
1N

Water damage was observed on window sill(s) at multiple windows at rear in master bedroom (PIC 1I,1J,1K), left window in upstairs front left bedroom (PIC 1L), upstairs rear left bedroom (PIC 1M), upstairs front right bedroom (PIC 1N,1O) and windows in upstairs living room(4) (PIC 1P,1Q).

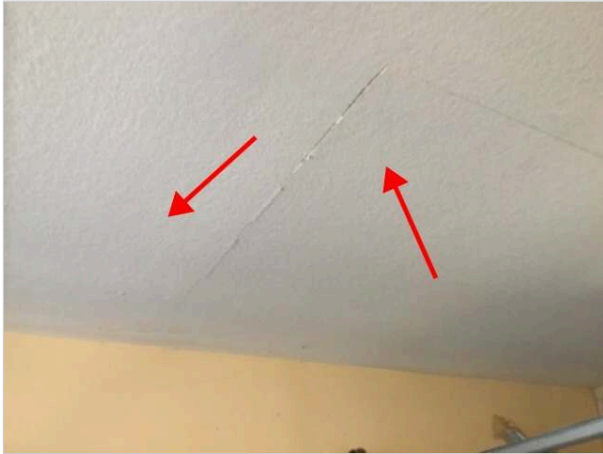
A

Sheetrock crack(s) were observed at ceiling surfaces at rear left in garage (PIC A).

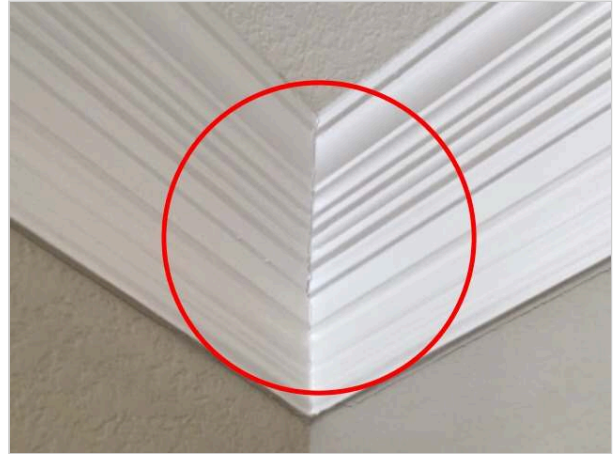
B

Separation was observed between ceiling(s) and crown molding at multiple locations in master bedroom (PIC B,C).

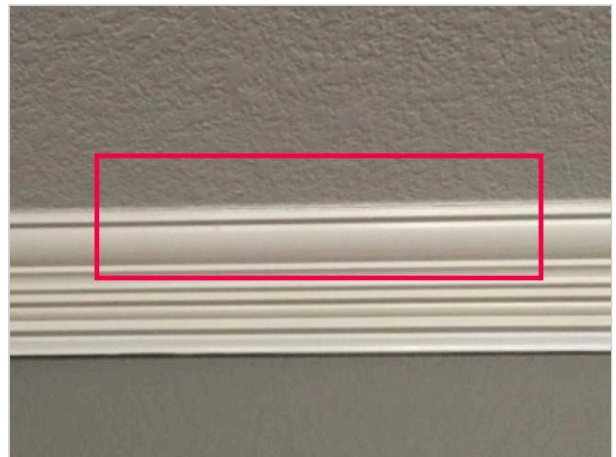
D

Gaps were observed in crown molding joints at rear left and right corners in front dining room (PIC D).

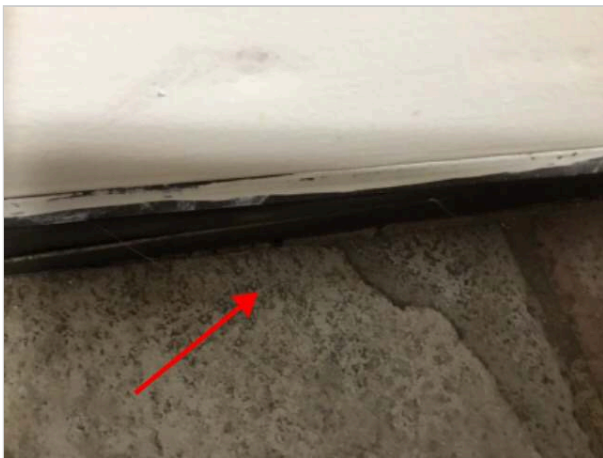
E

Cracked/missing grout was observed at threshold at garage entry (PIC E).

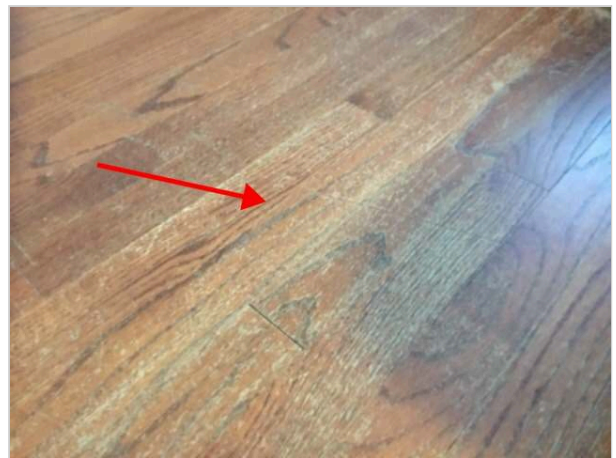
F

Significant wear was observed on wood flooring at multiple locations in study (PIC F,G).

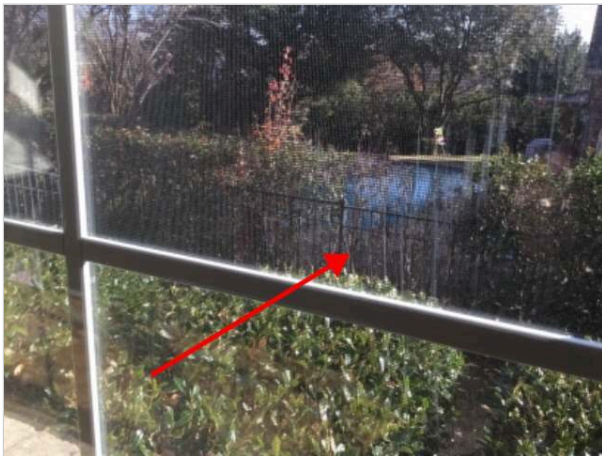
A

Window glass was scratched/damaged at lower panel at rear in kitchen (PIC A).

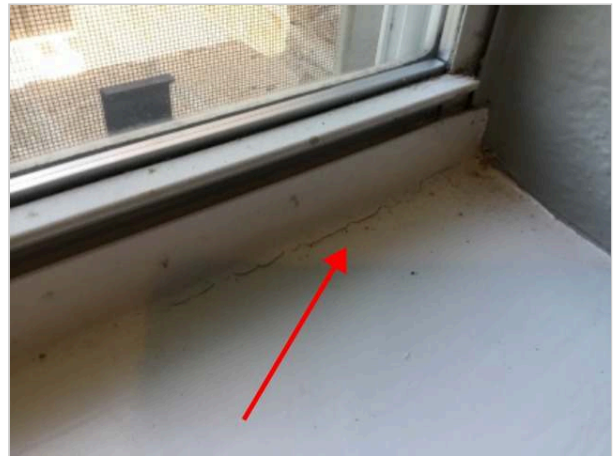
B

Gaps at interior window framing were observed at multiple interior window locations, caulk/seal as needed (PIC B,C).

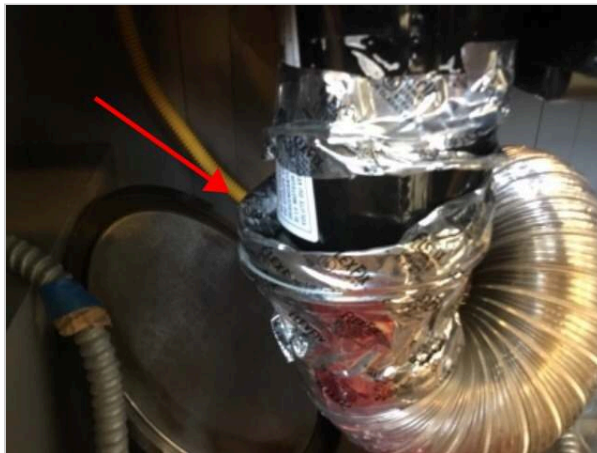
A

The downdraft vent line was damaged and/or disconnected in the cabinet under the cooktop (PIC A).

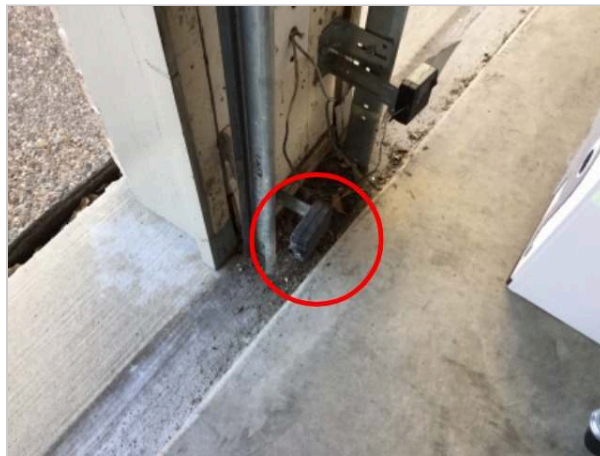
A

The laser safety sensor(s) were loose at the front garage door (PIC A), the garage door operation was inconsistently closing when activating the garage door button at the time of inspection.

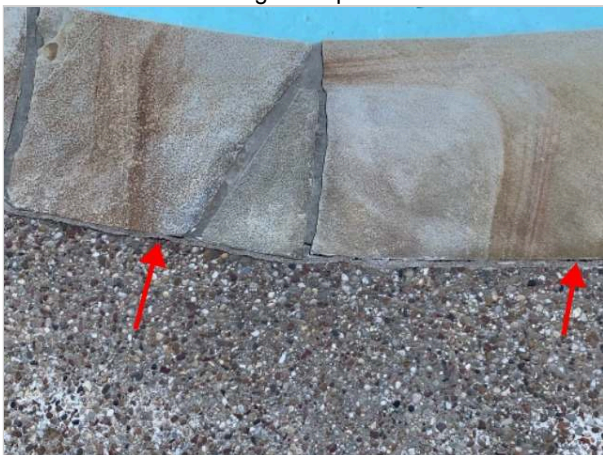
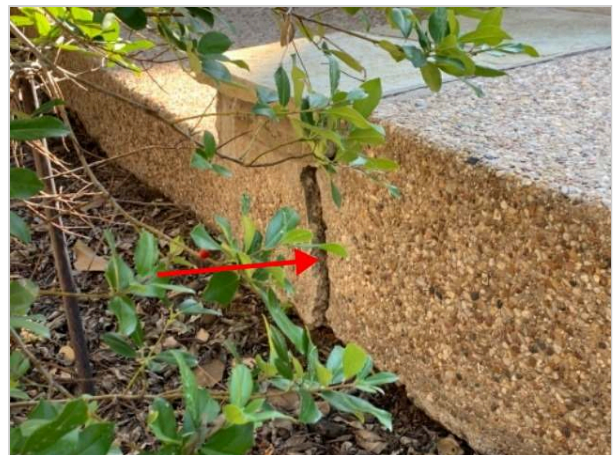
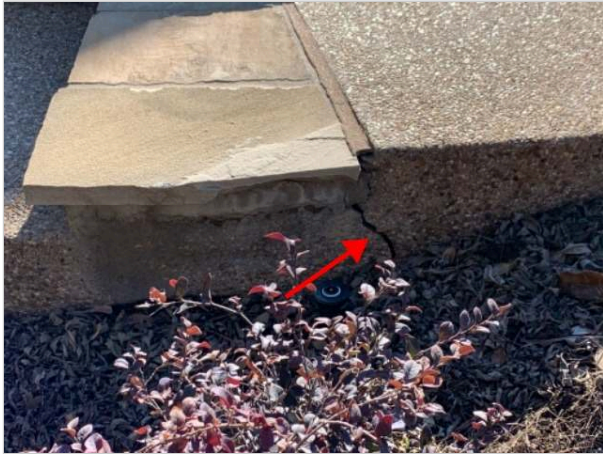
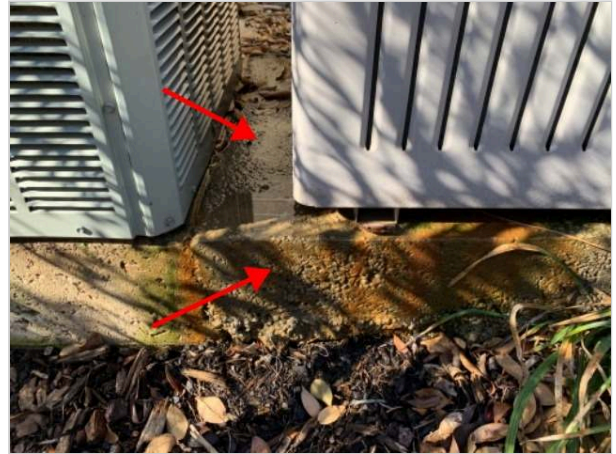
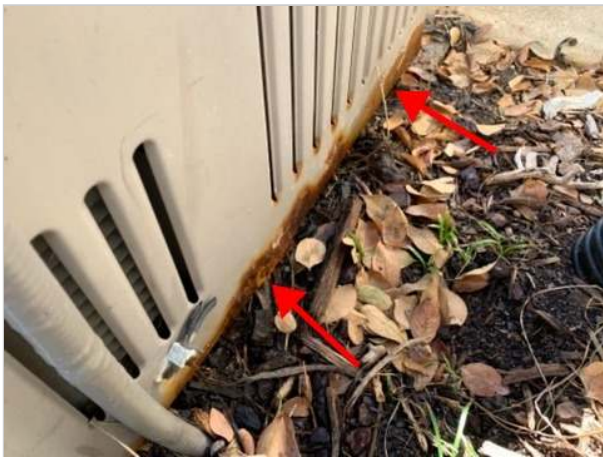
There was no anti vortex cover installed at the main pool drains.  
 The fence gates opening to the rear yard did not self close/latch properly.  
 Gaps were observed in the expansion joint between the pool deck and pool edge around the pool perimeter (PIC A, B).  
 The pool deck was cracked and/or damaged at rear (2) (PIC C, D).  
 The pool light did not function.  
 Leakage was observed on the pool equipment at heater (PIC E); the exact source of the leakage was unknown.  
 The gas pool heater did not function at the time of the inspection.  
 The base of the pool heater was severely corroded (PIC F).  
 Several top stones were loose around the pool perimeter (PIC G, H).  
 A crack was observed at the bottom of the pool from rear center to front right (PIC I, J).  
 The pool deck was damaged, rebar was showing, at front right (PIC K).  
 Recommend evaluation and repairs as needed by an independent pool specialist.
