### *HOME INSPECTION REPORT*

On Wednesday, August 5, 2026 The HomeTeam Inspection Service made a visual inspection of 123 Sample Drive, Brambleton, VA 20148. Enclosed please find a written, narrative report of our findings in accordance with the terms of our Inspection Agreement.

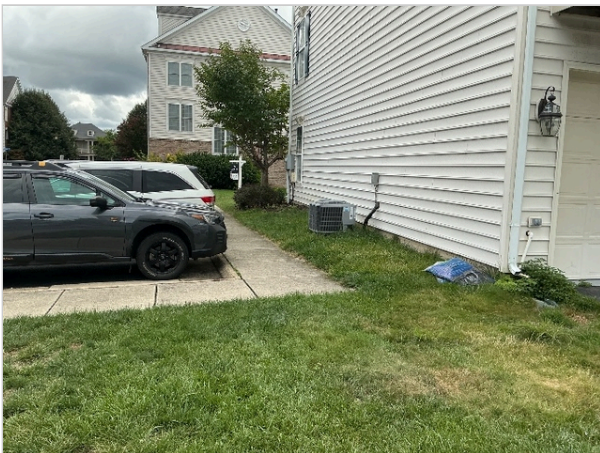
**Photo 1**

The structure was situated on a level lot. The general grade around the structure appeared to be adequate to direct rain water away from the foundation, assuming normal drainage and downspout, gutter, and other systems are functioning properly.

Side Grade

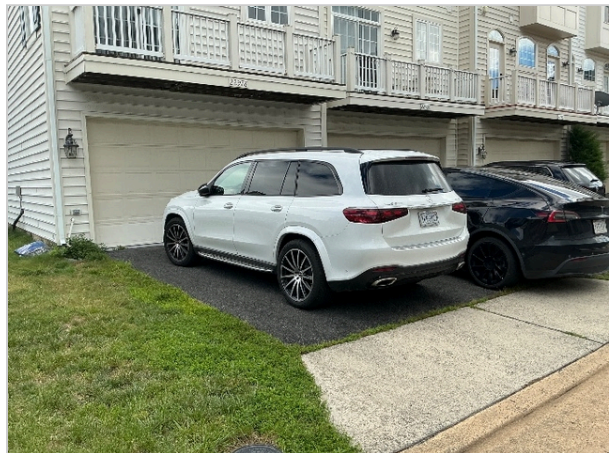
**Photo 2**

Back Grade

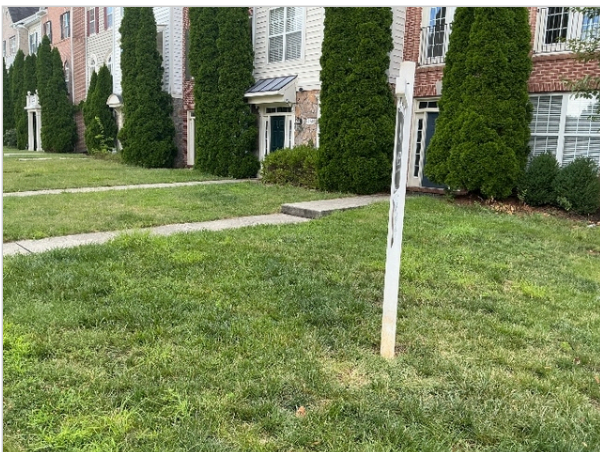
**Photo 3**

Front Grade

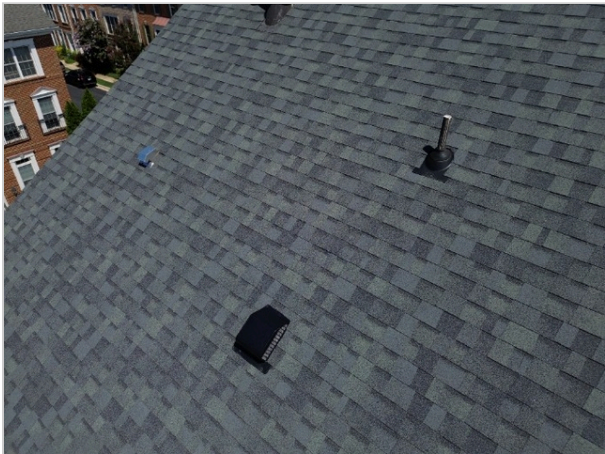
Photo 20

Roof Vents

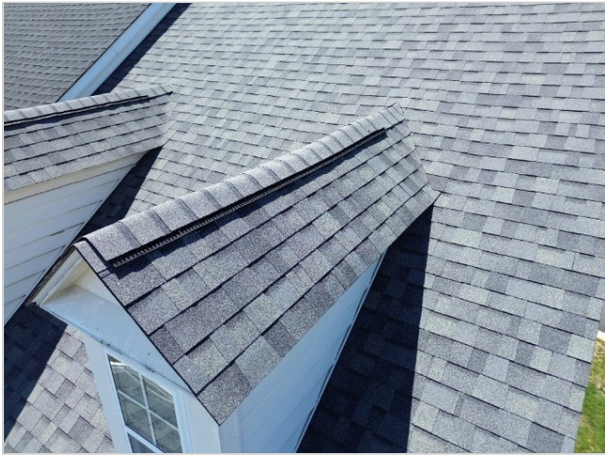
Photo 22

Dormers

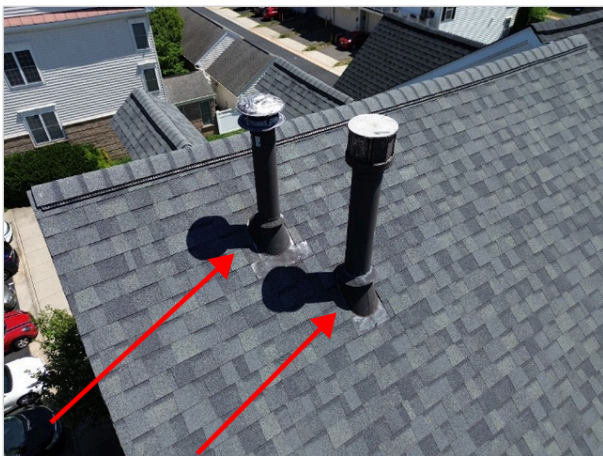
Photo 25

The structure had two flue chases. Observation of the flue chases was made from the drone photographs. The flashing around the roof penetration point appeared to be adequate.

Good Flashing

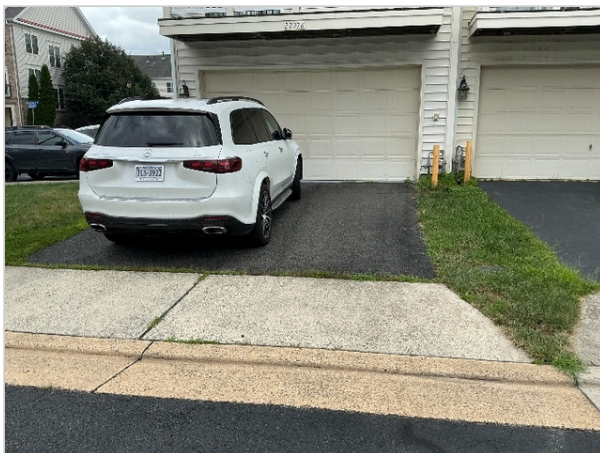
**Photo 26**

An asphalt driveway is present in the back of the structure. Cracks and spalling were not observed on the driveway. Surface defects in driveways develop and progress with age and are considered normal as long as they do not create a safety hazard. Sealing defects may help slow the rate of deterioration.

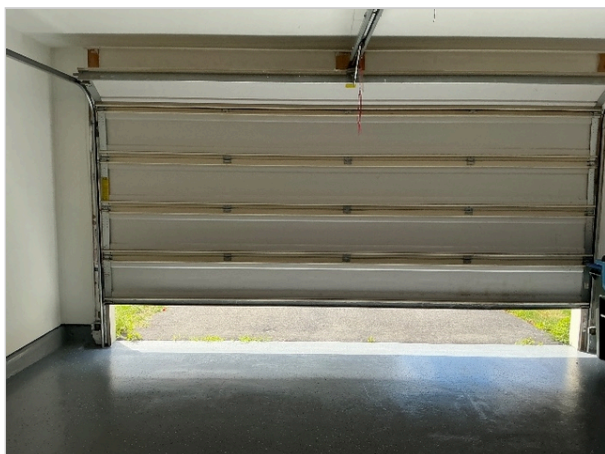
**Photo 27**

Garage Door in Operation

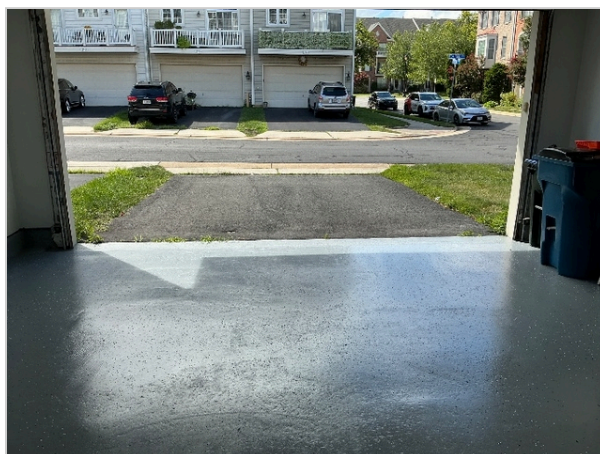
**Photo 28**

Garage Floor

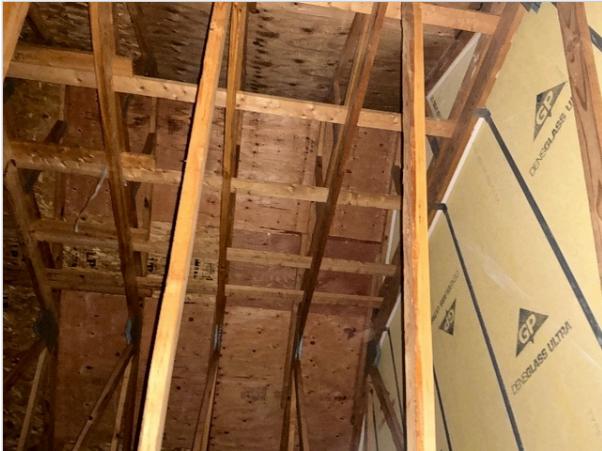
**Photo 29**

Attic Structure

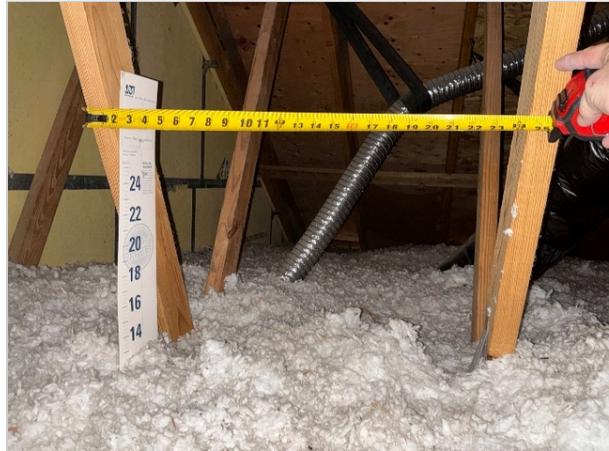
**Photo 30**

Truss Spacing

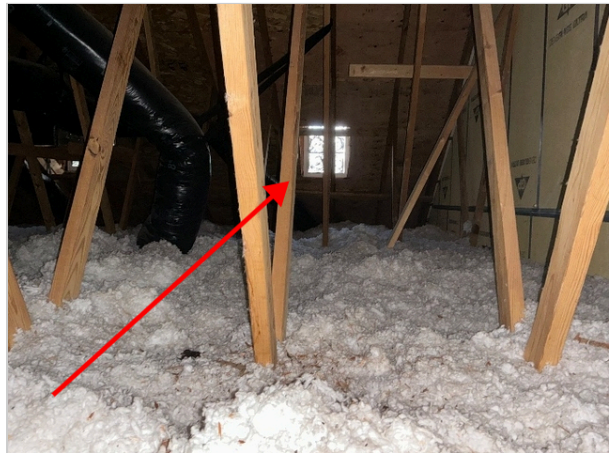
**Photo 32**

Gable Vent

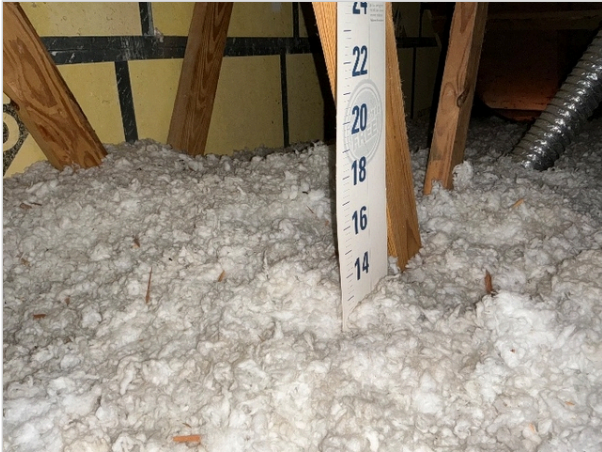
**Photo 33**

Insulation Depth

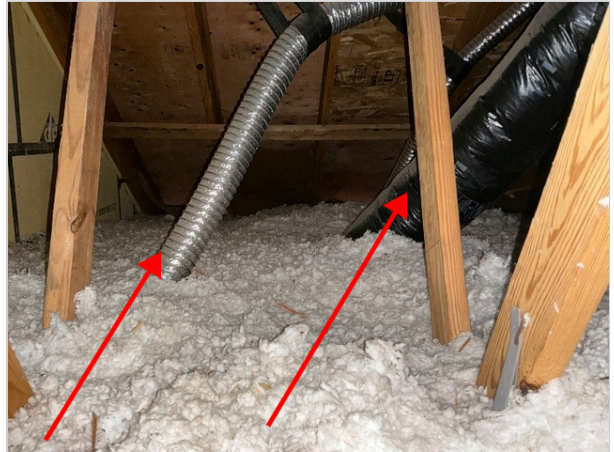
**Photo 34**

Proper Ventilation

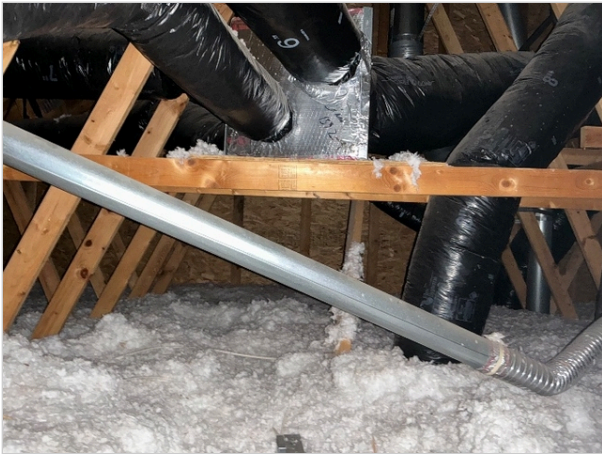
**Photo 35**

Ventilation

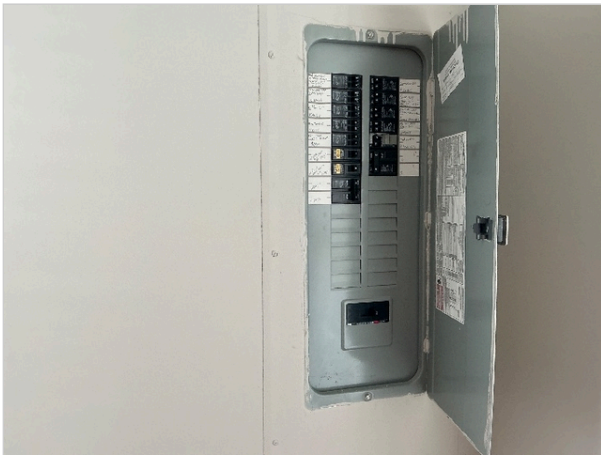
**Photo 38**

The service wire appeared to be 120/240 volt and 200 amp and entered a Cutler Hammer service panel, located on the right interior wall. The main service disconnect was 200-amp rated and was located in the main panel. The branch circuits within the panel were copper. These branch circuits and the circuit breaker to which they were attached appeared to be appropriately matched. The internal components of the service panel, i.e. main lugs, bus bars, etc were in good condition.

Electrical Panel

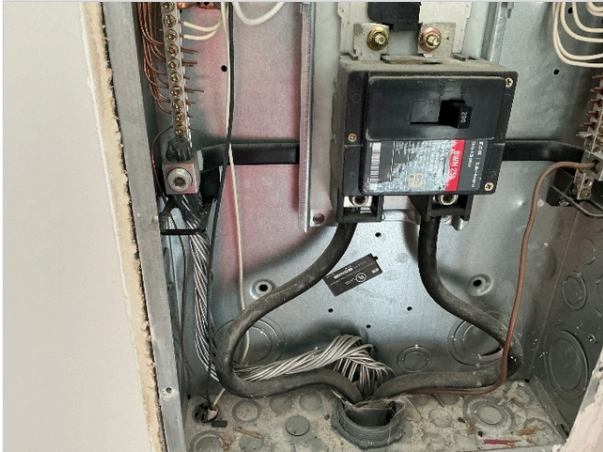
Photo 40

Main Breaker

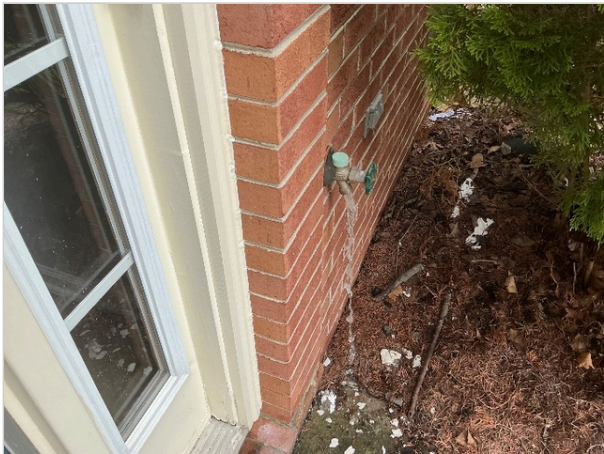
Photo 48

Front hose bib

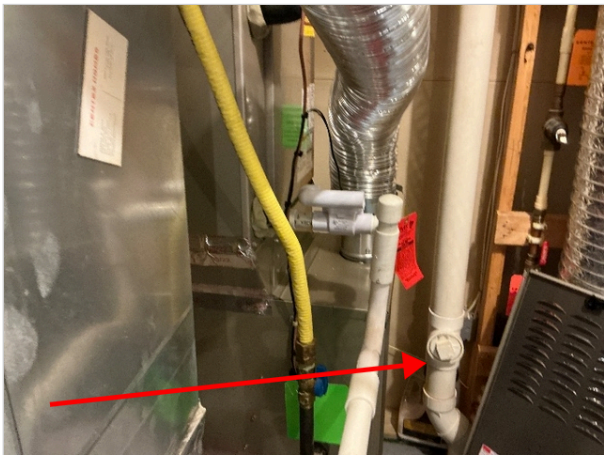
Photo 52

Plumbing Cleanout

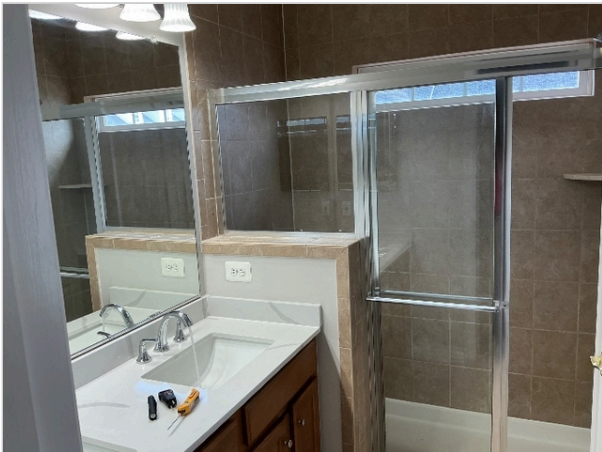
**Photo 55**

Bathroom in third bedroom

Water escaping from sliding glass door in the bathroom of the third bedroom. Leaking water can get into structure and cause mold issues.

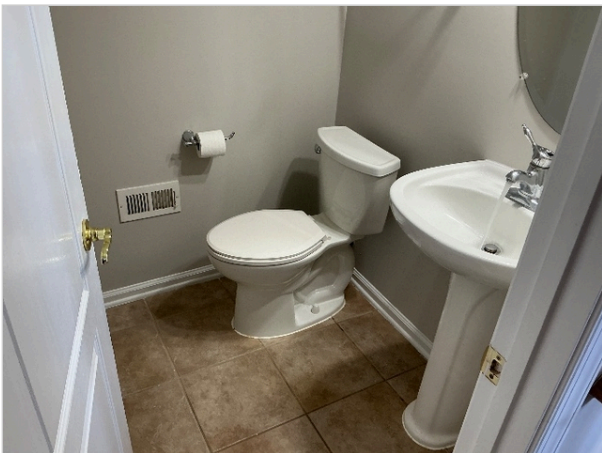
**Photo 57**

Second floor half bath

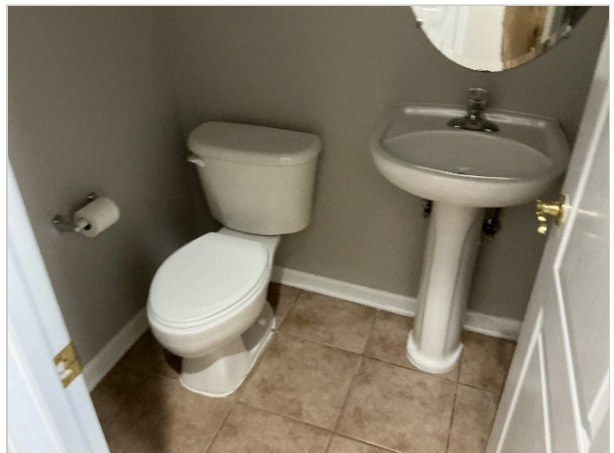
**Photo 58**

Basement half bath

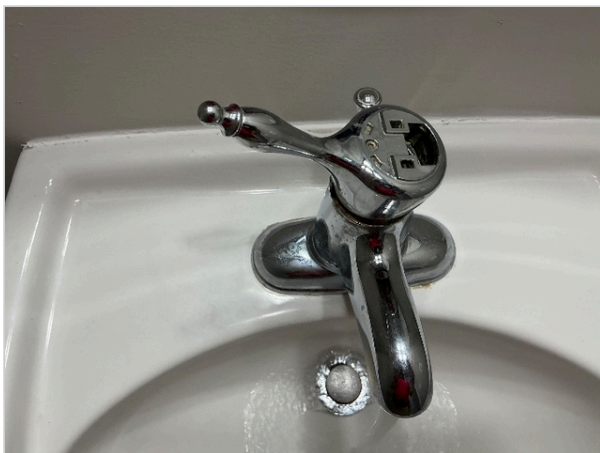
**Photo 64**

Second floor half bath

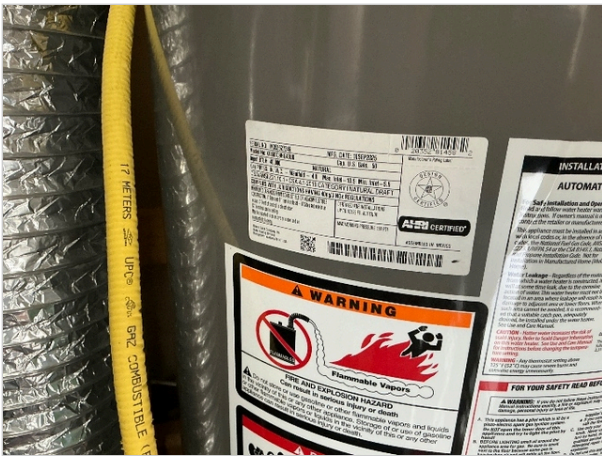
Photo 68

Water Heater Manufacturer Label

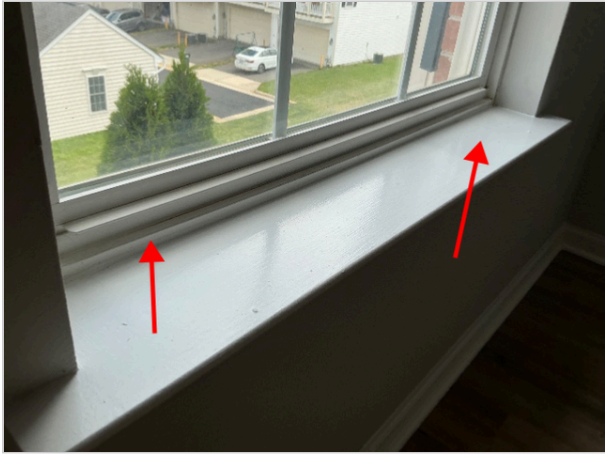
Photo 74

Bedroom one

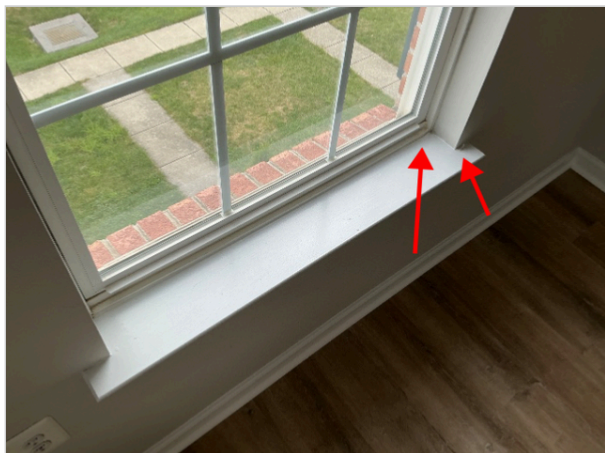
Photo 75

Bedroom two window

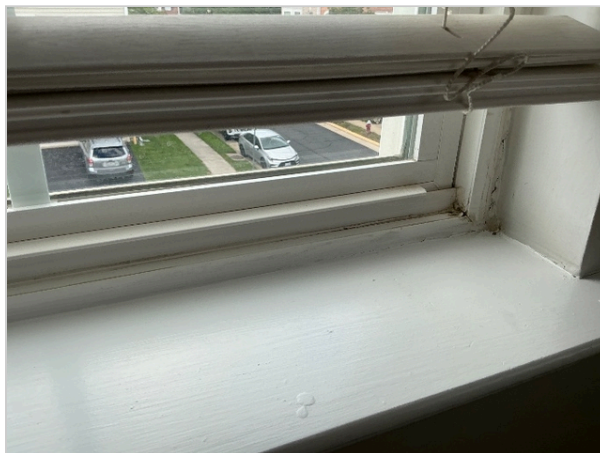
Photo 76

Third floor third bedroom

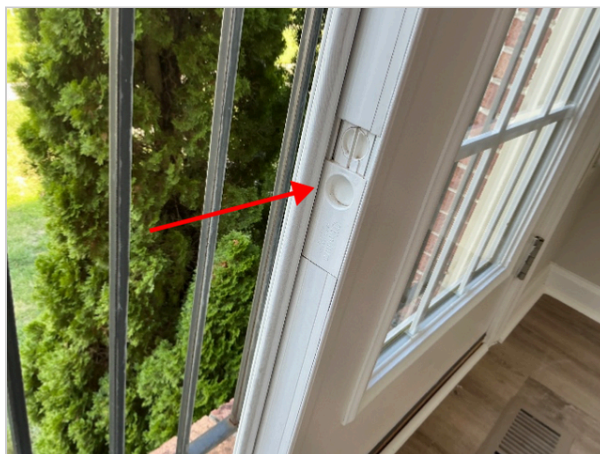
Photo 87

Exterior door latch

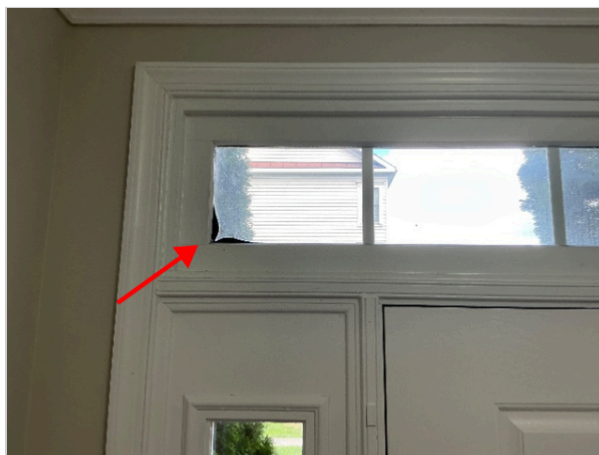
**Photo 90**

Window above main entry door

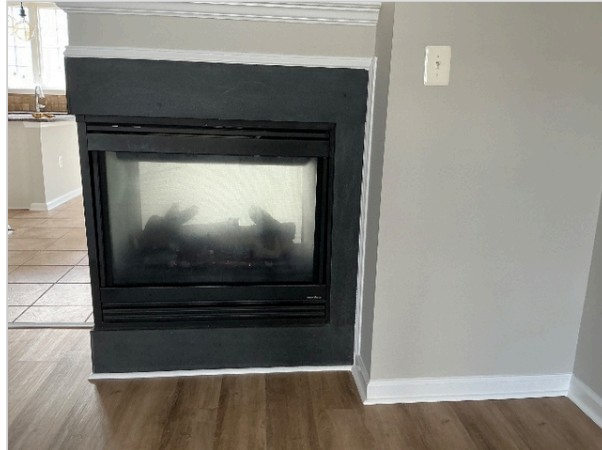
**Photo 91**

The visual condition at the time of the inspection was as follows: fireplaces appeared to function when turned on.

Living room fireplace

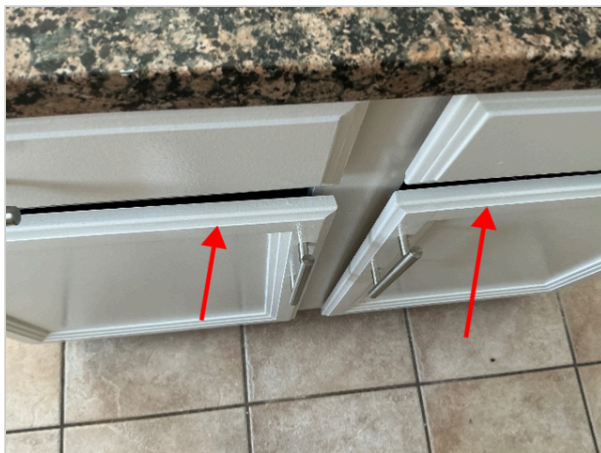
**Photo 93**

Cabinets and island are slightly out of square.

Island cabinets

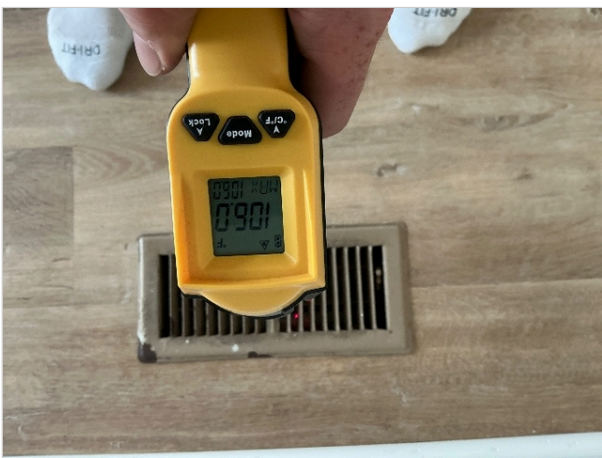
**Photo 106**

Temp while heat running

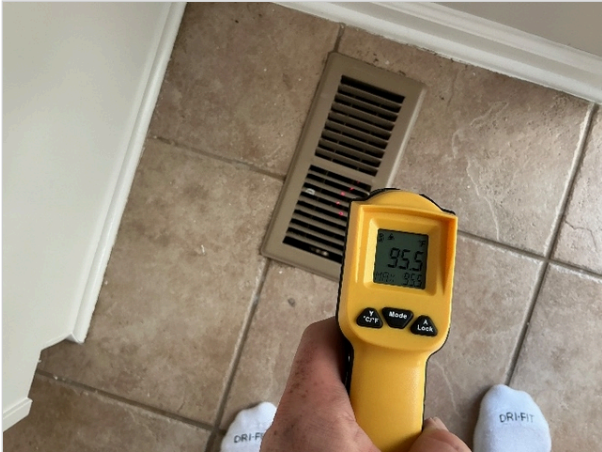
**Photo 108**

Temp while heat running

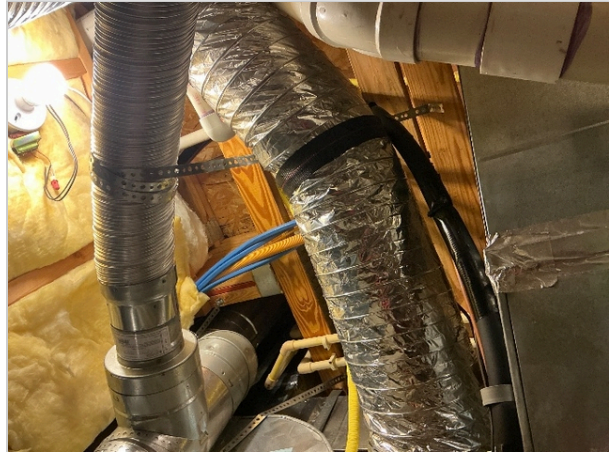
**Photo 116**

Furnace Venting
