*HOME INSPECTION REPORT*

On 06-22-2026 14:00:00 The HomeTeam Inspection Service made a visual inspection of 123 Sample Drive, Painesville OH 44077. Enclosed please find a written, narrative report of our findings in accordance with the terms of our Inspection Agreement.

## HOUSE- BASEMENT- ATTACHED GARAGE

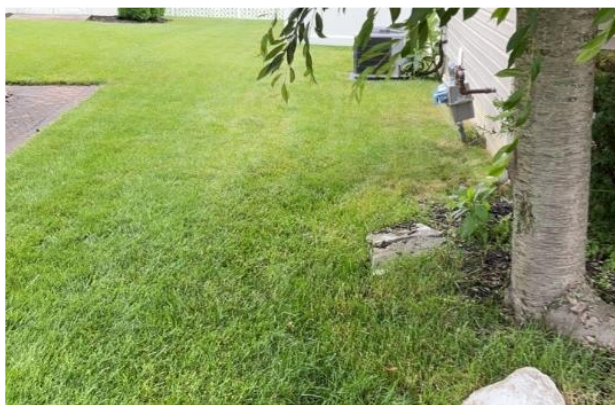
**Photo 3: Left side of home has a level grade**

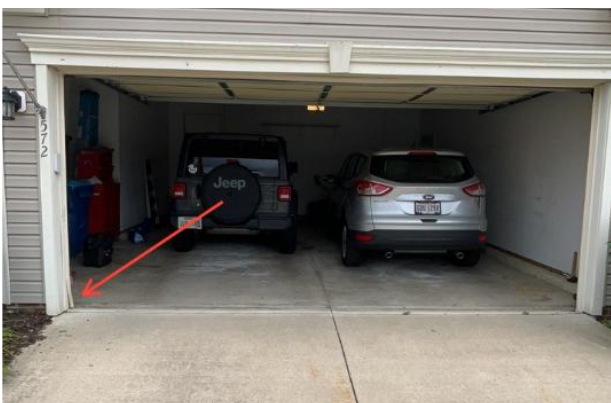
**Photo 36: Damaged trim front left corner of garage**

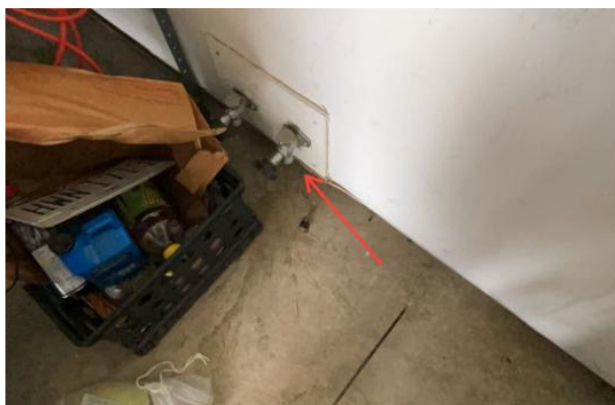
**Photo 38: Functioning water hose bib in garage**

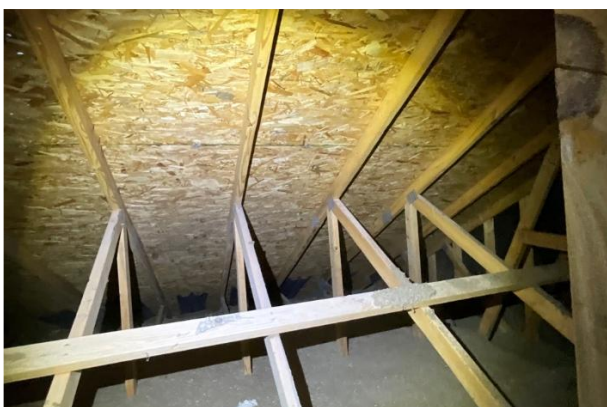
**Photo 50: Knee wall attic access bedroom to the left of the stair stairs**

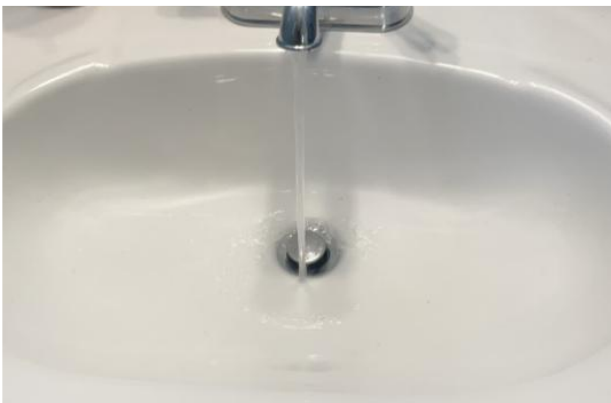
**Photo 82: Functional sink half bath**

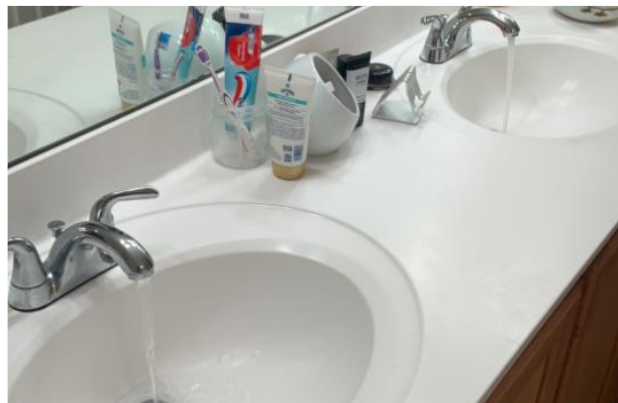
**Photo 83: Functional master bath sinks**

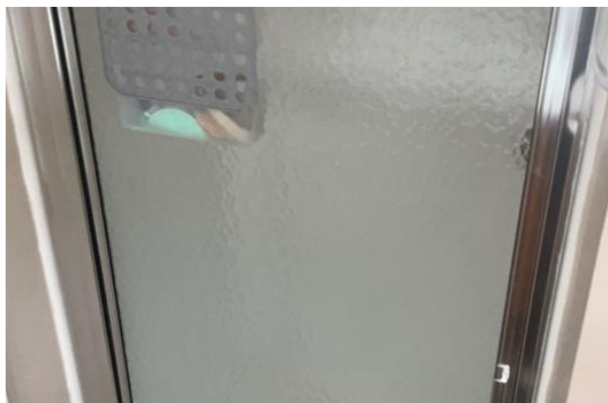
**Photo 85: Functional shower**

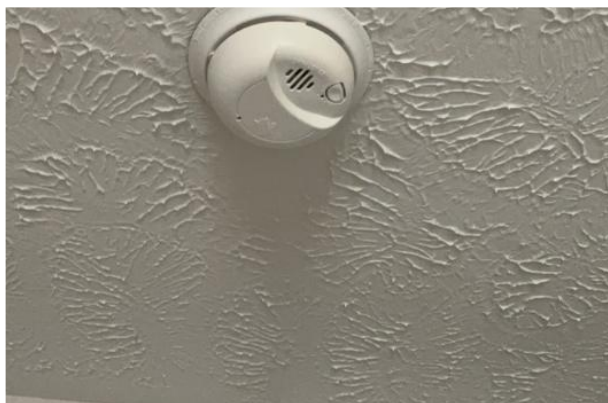
Photo 102: Smoke detector observed

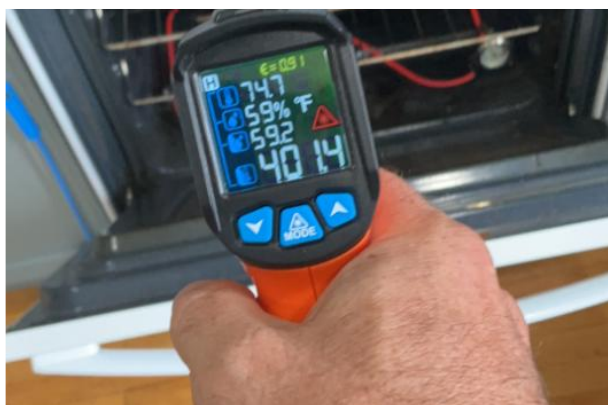
Photo 109: Oven temp

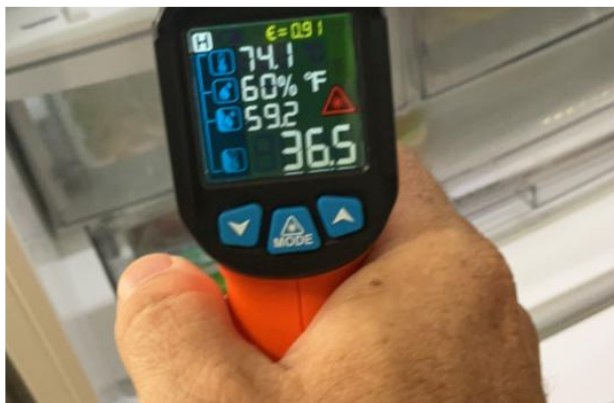
Photo 110: Fridge temp

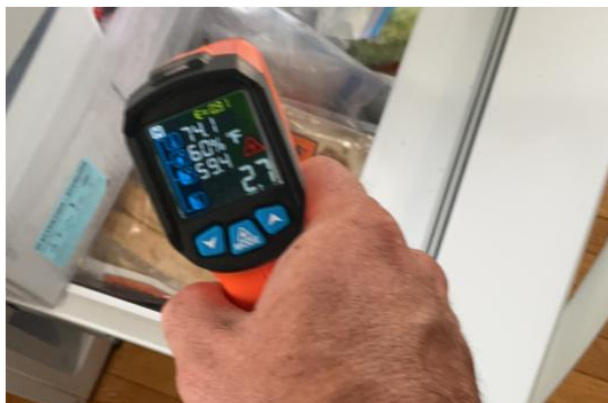
Photo 111: Freezer temp

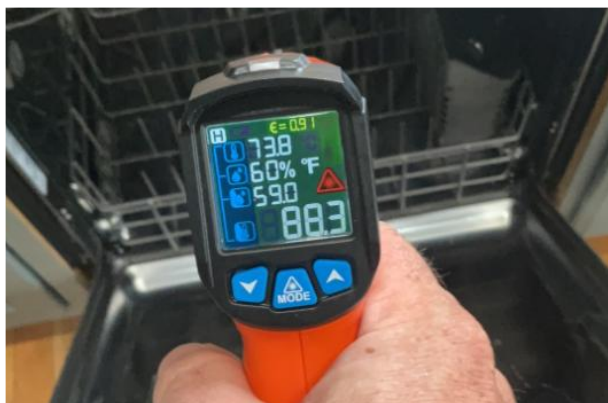
Photo 113: Dishwasher temp

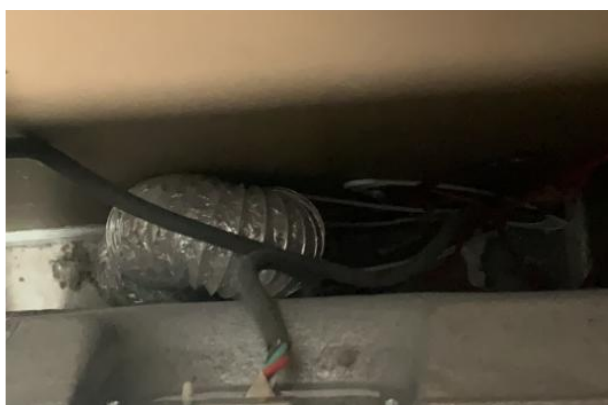
**Photo 117: Vent pipe**

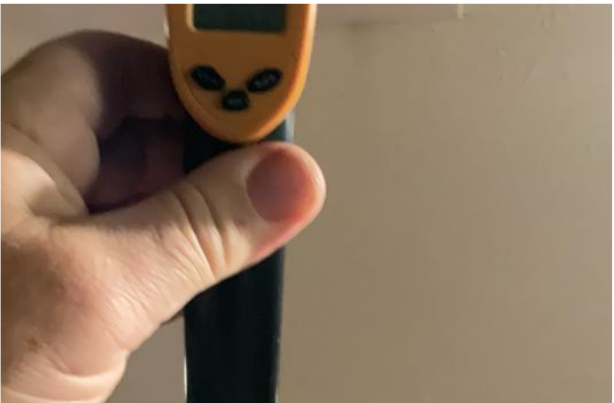
Photo 129: 93 degrees at register, functioning furnace
